## **Profile/Photo Observation Report**

Customer: City of Hobart, IN (Red Clean Date: 11/09/2021 Shape: C

Street: North Ash Street Flow Control: Not Controlled

US MH: M-604-111 DS MH: M-604-108 Total Length Surveyed (ft): 175.9

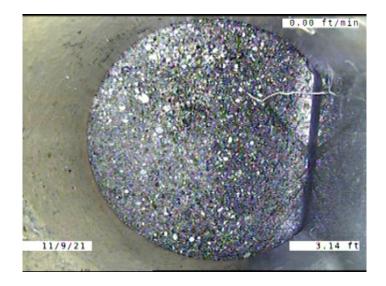
Code: **TFC**

Description: Tap Factory Capped

Distance (ft): 3.1
Structural Grade: 0
O&M Grade: 0
Clock Start/From: 3

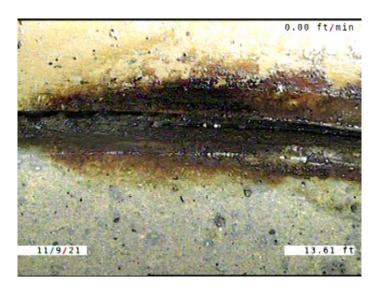
Code: ISJ

Description: Infiltration Stain Joint

Distance (ft): 13.6
Structural Grade: 0
O&M Grade: 1
Clock Start/From: 2
Clock To: 4
1st Value:
2nd Value:
Value Percent:
Continuous Index:

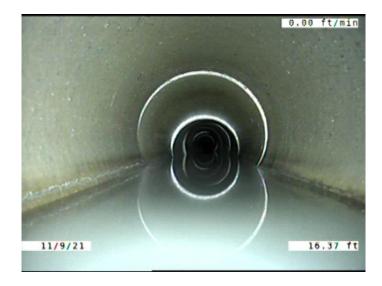
Code: MWLS

Description: Miscellaneous Water Level Sag

Distance (ft): 16.4
Structural Grade: 2
O&M Grade: 0

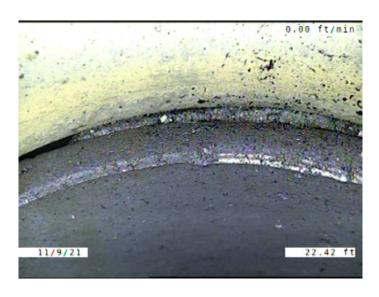
Code: JOMD

Description: Joint Offset Medium Defective

Distance (ft): 22.4
Structural Grade: 3
O&M Grade: 0

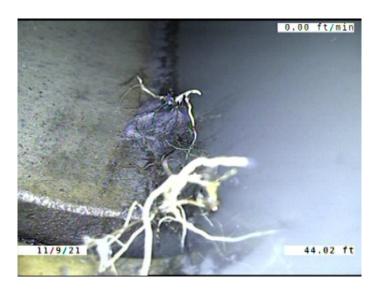
Code: OBZ

Description: Obstruction Other

Distance (ft): 44.0
Structural Grade: 0
O&M Grade: 2
Clock Start/From: 7
Clock To: 8
1st Value:

Remarks: ROOTS THAT HAVE BEEN CUT.

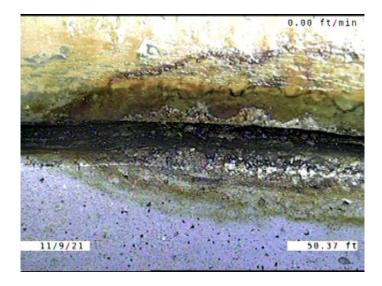
Code: ISJ

Description: Infiltration Stain Joint

Distance (ft): 50.4
Structural Grade: 0

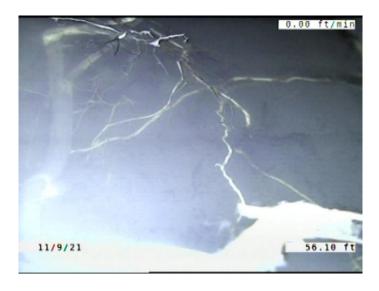
Code: OBZ

Description: Obstruction Other

Distance (ft): 56.1
Structural Grade: 0

Remarks: ROOTS THAT HAVE BEEN CUT.

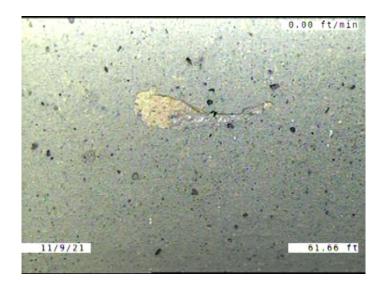
Code: SSS

Description: Surface Damage Surface Spalling

Distance (ft): 61.7
Structural Grade: 2
O&M Grade: 0
Clock Start/From: 10

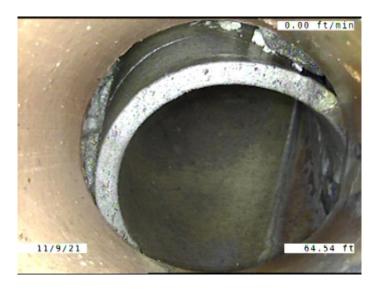
Code: **TFD**

Description: Tap Factory Defective

Distance (ft): 64.5
Structural Grade: 0
O&M Grade: 3
Clock Start/From: 2

Remarks: OFFSET. SOIL VISIBLE

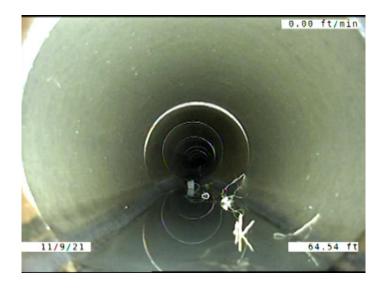
Code: OBZ

Description: **Obstruction Other**

Distance (ft): 64.5 Structural Grade: 0 2 O&M Grade: Clock Start/From: 5 Clock To: 7

Remarks: **ROOTS THAT HAVE BEEN CUT.**

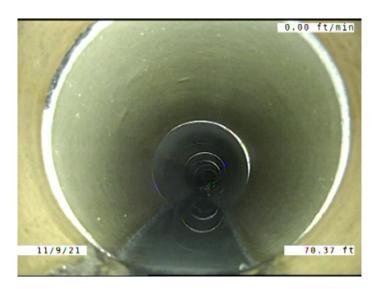
Code: **MWLS**

Description: **Miscellaneous Water Level Sag**

Distance (ft): 70.4 Structural Grade: 2 O&M Grade: 0

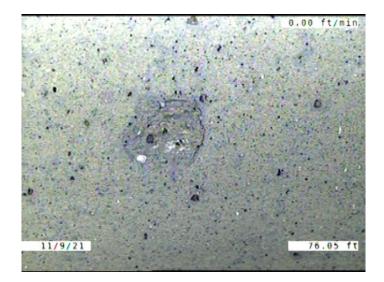
Code: SSS

Description: **Surface Damage Surface Spalling**

76.1 Distance (ft): Structural Grade: 2 O&M Grade: 0 Clock Start/From: 9

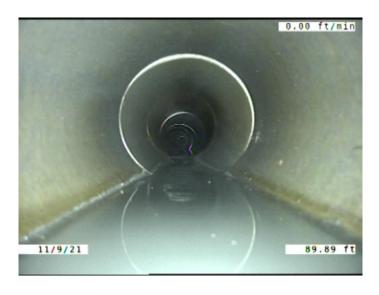
Code: **MWLS**

Description: **Miscellaneous Water Level Sag**

Distance (ft): 89.9 Structural Grade: 2 O&M Grade: 0

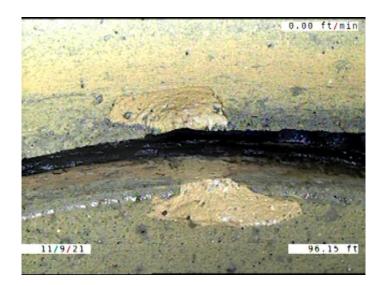
Code: SZ

Description: **Surface Damage Other**

96.2 Distance (ft): Structural Grade: 0 O&M Grade: 0 Clock Start/From: 9

Remarks: A PIECE CHIPPED OFF THE JOINT

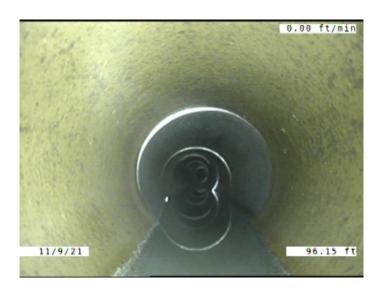
Code: **MWLS**

Description: **Miscellaneous Water Level Sag**

Distance (ft): 96.2 Structural Grade: 2 O&M Grade: 0

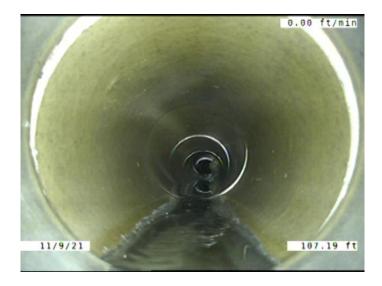
Code: **MWLS**

Description: **Miscellaneous Water Level Sag**

Distance (ft): 107.2 Structural Grade: 2 0 O&M Grade:

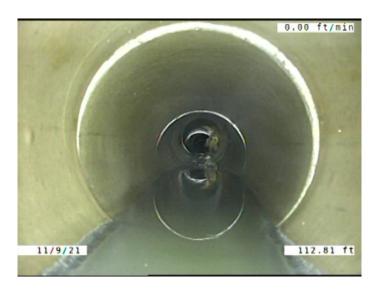
Code: **MWLS**

Description: **Miscellaneous Water Level Sag**

Distance (ft): 112.8 Structural Grade: 2 O&M Grade: 0

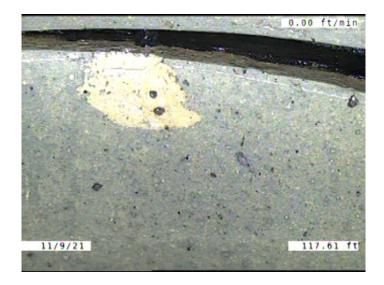
Code: SSS

Description: **Surface Damage Surface Spalling**

Distance (ft): 117.6 Structural Grade: 2 O&M Grade: 0 Clock Start/From: 1

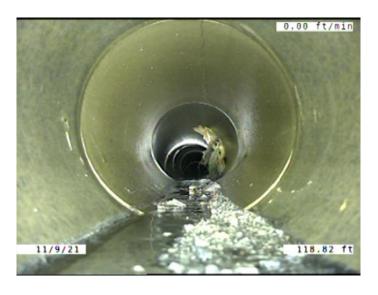
Code: DSF

Description: **Deposits Settled Fine**

Distance (ft): 118.8 Structural Grade: 0 O&M Grade: 2 Clock Start/From: 5 7 Clock To: 1st Value:

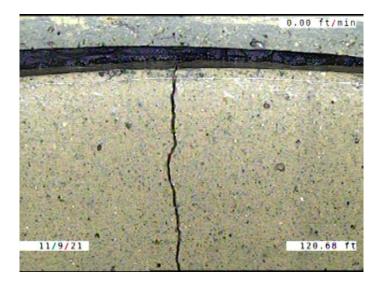
Code: FS

Description: **Fracture Spiral**

Distance (ft): 120.7

Structural Grade: 3 0 O&M Grade:

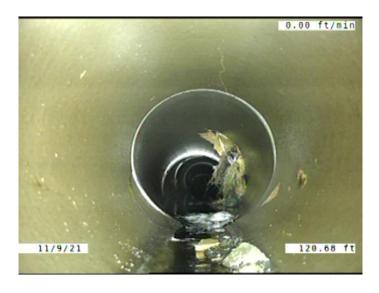
Code: **MWLS**

Description: **Miscellaneous Water Level Sag**

Distance (ft): 120.7 Structural Grade: 2 O&M Grade: 0

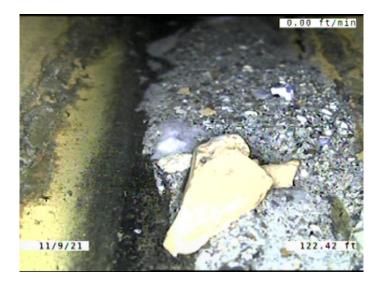
Code: OBM

Description: Obstruction Pipe Material in Invert

Distance (ft): 122.4
Structural Grade: 0
O&M Grade: 2
Clock Start/From: 6

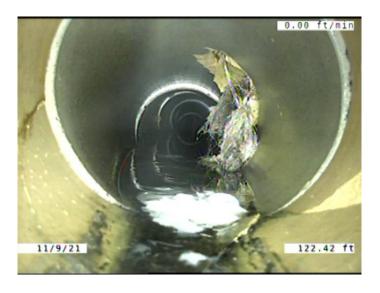
Code: **B**

Description: Broken

Distance (ft): 122.4
Structural Grade: 4
O&M Grade: 0
Clock Start/From: 3
Clock To: 9
1st Value:
2nd Value:

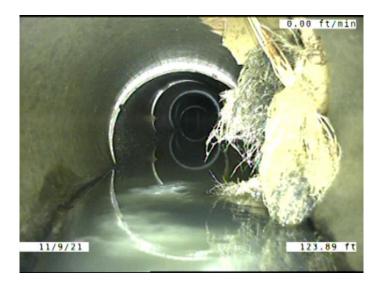
Code: MWLS

Description: Miscellaneous Water Level Sag

Distance (ft): 123.9
Structural Grade: 2
O&M Grade: 0

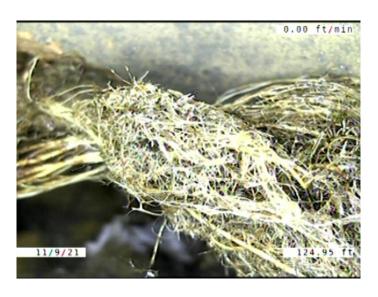
Code: RMC

Description: Roots Medium Connection

Distance (ft): 124.9
Structural Grade: 0
O&M Grade: 3
Clock Start/From: 1
Clock To: 3
1st Value:

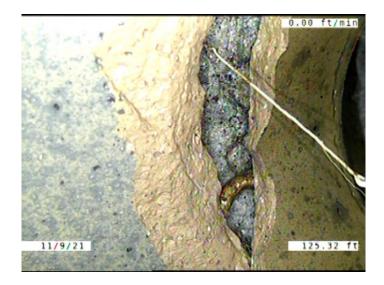
Code: SSS

Description: Surface Damage Surface Spalling

Distance (ft): 125.3
Structural Grade: 2
O&M Grade: 0
Clock Start/From: 12
Clock To: 3

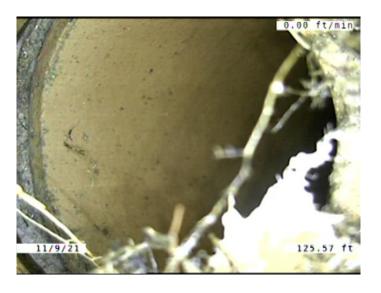
Code: TBI

Description: Tap Break-in Intruding

Distance (ft): 125.6
Structural Grade: 0
O&M Grade: 2
Clock Start/From: 2

Remarks: ROOTS GROWING AROUND IT AND INOT THE MAIN. CONSTANTLY RUN

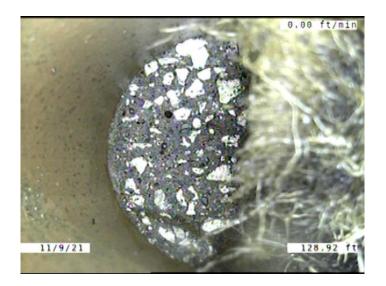
Code: **TFD**

Description: Tap Factory Defective

Distance (ft): 128.9
Structural Grade: 0
O&M Grade: 3
Clock Start/From: 3

Remarks: CAPPED. ROOTS GROWING AROUND

THE CAP INTO THE MAIN

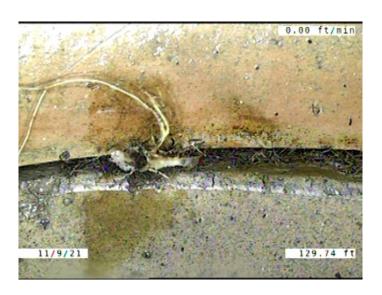
Code: RFJ

Description: Roots Fine Joint

Distance (ft): 129.7
Structural Grade: 0
O&M Grade: 1
Clock Start/From: 9
Clock To: 11
1st Value:
2nd Value:
Value Percent:

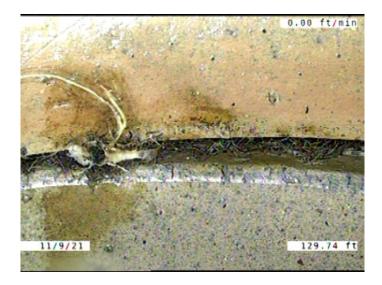
Code: ISJ

Description: Infiltration Stain Joint

Distance (ft): 129.7
Structural Grade: 0
O&M Grade: 1
Clock Start/From: 9
Clock To: 10

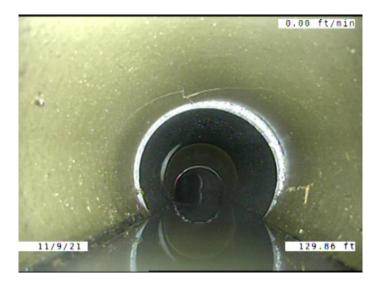
Code: OBZ

Description: Obstruction Other

Distance (ft): 129.9
Structural Grade: 0
O&M Grade: 2
Clock Start/From: 5
Clock To: 7
1st Value:

Remarks: ROOTS THAT HAVE BEEN CUT.

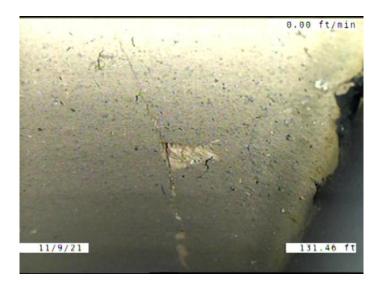
Code: Description: Broken

Distance (ft): 131.5 Structural Grade: 4 O&M Grade: 0 Clock Start/From: 12 Clock To: 12 1st Value: 2nd Value: Value Percent: Continuous Index: Within 8" of Joint:

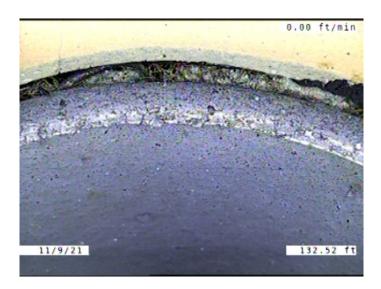
Code: **JOMD**

Description: **Joint Offset Medium Defective**

Distance (ft): 132.5 Structural Grade: 3 O&M Grade: 0 Clock Start/From:

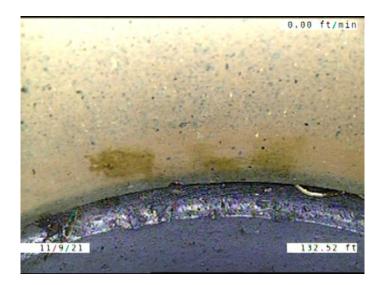
Code: RFJ

Description: Roots Fine Joint

Distance (ft): 132.5
Structural Grade: 0
O&M Grade: 1
Clock Start/From: 9
Clock To: 3

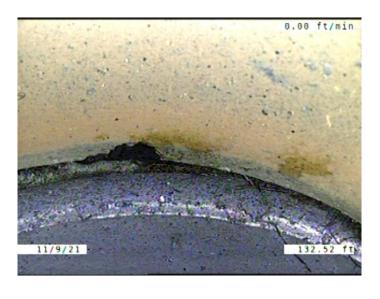
Code: ISJ

Description: Infiltration Stain Joint

Distance (ft): 132.5
Structural Grade: 0
O&M Grade: 1
Clock Start/From: 2
Clock To: 3
1st Value:
2nd Value:
Value Percent:
Continuous Index:

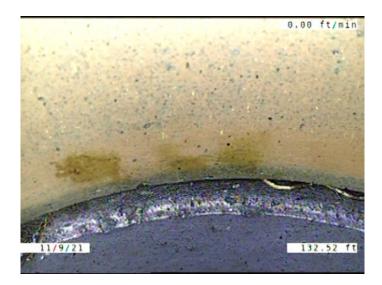
Code: ISJ

Description: Infiltration Stain Joint

Distance (ft): 132.5
Structural Grade: 0
O&M Grade: 1
Clock Start/From: 9
Clock To: 10

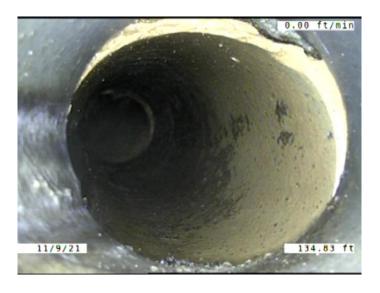
Code: TF

Description: Tap Factory

Distance (ft): 134.8
Structural Grade: 0
O&M Grade: 0
Clock Start/From: 10

Remarks: CONSTANTLY RUNNING WATER

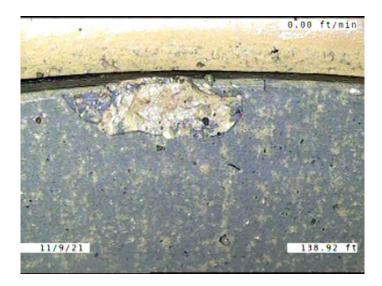
Code: SSS

Description: Surface Damage Surface Spalling

Distance (ft): 138.9
Structural Grade: 2
O&M Grade: 0
Clock Start/From: 11

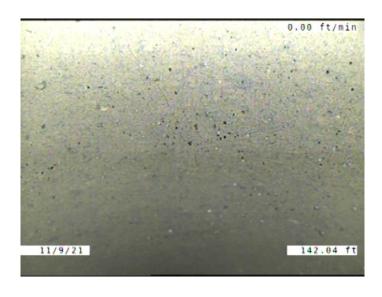
Code: CM

Description: Crack Multiple

Distance (ft): 142.0
Structural Grade: 3
O&M Grade: 0
Clock Start/From: 10
Clock To: 1
1st Value:
2nd Value:

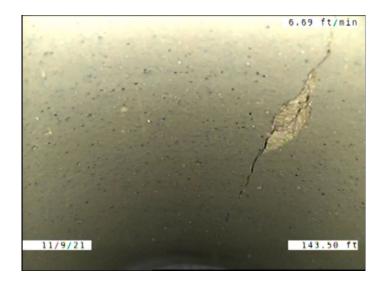
Code: SSS

Description: **Surface Damage Surface Spalling**

Distance (ft): 143.5 Structural Grade: 2 O&M Grade: 0 Clock Start/From: 12

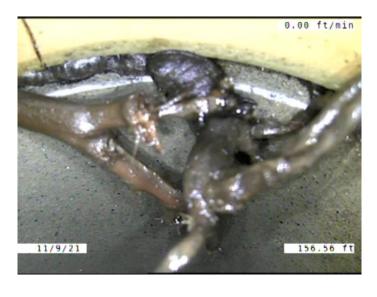
Code: RTJ

Description: **Roots Tap Joint**

Distance (ft): 156.6 Structural Grade: 0 O&M Grade: 2 Clock Start/From: 12 2 Clock To: 1st Value:

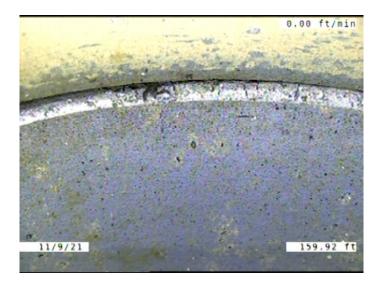
Code: RFJ

Description: Roots Fine Joint

Distance (ft): 159.9
Structural Grade: 0
O&M Grade: 1
Clock Start/From: 10

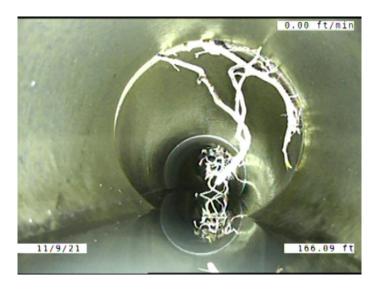
Code: RMJ

Description: Roots Medium Joint

Distance (ft): 166.1
Structural Grade: 0
O&M Grade: 3
Clock Start/From: 11
Clock To: 2
1st Value:

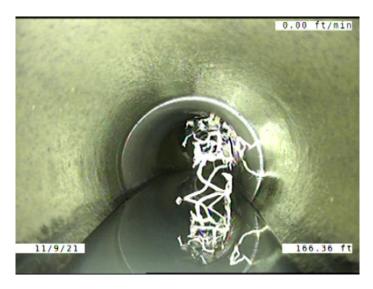
Code: **MWLS**

Description: **Miscellaneous Water Level Sag**

Distance (ft): 166.4 Structural Grade: 2 O&M Grade: 0

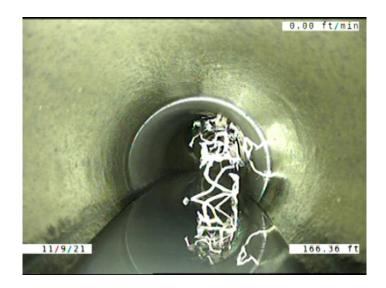
Code: MWLS

Description: Miscellaneous Water Level Sag

Distance (ft): 166.4
Structural Grade: 2
O&M Grade: 0

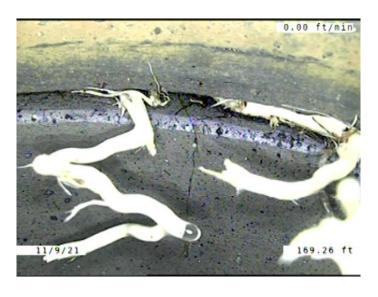
Code: RFJ

Description: Roots Fine Joint

Distance (ft): 169.3
Structural Grade: 0
O&M Grade: 1
Clock Start/From: 2
Clock To: 3
1st Value:
2nd Value:
Value Percent:
Continuous Index:

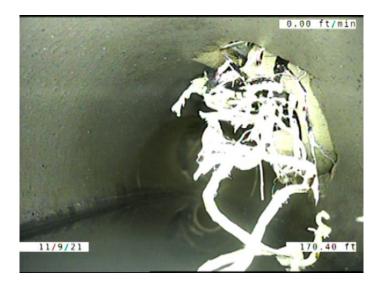
Code: **RMC**

Description: **Roots Medium Connection**

Distance (ft): 170.4 Structural Grade: 0 3 O&M Grade: Clock Start/From: 1 Clock To: 3

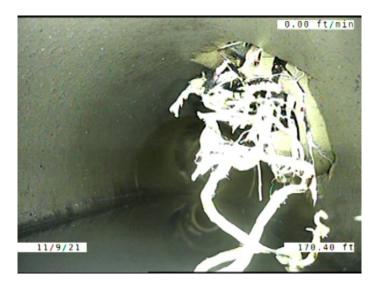
CM Code:

Description: **Crack Multiple**

Distance (ft): 170.4 Structural Grade: 3 O&M Grade: 0 Clock Start/From: 1 3 Clock To: 1st Value:

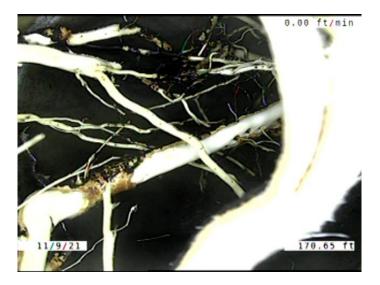
Code: TBI

Description: **Tap Break-in Intruding**

Distance (ft): 170.6 Structural Grade: 0 2 O&M Grade: Clock Start/From: 2

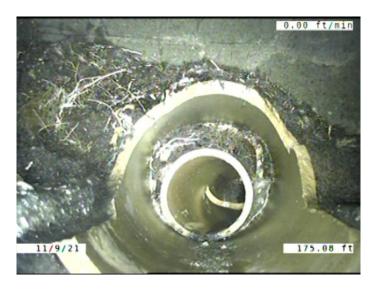
Code: **MWLS**

Description: **Miscellaneous Water Level Sag**

Distance (ft): 175.1 Structural Grade: 2 O&M Grade: 0

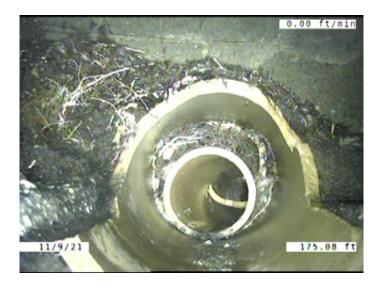
Code: **DSF**

Description: Deposits Settled Fine

Distance (ft): 175.1
Structural Grade: 0
O&M Grade: 2
Clock Start/From: 5
Clock To: 7

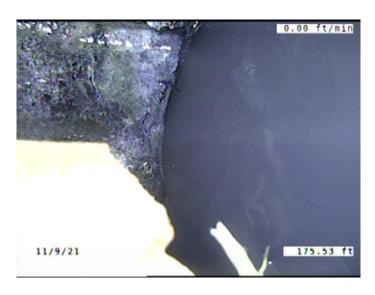
Code: MGO

Description: Miscellaneous General Observation

Distance (ft): 175.5
Structural Grade: 0
O&M Grade: 0

Remarks: Pipe floor missing in MH
