RedZone  
ROBOTICS

Street:	North Ash Street		Flow Control:	Not Controlled	
City:	City of Hobart		Year Renewed:		
Location:	Local rural streets with light traffic, t		Tape/Media #:		
Purpose:	Routine Assessment		Dia/Height:	10"	
Use:	Sanitary Sewage Pipe		Material:	VCP	
Drain Area:			Lining:	None	
Category:	NA				
Comment:					
Location Details:			Direction of Survey:	Upstream	
US MH:	M-604-111	DS MH:	M-604-108	Total Length Surveyed (ft):	175.9

**Wednesday, January 19, 2022**

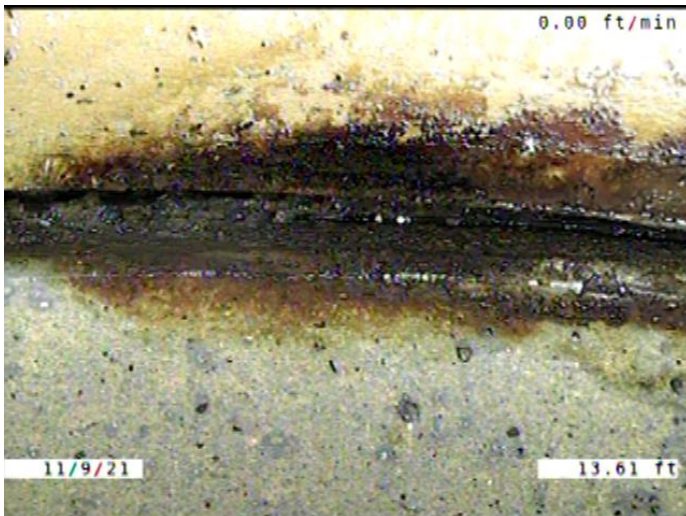
Code: **ISJ**  
 Description: **Infiltration Stain Joint**

Distance (ft): **13.6**  
 Structural Grade: **0**  
 O&M Grade: **1**  
 Clock Start/From: **2**  
 Clock To: **4**  
 1st Value:  
 2nd Value:  
 Value Percent:  
 Continuous Index:  
 Within 8" of Joint: **YES**  
 Remarks:

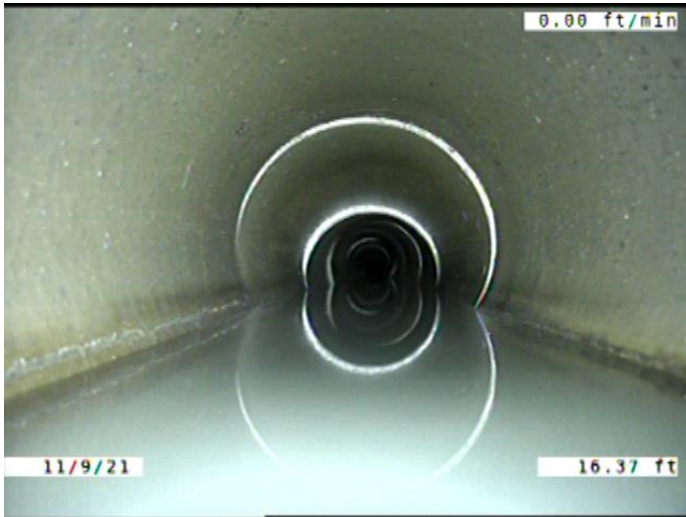
Code: **MWLS**  
Description: **Miscellaneous Water Level Sag**

Distance (ft): **16.4**  
Structural Grade: **2**  
O&M Grade: **0**  
Clock Start/From:  
Clock To:  
1st Value:  
2nd Value:  
Value Percent: **10.000**  
Continuous Index: **S01**  
Within 8" of Joint: **NO**  
Remarks:

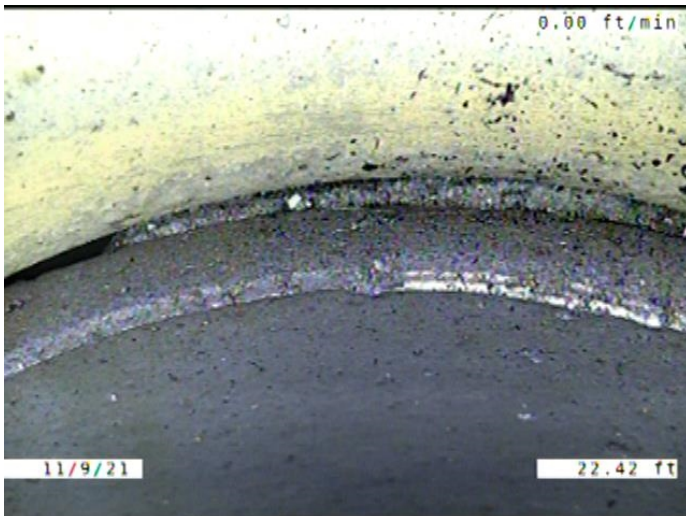
Code: **JOMD**  
Description: **Joint Offset Medium Defective**

Distance (ft): **22.4**  
Structural Grade: **3**  
O&M Grade: **0**  
Clock Start/From:  
Clock To:  
1st Value:  
2nd Value:  
Value Percent:  
Continuous Index:  
Within 8" of Joint: **NO**  
Remarks:

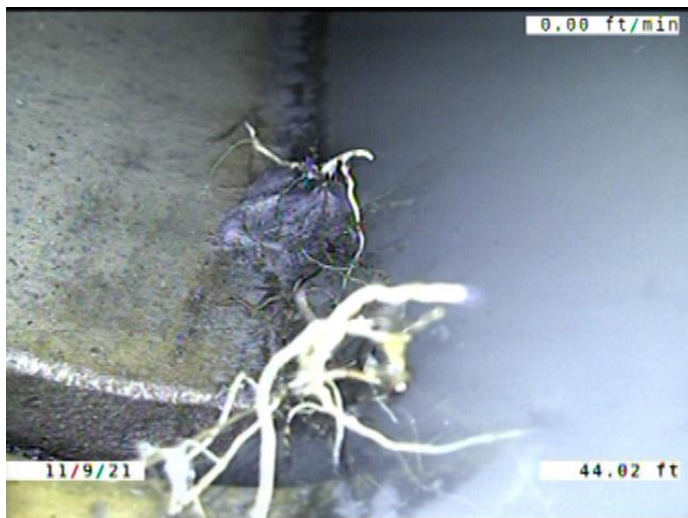
Code: **OBZ**  
 Description: **Obstruction Other**

Distance (ft): **44.0**  
 Structural Grade: **0**  
 O&M Grade: **2**  
 Clock Start/From: **7**  
 Clock To: **8**  
 1st Value:  
 2nd Value:  
 Value Percent: **5.000**  
 Continuous Index:  
 Within 8" of Joint: **YES**  
 Remarks: **ROOTS THAT HAVE BEEN CUT.**

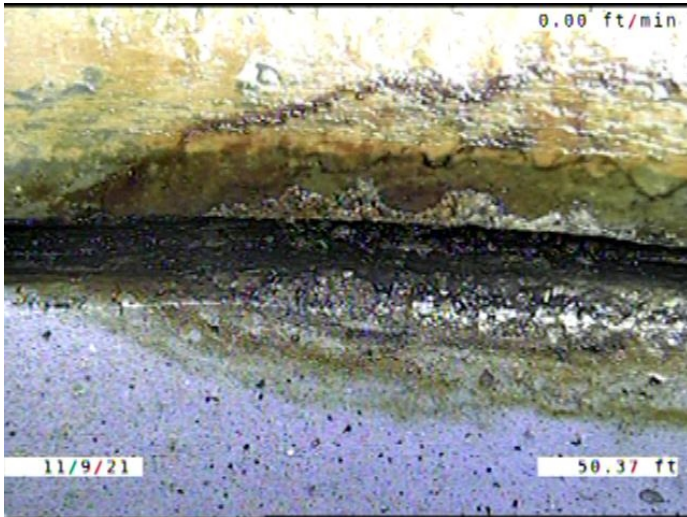
Code: **ISJ**  
 Description: **Infiltration Stain Joint**

Distance (ft): **50.4**  
 Structural Grade: **0**  
 O&M Grade: **1**  
 Clock Start/From: **1**  
 Clock To: **3**  
 1st Value:  
 2nd Value:  
 Value Percent:  
 Continuous Index:  
 Within 8" of Joint: **YES**  
 Remarks:

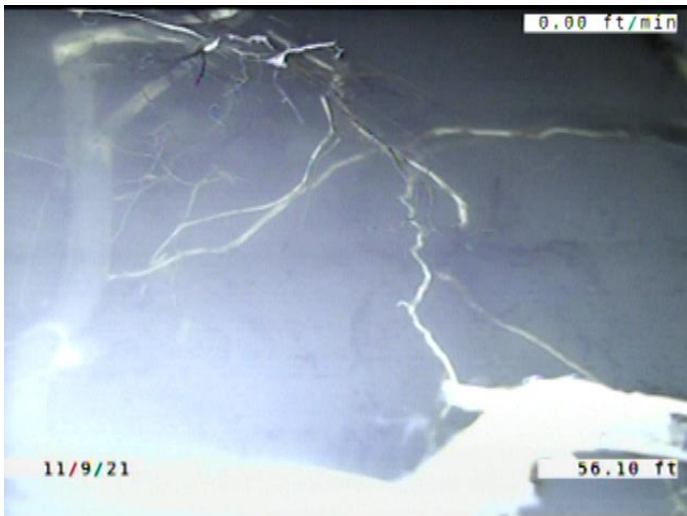
Code: **OBZ**  
 Description: **Obstruction Other**

Distance (ft): **56.1**  
 Structural Grade: **0**  
 O&M Grade: **2**  
 Clock Start/From: **5**  
 Clock To: **7**  
 1st Value:  
 2nd Value:  
 Value Percent: **5.000**  
 Continuous Index:  
 Within 8" of Joint: **YES**  
 Remarks: **ROOTS THAT HAVE BEEN CUT.**

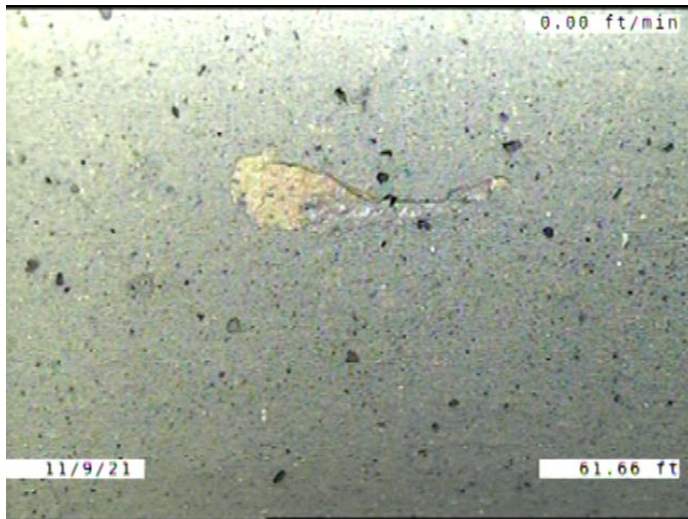
Code: **SSS**  
Description: **Surface Damage Surface Spalling**

Distance (ft): **61.7**  
Structural Grade: **2**  
O&M Grade: **0**  
Clock Start/From: **10**  
Clock To:  
1st Value:  
2nd Value:  
Value Percent:  
Continuous Index:  
Within 8" of Joint: **NO**  
Remarks:

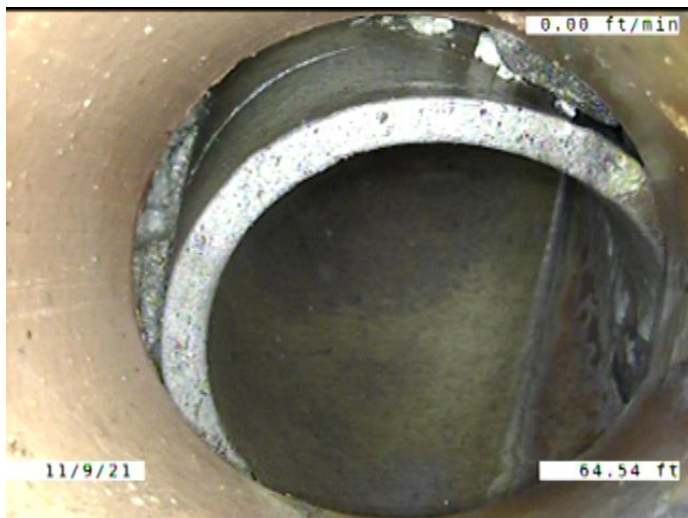
Code: **TFD**  
Description: **Tap Factory Defective**

Distance (ft): **64.5**  
Structural Grade: **0**  
O&M Grade: **3**  
Clock Start/From: **2**  
Clock To:  
1st Value: **4.000**  
2nd Value:  
Value Percent:  
Continuous Index:  
Within 8" of Joint: **YES**  
Remarks: **OFFSET. SOIL VISIBLE**

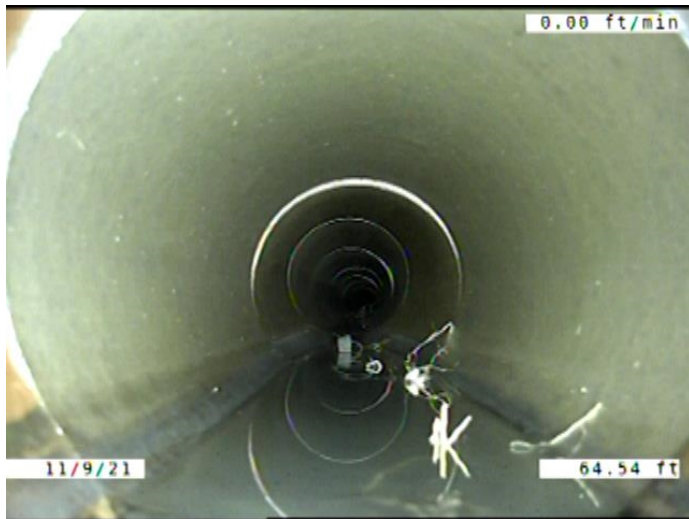
Code: **OBZ**  
Description: **Obstruction Other**

Distance (ft): **64.5**  
Structural Grade: **0**  
O&M Grade: **2**  
Clock Start/From: **5**  
Clock To: **7**  
1st Value:  
2nd Value:  
Value Percent: **5.000**  
Continuous Index: **S02**  
Within 8" of Joint: **YES**  
Remarks: **ROOTS THAT HAVE BEEN CUT.**

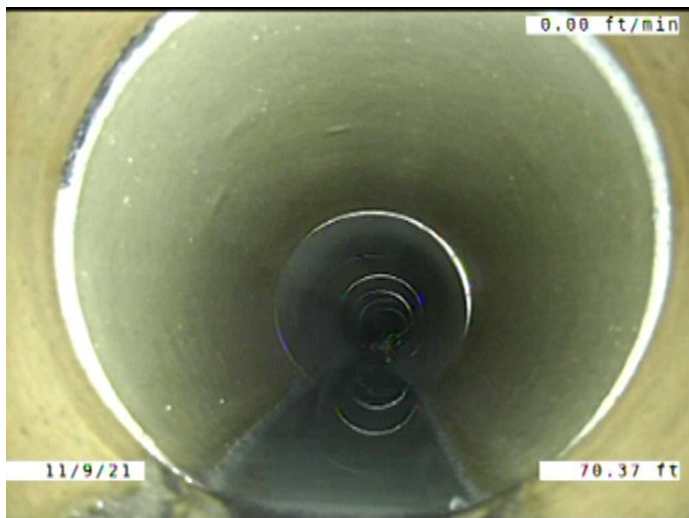
Code: **MWLS**  
Description: **Miscellaneous Water Level Sag**

Distance (ft): **70.4**  
Structural Grade: **2**  
O&M Grade: **0**  
Clock Start/From:  
Clock To:  
1st Value:  
2nd Value:  
Value Percent: **10.000**  
Continuous Index: **F01**  
Within 8" of Joint: **NO**  
Remarks:

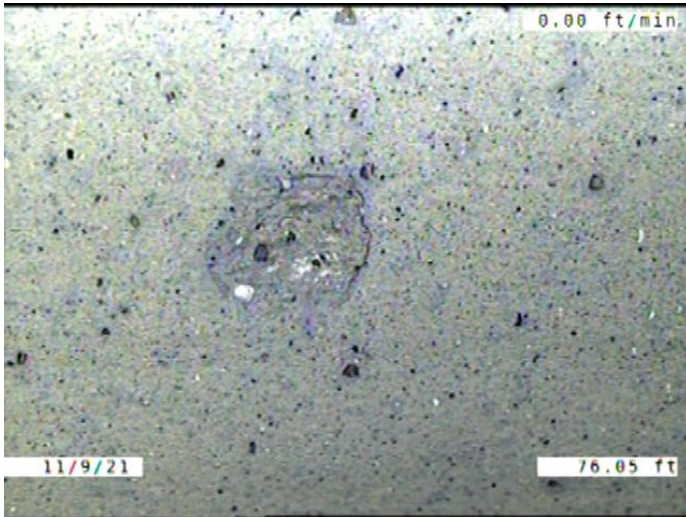
Code: **SSS**  
Description: **Surface Damage Surface Spalling**

Distance (ft): **76.1**  
Structural Grade: **2**  
O&M Grade: **0**  
Clock Start/From: **9**  
Clock To:  
1st Value:  
2nd Value:  
Value Percent:  
Continuous Index:  
Within 8" of Joint: **YES**  
Remarks:

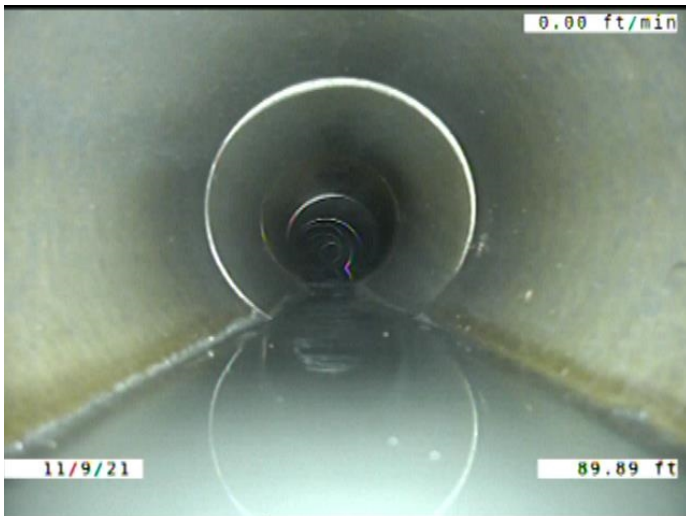
Code: **MWLS**  
Description: **Miscellaneous Water Level Sag**

Distance (ft): **89.9**  
Structural Grade: **2**  
O&M Grade: **0**  
Clock Start/From:  
Clock To:  
1st Value:  
2nd Value:  
Value Percent: **5.000**  
Continuous Index:  
Within 8" of Joint: **NO**  
Remarks:

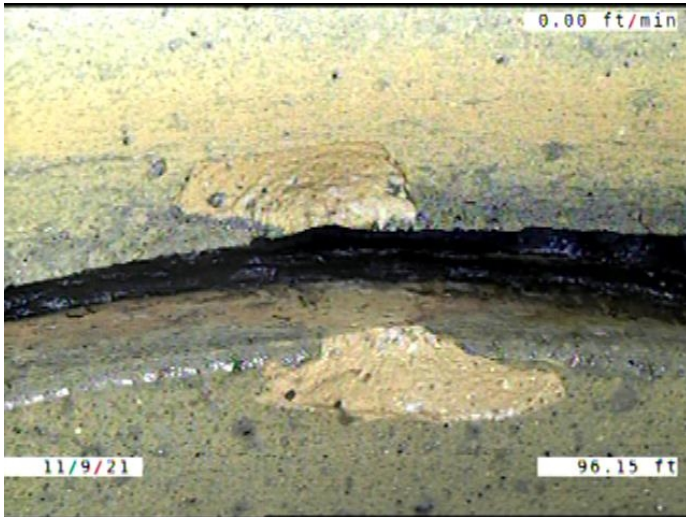
Code: **SZ**  
 Description: **Surface Damage Other**

Distance (ft): **96.2**  
 Structural Grade: **0**  
 O&M Grade: **0**  
 Clock Start/From: **9**  
 Clock To:  
 1st Value:  
 2nd Value:  
 Value Percent:  
 Continuous Index:  
 Within 8" of Joint: **YES**  
 Remarks: **A PIECE CHIPPED OFF THE JOINT**

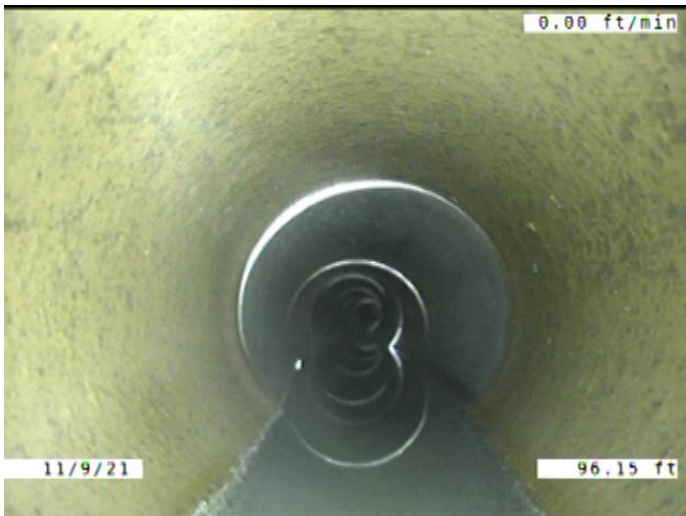
Code: **MWLS**  
 Description: **Miscellaneous Water Level Sag**

Distance (ft): **96.2**  
 Structural Grade: **2**  
 O&M Grade: **0**  
 Clock Start/From:  
 Clock To:  
 1st Value:  
 2nd Value:  
 Value Percent: **5.000**  
 Continuous Index: **S03**  
 Within 8" of Joint: **NO**  
 Remarks:

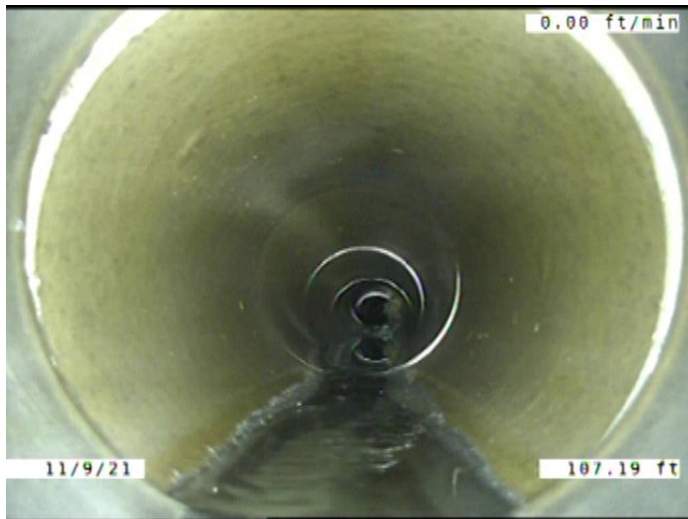
Code: **MWLS**  
Description: **Miscellaneous Water Level Sag**

Distance (ft): **107.2**  
Structural Grade: **2**  
O&M Grade: **0**  
Clock Start/From:  
Clock To:  
1st Value:  
2nd Value:  
Value Percent: **5.000**  
Continuous Index: **F03**  
Within 8" of Joint: **NO**  
Remarks:

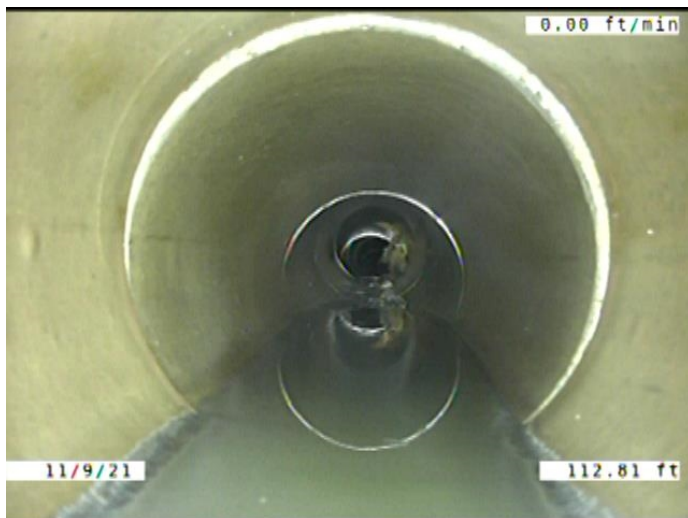
Code: **MWLS**  
Description: **Miscellaneous Water Level Sag**

Distance (ft): **112.8**  
Structural Grade: **2**  
O&M Grade: **0**  
Clock Start/From:  
Clock To:  
1st Value:  
2nd Value:  
Value Percent: **5.000**  
Continuous Index: **S04**  
Within 8" of Joint: **NO**  
Remarks:

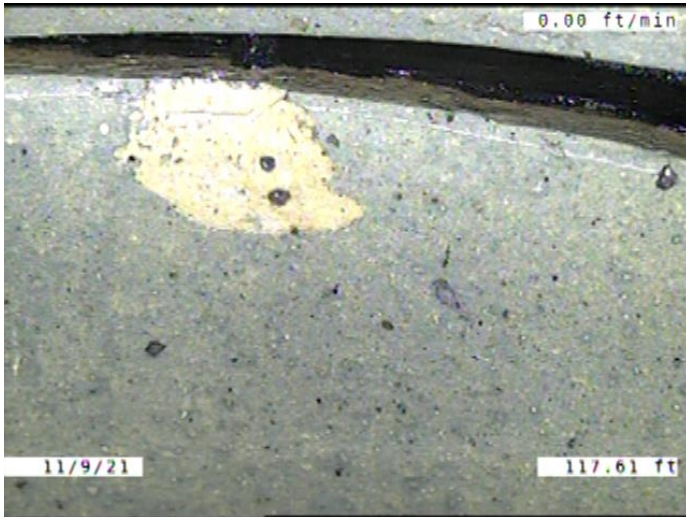
Code: **SSS**  
 Description: **Surface Damage Surface Spalling**

Distance (ft): **117.6**  
 Structural Grade: **2**  
 O&M Grade: **0**  
 Clock Start/From: **1**  
 Clock To:  
 1st Value:  
 2nd Value:  
 Value Percent:  
 Continuous Index:  
 Within 8" of Joint: **YES**  
 Remarks:

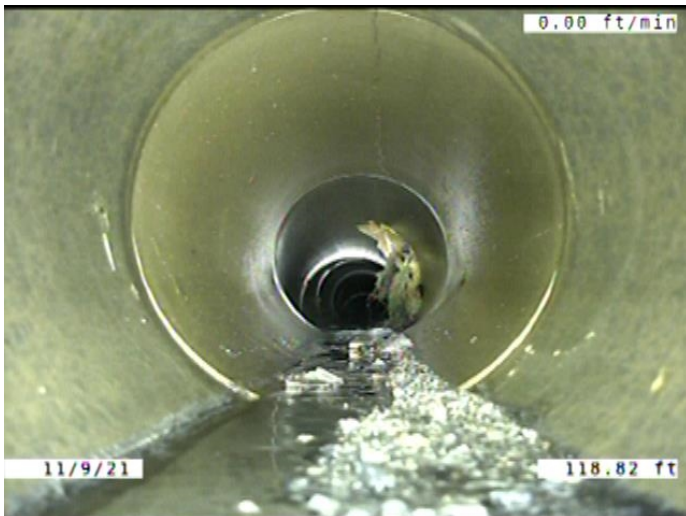
Code: **DSF**  
 Description: **Deposits Settled Fine**

Distance (ft): **118.8**  
 Structural Grade: **0**  
 O&M Grade: **2**  
 Clock Start/From: **5**  
 Clock To: **7**  
 1st Value:  
 2nd Value:  
 Value Percent: **5.000**  
 Continuous Index: **S05**  
 Within 8" of Joint: **YES**  
 Remarks:

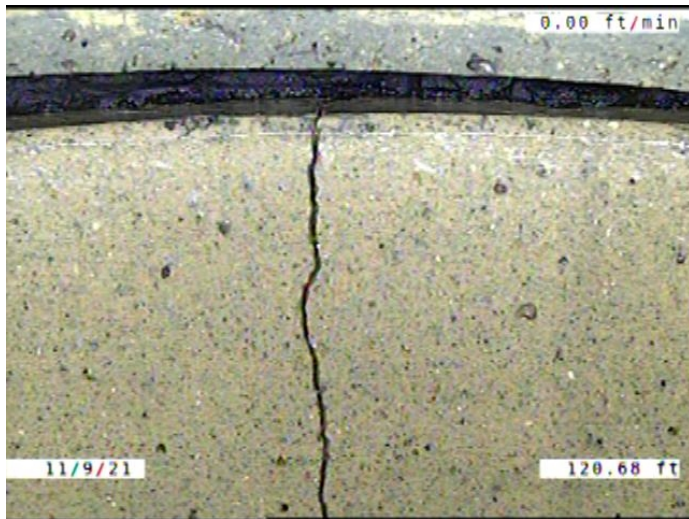
Code: **FS**  
 Description: **Fracture Spiral**

Distance (ft): **120.7**  
 Structural Grade: **3**  
 O&M Grade: **0**  
 Clock Start/From: **12**  
 Clock To: **1**  
 1st Value:  
 2nd Value:  
 Value Percent:  
 Continuous Index:  
 Within 8" of Joint: **YES**  
 Remarks:

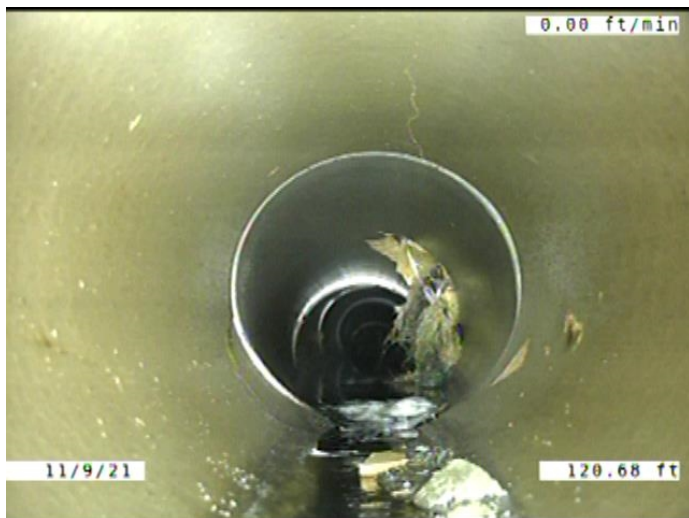
Code: **MWLS**  
 Description: **Miscellaneous Water Level Sag**

Distance (ft): **120.7**  
 Structural Grade: **2**  
 O&M Grade: **0**  
 Clock Start/From:  
 Clock To:  
 1st Value:  
 2nd Value:  
 Value Percent: **5.000**  
 Continuous Index: **F04**  
 Within 8" of Joint: **NO**  
 Remarks:

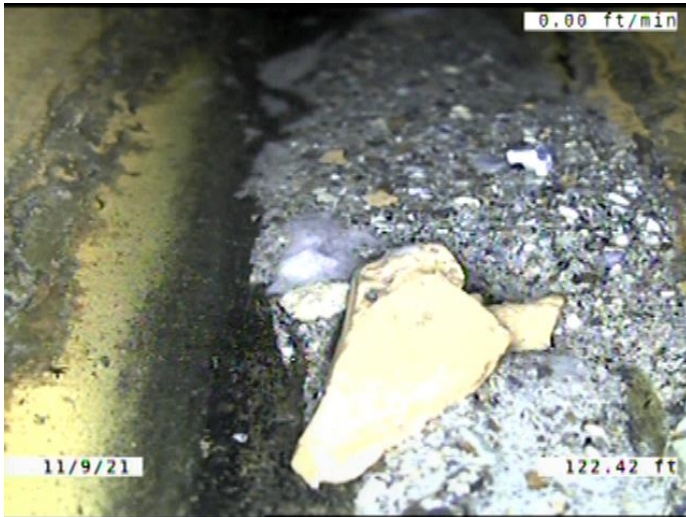
Code: **OBM**  
 Description: **Obstruction Pipe Material in Invert**

Distance (ft): **122.4**  
 Structural Grade: **0**  
 O&M Grade: **2**  
 Clock Start/From: **6**  
 Clock To:  
 1st Value:  
 2nd Value:  
 Value Percent: **5.000**  
 Continuous Index:  
 Within 8" of Joint: **NO**  
 Remarks:

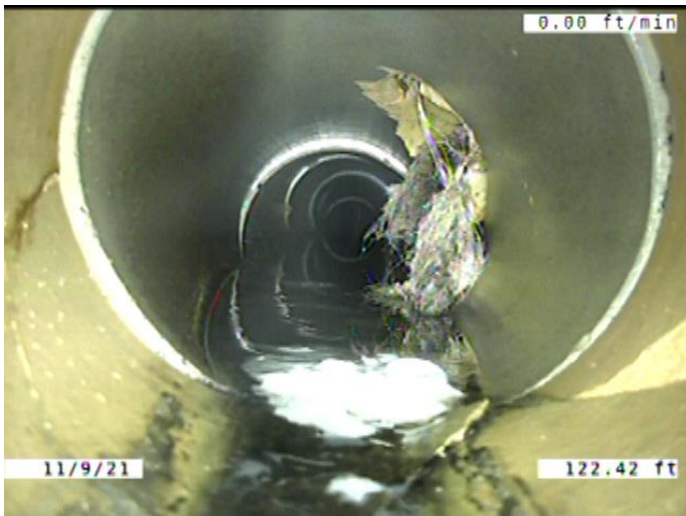
Code: **B**  
 Description: **Broken**

Distance (ft): **122.4**  
 Structural Grade: **4**  
 O&M Grade: **0**  
 Clock Start/From: **3**  
 Clock To: **9**  
 1st Value:  
 2nd Value:  
 Value Percent:  
 Continuous Index:  
 Within 8" of Joint: **YES**  
 Remarks:

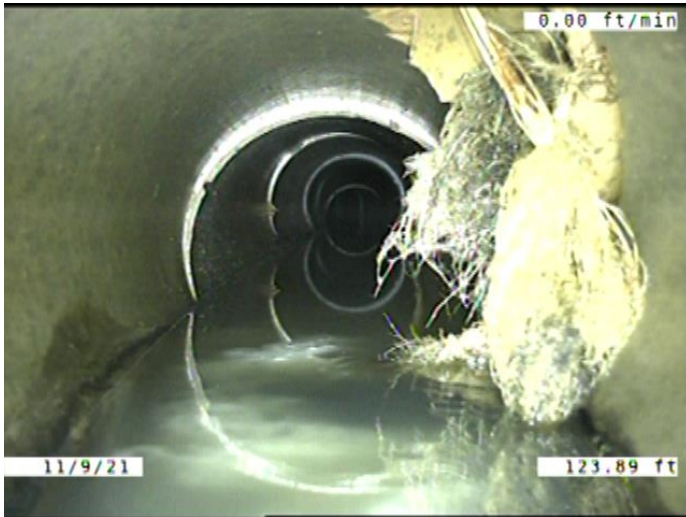
Code: **MWLS**  
 Description: **Miscellaneous Water Level Sag**

Distance (ft): **123.9**  
 Structural Grade: **2**  
 O&M Grade: **0**  
 Clock Start/From:  
 Clock To:  
 1st Value:  
 2nd Value:  
 Value Percent: **20.000**  
 Continuous Index: **S06**  
 Within 8" of Joint: **NO**  
 Remarks:

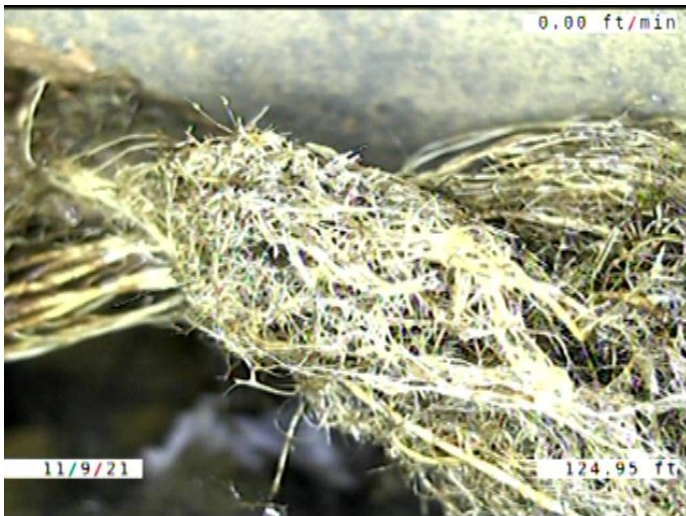
Code: **RMC**  
 Description: **Roots Medium Connection**

Distance (ft): **124.9**  
 Structural Grade: **0**  
 O&M Grade: **3**  
 Clock Start/From: **1**  
 Clock To: **3**  
 1st Value:  
 2nd Value:  
 Value Percent: **10.000**  
 Continuous Index:  
 Within 8" of Joint: **NO**  
 Remarks:

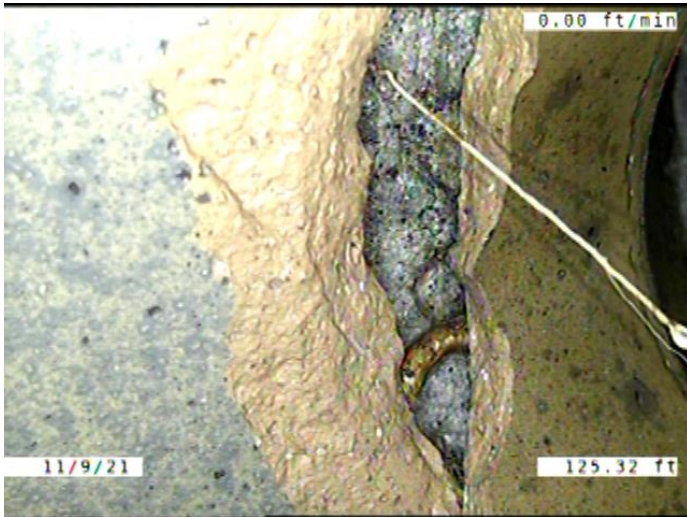
Code: **SSS**  
 Description: **Surface Damage Surface Spalling**

Distance (ft): **125.3**  
 Structural Grade: **2**  
 O&M Grade: **0**  
 Clock Start/From: **12**  
 Clock To: **3**  
 1st Value:  
 2nd Value:  
 Value Percent:  
 Continuous Index:  
 Within 8" of Joint: **YES**  
 Remarks:

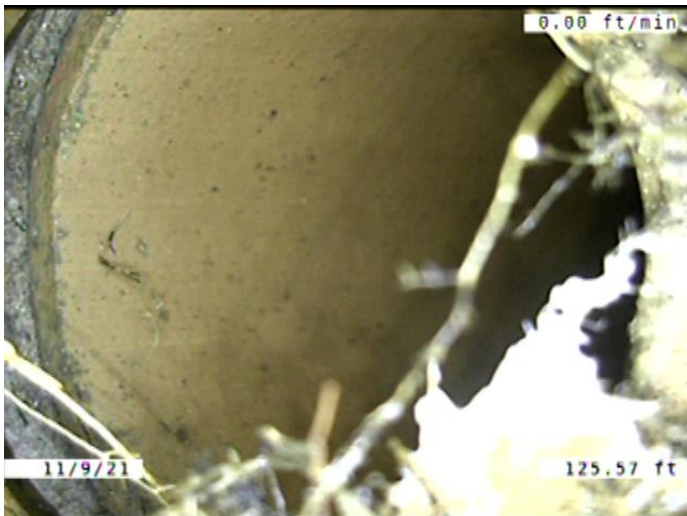
Code: **TBI**  
 Description: **Tap Break-in Intruding**

Distance (ft): **125.6**  
 Structural Grade: **0**  
 O&M Grade: **2**  
 Clock Start/From: **2**  
 Clock To:  
 1st Value: **4.000**  
 2nd Value: **1.000**  
 Value Percent:  
 Continuous Index:  
 Within 8" of Joint: **YES**  
 Remarks: **ROOTS GROWING AROUND IT AND INOT THE MAIN. CONSTANTLY RUN**

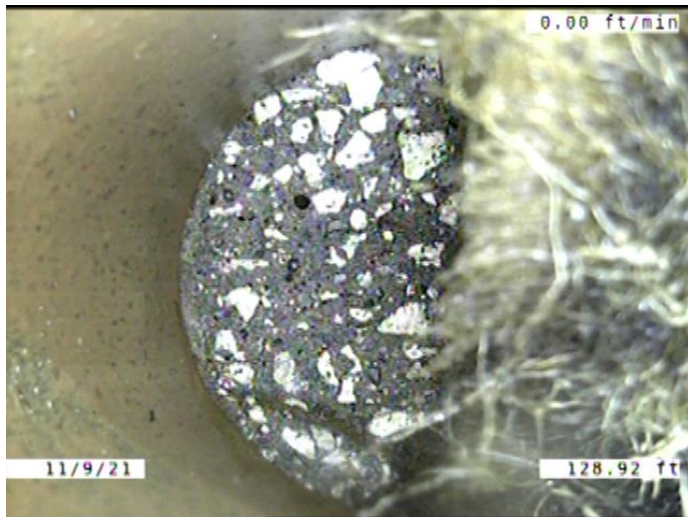
Code: **TFD**  
 Description: **Tap Factory Defective**

Distance (ft): **128.9**  
 Structural Grade: **0**  
 O&M Grade: **3**  
 Clock Start/From: **3**  
 Clock To:  
 1st Value: **4.000**  
 2nd Value:  
 Value Percent:  
 Continuous Index:  
 Within 8" of Joint: **YES**  
 Remarks: **CAPPED. ROOTS GROWING AROUND THE CAP INTO THE MAIN**

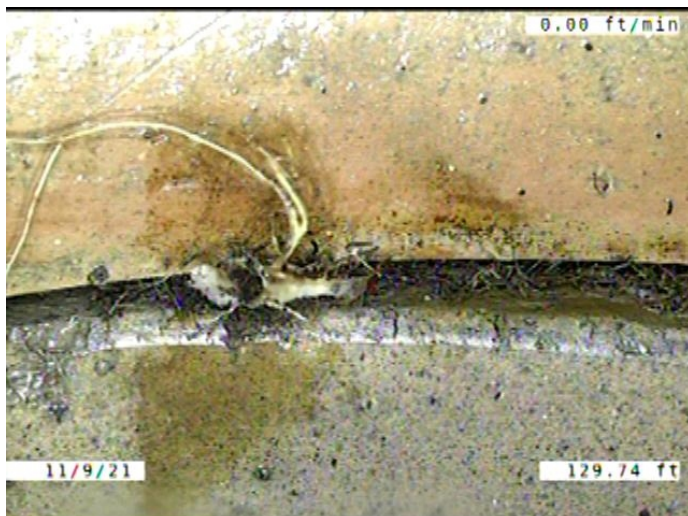
Code: **RFJ**  
 Description: **Roots Fine Joint**

Distance (ft): **129.7**  
 Structural Grade: **0**  
 O&M Grade: **1**  
 Clock Start/From: **9**  
 Clock To: **11**  
 1st Value:  
 2nd Value:  
 Value Percent:  
 Continuous Index:  
 Within 8" of Joint: **YES**  
 Remarks:

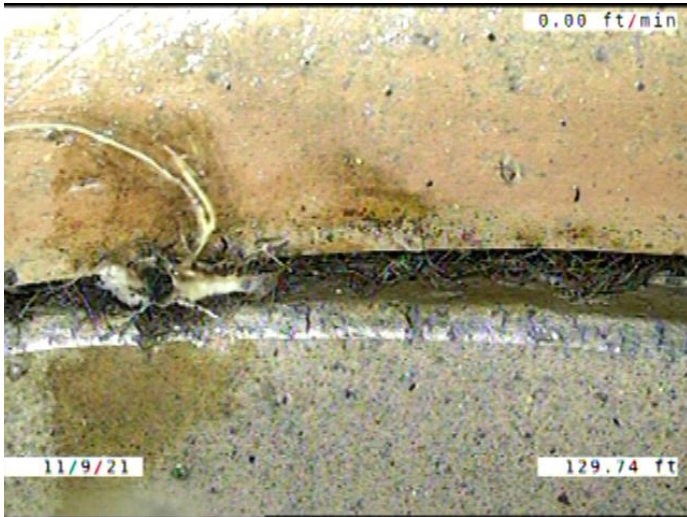
Code: **ISJ**  
Description: **Infiltration Stain Joint**

Distance (ft): **129.7**  
Structural Grade: **0**  
O&M Grade: **1**  
Clock Start/From: **9**  
Clock To: **10**  
1st Value:  
2nd Value:  
Value Percent:  
Continuous Index:  
Within 8" of Joint: **YES**  
Remarks:

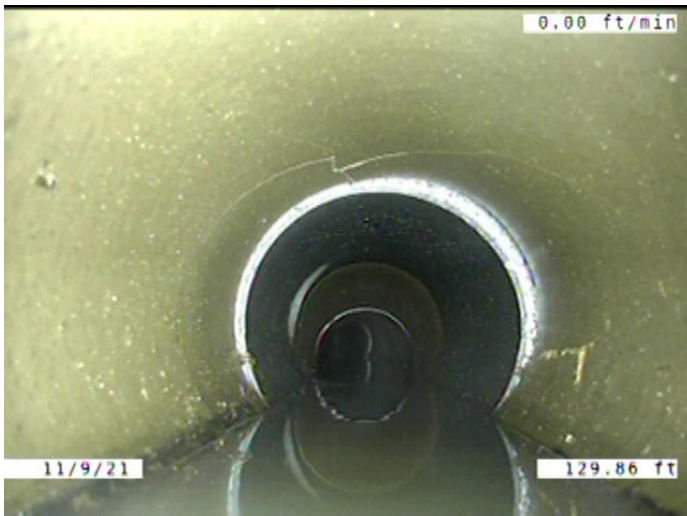
Code: **OBZ**  
Description: **Obstruction Other**

Distance (ft): **129.9**  
Structural Grade: **0**  
O&M Grade: **2**  
Clock Start/From: **5**  
Clock To: **7**  
1st Value:  
2nd Value:  
Value Percent: **5.000**  
Continuous Index: **F02**  
Within 8" of Joint: **YES**  
Remarks: **ROOTS THAT HAVE BEEN CUT.**

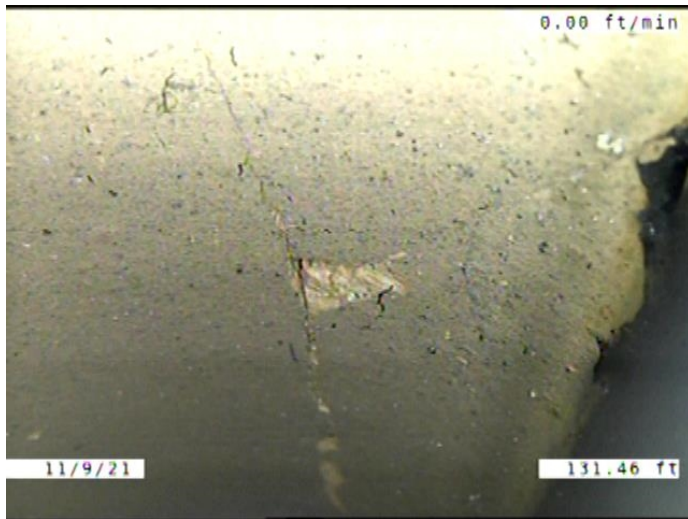
Code: **B**  
 Description: **Broken**

Distance (ft): **131.5**  
 Structural Grade: **4**  
 O&M Grade: **0**  
 Clock Start/From: **12**  
 Clock To: **12**  
 1st Value:  
 2nd Value:  
 Value Percent:  
 Continuous Index:  
 Within 8" of Joint: **YES**  
 Remarks:

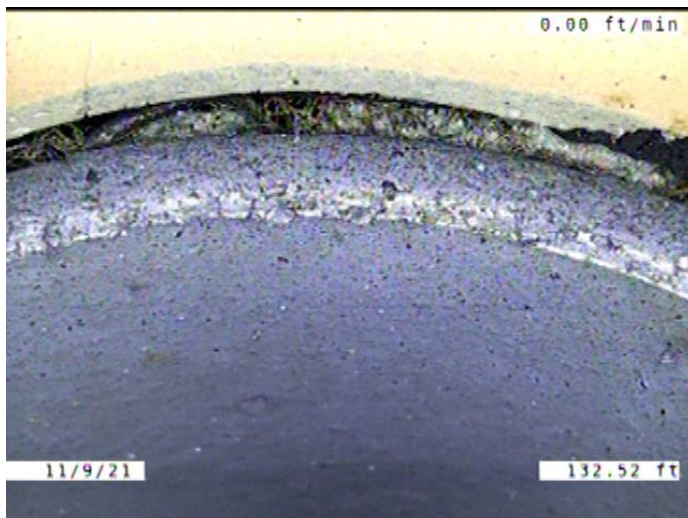
Code: **JOMD**  
 Description: **Joint Offset Medium Defective**

Distance (ft): **132.5**  
 Structural Grade: **3**  
 O&M Grade: **0**  
 Clock Start/From:  
 Clock To:  
 1st Value:  
 2nd Value:  
 Value Percent:  
 Continuous Index:  
 Within 8" of Joint: **NO**  
 Remarks:

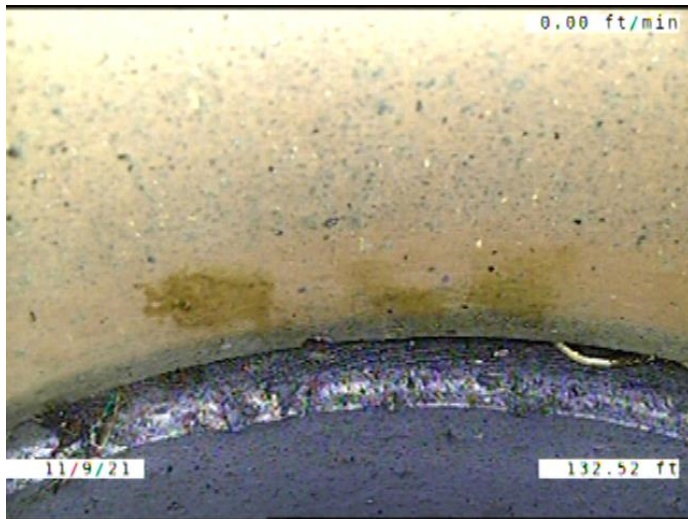
Code: **RFJ**  
 Description: **Roots Fine Joint**

Distance (ft): **132.5**  
 Structural Grade: **0**  
 O&M Grade: **1**  
 Clock Start/From: **9**  
 Clock To: **3**  
 1st Value:  
 2nd Value:  
 Value Percent:  
 Continuous Index:  
 Within 8" of Joint: **YES**  
 Remarks:

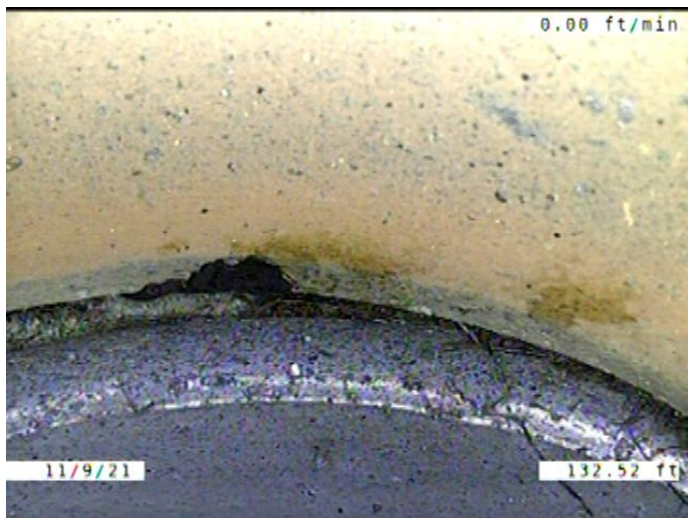
Code: **ISJ**  
 Description: **Infiltration Stain Joint**

Distance (ft): **132.5**  
 Structural Grade: **0**  
 O&M Grade: **1**  
 Clock Start/From: **2**  
 Clock To: **3**  
 1st Value:  
 2nd Value:  
 Value Percent:  
 Continuous Index:  
 Within 8" of Joint: **YES**  
 Remarks:

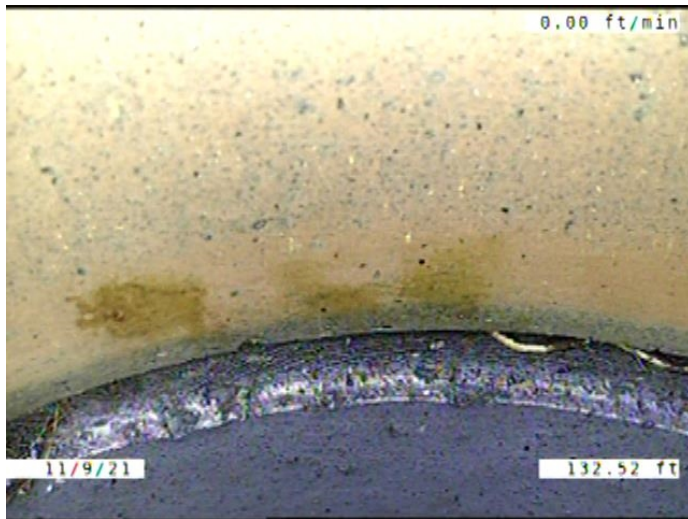
Code: **ISJ**  
 Description: **Infiltration Stain Joint**

Distance (ft): **132.5**  
 Structural Grade: **0**  
 O&M Grade: **1**  
 Clock Start/From: **9**  
 Clock To: **10**  
 1st Value:  
 2nd Value:  
 Value Percent:  
 Continuous Index:  
 Within 8" of Joint: **YES**  
 Remarks:

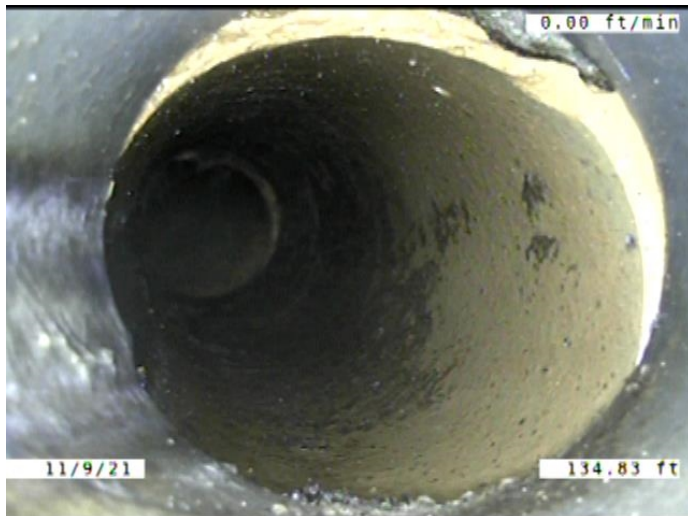
Code: **TF**  
 Description: **Tap Factory**

Distance (ft): **134.8**  
 Structural Grade: **0**  
 O&M Grade: **0**  
 Clock Start/From: **10**  
 Clock To:  
 1st Value: **4.000**  
 2nd Value:  
 Value Percent:  
 Continuous Index:  
 Within 8" of Joint: **YES**  
 Remarks: **CONSTANTLY RUNNING WATER**

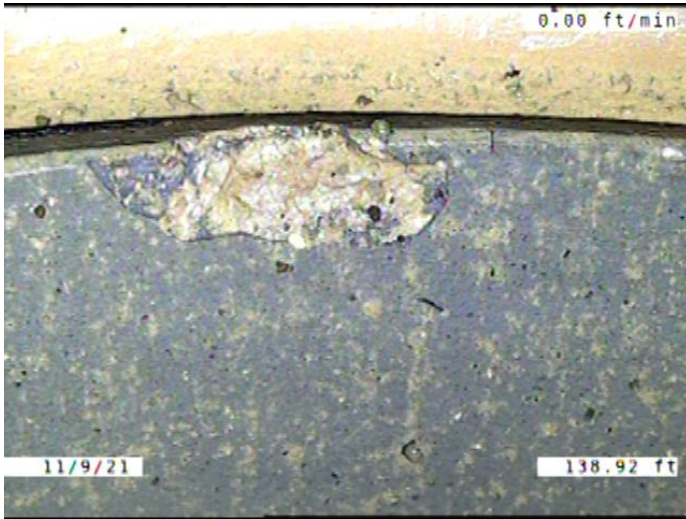
Code: **SSS**  
Description: **Surface Damage Surface Spalling**

Distance (ft): **138.9**  
Structural Grade: **2**  
O&M Grade: **0**  
Clock Start/From: **11**  
Clock To:  
1st Value:  
2nd Value:  
Value Percent:  
Continuous Index:  
Within 8" of Joint: **YES**  
Remarks:

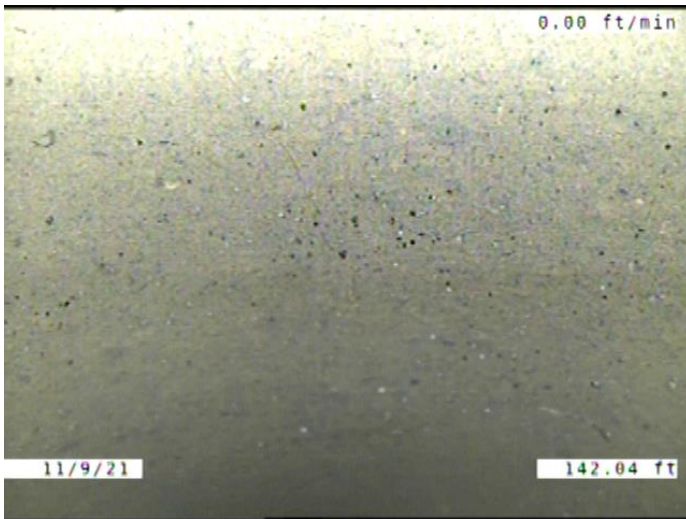
Code: **CM**  
Description: **Crack Multiple**

Distance (ft): **142.0**  
Structural Grade: **3**  
O&M Grade: **0**  
Clock Start/From: **10**  
Clock To: **1**  
1st Value:  
2nd Value:  
Value Percent:  
Continuous Index: **S07**  
Within 8" of Joint: **YES**  
Remarks:

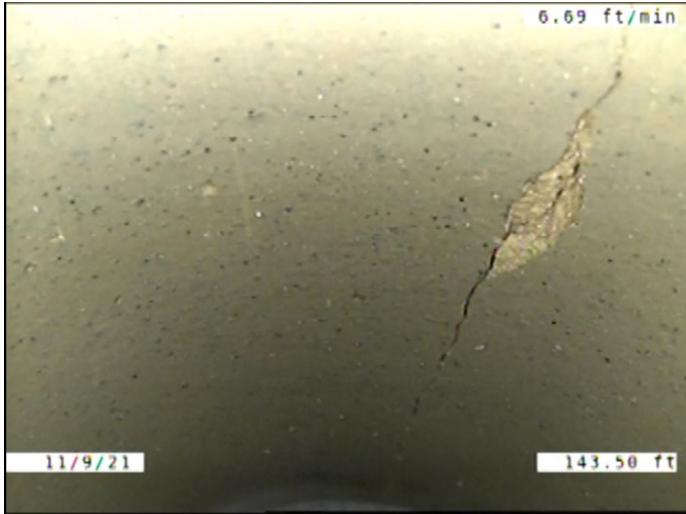
Code: **SSS**  
Description: **Surface Damage Surface Spalling**

Distance (ft): **143.5**  
Structural Grade: **2**  
O&M Grade: **0**  
Clock Start/From: **12**  
Clock To:  
1st Value:  
2nd Value:  
Value Percent:  
Continuous Index:  
Within 8" of Joint: **NO**  
Remarks:

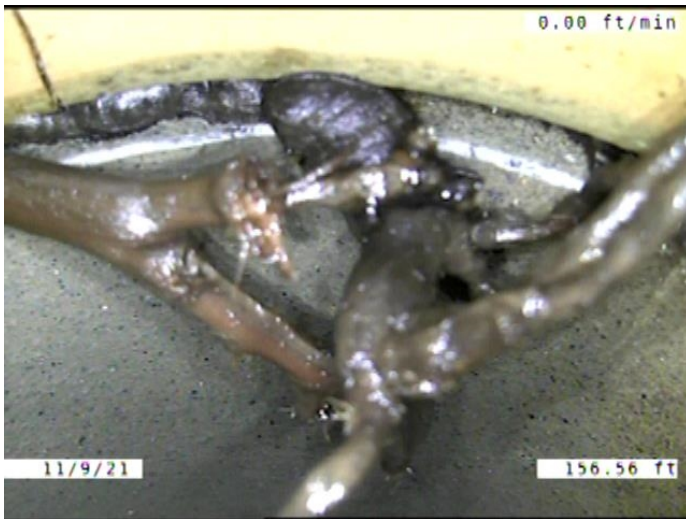
Code: **RTJ**  
Description: **Roots Tap Joint**

Distance (ft): **156.6**  
Structural Grade: **0**  
O&M Grade: **2**  
Clock Start/From: **12**  
Clock To: **2**  
1st Value:  
2nd Value:  
Value Percent: **5.000**  
Continuous Index:  
Within 8" of Joint: **YES**  
Remarks:

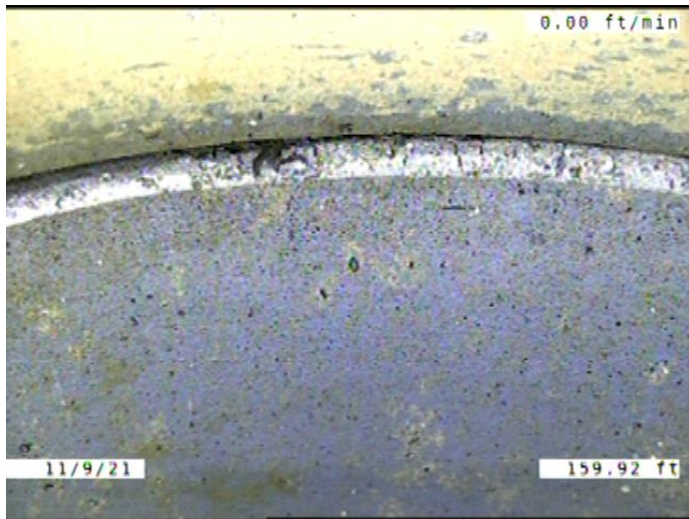
Code: **RFJ**  
 Description: **Roots Fine Joint**

Distance (ft): **159.9**  
 Structural Grade: **0**  
 O&M Grade: **1**  
 Clock Start/From: **10**  
 Clock To: **11**  
 1st Value:  
 2nd Value:  
 Value Percent:  
 Continuous Index:  
 Within 8" of Joint: **YES**  
 Remarks:

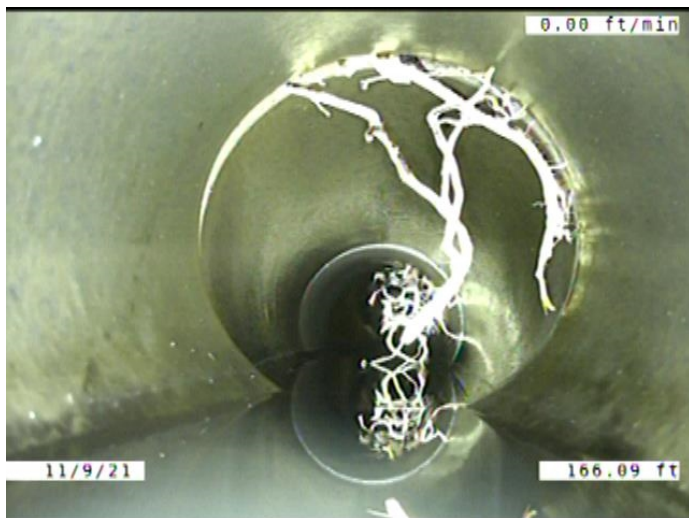
Code: **RMJ**  
 Description: **Roots Medium Joint**

Distance (ft): **166.1**  
 Structural Grade: **0**  
 O&M Grade: **3**  
 Clock Start/From: **11**  
 Clock To: **2**  
 1st Value:  
 2nd Value:  
 Value Percent: **5.000**  
 Continuous Index:  
 Within 8" of Joint: **YES**  
 Remarks:

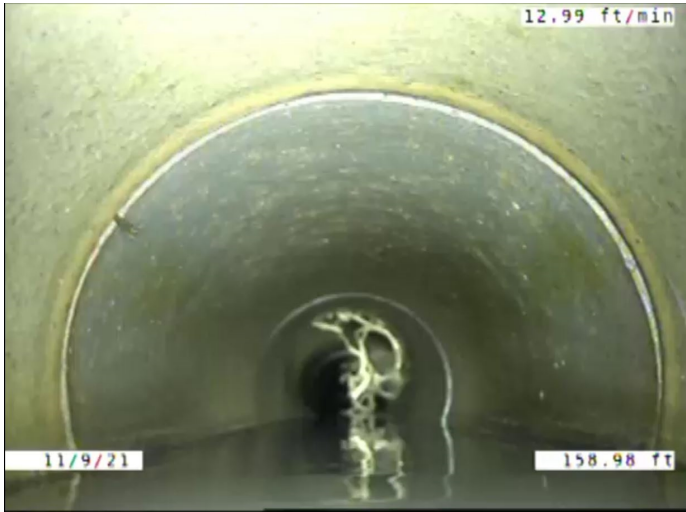
Code: **CM**  
Description: **Crack Multiple**

Distance (ft): **166.4**  
Structural Grade: **3**  
O&M Grade: **0**  
Clock Start/From: **10**  
Clock To: **1**  
1st Value:  
2nd Value:  
Value Percent:  
Continuous Index: **F07**  
Within 8" of Joint: **YES**  
Remarks:

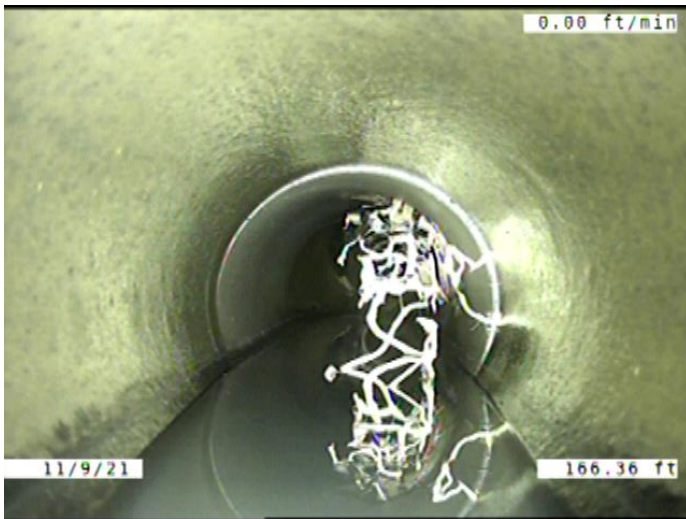
Code: **MWLS**  
Description: **Miscellaneous Water Level Sag**

Distance (ft): **166.4**  
Structural Grade: **2**  
O&M Grade: **0**  
Clock Start/From:  
Clock To:  
1st Value:  
2nd Value:  
Value Percent: **20.000**  
Continuous Index: **F06**  
Within 8" of Joint: **NO**  
Remarks:

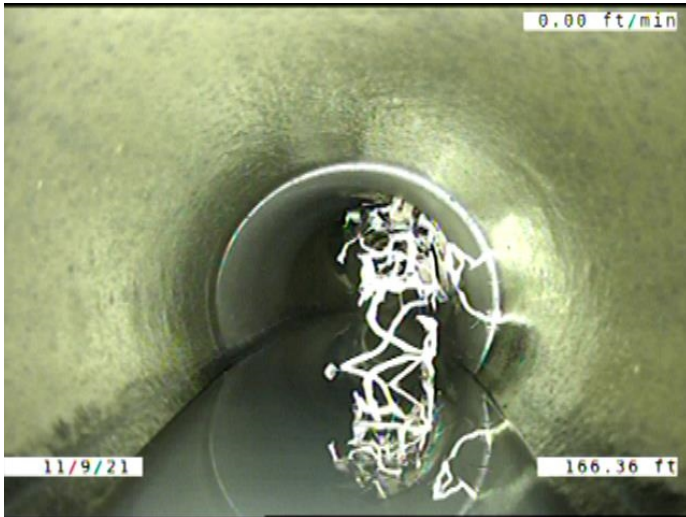
Code: **MWLS**  
 Description: **Miscellaneous Water Level Sag**

Distance (ft): **166.4**  
 Structural Grade: **2**  
 O&M Grade: **0**  
 Clock Start/From:  
 Clock To:  
 1st Value:  
 2nd Value:  
 Value Percent: **10.000**  
 Continuous Index: **S08**  
 Within 8" of Joint: **NO**  
 Remarks:

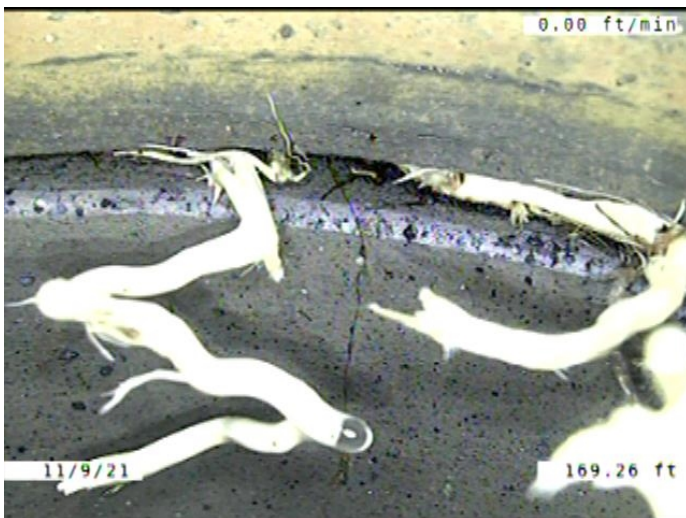
Code: **RFJ**  
 Description: **Roots Fine Joint**

Distance (ft): **169.3**  
 Structural Grade: **0**  
 O&M Grade: **1**  
 Clock Start/From: **2**  
 Clock To: **3**  
 1st Value:  
 2nd Value:  
 Value Percent:  
 Continuous Index:  
 Within 8" of Joint: **YES**  
 Remarks:

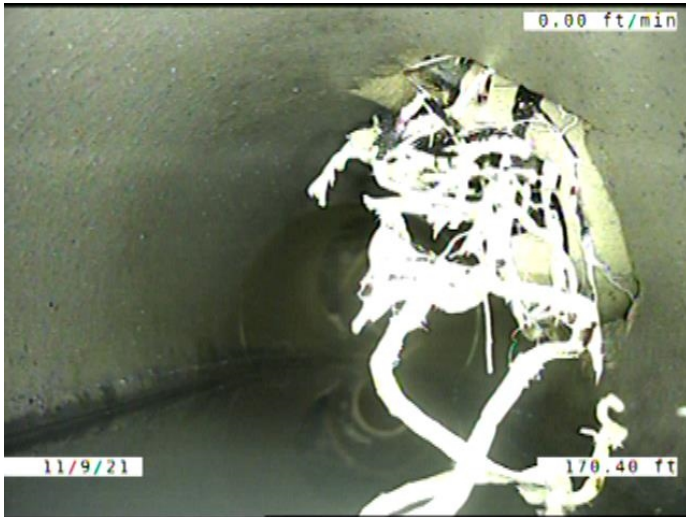
Code: **RMC**  
 Description: **Roots Medium Connection**

Distance (ft): **170.4**  
 Structural Grade: **0**  
 O&M Grade: **3**  
 Clock Start/From: **1**  
 Clock To: **3**  
 1st Value:  
 2nd Value:  
 Value Percent: **10.000**  
 Continuous Index:  
 Within 8" of Joint: **NO**  
 Remarks:

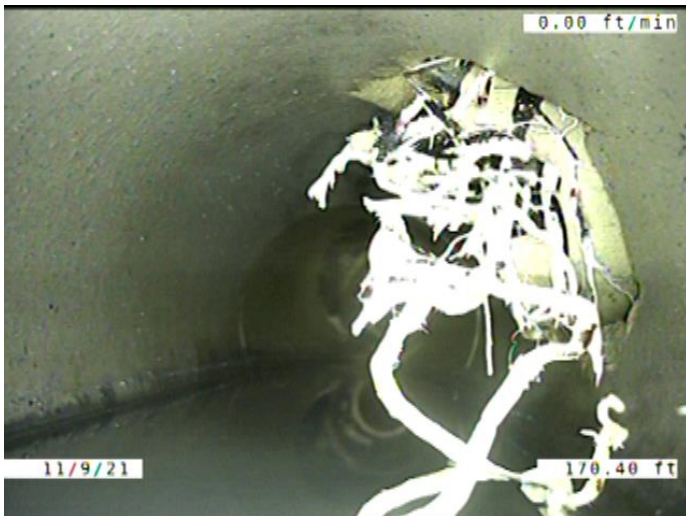
Code: **CM**  
 Description: **Crack Multiple**

Distance (ft): **170.4**  
 Structural Grade: **3**  
 O&M Grade: **0**  
 Clock Start/From: **1**  
 Clock To: **3**  
 1st Value:  
 2nd Value:  
 Value Percent:  
 Continuous Index:  
 Within 8" of Joint: **YES**  
 Remarks:

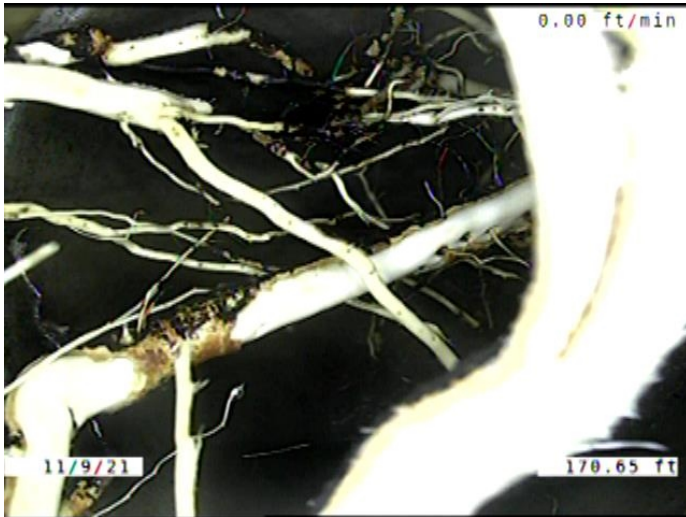
Code: **TBI**  
 Description: **Tap Break-in Intruding**

Distance (ft): **170.6**  
 Structural Grade: **0**  
 O&M Grade: **2**  
 Clock Start/From: **2**  
 Clock To:  
 1st Value: **4.000**  
 2nd Value: **2.000**  
 Value Percent:  
 Continuous Index:  
 Within 8" of Joint: **YES**  
 Remarks:

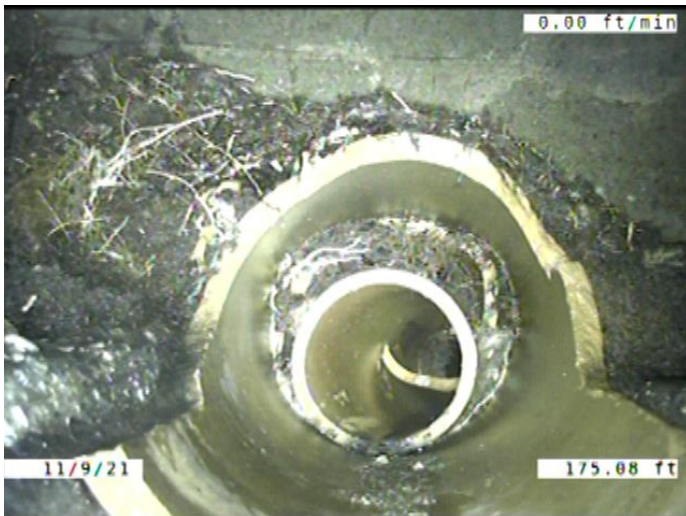
Code: **MWLS**  
 Description: **Miscellaneous Water Level Sag**

Distance (ft): **175.1**  
 Structural Grade: **2**  
 O&M Grade: **0**  
 Clock Start/From:  
 Clock To:  
 1st Value:  
 2nd Value:  
 Value Percent: **10.000**  
 Continuous Index: **F08**  
 Within 8" of Joint: **NO**  
 Remarks:

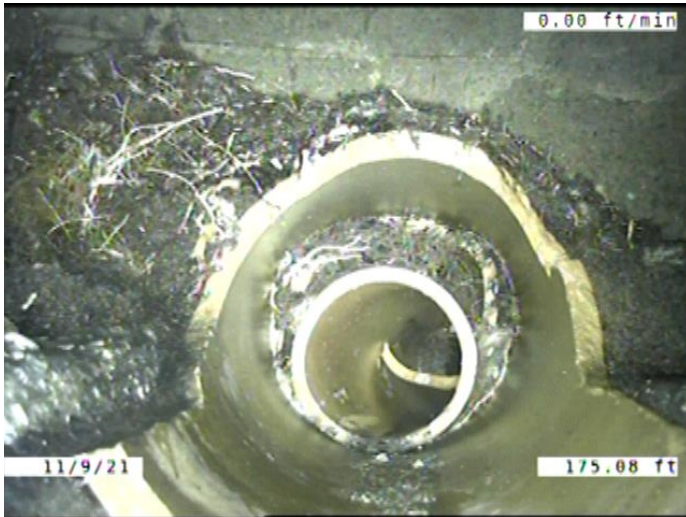
Code: **DSF**  
Description: **Deposits Settled Fine**

Distance (ft): **175.1**  
Structural Grade: **0**  
O&M Grade: **2**  
Clock Start/From: **5**  
Clock To: **7**  
1st Value:  
2nd Value:  
Value Percent: **5.000**  
Continuous Index: **F05**  
Within 8" of Joint: **YES**  
Remarks:

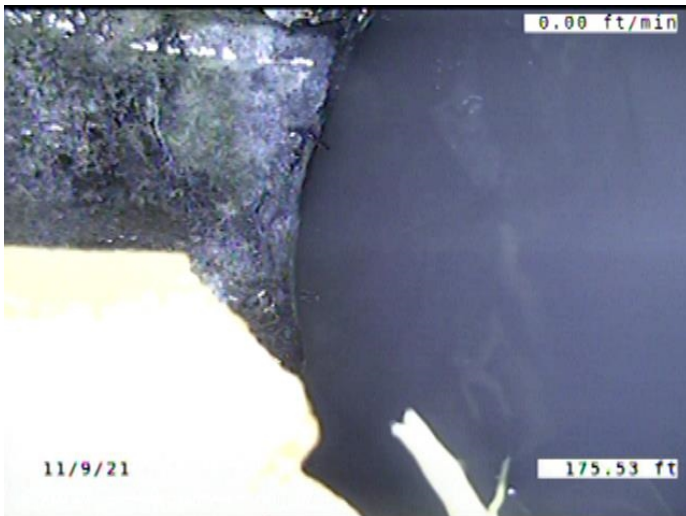
Code: **MGO**  
Description: **Miscellaneous General Observation**

Distance (ft): **175.5**  
Structural Grade: **0**  
O&M Grade: **0**  
Clock Start/From:  
Clock To:  
1st Value:  
2nd Value:  
Value Percent:  
Continuous Index:  
Within 8" of Joint: **NO**  
Remarks: **Pipe floor missing in MH**
