Profile/Photo Observation Report

Date:	04/24/2018	Weather:		Coding:	PACP 6.0
Pipe Length (ft):	168.6	Owner:	NA	Pre Clean:	Not Known
P.O.#:		Surveyor:	Jen Costello	PSR:	P-604-116-061
Customer:		Clean Date:	01/01/1900	Shape:	C

Street:	W CLEVELAND AVE & S CONNECTIC	Flow Control:	Not Controlled
City:	Hobart, IN	Year Renewed:	
Location:	Other	Tape/Media #:	
Purpose:	Not Known	Dia/Height:	12"
Use:	Sanitary	Material:	VCP
Drain Area:	NA	Lining:	
Category:	NA		
Comment:

Location Details:		Direction of Survey:	Downstream
US MH:	M-604-116	DS MH:	M-604-061
		Total Length Surveyed (ft):	91.2

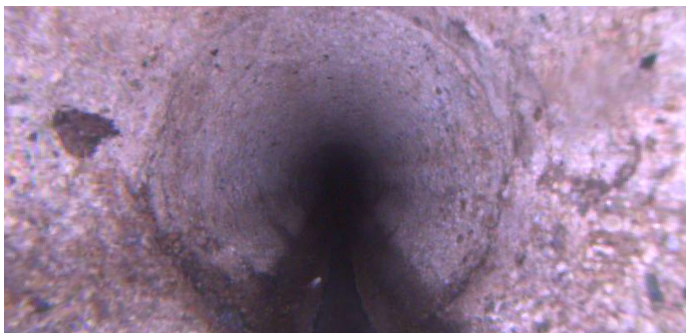
Code: **AMH**
Description: **Manhole**

Distance (ft): **.0**
Structural Grade: **0**
O&M Grade: **0**
Clock Start/From:
Clock To:
1st Value:
2nd Value:
Value Percent:
Continuous Index:
Within 8" of Joint: **NO**
Remarks: **M-604-116**

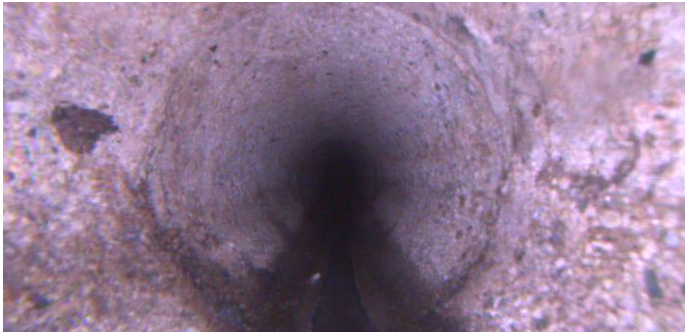
Code:	MWL
Description:	Water Level

Distance (ft):	.0
Structural Grade:	0
O&M Grade:	0
Clock Start/From:	
Clock To:	
1st Value:	
2nd Value:	
Value Percent:	5.000
Continuous Index:	
Within 8" of Joint:	NO
Remarks:

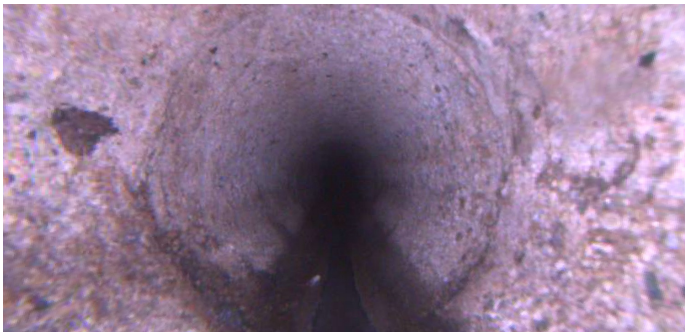
Code:	SAP
Description:	Surface Aggregate Projecting

Distance (ft):	.0
Structural Grade:	3
O&M Grade:	0
Clock Start/From:	7
Clock To:	5
1st Value:	
2nd Value:	
Value Percent:	
Continuous Index:	S01
Within 8" of Joint:	
Remarks:

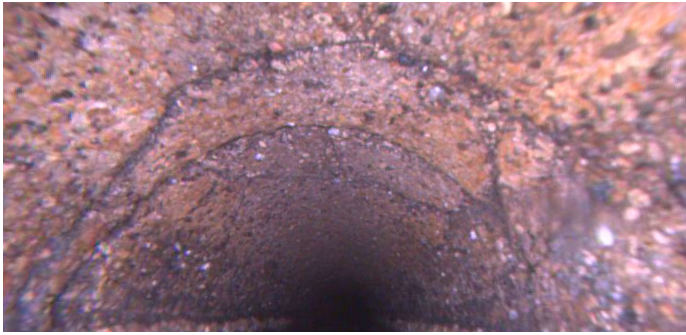
Code: **FM**
Description: **Fracture Multiple**

Distance (ft): **30.2**
Structural Grade: **4**
O&M Grade: **0**
Clock Start/From: **8**
Clock To: **4**
1st Value:
2nd Value:
Value Percent:
Continuous Index:
Within 8" of Joint:
Remarks:

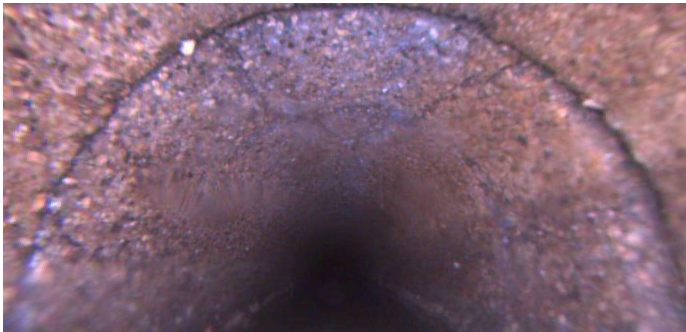
Code: **FM**
Description: **Fracture Multiple**

Distance (ft): **53.7**
Structural Grade: **4**
O&M Grade: **0**
Clock Start/From: **10**
Clock To: **2**
1st Value:
2nd Value:
Value Percent:
Continuous Index: **S02**
Within 8" of Joint: **YES**
Remarks:

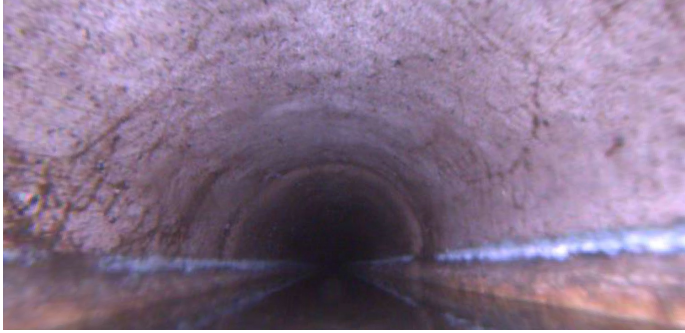
Code: **FM**
Description: **Fracture Multiple**

Distance (ft): **66.0**
Structural Grade: **4**
O&M Grade: **0**
Clock Start/From: **10**
Clock To: **2**
1st Value:
2nd Value:
Value Percent:
Continuous Index: **F02**
Within 8" of Joint: **YES**
Remarks:

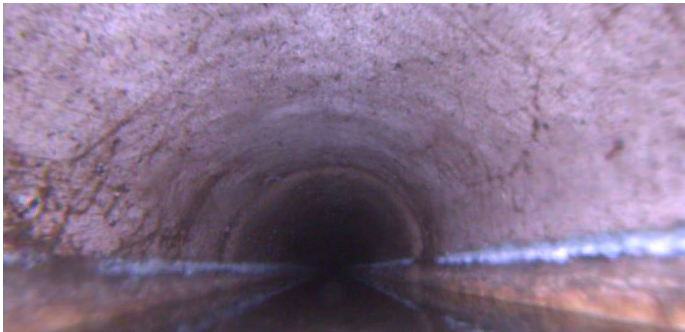
Code: **SAP**
Description: **Surface Aggregate Projecting**

Distance (ft): **66.0**
Structural Grade: **3**
O&M Grade: **0**
Clock Start/From: **7**
Clock To: **5**
1st Value:
2nd Value:
Value Percent:
Continuous Index: **F01**
Within 8" of Joint:
Remarks:

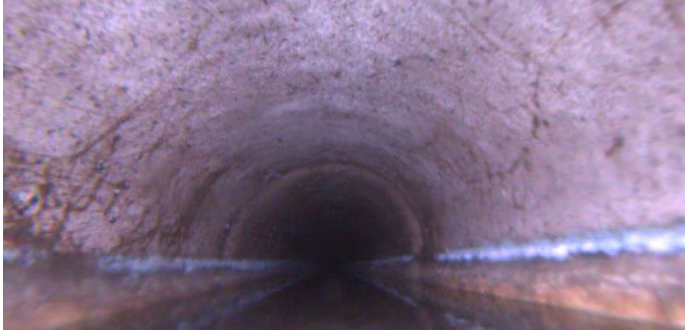
Code: **MMC**
Description: **Material Change**

Distance (ft): **66.0**
Structural Grade: **0**
O&M Grade: **0**
Clock Start/From:
Clock To:
1st Value:
2nd Value:
Value Percent:
Continuous Index:
Within 8" of Joint: **NO**
Remarks: **PVC**

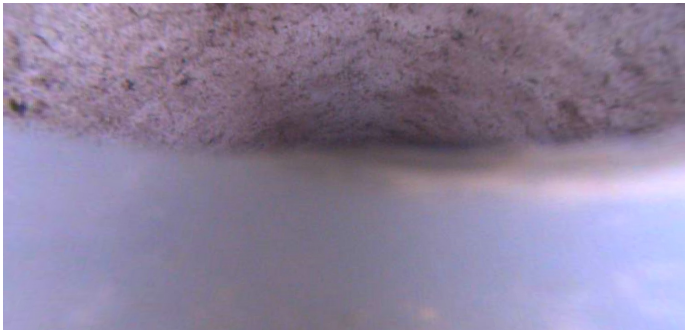
Code: **MWL**
Description: **Water Level**

Distance (ft): **77.5**
Structural Grade: **0**
O&M Grade: **0**
Clock Start/From:
Clock To:
1st Value:
2nd Value:
Value Percent: **40.000**
Continuous Index:
Within 8" of Joint: **NO**
Remarks:
