## Profile/Photo Observation Report

Date:	<b>04/24/2018</b>	Weather:		Coding:	<b>PACP 6.0</b>
Pipe Length (ft):	<b>168.6</b>	Owner:	<b>NA</b>	Pre Clean:	<b>Not Known</b>
P.O.#:		Surveyor:	<b>Jen Costello</b>	PSR:	<b>P-604-116-061</b>
Customer:		Clean Date:	<b>01/01/1900</b>	Shape:	<b>C</b>

Street:	<b>W Cleveland Ave.</b>	Flow Control:	<b>Not Controlled</b>
City:	<b>Hobart, IN</b>	Year Renewed:	
Location:	<b>Other</b>	Tape/Media #:	
Purpose:	<b>Not Known</b>	Dia/Height:	<b>12"</b>
Use:	<b>Sanitary</b>	Material:	<b>VCP</b>
Drain Area:	<b>NA</b>	Lining:	
Category:	<b>NA</b>		
Comment:

Location Details:		Direction of Survey:	<b>Downstream</b>
US MH:	<b>M-604-116</b>	DS MH:	<b>M-604-061</b>
		Total Length Surveyed (ft):	<b>91.2</b>

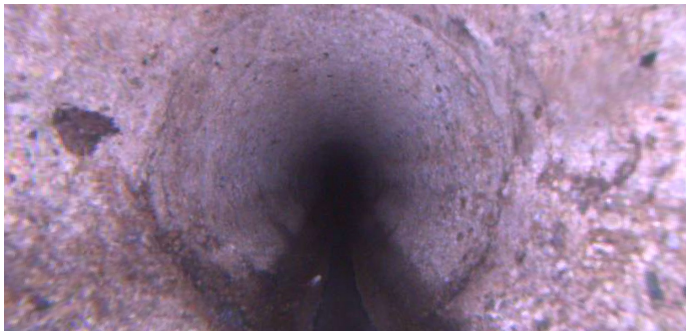
Code: **AMH**  
Description: **Manhole**

Distance (ft): **.0**  
Structural Grade: **0**  
O&M Grade: **0**  
Clock Start/From:  
Clock To:  
1st Value:  
2nd Value:  
Value Percent:  
Continuous Index:  
Within 8" of Joint: **NO**  
Remarks: **M-604-116**

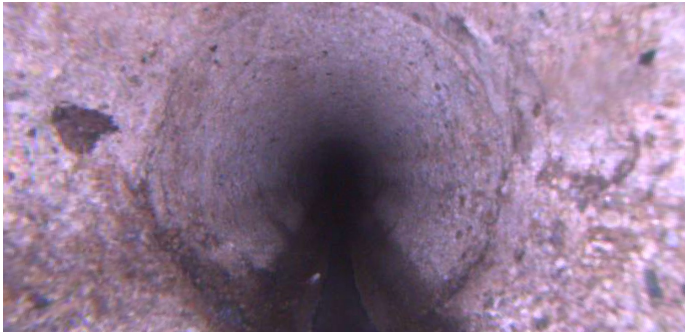
Code:	<b>MWL</b>
Description:	<b>Water Level</b>

Distance (ft):	<b>.0</b>
Structural Grade:	<b>0</b>
O&M Grade:	<b>0</b>
Clock Start/From:	
Clock To:	
1st Value:	
2nd Value:	
Value Percent:	<b>5.000</b>
Continuous Index:	
Within 8" of Joint:	<b>NO</b>
Remarks:

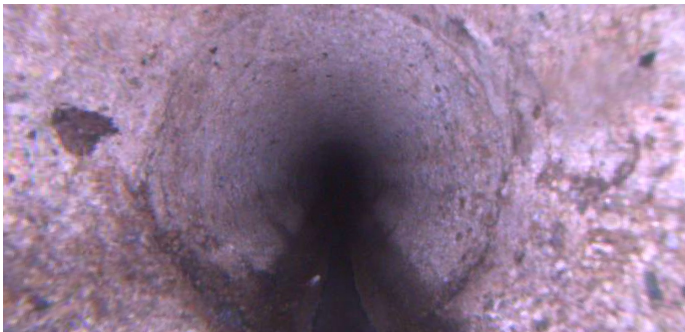
Code:	<b>SAP</b>
Description:	<b>Surface Aggregate Projecting</b>

Distance (ft):	<b>.0</b>
Structural Grade:	<b>3</b>
O&M Grade:	<b>0</b>
Clock Start/From:	<b>7</b>
Clock To:	<b>5</b>
1st Value:	
2nd Value:	
Value Percent:	
Continuous Index:	<b>S01</b>
Within 8" of Joint:	
Remarks:

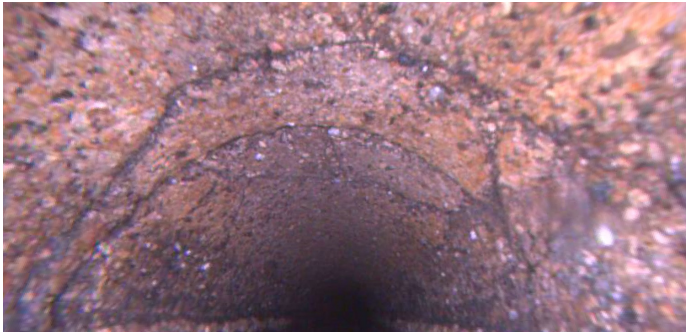
Code: **FM**  
Description: **Fracture Multiple**

Distance (ft): **30.2**  
Structural Grade: **4**  
O&M Grade: **0**  
Clock Start/From: **8**  
Clock To: **4**  
1st Value:  
2nd Value:  
Value Percent:  
Continuous Index:  
Within 8" of Joint:  
Remarks:

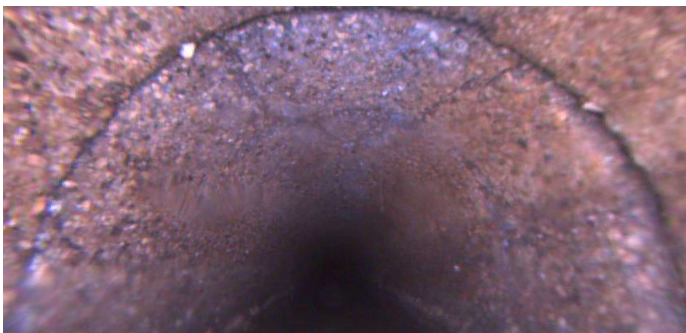
Code: **FM**  
Description: **Fracture Multiple**

Distance (ft): **53.7**  
Structural Grade: **4**  
O&M Grade: **0**  
Clock Start/From: **10**  
Clock To: **2**  
1st Value:  
2nd Value:  
Value Percent:  
Continuous Index: **S02**  
Within 8" of Joint: **YES**  
Remarks:

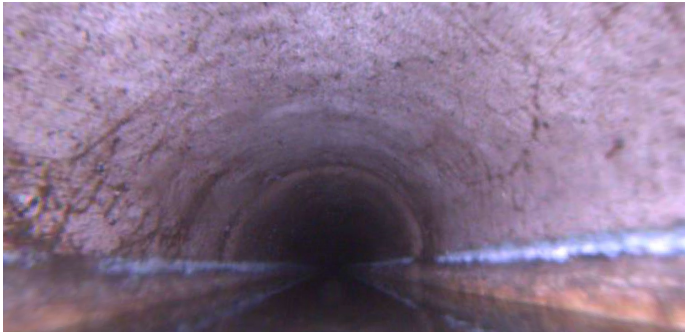
Code: **FM**  
Description: **Fracture Multiple**

Distance (ft): **66.0**  
Structural Grade: **4**  
O&M Grade: **0**  
Clock Start/From: **10**  
Clock To: **2**  
1st Value:  
2nd Value:  
Value Percent:  
Continuous Index: **F02**  
Within 8" of Joint: **YES**  
Remarks:

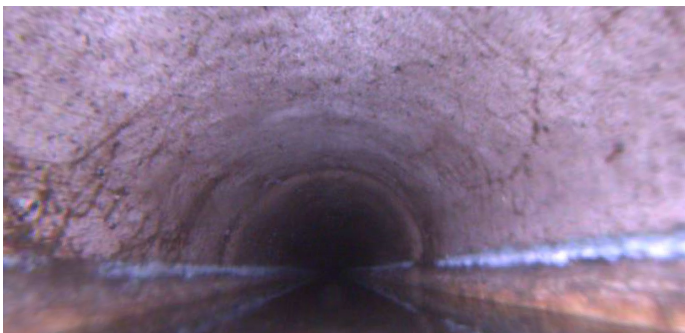
Code: **SAP**  
Description: **Surface Aggregate Projecting**

Distance (ft): **66.0**  
Structural Grade: **3**  
O&M Grade: **0**  
Clock Start/From: **7**  
Clock To: **5**  
1st Value:  
2nd Value:  
Value Percent:  
Continuous Index: **F01**  
Within 8" of Joint:  
Remarks:

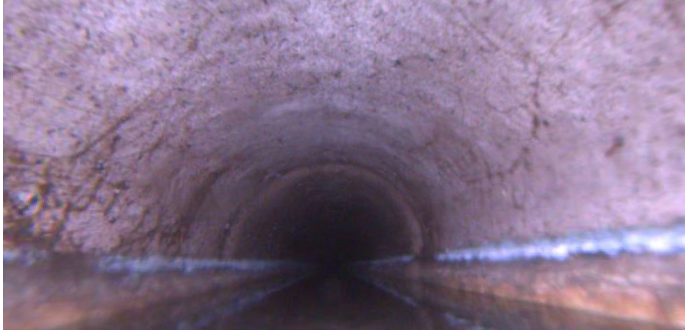
Code: **MMC**  
Description: **Material Change**

Distance (ft): **66.0**  
Structural Grade: **0**  
O&M Grade: **0**  
Clock Start/From:  
Clock To:  
1st Value:  
2nd Value:  
Value Percent:  
Continuous Index:  
Within 8" of Joint: **NO**  
Remarks: **PVC**

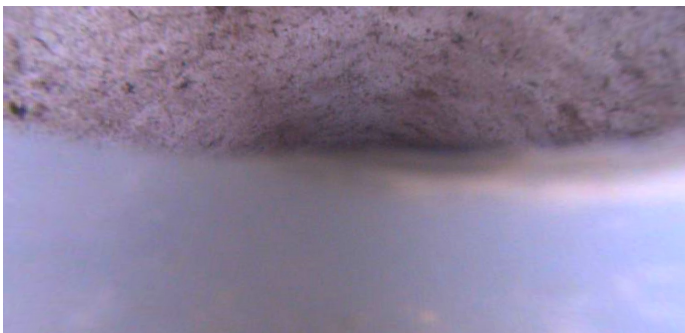
Code: **MWL**  
Description: **Water Level**

Distance (ft): **77.5**  
Structural Grade: **0**  
O&M Grade: **0**  
Clock Start/From:  
Clock To:  
1st Value:  
2nd Value:  
Value Percent: **40.000**  
Continuous Index:  
Within 8" of Joint: **NO**  
Remarks:
