Profile/Photo Observation Report

Date:	11/10/2021	Weather:		Coding:	PACP 7.0
Pipe Length (ft):	165.2	Owner:	City of Hobart	Pre Clean:	Heavy Cleaning
P.O.#:	YES502259	Surveyor:	Steven Bucklin	PSR:	P-604-116-061
Customer:	City of Hobart, IN (Red	Clean Date:	11/10/2021	Shape:	C

Street:	West Cleveland Avenue	Flow Control:	Not Controlled
City:	City of Hobart	Year Renewed:	
Location:	Local rural streets with light traffic, t	Tape/Media #:	
Purpose:	Routine Assessment	Dia/Height:	12"
Use:	Sanitary Sewage Pipe	Material:	CP
Drain Area:		Lining:	None
Category:	NA		
Comment:			
Location Details:		Direction of Survey:	Upstream
US MH:	M-604-116	DS MH:	M-604-061
		Total Length Surveyed (ft):	165.2

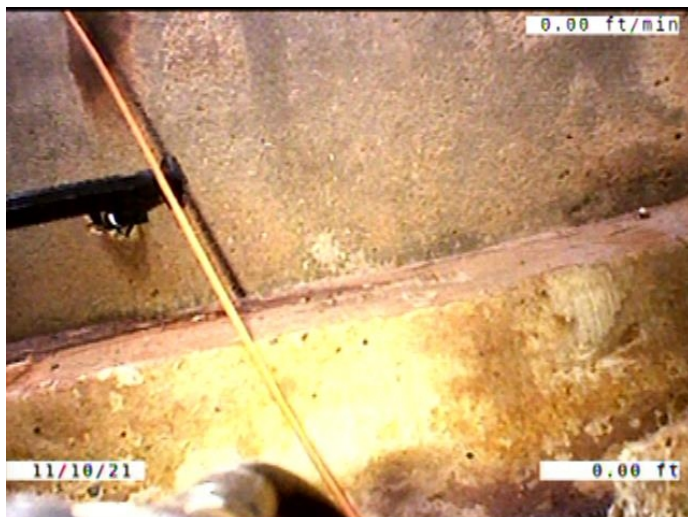
Code: **AMH**
 Description: **Manhole**

Distance (ft): **.0**
 Structural Grade: **0**
 O&M Grade: **0**
 Clock Start/From:
 Clock To:
 1st Value:
 2nd Value:
 Value Percent:
 Continuous Index:
 Within 8" of Joint: **NO**
 Remarks: **M-604-061**

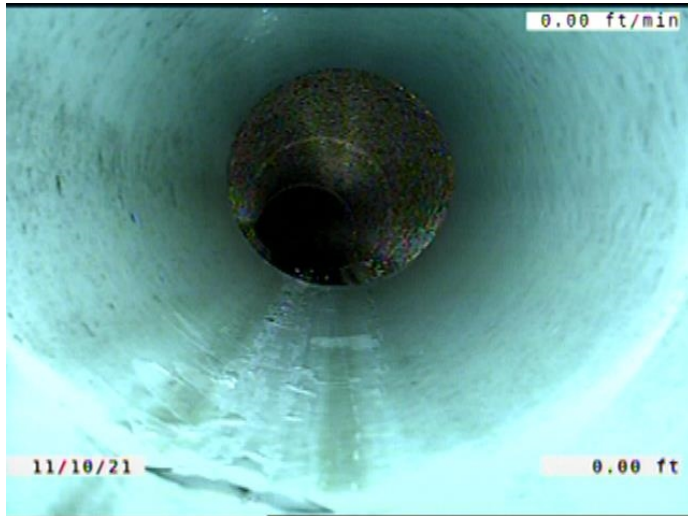
Code: **MWL**
Description: **Miscellaneous Water Level**

Distance (ft): **.0**
Structural Grade: **0**
O&M Grade: **0**
Clock Start/From:
Clock To:
1st Value:
2nd Value:
Value Percent: **5.000**
Continuous Index:
Within 8" of Joint: **NO**
Remarks:

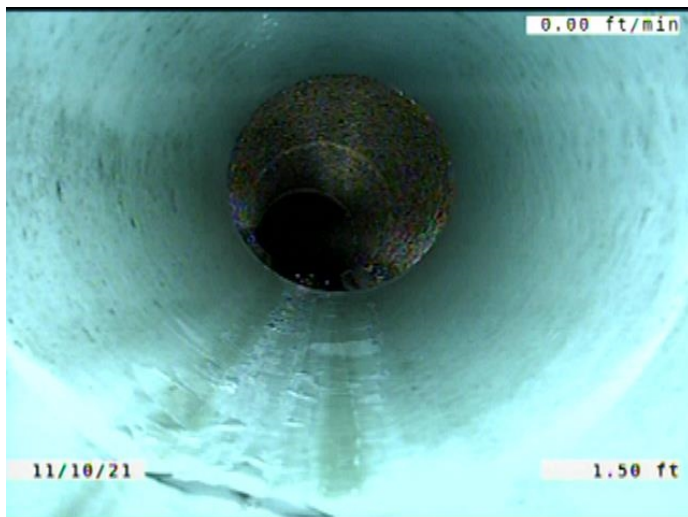
Code: **MGO**
Description: **Miscellaneous General Observation**

Distance (ft): **1.5**
Structural Grade: **0**
O&M Grade: **0**
Clock Start/From:
Clock To:
1st Value:
2nd Value:
Value Percent:
Continuous Index:
Within 8" of Joint: **NO**
Remarks: **CHANNEL BUILT TO SMALL FOR THE CRAWLER TO FIT IN IT. HAD TO STAR**

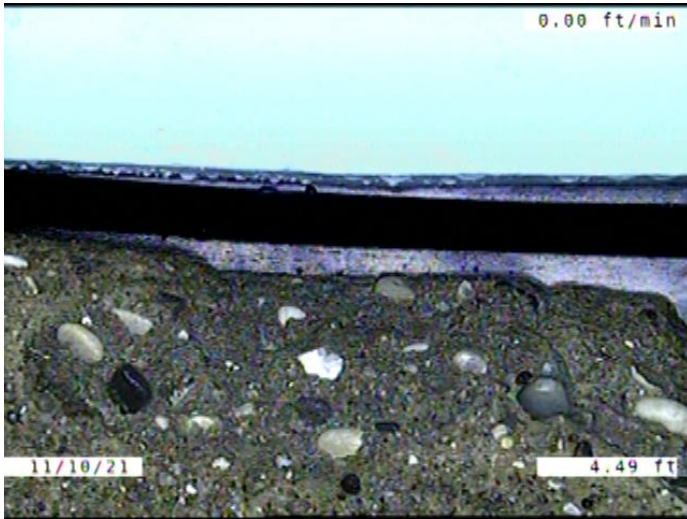
Code: **MMC**
 Description: **Miscellaneous Material Change**

Distance (ft): **4.5**
 Structural Grade: **0**
 O&M Grade: **0**
 Clock Start/From:
 Clock To:
 1st Value:
 2nd Value:
 Value Percent:
 Continuous Index:
 Within 8" of Joint: **NO**
 Remarks: **PVC TO CONCRETE**

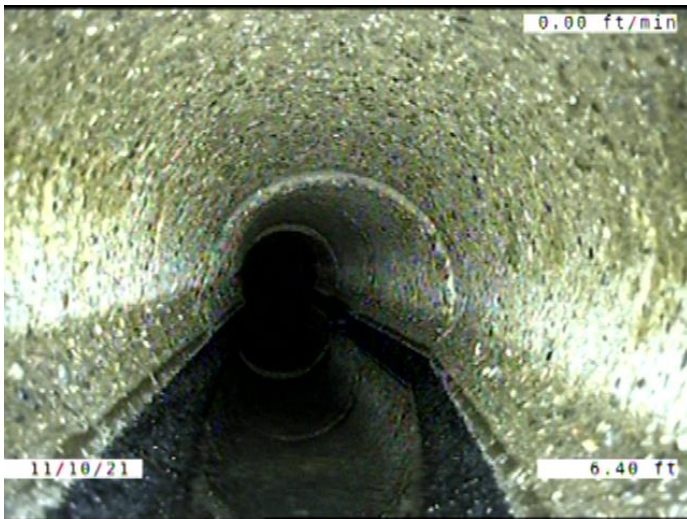
Code: **MWLS**
 Description: **Miscellaneous Water Level Sag**

Distance (ft): **6.4**
 Structural Grade: **2**
 O&M Grade: **0**
 Clock Start/From:
 Clock To:
 1st Value:
 2nd Value:
 Value Percent: **15.000**
 Continuous Index: **S01**
 Within 8" of Joint: **NO**
 Remarks:

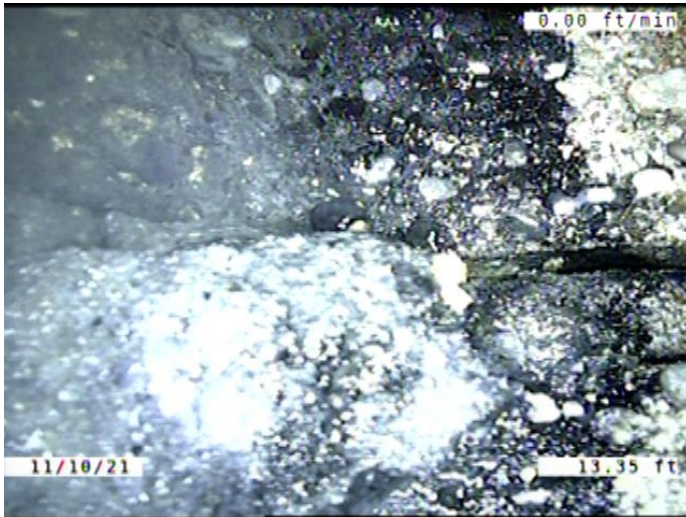
Code: **DAE**
 Description: **Deposits Attached Encrustation**

Distance (ft): **13.4**
 Structural Grade: **0**
 O&M Grade: **2**
 Clock Start/From: **4**
 Clock To: **5**
 1st Value:
 2nd Value:
 Value Percent: **5.000**
 Continuous Index:
 Within 8" of Joint: **YES**
 Remarks:

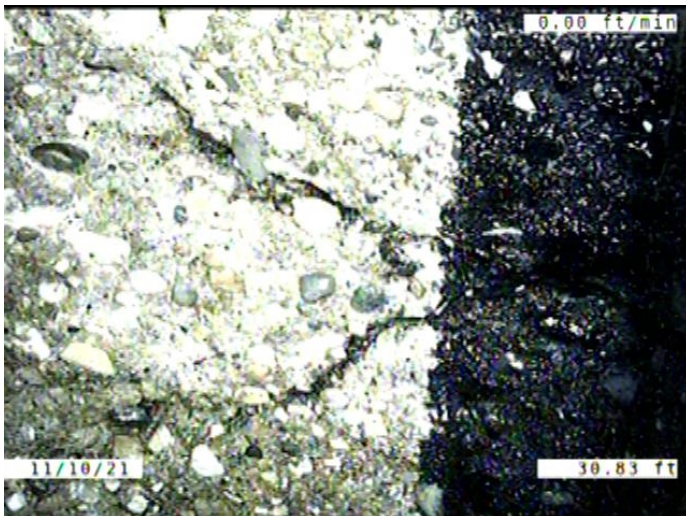
Code: **FM**
 Description: **Fracture Multiple**

Distance (ft): **30.8**
 Structural Grade: **4**
 O&M Grade: **0**
 Clock Start/From: **8**
 Clock To: **4**
 1st Value:
 2nd Value:
 Value Percent:
 Continuous Index:
 Within 8" of Joint: **YES**
 Remarks:

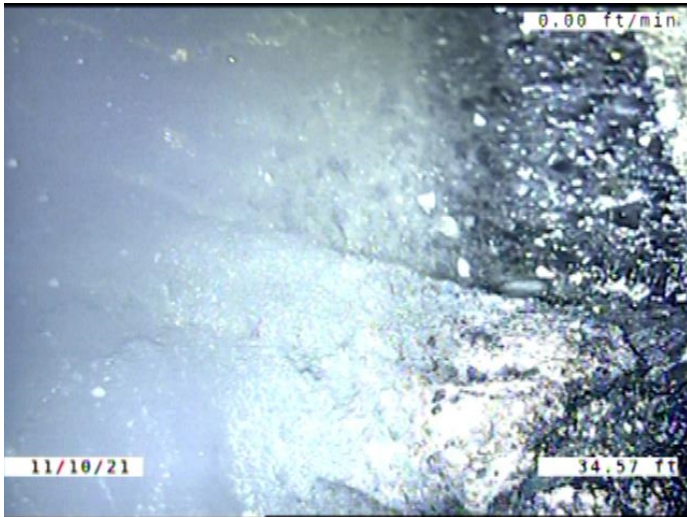
Code: **DAE**
 Description: **Deposits Attached Encrustation**

Distance (ft): **34.6**
 Structural Grade: **0**
 O&M Grade: **2**
 Clock Start/From: **4**
 Clock To: **5**
 1st Value:
 2nd Value:
 Value Percent: **5.000**
 Continuous Index:
 Within 8" of Joint: **YES**
 Remarks:

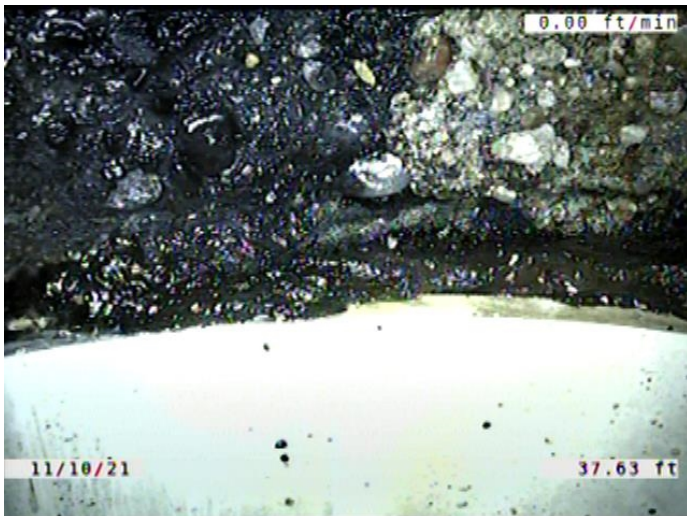
Code: **MMC**
 Description: **Miscellaneous Material Change**

Distance (ft): **37.6**
 Structural Grade: **0**
 O&M Grade: **0**
 Clock Start/From:
 Clock To:
 1st Value:
 2nd Value:
 Value Percent:
 Continuous Index:
 Within 8" of Joint: **NO**
 Remarks: **CONCRETE TO PVC**

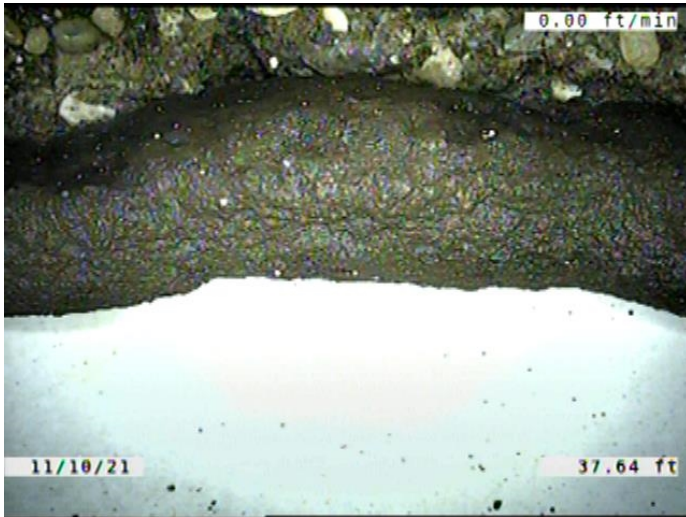
Code: **ISSRH**
 Description: **Intruding Sealing Material Sealing Ring Hanging**

Distance (ft): **37.6**
 Structural Grade: **0**
 O&M Grade: **2**
 Clock Start/From: **9**
 Clock To: **3**
 1st Value:
 2nd Value:
 Value Percent: **5.000**
 Continuous Index:
 Within 8" of Joint: **NO**
 Remarks:

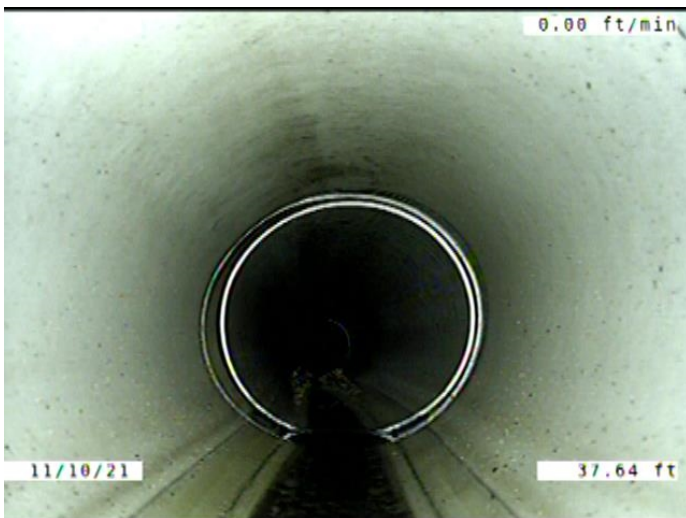
Code: **MWLS**
 Description: **Miscellaneous Water Level Sag**

Distance (ft): **37.6**
 Structural Grade: **2**
 O&M Grade: **0**
 Clock Start/From:
 Clock To:
 1st Value:
 2nd Value:
 Value Percent: **15.000**
 Continuous Index: **F01**
 Within 8" of Joint: **NO**
 Remarks:

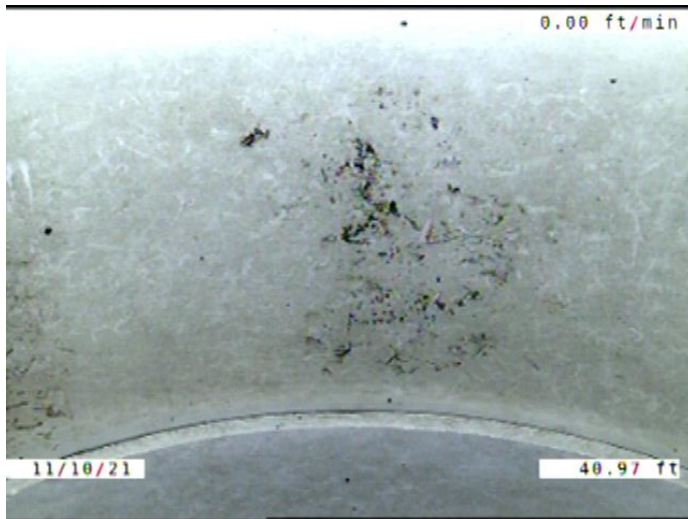
Code:	MGO
Description:	Miscellaneous General Observation
Distance (ft):	41.0
Structural Grade:	0
O&M Grade:	0
Clock Start/From:	
Clock To:	
1st Value:	
2nd Value:	
Value Percent:	
Continuous Index:	
Within 8" of Joint:	NO
Remarks:	JOINT/ PIPES NOT PUSHED ALL THE WAY TOGETHER WHEN INSTALLED

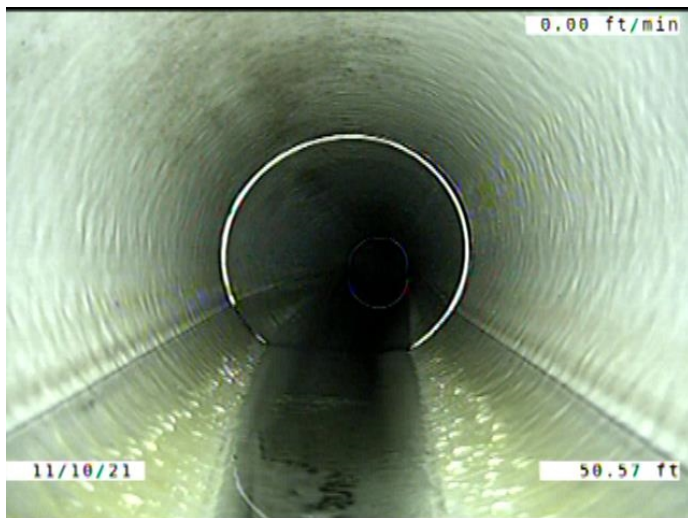
Code:	MWLS
Description:	Miscellaneous Water Level Sag
Distance (ft):	50.6
Structural Grade:	2
O&M Grade:	0
Clock Start/From:	
Clock To:	
1st Value:	
2nd Value:	
Value Percent:	15.000
Continuous Index:	S02
Within 8" of Joint:	NO
Remarks:

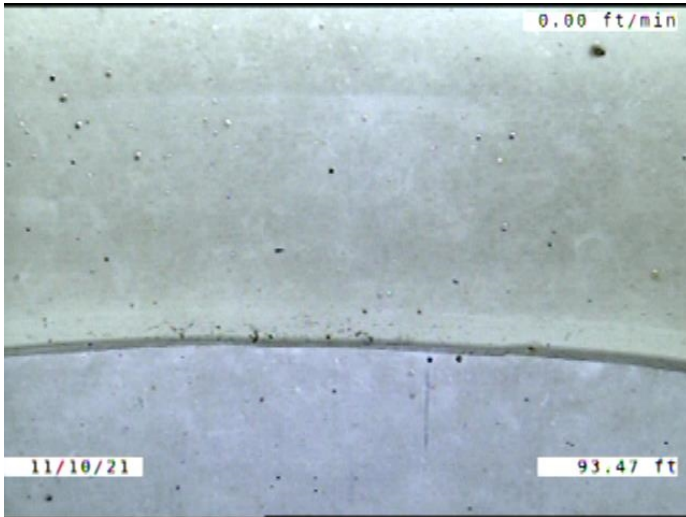
Code: **MGO**
 Description: **Miscellaneous General Observation**

Distance (ft): **93.5**
 Structural Grade: **0**
 O&M Grade: **0**
 Clock Start/From:
 Clock To:
 1st Value:
 2nd Value:
 Value Percent:
 Continuous Index:
 Within 8" of Joint: **NO**
 Remarks: **JOINT/ PIPES NOT PUSHED ALL THE WAY TOGETHER WHEN INSTALLED**

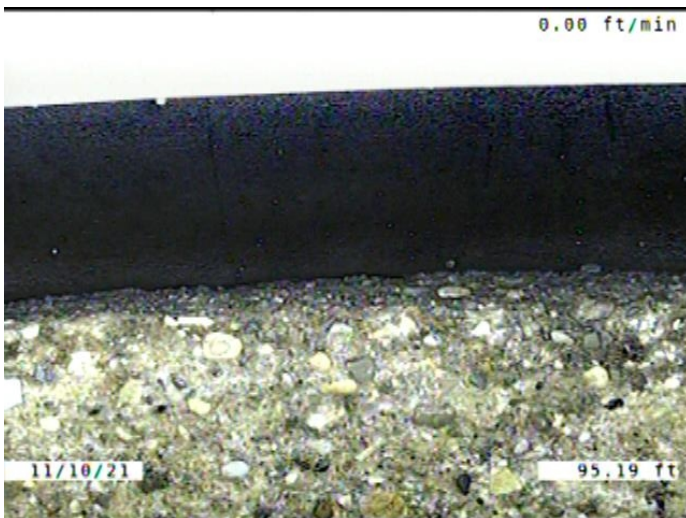
Code: **MMC**
 Description: **Miscellaneous Material Change**

Distance (ft): **95.2**
 Structural Grade: **0**
 O&M Grade: **0**
 Clock Start/From:
 Clock To:
 1st Value:
 2nd Value:
 Value Percent:
 Continuous Index:
 Within 8" of Joint: **NO**
 Remarks: **PVC TO CONCRETE**

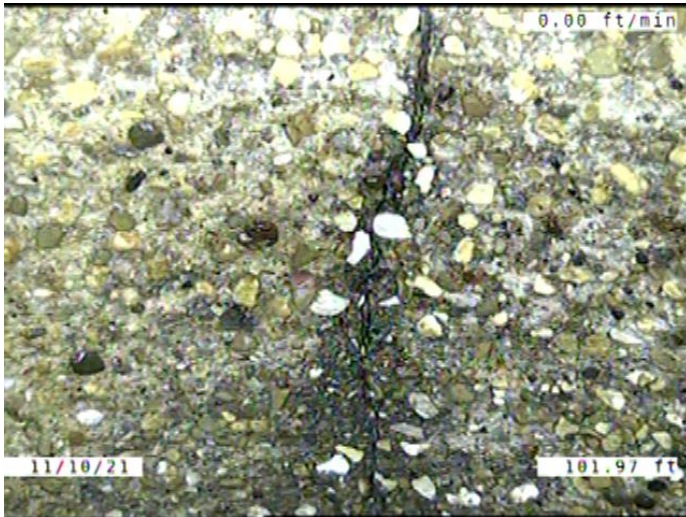
Code: **FS**
Description: **Fracture Spiral**

Distance (ft): **102.0**
Structural Grade: **3**
O&M Grade: **0**
Clock Start/From: **11**
Clock To: **1**
1st Value:
2nd Value:
Value Percent:
Continuous Index: **S03**
Within 8" of Joint: **YES**
Remarks:

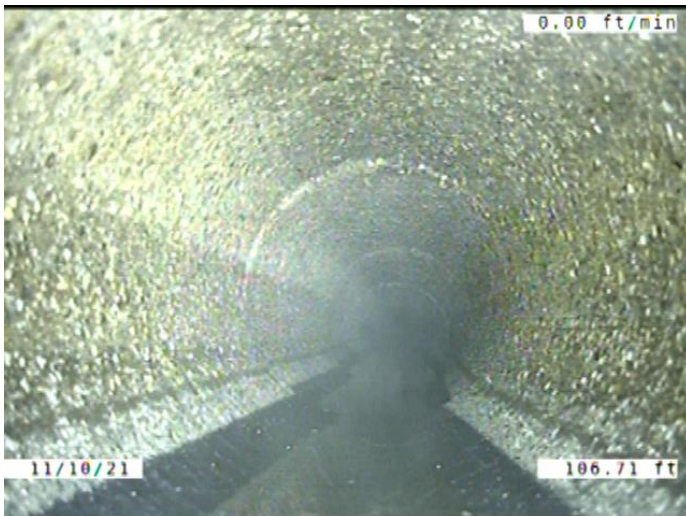
Code: **MWLS**
Description: **Miscellaneous Water Level Sag**

Distance (ft): **106.7**
Structural Grade: **2**
O&M Grade: **0**
Clock Start/From:
Clock To:
1st Value:
2nd Value:
Value Percent: **15.000**
Continuous Index: **F02**
Within 8" of Joint: **NO**
Remarks:

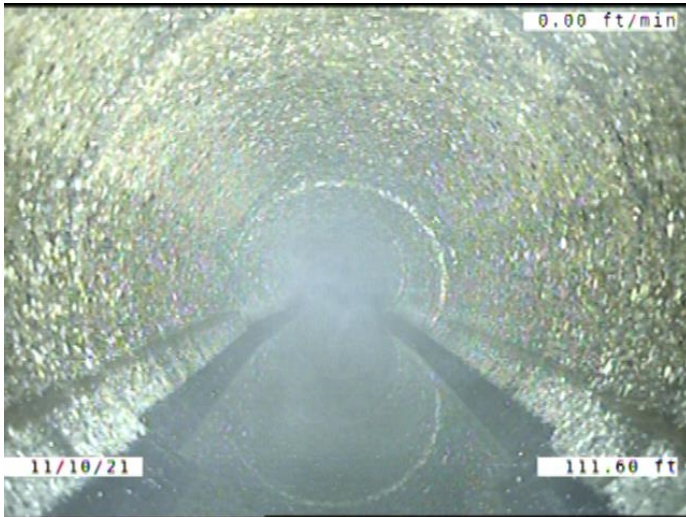
Code: **FS**
 Description: **Fracture Spiral**

Distance (ft): **111.6**
 Structural Grade: **3**
 O&M Grade: **0**
 Clock Start/From: **11**
 Clock To: **1**
 1st Value:
 2nd Value:
 Value Percent:
 Continuous Index: **F03**
 Within 8" of Joint: **YES**
 Remarks:

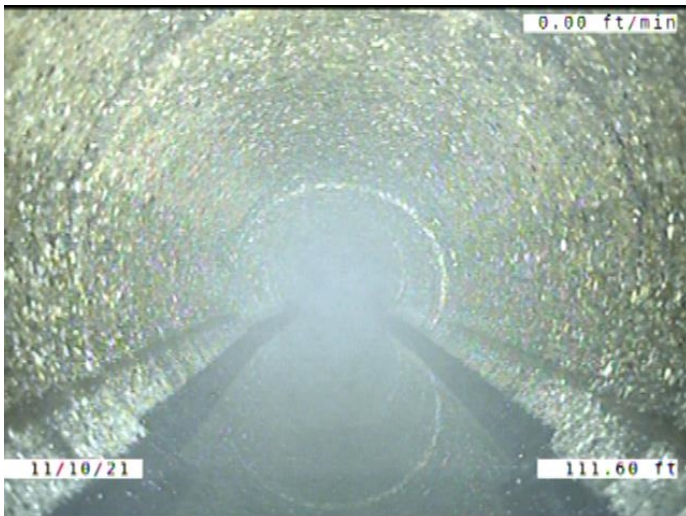
Code: **MWLS**
 Description: **Miscellaneous Water Level Sag**

Distance (ft): **111.6**
 Structural Grade: **2**
 O&M Grade: **0**
 Clock Start/From:
 Clock To:
 1st Value:
 2nd Value:
 Value Percent: **10.000**
 Continuous Index: **S04**
 Within 8" of Joint: **NO**
 Remarks:

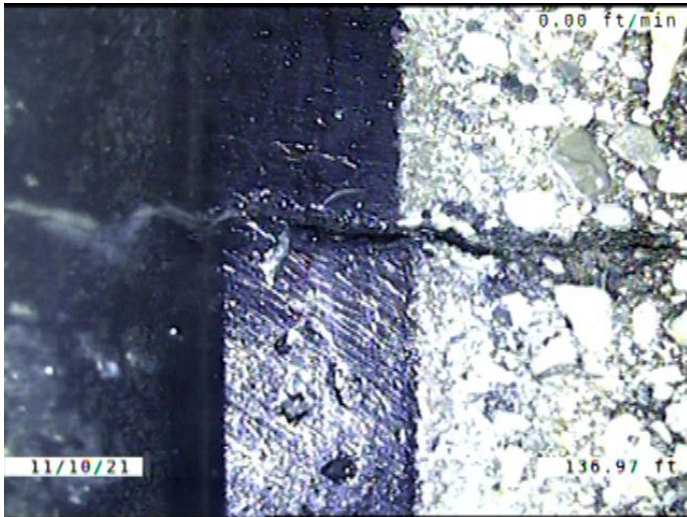
Code: **FM**
 Description: **Fracture Multiple**

Distance (ft): **137.0**
 Structural Grade: **4**
 O&M Grade: **0**
 Clock Start/From: **12**
 Clock To: **12**
 1st Value:
 2nd Value:
 Value Percent:
 Continuous Index:
 Within 8" of Joint: **NO**
 Remarks:

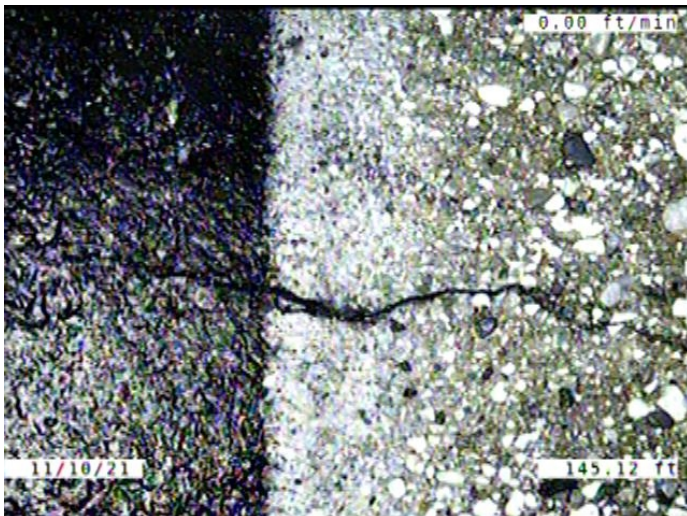
Code: **FM**
 Description: **Fracture Multiple**

Distance (ft): **145.1**
 Structural Grade: **4**
 O&M Grade: **0**
 Clock Start/From: **3**
 Clock To: **9**
 1st Value:
 2nd Value:
 Value Percent:
 Continuous Index:
 Within 8" of Joint: **YES**
 Remarks:

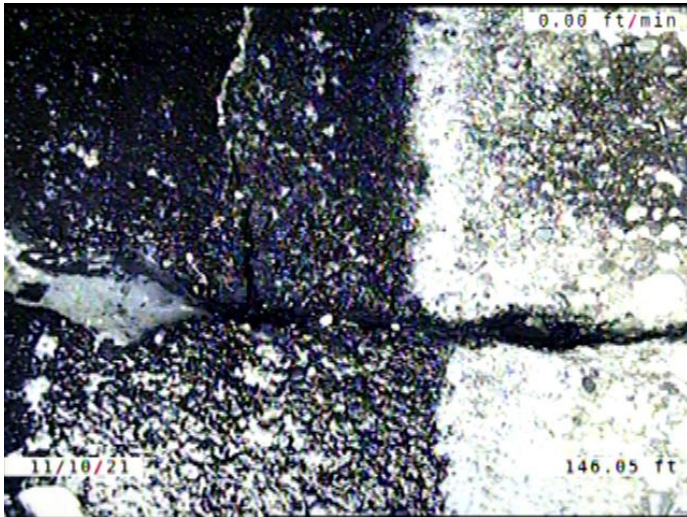
Code: **FM**
 Description: **Fracture Multiple**

Distance (ft): **146.0**
 Structural Grade: **4**
 O&M Grade: **0**
 Clock Start/From: **3**
 Clock To: **9**
 1st Value:
 2nd Value:
 Value Percent:
 Continuous Index:
 Within 8" of Joint: **YES**
 Remarks:

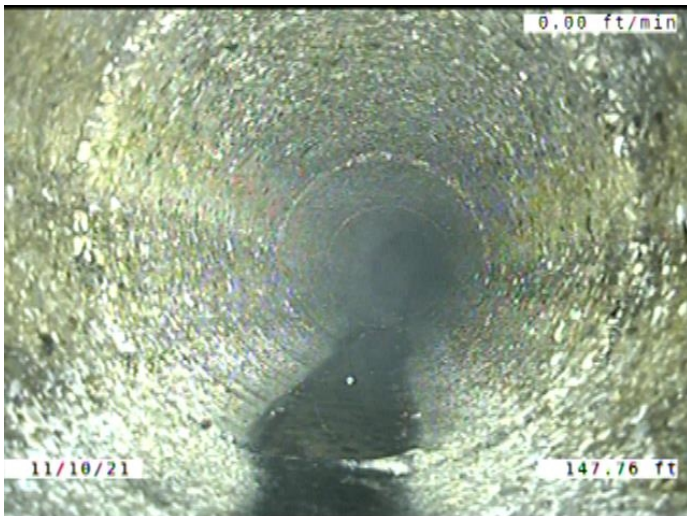
Code: **MWLS**
 Description: **Miscellaneous Water Level Sag**

Distance (ft): **147.8**
 Structural Grade: **2**
 O&M Grade: **0**
 Clock Start/From:
 Clock To:
 1st Value:
 2nd Value:
 Value Percent: **10.000**
 Continuous Index: **F04**
 Within 8" of Joint: **NO**
 Remarks:

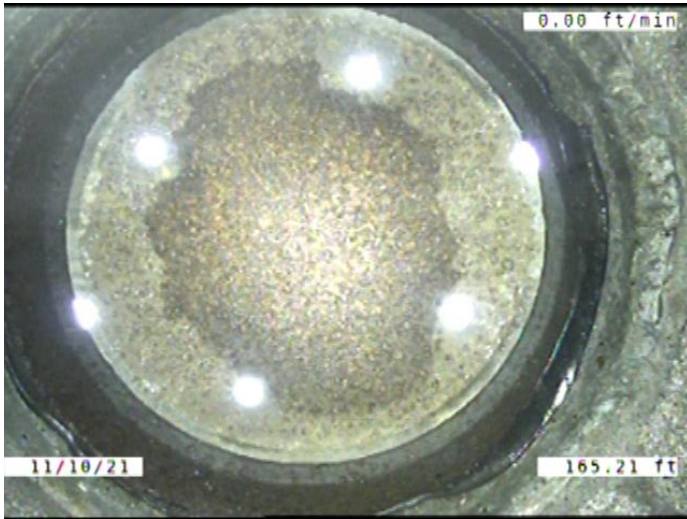
Code:	AMH
Description:	Manhole
Distance (ft):	165.2
Structural Grade:	0
O&M Grade:	0
Clock Start/From:	
Clock To:	
1st Value:	
2nd Value:	
Value Percent:	
Continuous Index:	
Within 8" of Joint:	NO
Remarks:	M-604-116
