Profile/Photo Observation Report

Date:	04/24/2018	Weather:		Coding:	PACP 6.0
Pipe Length (ft):	100.2	Owner:	NA	Pre Clean:	Not Known
P.O.#:		Surveyor:	Jen Costello	PSR:	P-604-UNK-116A
Customer:		Clean Date:	01/01/1900	Shape:	C

Street:	W CLEVELAND AVE	Flow Control:	Not Controlled
City:	Hobart, IN	Year Renewed:	
Location:	Other	Tape/Media #:	
Purpose:	Not Known	Dia/Height:	12"
Use:	Sanitary	Material:	CP
Drain Area:	NA	Lining:	
Category:	NA		
Comment:			
Location Details:		Direction of Survey:	Downstream
US MH:	M-604-116	DS MH:	M-604-116
		Total Length Surveyed (ft):	8.0

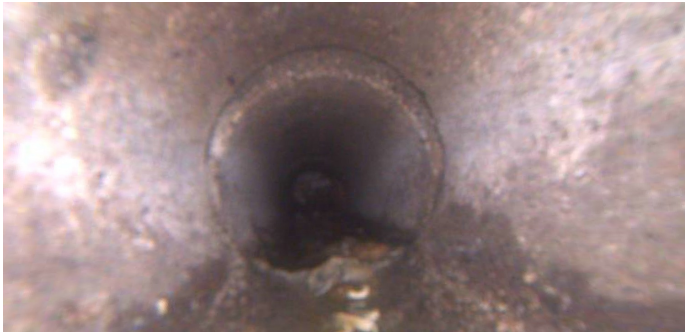
Code:	MWL
Description:	Water Level

Distance (ft):	.0
Structural Grade:	0
O&M Grade:	0
Clock Start/From:	
Clock To:	
1st Value:	
2nd Value:	
Value Percent:	5.000
Continuous Index:	
Within 8" of Joint:	NO
Remarks:

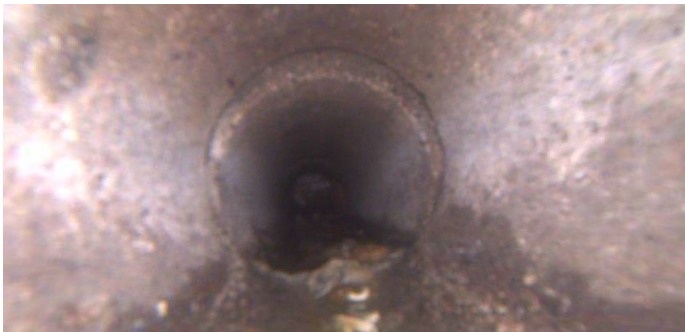
Code:	SAV
Description:	Surface Aggregate Visible

Distance (ft):	.0
Structural Grade:	3
O&M Grade:	0
Clock Start/From:	7
Clock To:	5
1st Value:	
2nd Value:	
Value Percent:	
Continuous Index:	S01
Within 8" of Joint:	
Remarks:

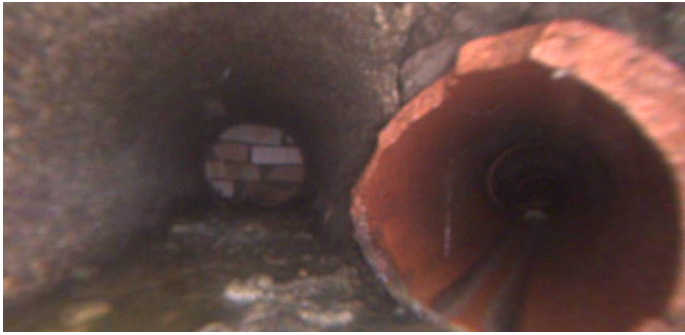
Code: **TBI**
Description: **Tap Break-in Intruding**

Distance (ft): **4.6**
Structural Grade: **0**
O&M Grade: **2**
Clock Start/From: **3**
Clock To:
1st Value: **4.000**
2nd Value: **2.000**
Value Percent:
Continuous Index:
Within 8" of Joint:
Remarks:

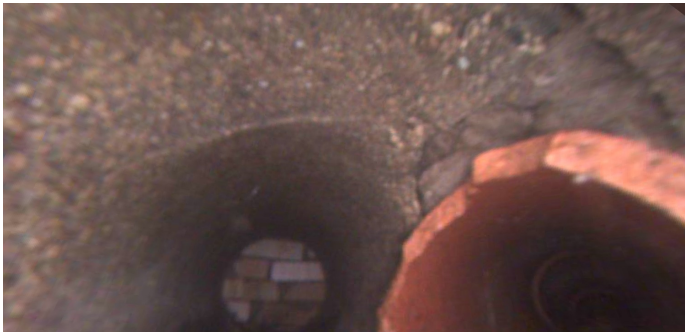
Code: **FC**
Description: **Fracture Circumferential**

Distance (ft): **4.6**
Structural Grade: **2**
O&M Grade: **0**
Clock Start/From: **10**
Clock To: **2**
1st Value:
2nd Value:
Value Percent:
Continuous Index:
Within 8" of Joint:
Remarks:

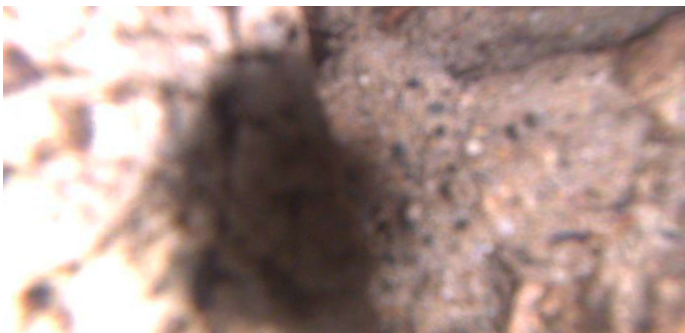
Code: **SAV**
Description: **Surface Aggregate Visible**

Distance (ft): **8.0**
Structural Grade: **3**
O&M Grade: **0**
Clock Start/From: **7**
Clock To: **5**
1st Value:
2nd Value:
Value Percent:
Continuous Index: **F01**
Within 8" of Joint:
Remarks:
