Profile/Photo Observation Report

Street:	W Cleveland Ave. Alley	Flow Control:	Not Controlled
City:	Hobart, IN	Year Renewed:	
Location:	Other	Tape/Media #:	
Purpose:	Not Known	Dia/Height:	12"
Use:	Sanitary	Material:	CP
Drain Area:	NA	Lining:	
Category:	NA		
Comment:

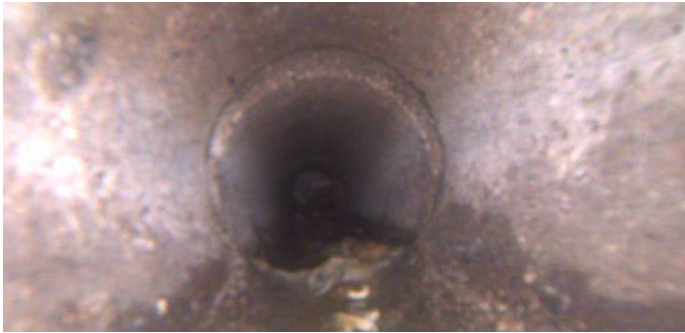
Code:	MWL
Description:	Water Level

Distance (ft):	.0
Structural Grade:	0
O&M Grade:	0
Clock Start/From:	
Clock To:	
1st Value:	
2nd Value:	
Value Percent:	5.000
Continuous Index:	
Within 8" of Joint:	NO
Remarks:

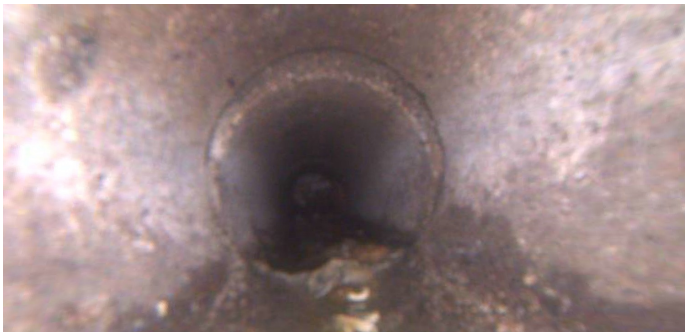
Code:	SAV
Description:	Surface Aggregate Visible

Distance (ft):	.0
Structural Grade:	3
O&M Grade:	0
Clock Start/From:	7
Clock To:	5
1st Value:	
2nd Value:	
Value Percent:	
Continuous Index:	S01
Within 8" of Joint:	
Remarks:

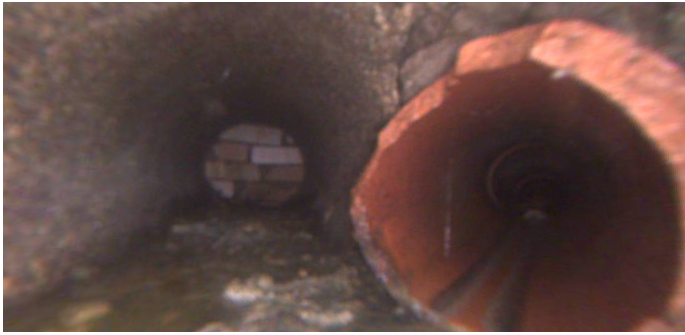
Code: **TBI**
Description: **Tap Break-in Intruding**

Distance (ft): **4.6**
Structural Grade: **0**
O&M Grade: **2**
Clock Start/From: **3**
Clock To:
1st Value: **4.000**
2nd Value: **2.000**
Value Percent:
Continuous Index:
Within 8" of Joint:
Remarks:

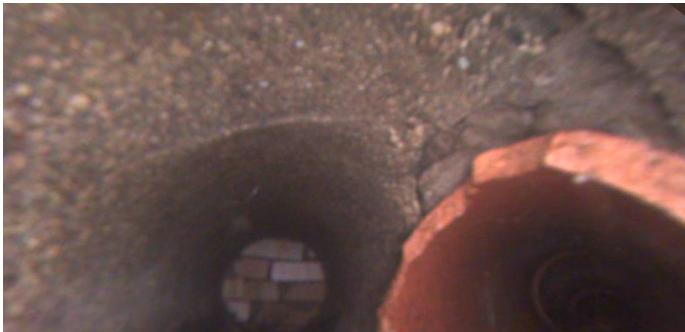
Code: **FC**
Description: **Fracture Circumferential**

Distance (ft): **4.6**
Structural Grade: **2**
O&M Grade: **0**
Clock Start/From: **10**
Clock To: **2**
1st Value:
2nd Value:
Value Percent:
Continuous Index:
Within 8" of Joint:
Remarks:

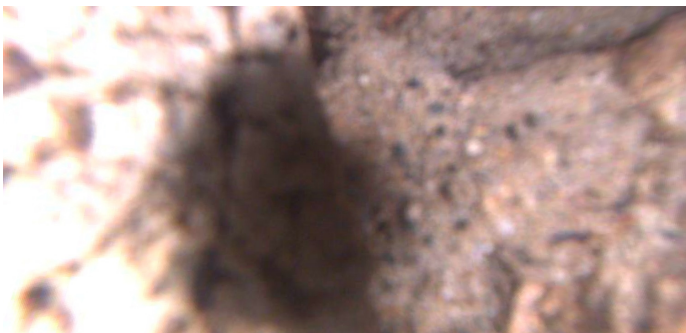
Code: **SAV**
Description: **Surface Aggregate Visible**

Distance (ft): **8.0**
Structural Grade: **3**
O&M Grade: **0**
Clock Start/From: **7**
Clock To: **5**
1st Value:
2nd Value:
Value Percent:
Continuous Index: **F01**
Within 8" of Joint:
Remarks:
