Profile/Photo Observation Report

Date:	04/24/2018	Weather:		Coding:	PACP 6.0
Pipe Length (ft):	100.2	Owner:	NA	Pre Clean:	Not Known
P.O.#:		Surveyor:	Jen Costello	PSR:	P-604-UNK-116A
Customer:		Clean Date:	01/01/1900	Shape:	C

Street:	W CLEVELAND AVE	Flow Control:	Not Controlled
City:	Hobart, IN	Year Renewed:	
Location:	Other	Tape/Media #:	
Purpose:	Not Known	Dia/Height:	12"
Use:	Sanitary	Material:	VCP
Drain Area:	NA	Lining:	
Category:	NA		
Comment:

Location Details:		Direction of Survey:	Downstream
US MH:	M-604-116	DS MH:	M-604-116
		Total Length Surveyed (ft):	1.4

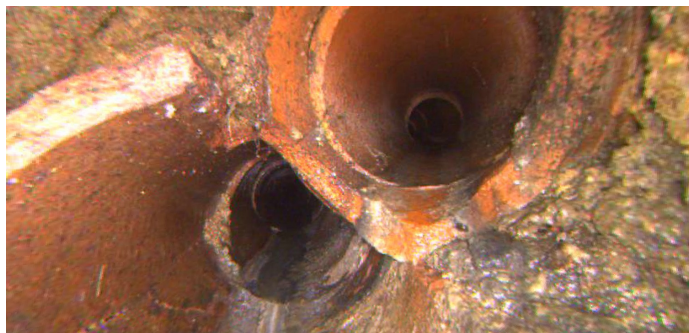
Code: **AMH**
Description: **Manhole**

Distance (ft): **.0**
Structural Grade: **0**
O&M Grade: **0**
Clock Start/From:
Clock To:
1st Value:
2nd Value:
Value Percent:
Continuous Index:
Within 8" of Joint: **NO**
Remarks: **M-604-116**

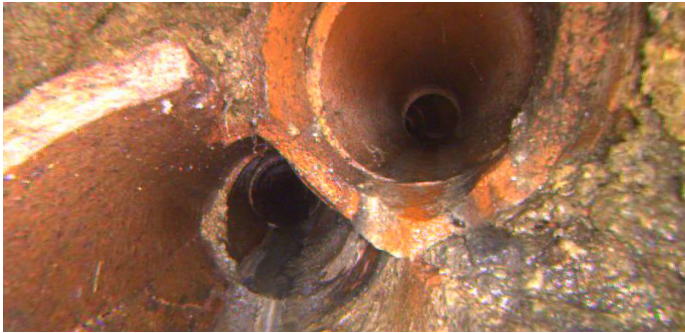
Code: **MWL**
Description: **Water Level**

Distance (ft): **.0**
Structural Grade: **0**
O&M Grade: **0**
Clock Start/From:
Clock To:
1st Value:
2nd Value:
Value Percent: **5.000**
Continuous Index:
Within 8" of Joint: **NO**
Remarks:

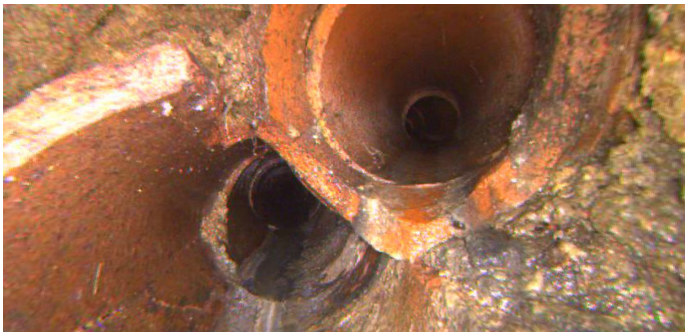
Code: **TBI**
Description: **Tap Break-in Intruding**

Distance (ft): **.0**
Structural Grade: **0**
O&M Grade: **2**
Clock Start/From: **3**
Clock To:
1st Value: **4.000**
2nd Value: **3.000**
Value Percent:
Continuous Index:
Within 8" of Joint:
Remarks:

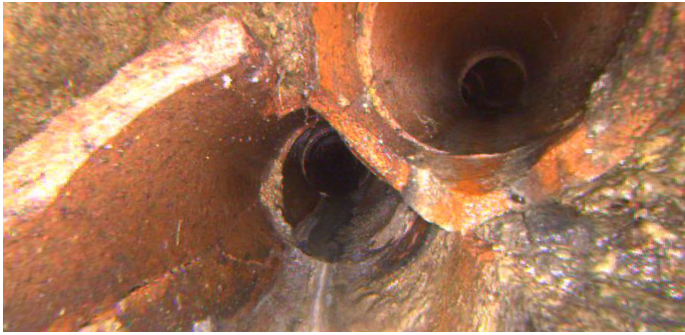
Code: **FL**
Description: **Fracture Longitudinal**

Distance (ft): **.0**
Structural Grade: **3**
O&M Grade: **0**
Clock Start/From: **8**
Clock To:
1st Value:
2nd Value:
Value Percent:
Continuous Index:
Within 8" of Joint:
Remarks:

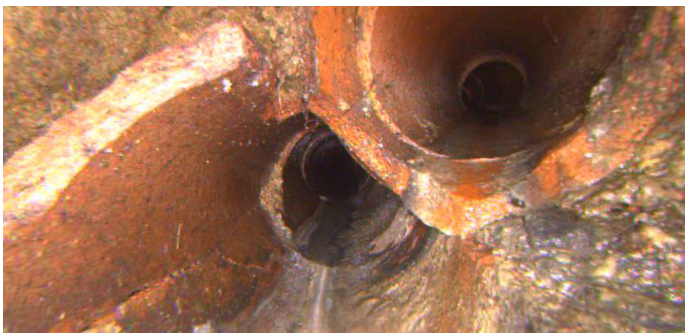
Code: **B**
Description: **Broken**

Distance (ft): **.0**
Structural Grade: **5**
O&M Grade: **0**
Clock Start/From: **9**
Clock To: **12**
1st Value:
2nd Value:
Value Percent:
Continuous Index:
Within 8" of Joint:
Remarks:

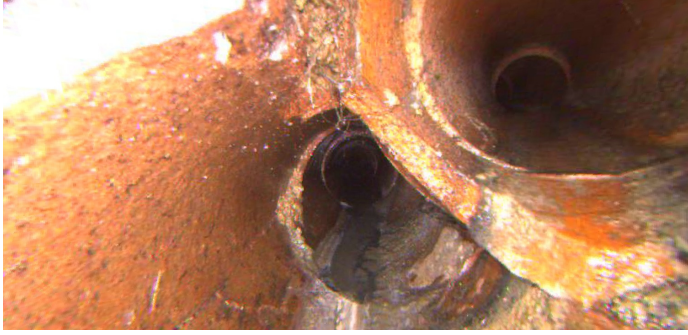
Code:	MSA
Description:	Abandoned Survey
Distance (ft):	1.4
Structural Grade:	0
O&M Grade:	0
Clock Start/From:	
Clock To:	
1st Value:	
2nd Value:	
Value Percent:	
Continuous Index:	
Within 8" of Joint:	NO
Remarks:	TBI
