Profile/Photo Observation Report

Street:	W Cleveland Ave.	Flow Control:	Not Controlled
City:	Hobart, IN	Year Renewed:	
Location:	Other	Tape/Media #:	
Purpose:	Not Known	Dia/Height:	12"
Use:	Sanitary	Material:	VCP
Drain Area:	NA	Lining:	
Category:	NA		
Comment:

Location Details:		Direction of Survey:	Downstream
US MH:	M-604-116	DS MH:	M-604-116
		Total Length Surveyed (ft):	1.4

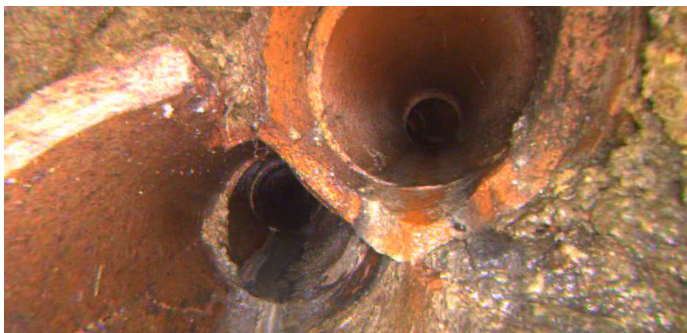
Code: **AMH**
Description: **Manhole**

Distance (ft): **.0**
Structural Grade: **0**
O&M Grade: **0**
Clock Start/From:
Clock To:
1st Value:
2nd Value:
Value Percent:
Continuous Index:
Within 8" of Joint: **NO**
Remarks: **M-604-116**

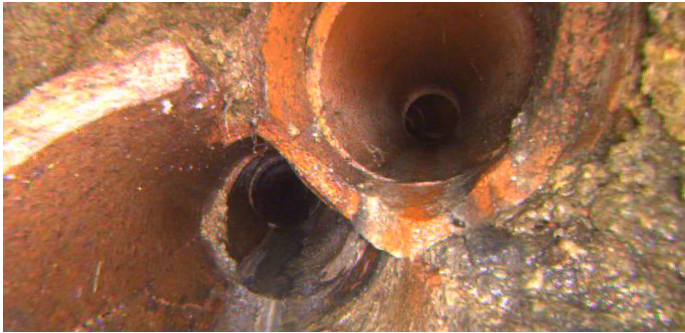
Code: **MWL**
Description: **Water Level**

Distance (ft): **.0**
Structural Grade: **0**
O&M Grade: **0**
Clock Start/From:
Clock To:
1st Value:
2nd Value:
Value Percent: **5.000**
Continuous Index:
Within 8" of Joint: **NO**
Remarks:

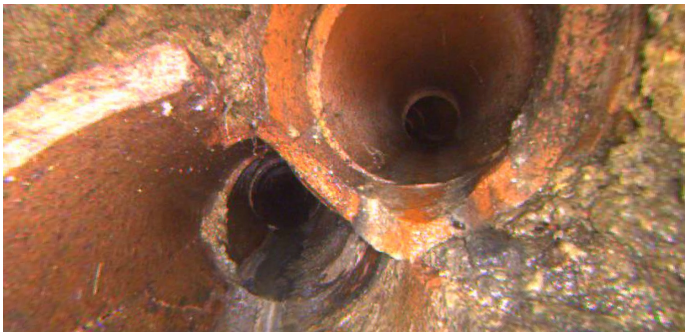
Code: **TBI**
Description: **Tap Break-in Intruding**

Distance (ft): **.0**
Structural Grade: **0**
O&M Grade: **2**
Clock Start/From: **3**
Clock To:
1st Value: **4.000**
2nd Value: **3.000**
Value Percent:
Continuous Index:
Within 8" of Joint:
Remarks:

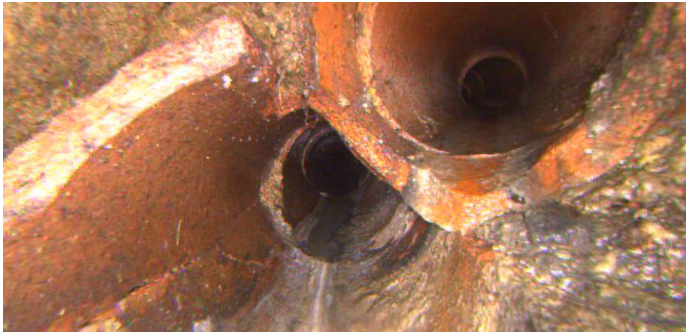
Code: **FL**
Description: **Fracture Longitudinal**

Distance (ft): **.0**
Structural Grade: **3**
O&M Grade: **0**
Clock Start/From: **8**
Clock To:
1st Value:
2nd Value:
Value Percent:
Continuous Index:
Within 8" of Joint:
Remarks:

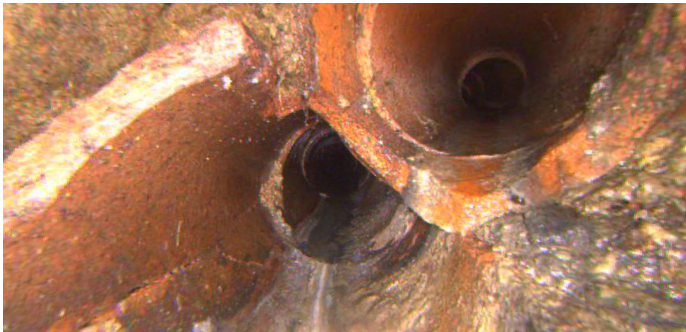
Code: **B**
Description: **Broken**

Distance (ft): **.0**
Structural Grade: **5**
O&M Grade: **0**
Clock Start/From: **9**
Clock To: **12**
1st Value:
2nd Value:
Value Percent:
Continuous Index:
Within 8" of Joint:
Remarks:

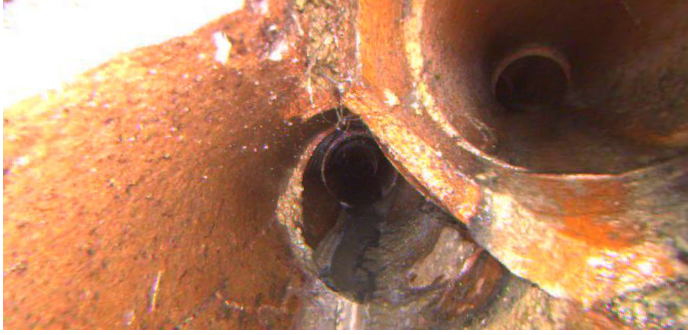
Code:	MSA
Description:	Abandoned Survey
Distance (ft):	1.4
Structural Grade:	0
O&M Grade:	0
Clock Start/From:	
Clock To:	
1st Value:	
2nd Value:	
Value Percent:	
Continuous Index:	
Within 8" of Joint:	NO
Remarks:	TBI
