Profile/Photo Observation Report

Street:	N Lake Park Ave	Flow Control:	Not Controlled
City:	Hobart, IN	Year Renewed:	
Location:	Other	Tape/Media #:	
Purpose:	Not Known	Dia/Height:	8"
Use:	Sanitary	Material:	CP
Drain Area:	NA	Lining:	
Category:	NA		
Comment:

Location Details:		Direction of Survey:	Downstream
US MH:	M-604-120	DS MH:	M-604-121
		Total Length Surveyed (ft):	3.4

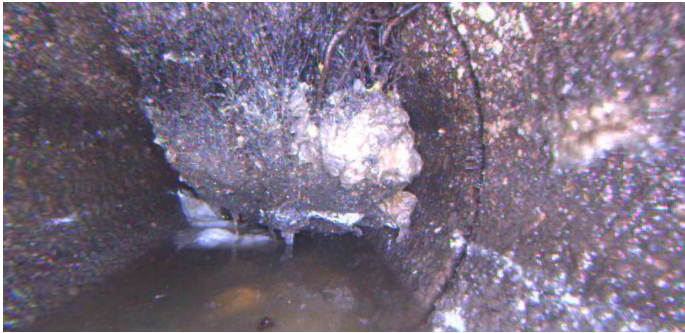
Code:	MWL
Description:	Water Level

Distance (ft):	.0
Structural Grade:	0
O&M Grade:	0
Clock Start/From:	
Clock To:	
1st Value:	
2nd Value:	
Value Percent:	10.000
Continuous Index:	
Within 8" of Joint:	NO
Remarks:

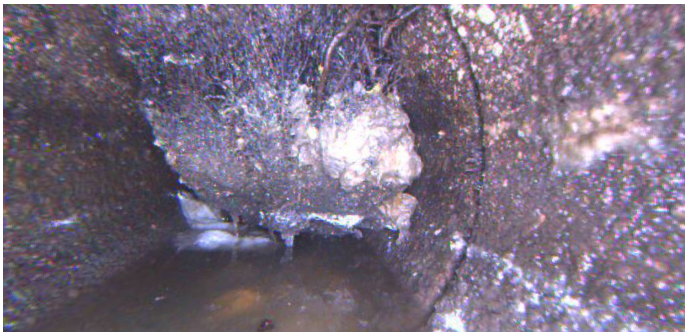
Code:	SAP
Description:	Surface Aggregate Projecting

Distance (ft):	.0
Structural Grade:	3
O&M Grade:	0
Clock Start/From:	8
Clock To:	4
1st Value:	
2nd Value:	
Value Percent:	
Continuous Index:	
Within 8" of Joint:	
Remarks:

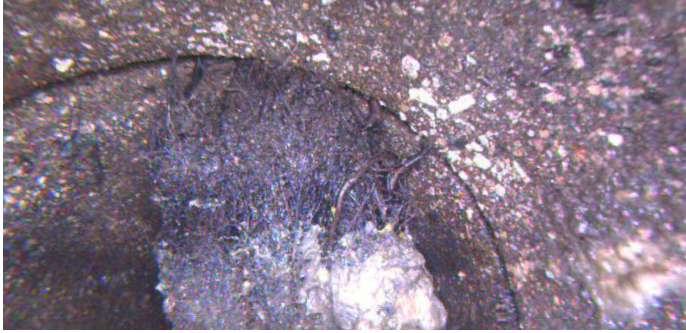
Code: **RBJ**
Description: **Roots Ball Joint**

Distance (ft): **.0**
Structural Grade: **0**
O&M Grade: **4**
Clock Start/From: **1**
Clock To: **6**
1st Value:
2nd Value:
Value Percent: **70.000**
Continuous Index:
Within 8" of Joint: **YES**
Remarks:

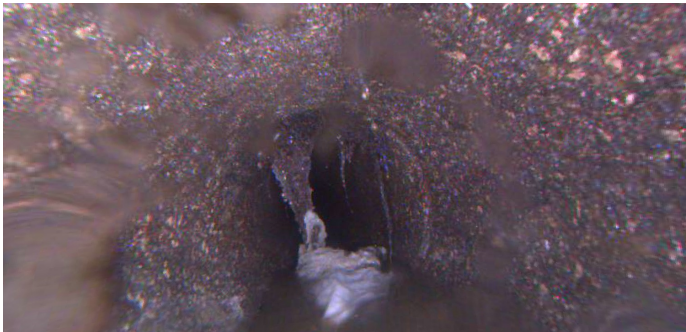
Code: **MSA**
Description: **Abandoned Survey**

Distance (ft): **3.4**
Structural Grade: **0**
O&M Grade: **0**
Clock Start/From:
Clock To:
1st Value:
2nd Value:
Value Percent:
Continuous Index:
Within 8" of Joint: **NO**
Remarks: **roots**
