## Profile/Photo Observation Report

Street:	<b>E Old Ridge Rd.</b>	Flow Control:	<b>Not Controlled</b>
City:	<b>Hobart, IN</b>	Year Renewed:	
Location:	<b>Other</b>	Tape/Media #:	
Purpose:	<b>Not Known</b>	Dia/Height:	<b>10"</b>
Use:	<b>Sanitary</b>	Material:	<b>CP</b>
Drain Area:	<b>NA</b>	Lining:	
Category:	<b>NA</b>		
Comment:

Location Details:		Direction of Survey:	<b>Downstream</b>
US MH:	<b>M-604-121</b>	DS MH:	<b>M-604-023</b>
		Total Length Surveyed (ft):	<b>20.9</b>

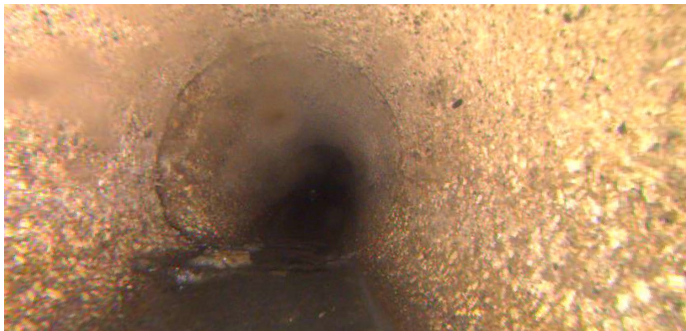
Code: **AMH**  
Description: **Manhole**

Distance (ft): **.0**  
Structural Grade: **0**  
O&M Grade: **0**  
Clock Start/From:  
Clock To:  
1st Value:  
2nd Value:  
Value Percent:  
Continuous Index:  
Within 8" of Joint: **NO**  
Remarks: **M-604-121**

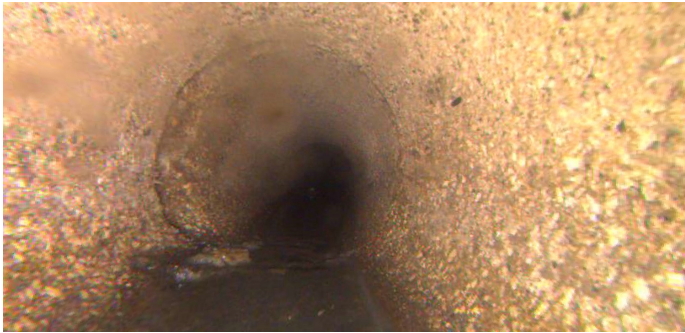
Code:	<b>MWL</b>
Description:	<b>Water Level</b>

Distance (ft):	<b>.0</b>
Structural Grade:	<b>0</b>
O&M Grade:	<b>0</b>
Clock Start/From:	
Clock To:	
1st Value:	
2nd Value:	
Value Percent:	<b>5.000</b>
Continuous Index:	
Within 8" of Joint:	<b>NO</b>
Remarks:

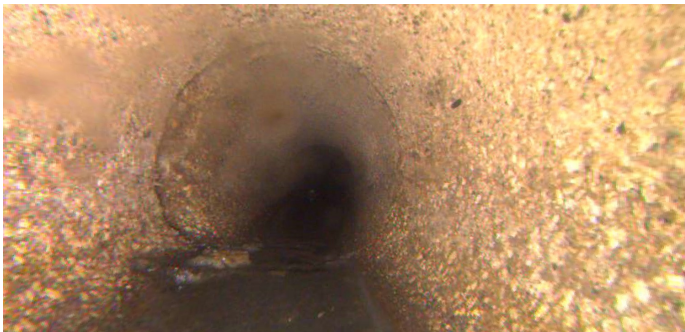
Code:	<b>SAP</b>
Description:	<b>Surface Aggregate Projecting</b>

Distance (ft):	<b>.0</b>
Structural Grade:	<b>3</b>
O&M Grade:	<b>0</b>
Clock Start/From:	<b>7</b>
Clock To:	<b>5</b>
1st Value:	
2nd Value:	
Value Percent:	
Continuous Index:	<b>S01</b>
Within 8" of Joint:	
Remarks:

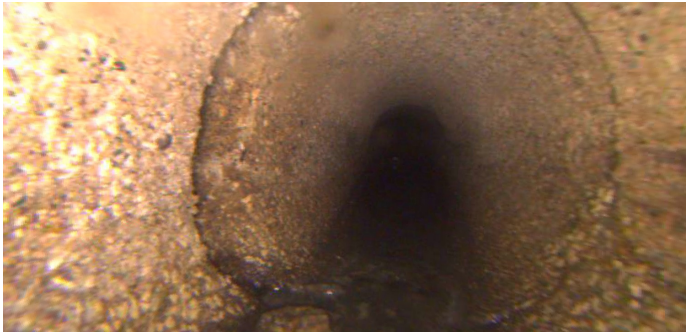
Code: **SSS**  
Description: **Surface Spalling**

Distance (ft): **1.7**  
Structural Grade: **2**  
O&M Grade: **0**  
Clock Start/From: **7**  
Clock To: **11**  
1st Value:  
2nd Value:  
Value Percent:  
Continuous Index:  
Within 8" of Joint: **YES**  
Remarks:

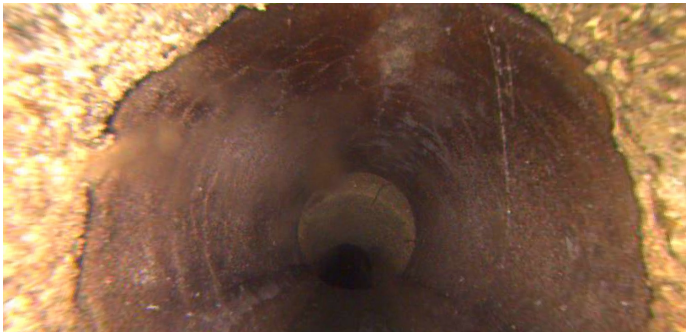
Code: **MMC**  
Description: **Material Change**

Distance (ft): **14.0**  
Structural Grade: **0**  
O&M Grade: **0**  
Clock Start/From:  
Clock To:  
1st Value:  
2nd Value:  
Value Percent:  
Continuous Index:  
Within 8" of Joint: **NO**  
Remarks: **vcp**

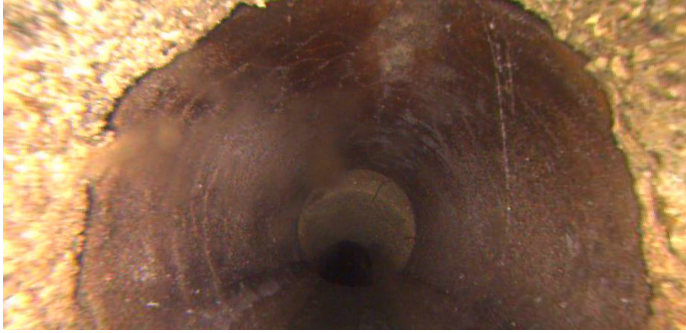
Code: **CM**  
Description: **Crack Multiple**

Distance (ft): **14.0**  
Structural Grade: **3**  
O&M Grade: **0**  
Clock Start/From: **8**  
Clock To: **4**  
1st Value:  
2nd Value:  
Value Percent:  
Continuous Index:  
Within 8" of Joint:  
Remarks:

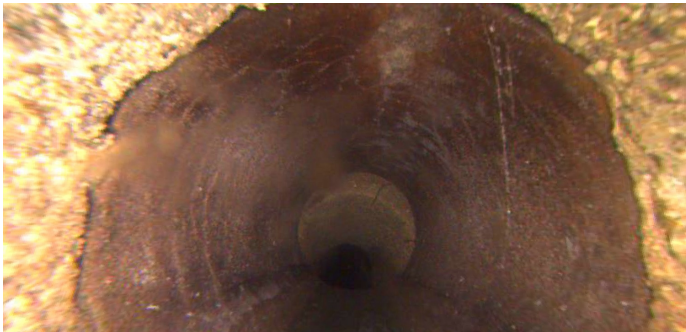
Code: **SAP**  
Description: **Surface Aggregate Projecting**

Distance (ft): **14.0**  
Structural Grade: **3**  
O&M Grade: **0**  
Clock Start/From: **7**  
Clock To: **5**  
1st Value:  
2nd Value:  
Value Percent:  
Continuous Index: **F01**  
Within 8" of Joint:  
Remarks:

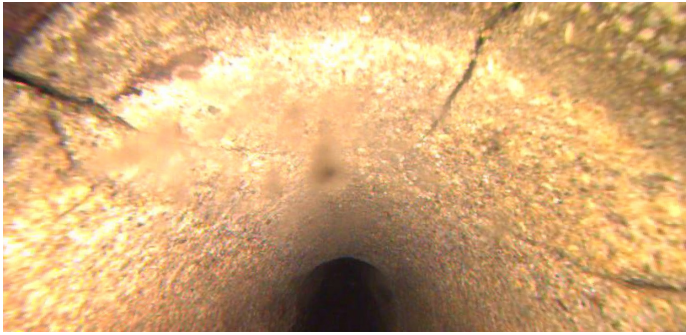
Code: **MMC**  
Description: **Material Change**

Distance (ft): **16.3**  
Structural Grade: **0**  
O&M Grade: **0**  
Clock Start/From:  
Clock To:  
1st Value:  
2nd Value:  
Value Percent:  
Continuous Index:  
Within 8" of Joint: **NO**  
Remarks: **cp**

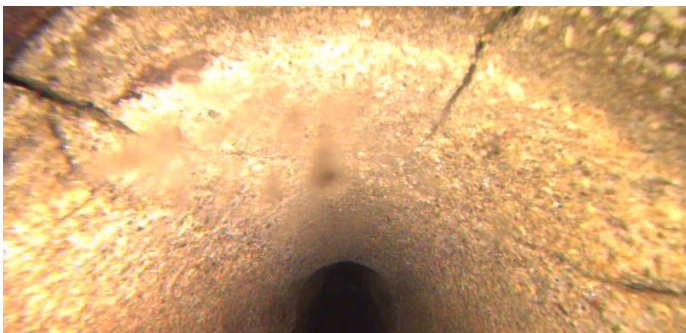
Code: **JOM**  
Description: **Joint Offset Medium**

Distance (ft): **16.3**  
Structural Grade: **1**  
O&M Grade: **0**  
Clock Start/From:  
Clock To:  
1st Value:  
2nd Value:  
Value Percent:  
Continuous Index:  
Within 8" of Joint: **NO**  
Remarks:

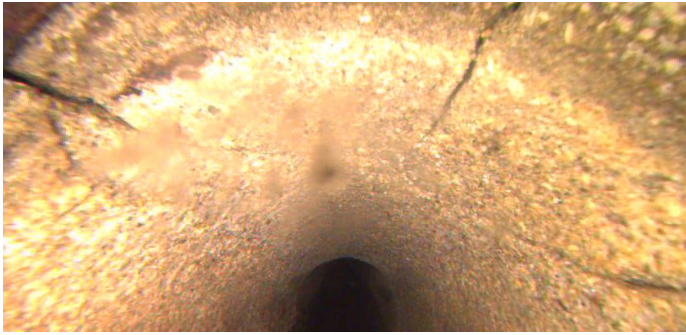
Code: **FM**  
Description: **Fracture Multiple**

Distance (ft): **16.3**  
Structural Grade: **4**  
O&M Grade: **0**  
Clock Start/From: **9**  
Clock To: **6**  
1st Value:  
2nd Value:  
Value Percent:  
Continuous Index:  
Within 8" of Joint: **YES**  
Remarks:

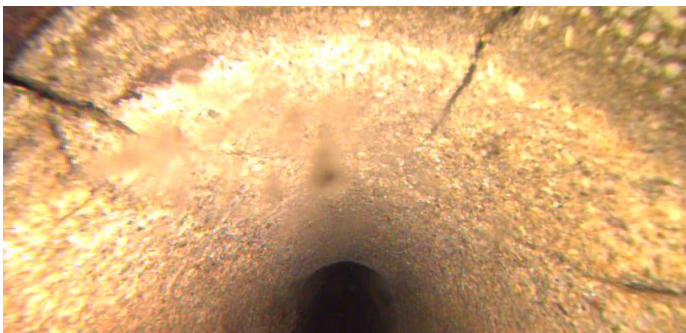
Code: **SAP**  
Description: **Surface Aggregate Projecting**

Distance (ft): **16.3**  
Structural Grade: **3**  
O&M Grade: **0**  
Clock Start/From: **8**  
Clock To: **4**  
1st Value:  
2nd Value:  
Value Percent:  
Continuous Index: **S02**  
Within 8" of Joint:  
Remarks:

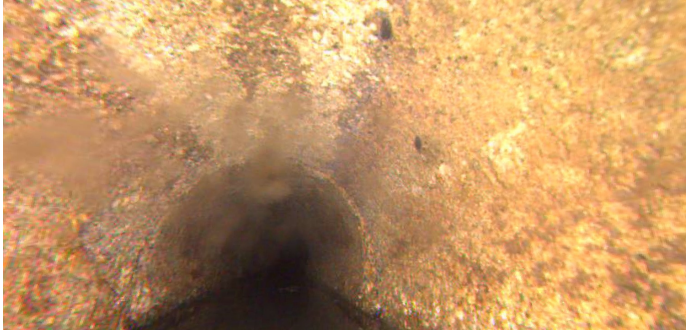
Code: **MSA**  
Description: **Abandoned Survey**

Distance (ft): **20.9**  
Structural Grade: **0**  
O&M Grade: **0**  
Clock Start/From:  
Clock To:  
1st Value:  
2nd Value:  
Value Percent:  
Continuous Index:  
Within 8" of Joint: **NO**  
Remarks: **debris under water**

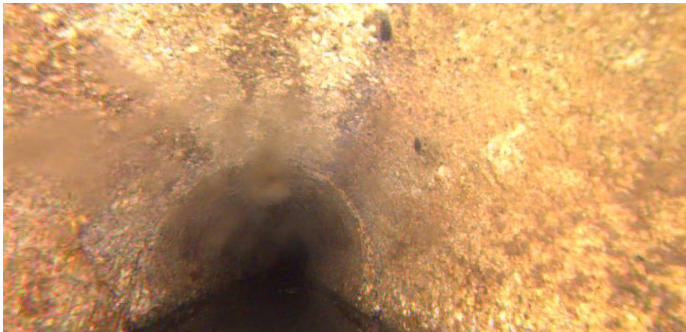
Code: **SAP**  
Description: **Surface Aggregate Projecting**

Distance (ft): **20.9**  
Structural Grade: **3**  
O&M Grade: **0**  
Clock Start/From: **8**  
Clock To: **4**  
1st Value:  
2nd Value:  
Value Percent:  
Continuous Index: **F02**  
Within 8" of Joint:  
Remarks:
