Profile/Photo Observation Report

Date:	09/16/2022	Weather:		Coding:	PACP 7.0
Pipe Length (ft):	249.8	Owner:	City of Hobart	Pre Clean:	No Pre-Cleaning
P.O.#:	YES502259	Surveyor:	S. Bucklin	PSR:	M-605-001-M-705-055
Customer:	City of Hobart	Clean Date:		Shape:	C

Street:	East 3rd Street	Flow Control:	Not Controlled
City:	Hobart, IN	Year Renewed:	
Location:	Local rural streets with light traffic, t	Tape/Media #:	
Purpose:	Routine Assessment	Dia/Height:	10"
Use:	Sanitary Sewage Pipe	Material:	VCP
Drain Area:		Lining:	None
Category:	NA		
Comment:			
Location Details:		Direction of Survey:	Downstream
US MH:	M-605-001	DS MH:	M-705-055
		Total Length Surveyed (ft):	246.3

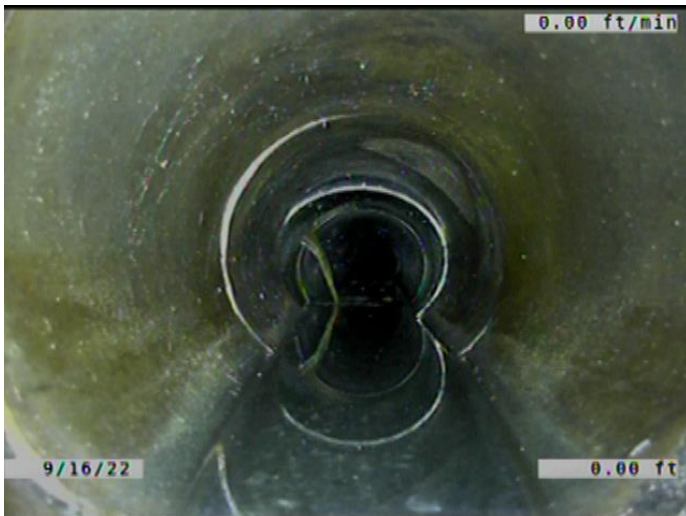
Code: **DSF**
 Description: **Deposits Settled Fine**

Distance (ft): **.0**
 Structural Grade: **0**
 O&M Grade: **2**
 Clock Start/From: **5**
 Clock To: **7**
 1st Value:
 2nd Value:
 Value Percent: **5.000**
 Continuous Index: **S01**
 Within 8" of Joint: **YES**
 Remarks:

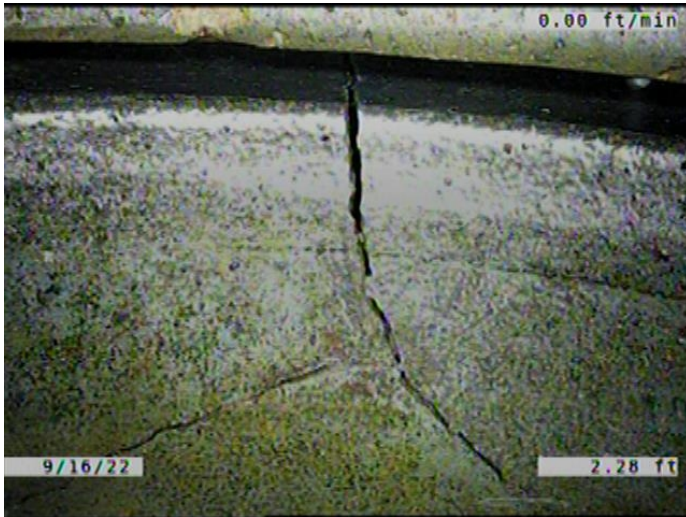
Code: **B**
 Description: **Broken**

Distance (ft): **2.3**
 Structural Grade: **4**
 O&M Grade: **0**
 Clock Start/From: **9**
 Clock To: **3**
 1st Value:
 2nd Value:
 Value Percent:
 Continuous Index:
 Within 8" of Joint: **YES**
 Remarks:

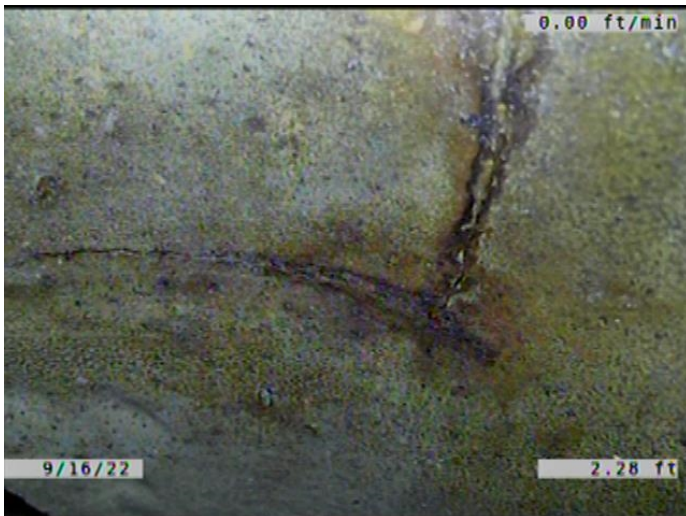
Code: **ISB**
 Description: **Infiltration Stain Barrel**

Distance (ft): **2.3**
 Structural Grade: **0**
 O&M Grade: **1**
 Clock Start/From: **8**
 Clock To: **4**
 1st Value:
 2nd Value:
 Value Percent:
 Continuous Index:
 Within 8" of Joint: **YES**
 Remarks:

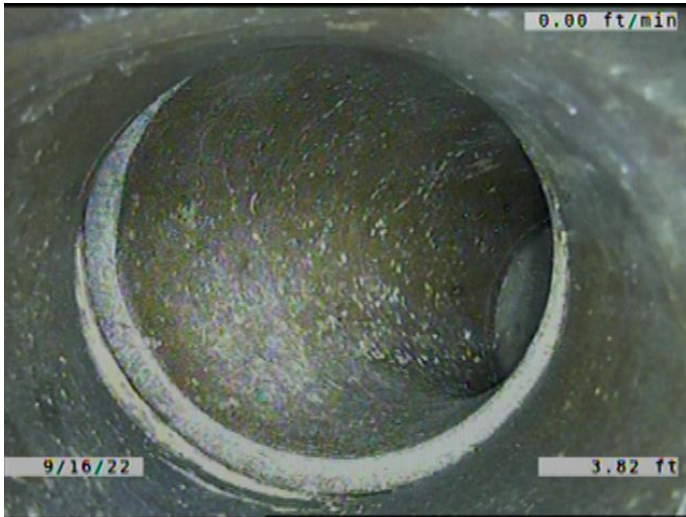
Code: **TFD**
Description: **Tap Factory Defective**

Distance (ft): **3.8**
Structural Grade: **0**
O&M Grade: **3**
Clock Start/From: **1**
Clock To:
1st Value: **6.000**
2nd Value:
Value Percent:
Continuous Index:
Within 8" of Joint: **YES**
Remarks: **TAP BROKEN. SERVICE OFFSET.**

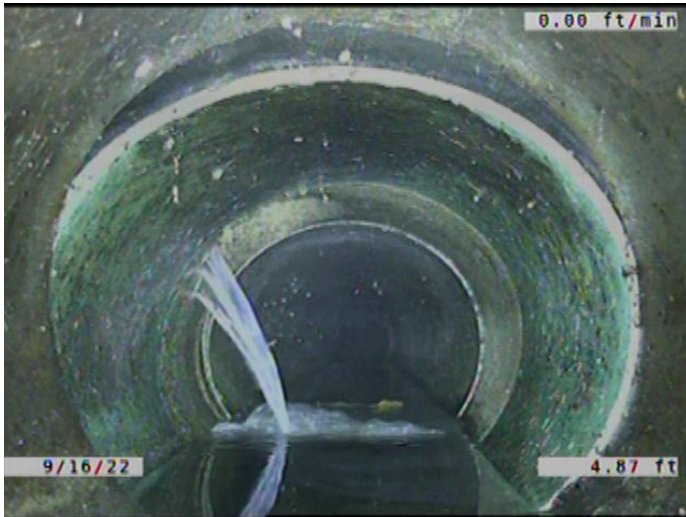
Code: **JOL**
 Description: **Joint Offset Large**

Distance (ft): **4.9**
 Structural Grade: **4**
 O&M Grade: **0**
 Clock Start/From:
 Clock To:
 1st Value:
 2nd Value:
 Value Percent:
 Continuous Index:
 Within 8" of Joint: **NO**
 Remarks:

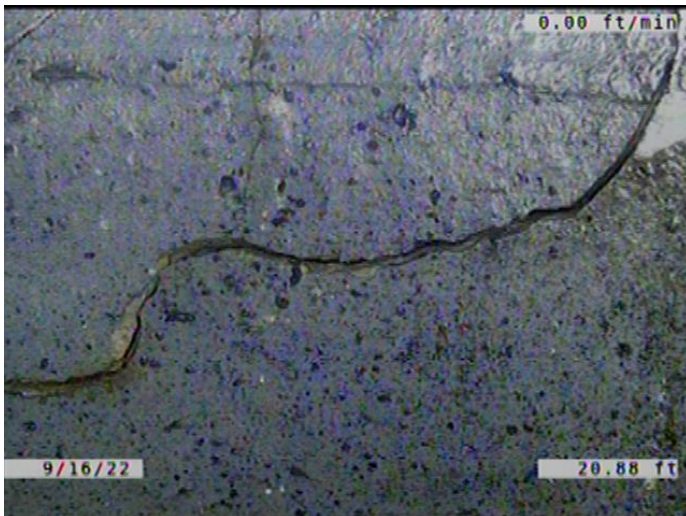
Code:	B
Description:	Broken
Distance (ft):	20.9
Structural Grade:	4
O&M Grade:	0
Clock Start/From:	8
Clock To:	4
1st Value:	
2nd Value:	
Value Percent:	
Continuous Index:	S02
Within 8" of Joint:	YES
Remarks:

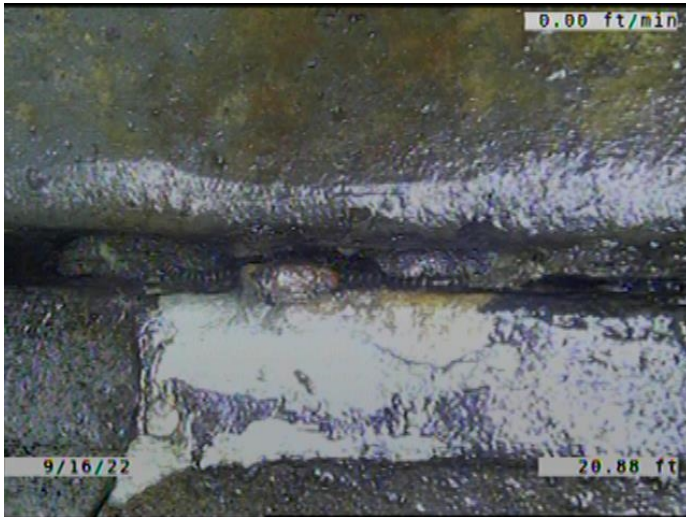
Code: **ISJ**
 Description: **Infiltration Stain Joint**

Distance (ft): **20.9**
 Structural Grade: **0**
 O&M Grade: **1**
 Clock Start/From: **8**
 Clock To: **4**
 1st Value:
 2nd Value:
 Value Percent:
 Continuous Index:
 Within 8" of Joint: **YES**
 Remarks:

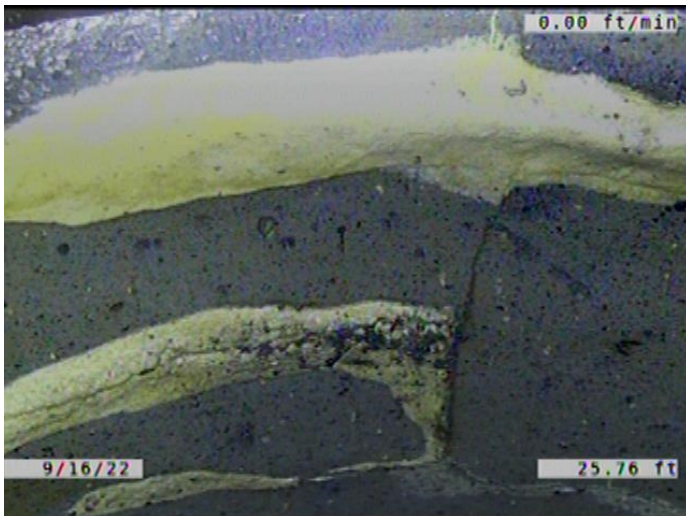
Code: **DAE**
 Description: **Deposits Attached Encrustation**

Distance (ft): **25.8**
 Structural Grade: **0**
 O&M Grade: **2**
 Clock Start/From: **8**
 Clock To: **4**
 1st Value:
 2nd Value:
 Value Percent: **5.000**
 Continuous Index: **S03**
 Within 8" of Joint: **YES**
 Remarks:

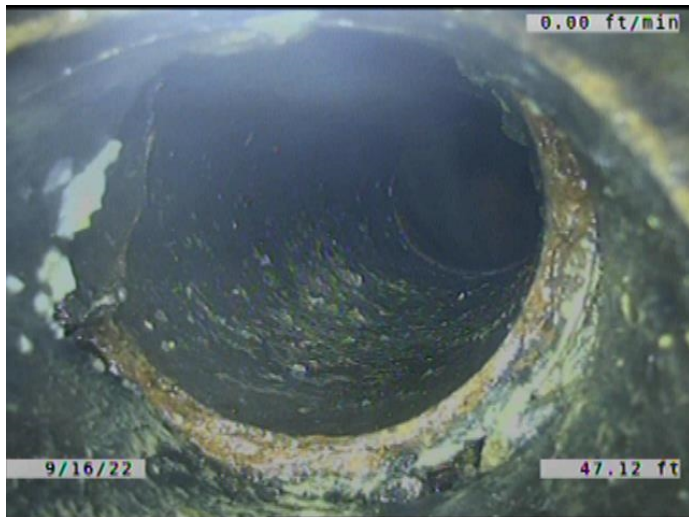
Code: **TFD**
 Description: **Tap Factory Defective**

Distance (ft): **47.1**
 Structural Grade: **0**
 O&M Grade: **3**
 Clock Start/From: **11**
 Clock To:
 1st Value: **6.000**
 2nd Value:
 Value Percent:
 Continuous Index:
 Within 8" of Joint: **YES**
 Remarks: **TAP BROKEN. SERVICE BROKEN AND OFFSET.**

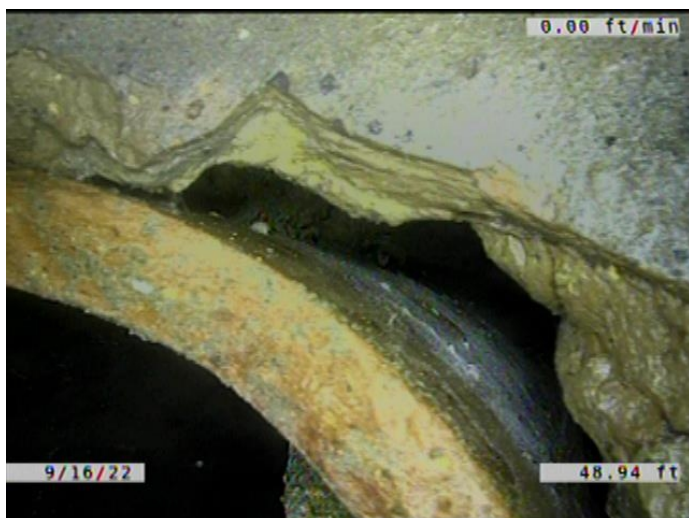
Code: **HVV**
 Description: **Hole Void Visible**

Distance (ft): **48.9**
 Structural Grade: **5**
 O&M Grade: **0**
 Clock Start/From: **3**
 Clock To:
 1st Value:
 2nd Value:
 Value Percent:
 Continuous Index:
 Within 8" of Joint: **YES**
 Remarks:

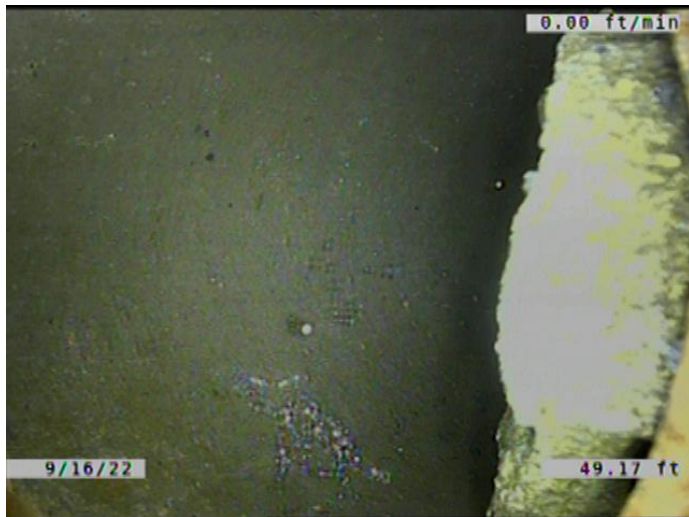
Code: **TBI**
 Description: **Tap Break-in Intruding**

Distance (ft): **49.2**
 Structural Grade: **0**
 O&M Grade: **2**
 Clock Start/From: **2**
 Clock To:
 1st Value: **6.000**
 2nd Value: **1.000**
 Value Percent:
 Continuous Index:
 Within 8" of Joint: **YES**
 Remarks:

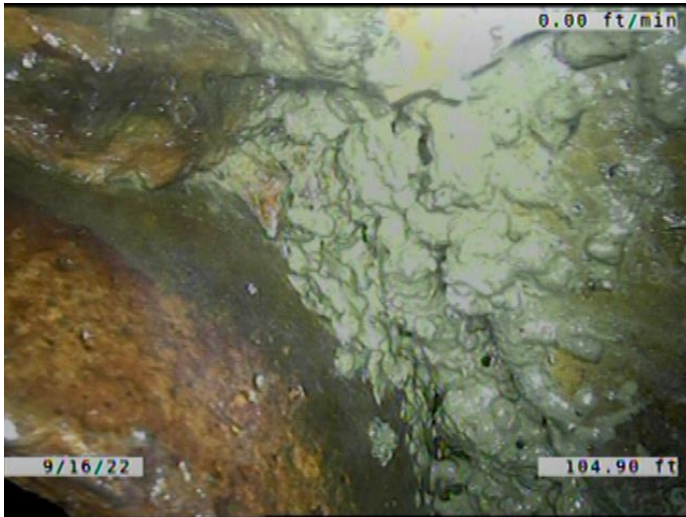
Code: **BSV**
 Description: **Broken Soil Visible**

Distance (ft): **104.9**
 Structural Grade: **5**
 O&M Grade: **0**
 Clock Start/From: **12**
 Clock To: **4**
 1st Value:
 2nd Value:
 Value Percent:
 Continuous Index:
 Within 8" of Joint: **YES**
 Remarks:

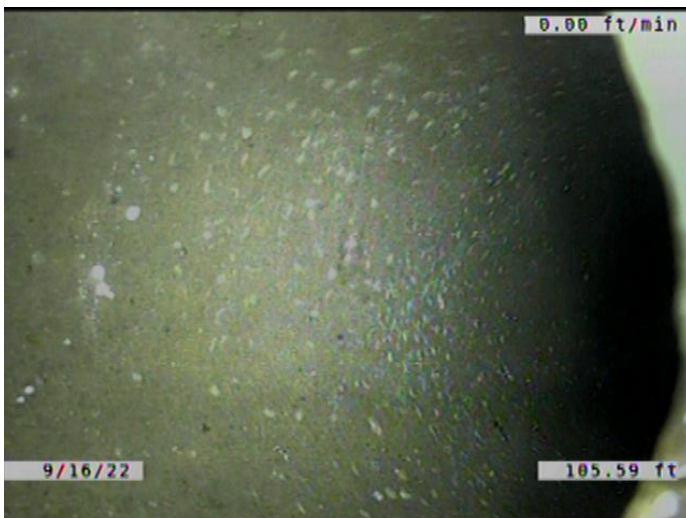
Code: **TBI**
 Description: **Tap Break-in Intruding**

Distance (ft): **105.6**
 Structural Grade: **0**
 O&M Grade: **2**
 Clock Start/From: **1**
 Clock To:
 1st Value: **6.000**
 2nd Value: **1.000**
 Value Percent:
 Continuous Index:
 Within 8" of Joint: **YES**
 Remarks:

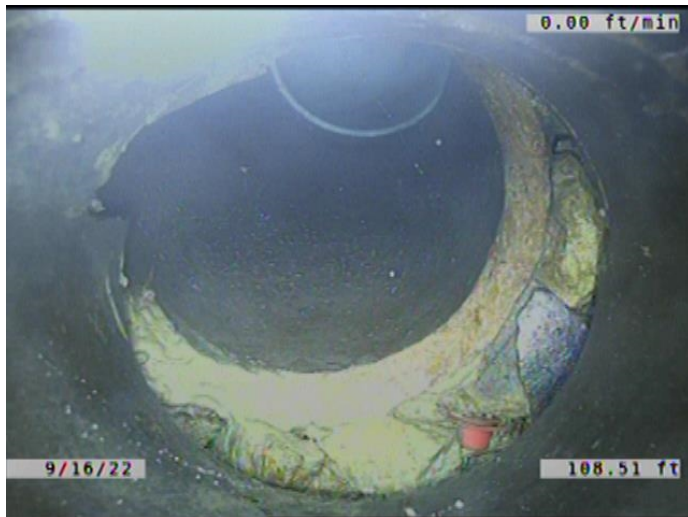
Code:	TFD
Description:	Tap Factory Defective
Distance (ft):	108.5
Structural Grade:	0
O&M Grade:	3
Clock Start/From:	11
Clock To:	
1st Value:	6.000
2nd Value:	
Value Percent:	
Continuous Index:	
Within 8" of Joint:	YES
Remarks:	TAP BROKEN. SERVICE LARGE OFFSET. SOIL VISIBLE. SOME OF THE

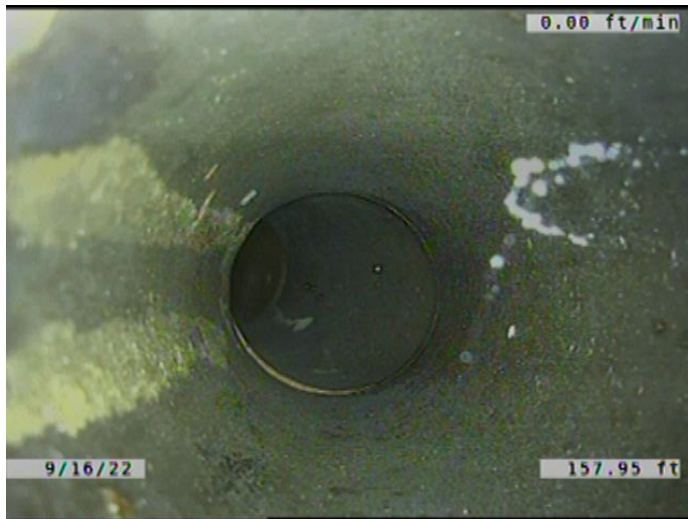
Code: **TBI**
 Description: **Tap Break-in Intruding**

Distance (ft): **157.9**
 Structural Grade: **0**
 O&M Grade: **2**
 Clock Start/From: **11**
 Clock To:
 1st Value: **6.000**
 2nd Value: **1.000**
 Value Percent:
 Continuous Index:
 Within 8" of Joint: **YES**
 Remarks:

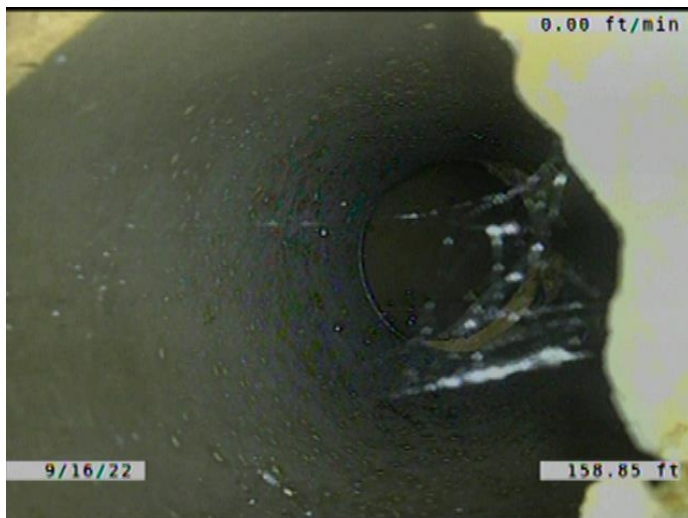
Code: **TBD**
 Description: **Tap Break-in/Hammer Defective**

Distance (ft): **158.8**
 Structural Grade: **0**
 O&M Grade: **3**
 Clock Start/From: **1**
 Clock To:
 1st Value: **6.000**
 2nd Value:
 Value Percent:
 Continuous Index:
 Within 8" of Joint: **YES**
 Remarks: **DAE**

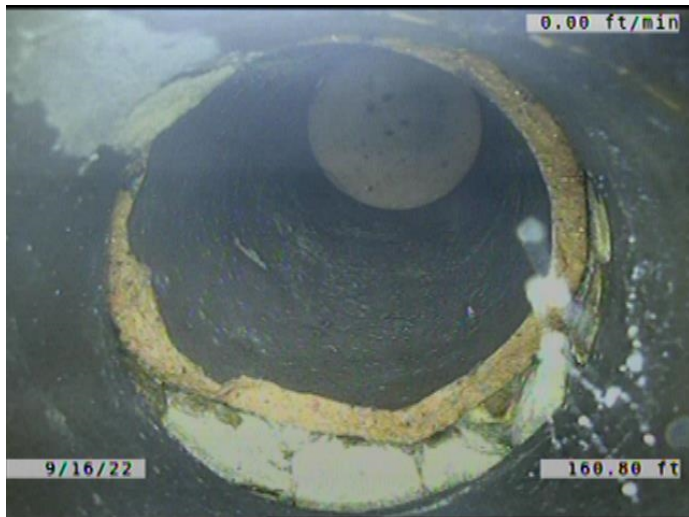
Code: **TFD**
 Description: **Tap Factory Defective**

Distance (ft): **160.8**
 Structural Grade: **0**
 O&M Grade: **3**
 Clock Start/From: **11**
 Clock To:
 1st Value: **6.000**
 2nd Value:
 Value Percent:
 Continuous Index:
 Within 8" of Joint: **YES**
 Remarks: **TAP BROKEN. SERVICE BROKEN AND OFFSET. CAPPED.**

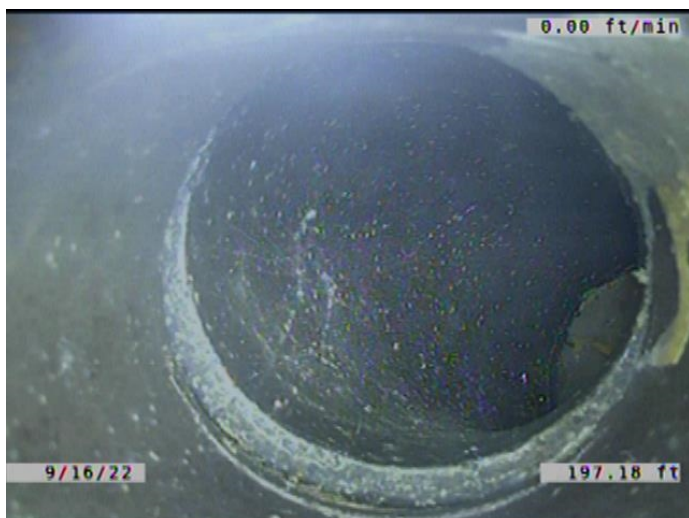
Code: **TFD**
 Description: **Tap Factory Defective**

Distance (ft): **197.2**
 Structural Grade: **0**
 O&M Grade: **3**
 Clock Start/From: **1**
 Clock To:
 1st Value: **6.000**
 2nd Value:
 Value Percent:
 Continuous Index:
 Within 8" of Joint: **YES**
 Remarks: **TAP BROKEN. SERVICE OFFSET. CAPPED. CAP BROKEN.**

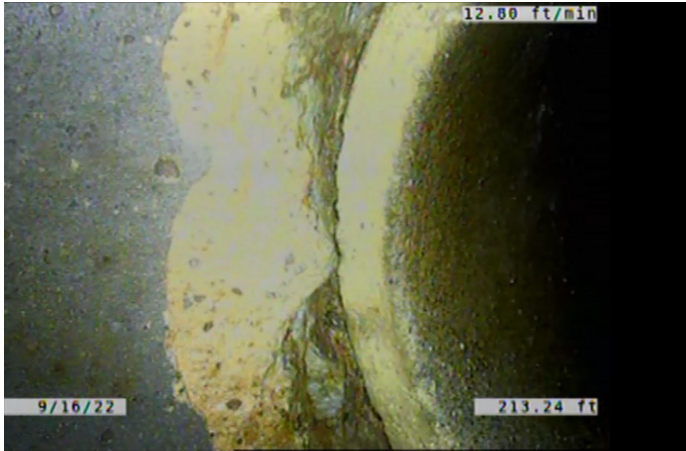
Code:	SSS
Description:	Surface Damage Surface Spalling
Distance (ft):	213.2
Structural Grade:	2
O&M Grade:	0
Clock Start/From:	1
Clock To:	3
1st Value:	
2nd Value:	
Value Percent:	
Continuous Index:	
Within 8" of Joint:	NO
Remarks:

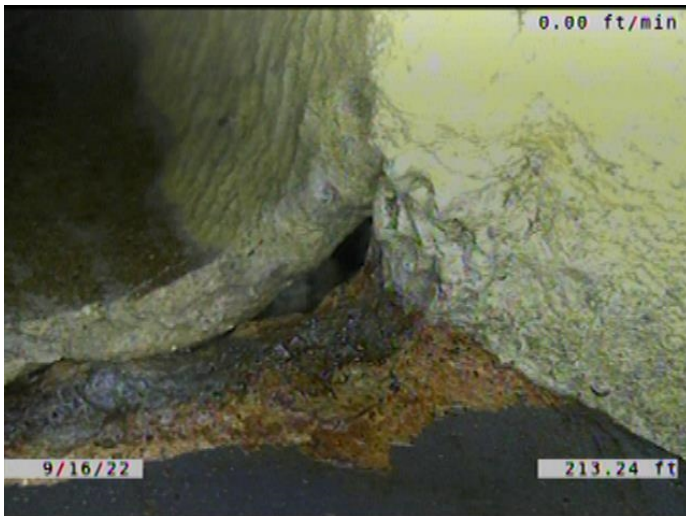
Code:	HVV
Description:	Hole Void Visible
Distance (ft):	213.2
Structural Grade:	5
O&M Grade:	0
Clock Start/From:	12
Clock To:	3
1st Value:	
2nd Value:	
Value Percent:	
Continuous Index:	
Within 8" of Joint:	YES
Remarks:

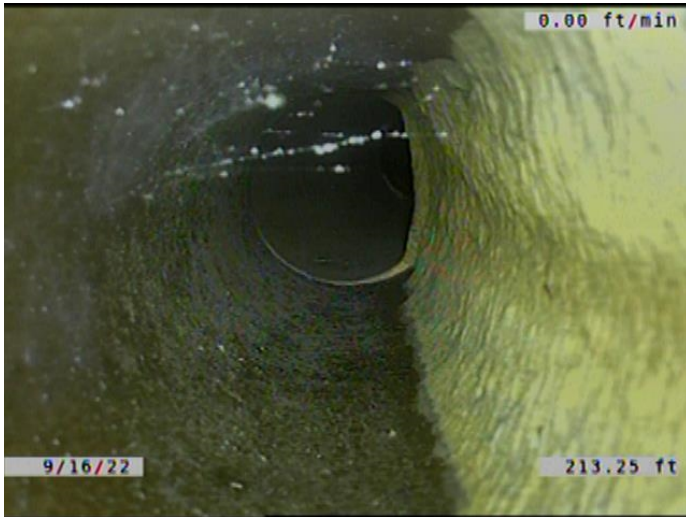
Code: **TBD**
Description: **Tap Break-in/Hammer Defective**

Distance (ft): **213.3**
Structural Grade: **0**
O&M Grade: **3**
Clock Start/From: **2**
Clock To:
1st Value: **6.000**
2nd Value:
Value Percent:
Continuous Index:
Within 8" of Joint: **YES**
Remarks: **ENCRUSTATION COMING DOWN THE SERVICE INTO THE MAIN.**

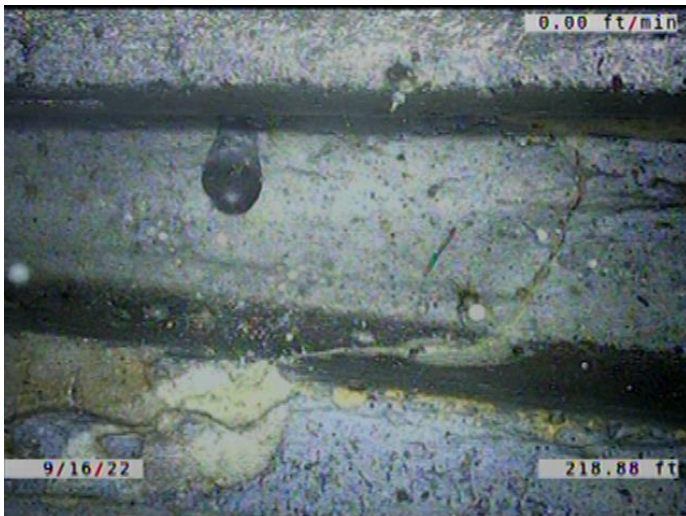
Code: **JAM**
Description: **Joint Angular Medium**

Distance (ft): **218.9**
Structural Grade: **3**
O&M Grade: **0**
Clock Start/From:
Clock To:
1st Value:
2nd Value:
Value Percent:
Continuous Index:
Within 8" of Joint: **NO**
Remarks:

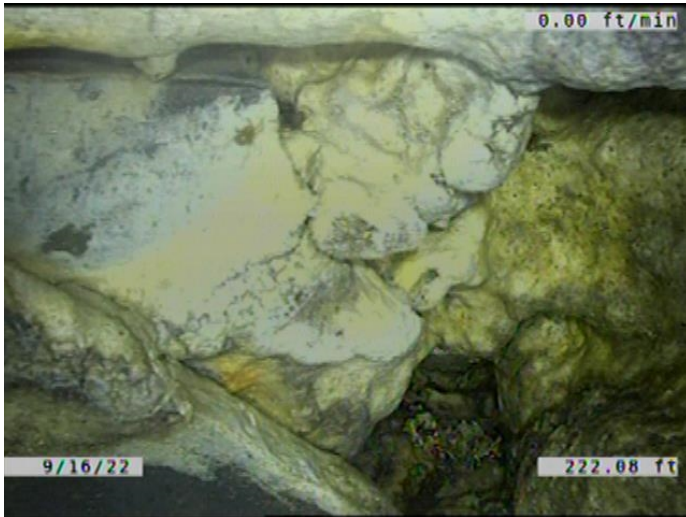
Code: **BSV**
 Description: **Broken Soil Visible**

Distance (ft): **222.1**
 Structural Grade: **5**
 O&M Grade: **0**
 Clock Start/From: **12**
 Clock To: **4**
 1st Value:
 2nd Value:
 Value Percent:
 Continuous Index:
 Within 8" of Joint: **YES**
 Remarks: **SOIL AND VOID VISIBLE.**

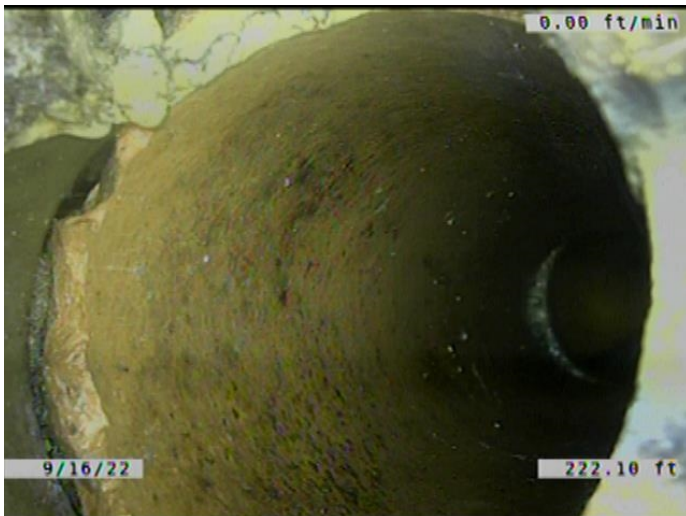
Code: **TBI**
 Description: **Tap Break-in Intruding**

Distance (ft): **222.1**
 Structural Grade: **0**
 O&M Grade: **2**
 Clock Start/From: **2**
 Clock To:
 1st Value: **6.000**
 2nd Value: **2.000**
 Value Percent:
 Continuous Index:
 Within 8" of Joint: **YES**
 Remarks:

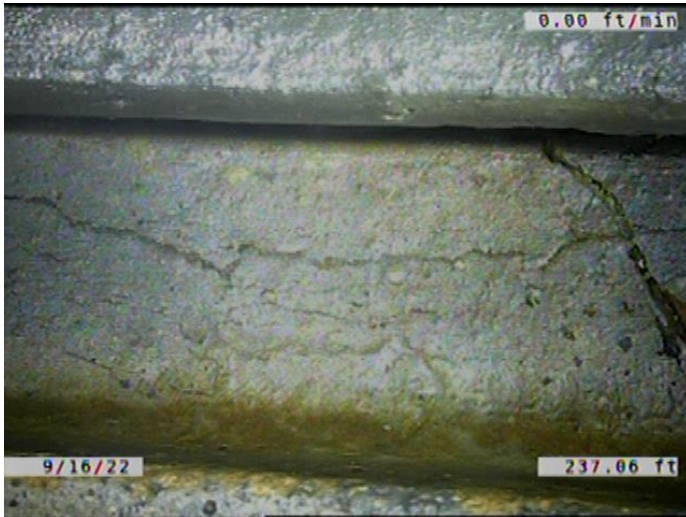
Code: **JAL**
Description: **Joint Angular Large**

Distance (ft): **237.1**
Structural Grade: **4**
O&M Grade: **0**
Clock Start/From:
Clock To:
1st Value:
2nd Value:
Value Percent:
Continuous Index:
Within 8" of Joint: **NO**
Remarks:

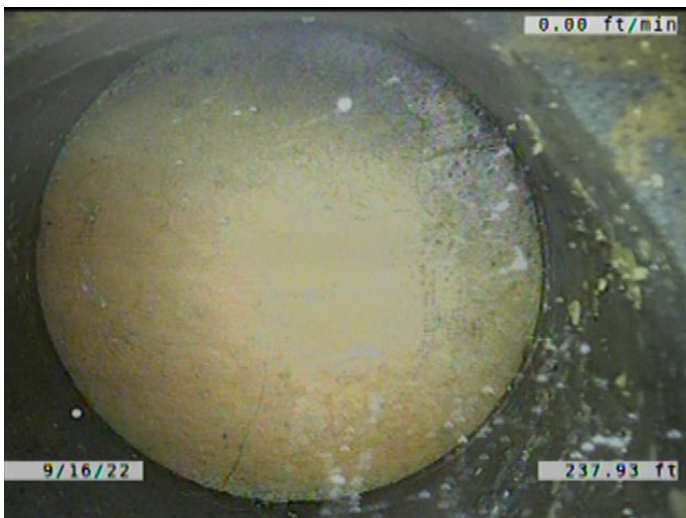
Code: **TFC**
Description: **Tap Factory Capped**

Distance (ft): **237.9**
Structural Grade: **0**
O&M Grade: **0**
Clock Start/From: **1**
Clock To:
1st Value: **6.000**
2nd Value:
Value Percent:
Continuous Index:
Within 8" of Joint: **YES**
Remarks: **CAP CRACKED.**

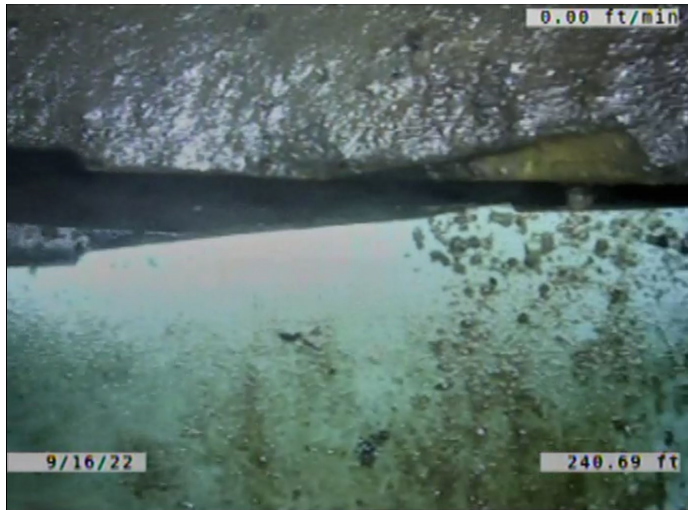
Code: **B**
Description: **Broken**

Distance (ft): **240.7**
Structural Grade: **4**
O&M Grade: **0**
Clock Start/From: **8**
Clock To: **4**
1st Value:
2nd Value:
Value Percent:
Continuous Index: **F02**
Within 8" of Joint: **YES**
Remarks:

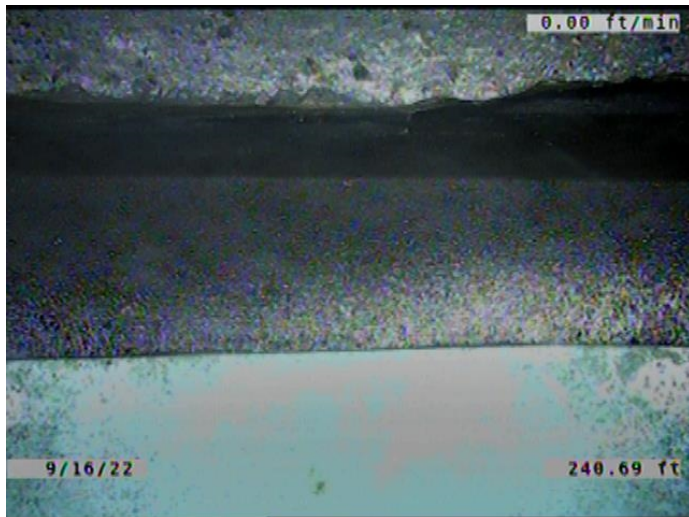
Code: **JAL**
 Description: **Joint Angular Large**

Distance (ft): **240.7**
 Structural Grade: **4**
 O&M Grade: **0**
 Clock Start/From:
 Clock To:
 1st Value:
 2nd Value:
 Value Percent:
 Continuous Index:
 Within 8" of Joint: **NO**
 Remarks:

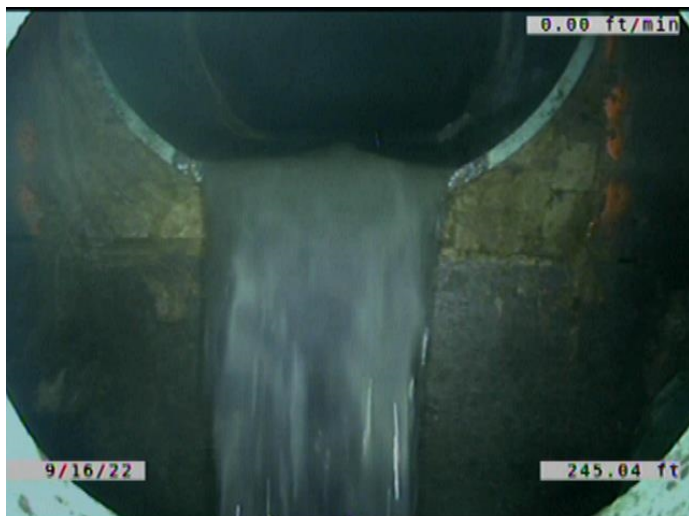
Code: **DSF**
 Description: **Deposits Settled Fine**

Distance (ft): **245.0**
 Structural Grade: **0**
 O&M Grade: **2**
 Clock Start/From: **5**
 Clock To: **7**
 1st Value:
 2nd Value:
 Value Percent: **5.000**
 Continuous Index: **F01**
 Within 8" of Joint: **YES**
 Remarks:

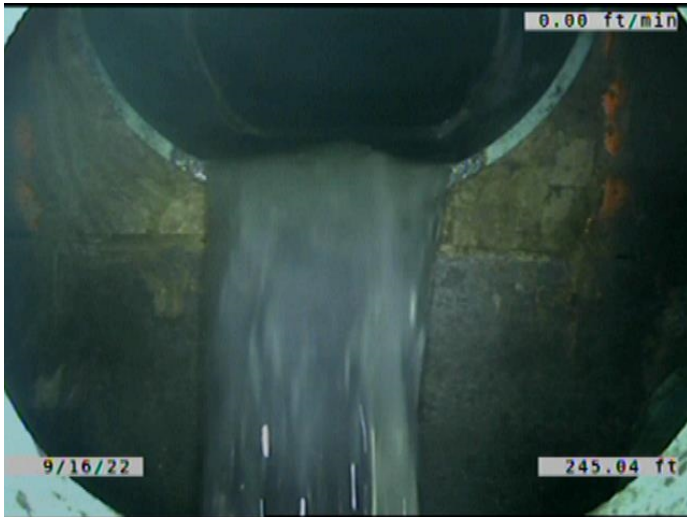
Code:	DAE
Description:	Deposits Attached Encrustation
Distance (ft):	245.0
Structural Grade:	0
O&M Grade:	2
Clock Start/From:	8
Clock To:	4
1st Value:	
2nd Value:	
Value Percent:	5.000
Continuous Index:	F03
Within 8" of Joint:	YES
Remarks:
