Profile/Photo Observation Report

Date:	04/26/2018	Weather:		Coding:	PACP 6.0
Pipe Length (ft):		Owner:	City of Hobart	Pre Clean:	No Pre-Cleaning
P.O.#:	103	Surveyor:	M. Pielacha	PSR:	P-605-006-004
Customer:	City of Hobart	Clean Date:		Shape:	C

Street:	Ellendale Street	Flow Control:	Not Controlled
City:	Hobart, IN	Year Renewed:	
Location:	Light Highway	Tape/Media #:	DEP 103
Purpose:	Routine Assessment	Dia/Height:	15"
Use:	Sanitary	Material:	VCP
Drain Area:		Lining:	
Category:	NA		
Comment:	YES501824 Submittal 2		
Location Details:		Direction of Survey:	Downstream
US MH:	M-605-070	DS MH:	M-605-006
		Total Length Surveyed (ft):	3.1

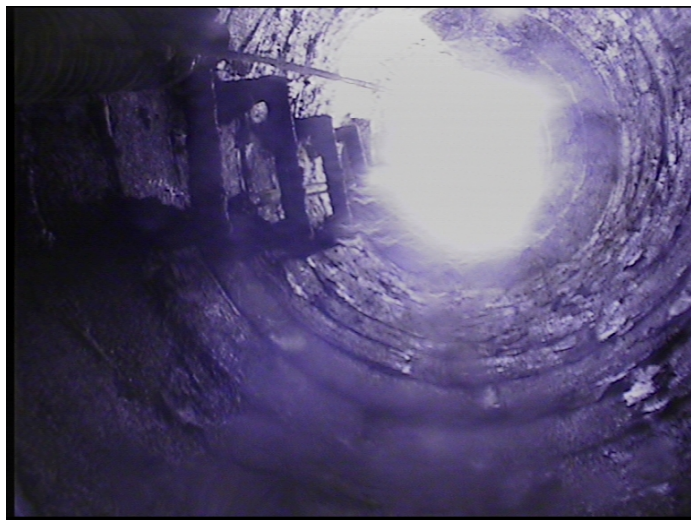
AMH

Manhole

M-605-070

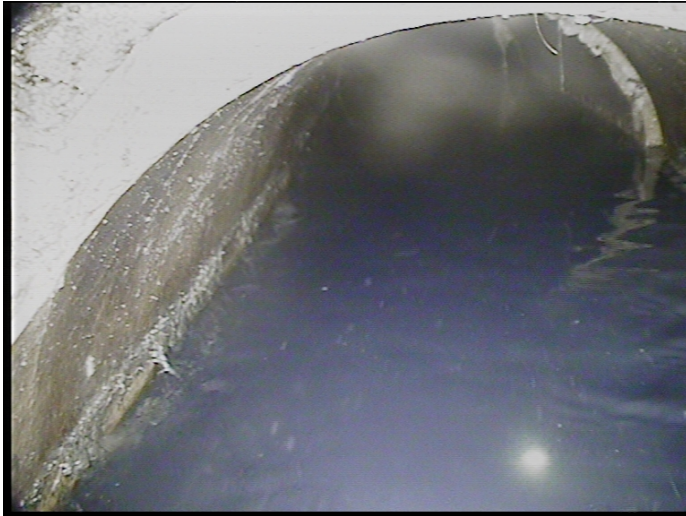
Code: **MWL**
Description: **Water Level**

Distance (ft): **.0**
Structural Grade: **0**
O&M Grade: **0**
Clock Start/From:
Clock To:
1st Value:
2nd Value:
Value Percent: **20.000**
Continuous Index:
Within 8" of Joint: **NO**
Remarks:

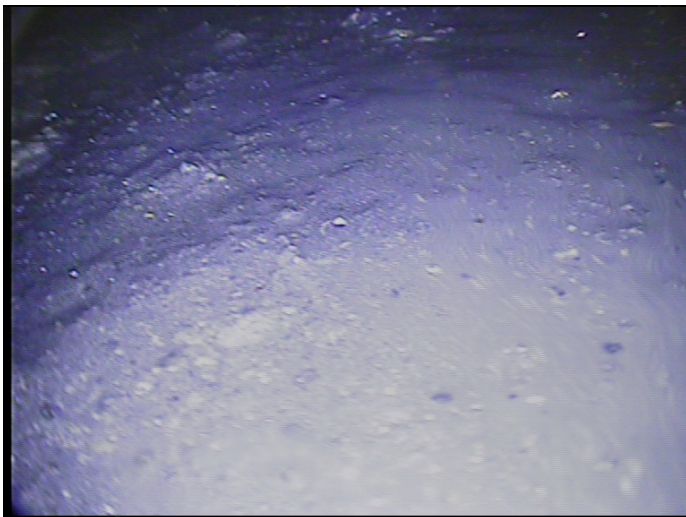
Code: **DSF**
Description: **Deposits Settled Fine**

Distance (ft): **2.6**
Structural Grade: **0**
O&M Grade: **4**
Clock Start/From: **4**
Clock To: **8**
1st Value:
2nd Value:
Value Percent: **30.000**
Continuous Index:
Within 8" of Joint: **NO**
Remarks:

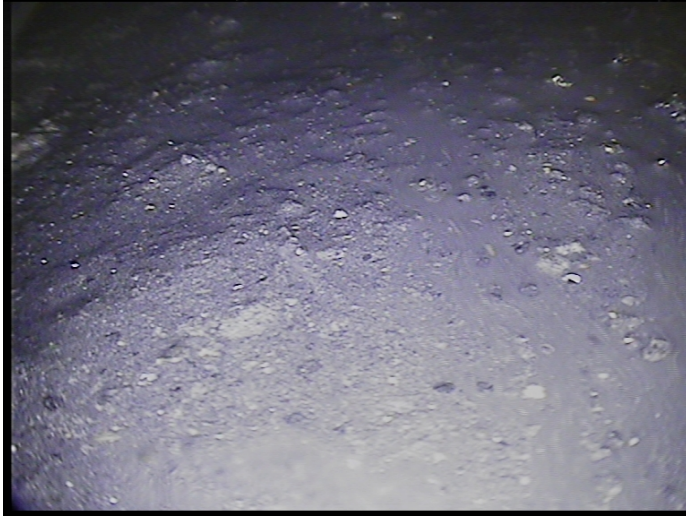
Code:	MSA
Description:	Abandoned Survey
Distance (ft):	2.6
Structural Grade:	0
O&M Grade:	0
Clock Start/From:	
Clock To:	
1st Value:	
2nd Value:	
Value Percent:	
Continuous Index:	
Within 8" of Joint:	NO
Remarks:	deep sediment
