Profile/Photo Observation Report

Date:	08/11/2022	Weather:		Coding:	PACP 7.0
Pipe Length (ft):	127.0	Owner:	City of Hobart	Pre Clean:	Heavy Cleaning
P.O.#:	YES502259	Surveyor:	S. Bucklin	PSR:	P-605-070-006
Customer:	City of Hobart	Clean Date:	08/01/2022	Shape:	C

Street:	Ellendale Street	Flow Control:	Not Controlled
City:	Hobart, IN	Year Renewed:	
Location:	Local rural streets with light traffic, t	Tape/Media #:	
Purpose:	Routine Assessment	Dia/Height:	12"
Use:	Sanitary Sewage Pipe	Material:	VCP
Drain Area:		Lining:	None
Category:	NA		
Comment:			
Location Details:		Direction of Survey:	Downstream
US MH:	M-605-006	DS MH:	M-605-070
		Total Length Surveyed (ft):	129.3

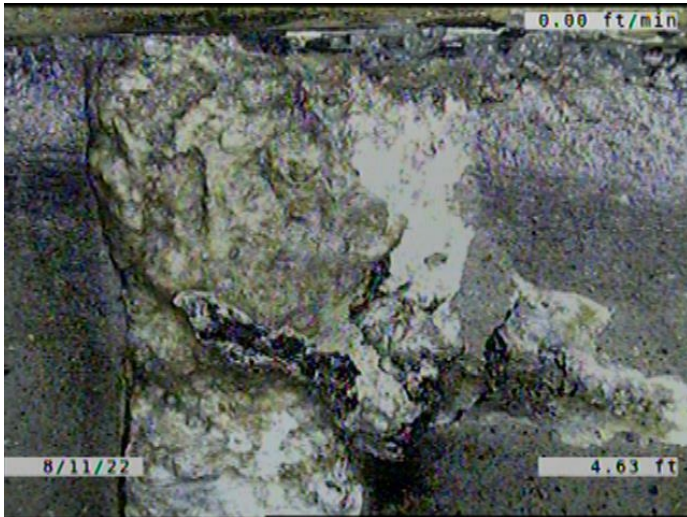
Code: **DAE**
 Description: **Deposits Attached Encrustation**

Distance (ft): **4.6**
 Structural Grade: **0**
 O&M Grade: **2**
 Clock Start/From: **12**
 Clock To: **12**
 1st Value:
 2nd Value:
 Value Percent: **5.000**
 Continuous Index: **S01**
 Within 8" of Joint: **YES**
 Remarks:

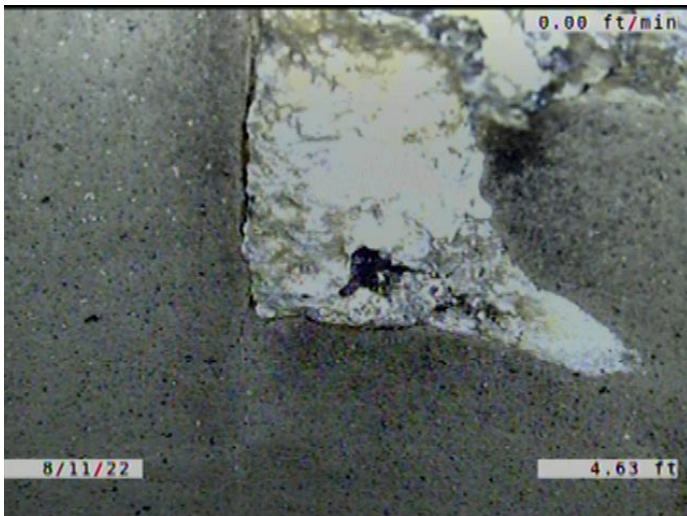
Code: **CL**
 Description: **Crack Longitudinal**

Distance (ft): **4.6**
 Structural Grade: **2**
 O&M Grade: **0**
 Clock Start/From: **1**
 Clock To:
 1st Value:
 2nd Value:
 Value Percent:
 Continuous Index:
 Within 8" of Joint: **YES**
 Remarks:

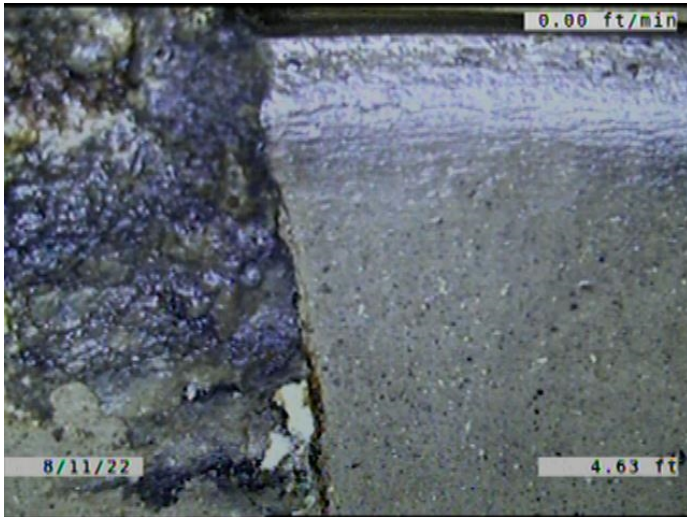
Code: **CL**
 Description: **Crack Longitudinal**

Distance (ft): **4.6**
 Structural Grade: **2**
 O&M Grade: **0**
 Clock Start/From: **10**
 Clock To:
 1st Value:
 2nd Value:
 Value Percent:
 Continuous Index:
 Within 8" of Joint: **YES**
 Remarks:

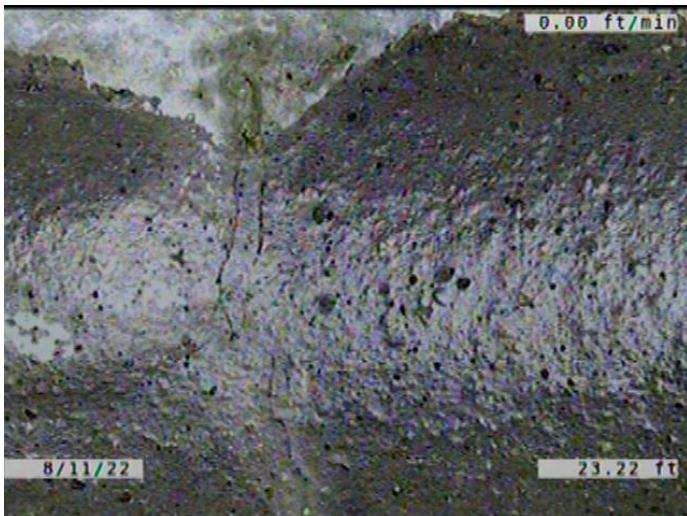
Code: **CM**
 Description: **Crack Multiple**

Distance (ft): **23.2**
 Structural Grade: **3**
 O&M Grade: **0**
 Clock Start/From: **11**
 Clock To: **1**
 1st Value:
 2nd Value:
 Value Percent:
 Continuous Index: **S02**
 Within 8" of Joint: **YES**
 Remarks:

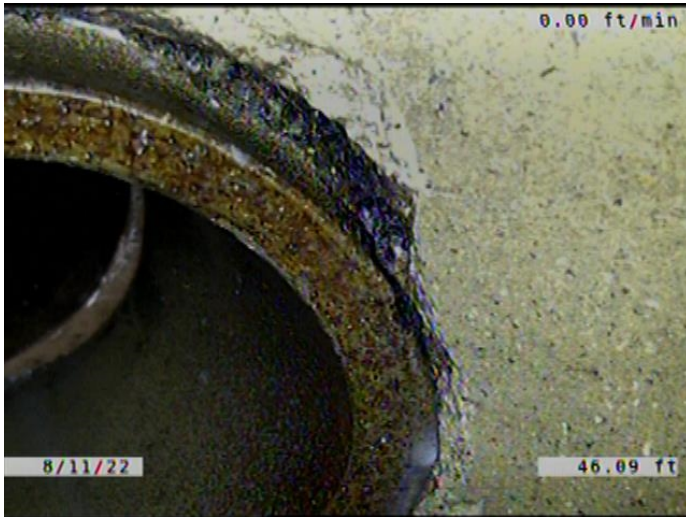
Code:	SSS
Description:	Surface Damage Surface Spalling
Distance (ft):	46.1
Structural Grade:	2
O&M Grade:	0
Clock Start/From:	11
Clock To:	1
1st Value:	
2nd Value:	
Value Percent:	
Continuous Index:	
Within 8" of Joint:	NO
Remarks:

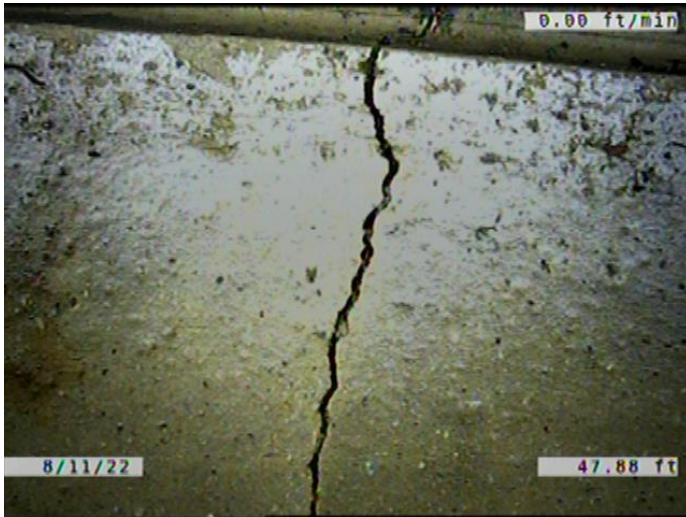
Code: **FM**
 Description: **Fracture Multiple**

Distance (ft): **47.9**
 Structural Grade: **4**
 O&M Grade: **0**
 Clock Start/From: **11**
 Clock To: **4**
 1st Value:
 2nd Value:
 Value Percent:
 Continuous Index: **S03**
 Within 8" of Joint: **YES**
 Remarks:

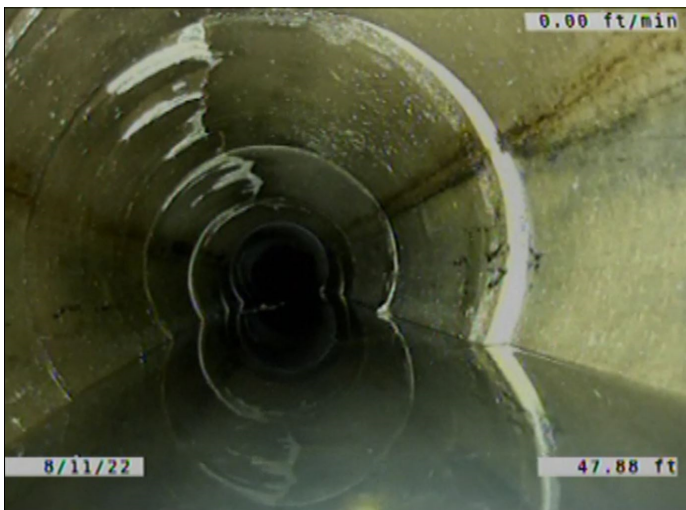
Code: **IS**
 Description: **Infiltration Stain**

Distance (ft): **47.9**
 Structural Grade: **0**
 O&M Grade: **1**
 Clock Start/From: **10**
 Clock To: **12**
 1st Value:
 2nd Value:
 Value Percent:
 Continuous Index: **S07**
 Within 8" of Joint: **NO**
 Remarks:

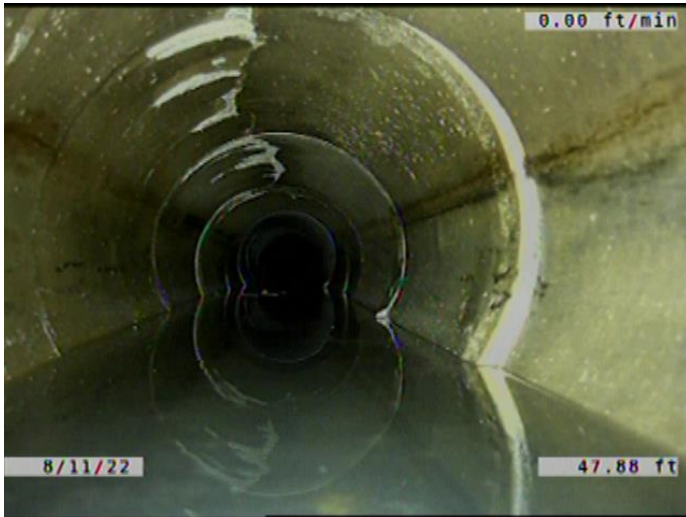
Code: **CM**
Description: **Crack Multiple**

Distance (ft): **47.9**
Structural Grade: **3**
O&M Grade: **0**
Clock Start/From: **11**
Clock To: **1**
1st Value:
2nd Value:
Value Percent:
Continuous Index: **F02**
Within 8" of Joint: **YES**
Remarks:

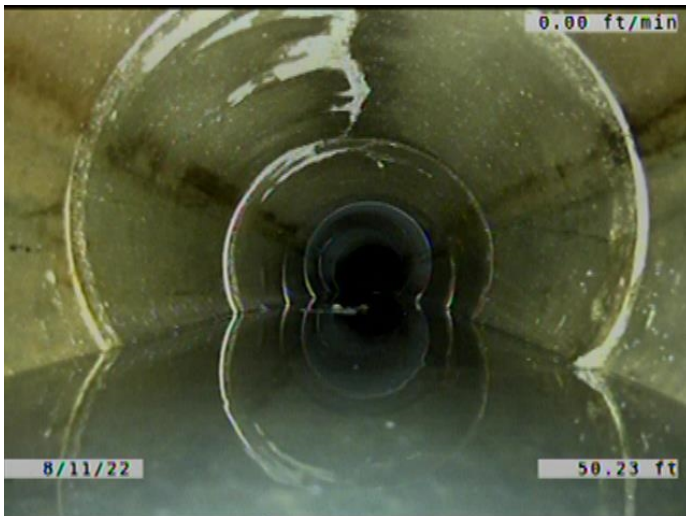
Code: **MWLS**
Description: **Miscellaneous Water Level Sag**

Distance (ft): **50.2**
Structural Grade: **2**
O&M Grade: **0**
Clock Start/From:
Clock To:
1st Value:
2nd Value:
Value Percent: **15.000**
Continuous Index: **S04**
Within 8" of Joint: **NO**
Remarks:

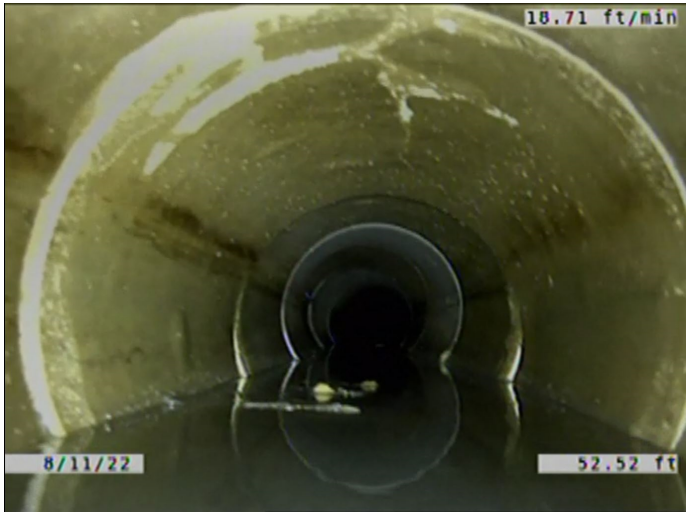
Code: **IS**
Description: **Infiltration Stain**

Distance (ft): **52.5**
Structural Grade: **0**
O&M Grade: **1**
Clock Start/From: **10**
Clock To: **12**
1st Value:
2nd Value:
Value Percent:
Continuous Index: **F07**
Within 8" of Joint: **NO**
Remarks:

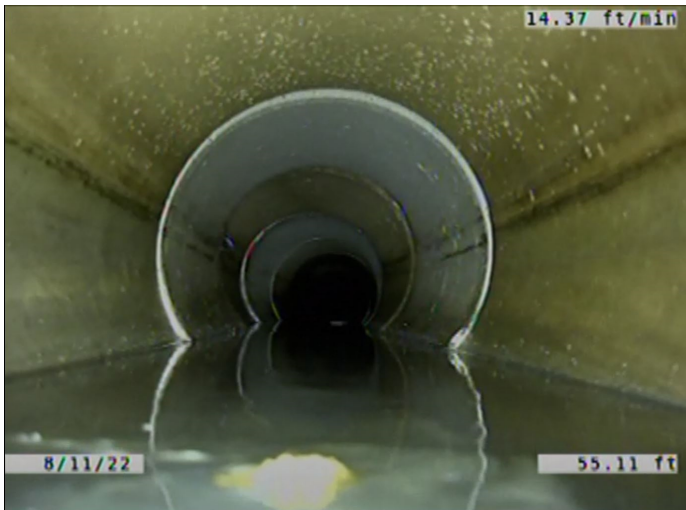
Code: **FM**
Description: **Fracture Multiple**

Distance (ft): **55.1**
Structural Grade: **4**
O&M Grade: **0**
Clock Start/From: **11**
Clock To: **4**
1st Value:
2nd Value:
Value Percent:
Continuous Index: **F03**
Within 8" of Joint: **YES**
Remarks:

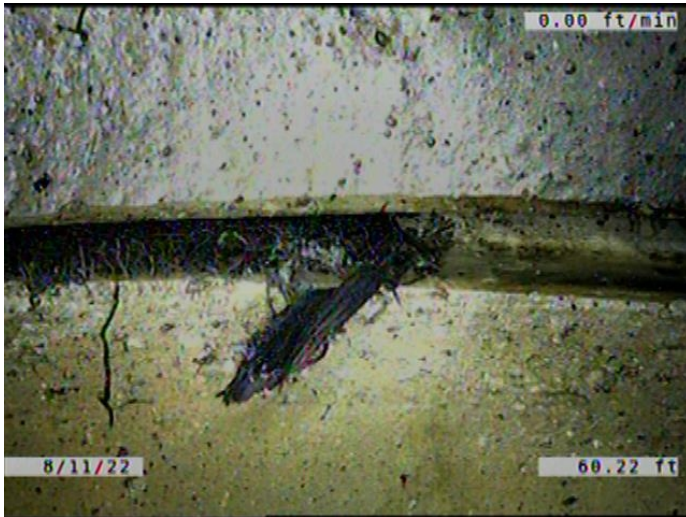
Code: **RFJ**
 Description: **Roots Fine Joint**

Distance (ft): **60.2**
 Structural Grade: **0**
 O&M Grade: **1**
 Clock Start/From: **8**
 Clock To: **10**
 1st Value:
 2nd Value:
 Value Percent:
 Continuous Index:
 Within 8" of Joint: **YES**
 Remarks:

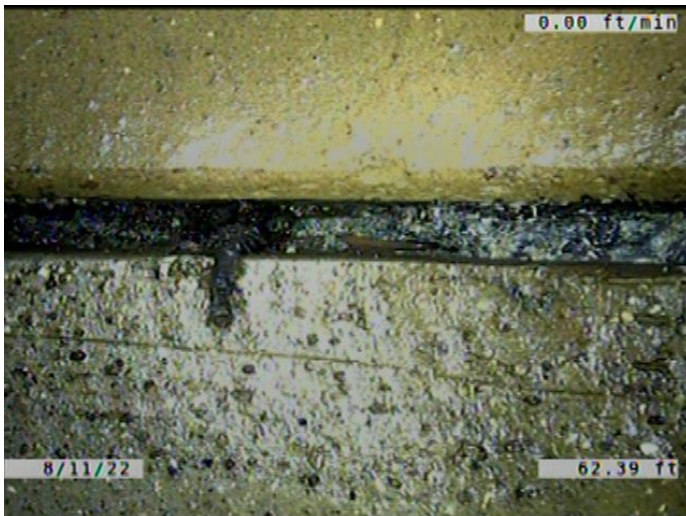
Code: **RFJ**
 Description: **Roots Fine Joint**

Distance (ft): **62.4**
 Structural Grade: **0**
 O&M Grade: **1**
 Clock Start/From: **2**
 Clock To: **4**
 1st Value:
 2nd Value:
 Value Percent:
 Continuous Index:
 Within 8" of Joint: **YES**
 Remarks:

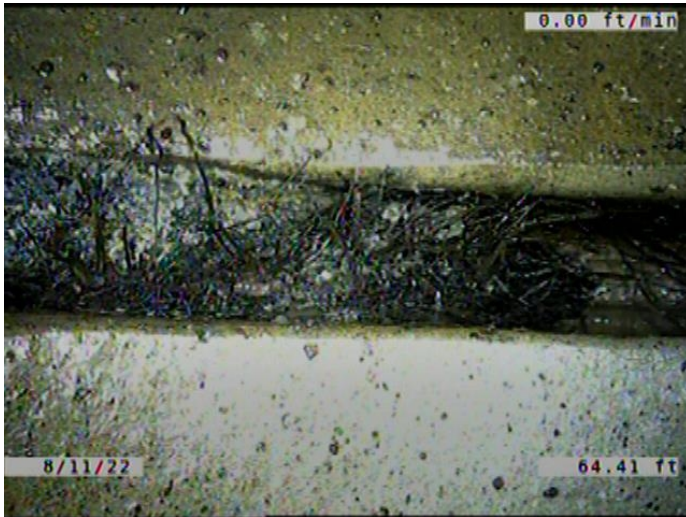
Code: **RFJ**
Description: **Roots Fine Joint**

Distance (ft): **64.4**
Structural Grade: **0**
O&M Grade: **1**
Clock Start/From: **4**
Clock To: **5**
1st Value:
2nd Value:
Value Percent:
Continuous Index:
Within 8" of Joint: **YES**
Remarks:

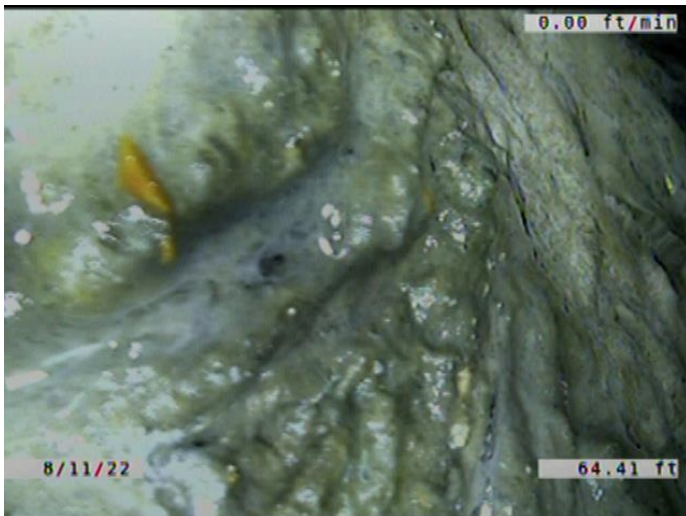
Code: **DAR**
Description: **Deposits Attached Ragging**

Distance (ft): **64.4**
Structural Grade: **0**
O&M Grade: **2**
Clock Start/From: **5**
Clock To: **7**
1st Value:
2nd Value:
Value Percent: **5.000**
Continuous Index:
Within 8" of Joint: **YES**
Remarks:

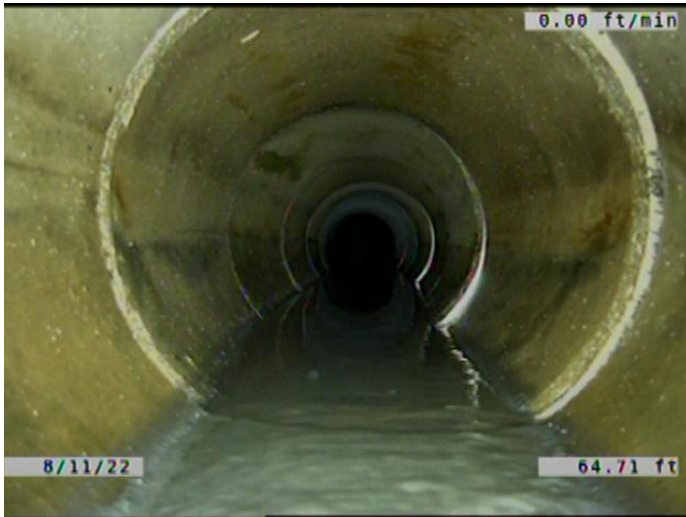
Code: **MWLS**
 Description: **Miscellaneous Water Level Sag**

Distance (ft): **64.7**
 Structural Grade: **2**
 O&M Grade: **0**
 Clock Start/From:
 Clock To:
 1st Value:
 2nd Value:
 Value Percent: **15.000**
 Continuous Index: **F04**
 Within 8" of Joint: **NO**
 Remarks:

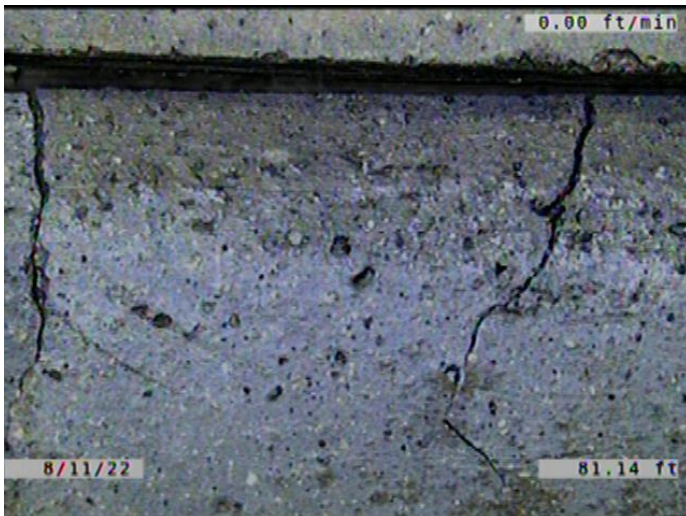
Code: **B**
 Description: **Broken**

Distance (ft): **81.1**
 Structural Grade: **4**
 O&M Grade: **0**
 Clock Start/From: **10**
 Clock To: **2**
 1st Value:
 2nd Value:
 Value Percent:
 Continuous Index:
 Within 8" of Joint: **YES**
 Remarks:

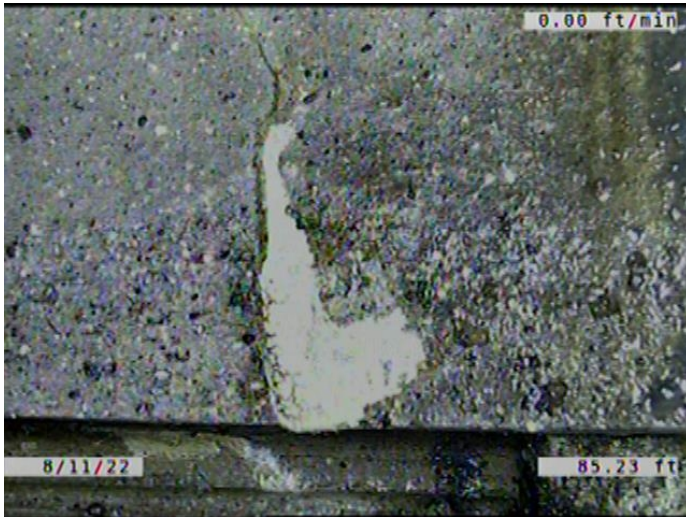
Code: **CL**
Description: **Crack Longitudinal**

Distance (ft): **85.2**
Structural Grade: **2**
O&M Grade: **0**
Clock Start/From: **8**
Clock To:
1st Value:
2nd Value:
Value Percent:
Continuous Index:
Within 8" of Joint: **YES**
Remarks:

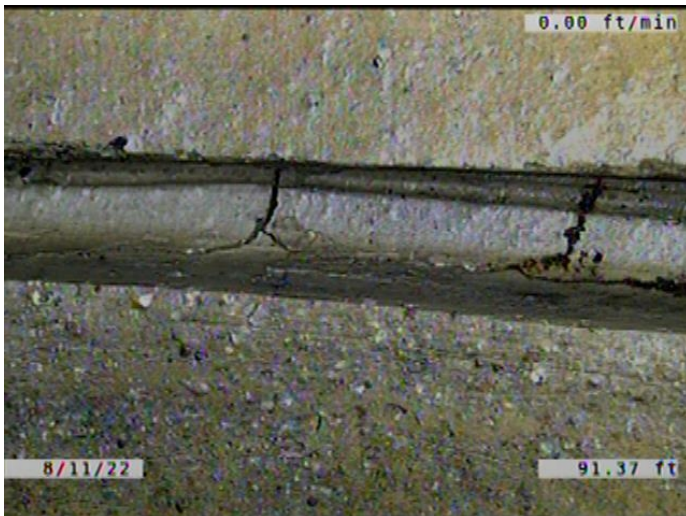
Code: **FM**
Description: **Fracture Multiple**

Distance (ft): **91.4**
Structural Grade: **4**
O&M Grade: **0**
Clock Start/From: **7**
Clock To: **5**
1st Value:
2nd Value:
Value Percent:
Continuous Index:
Within 8" of Joint: **YES**
Remarks:

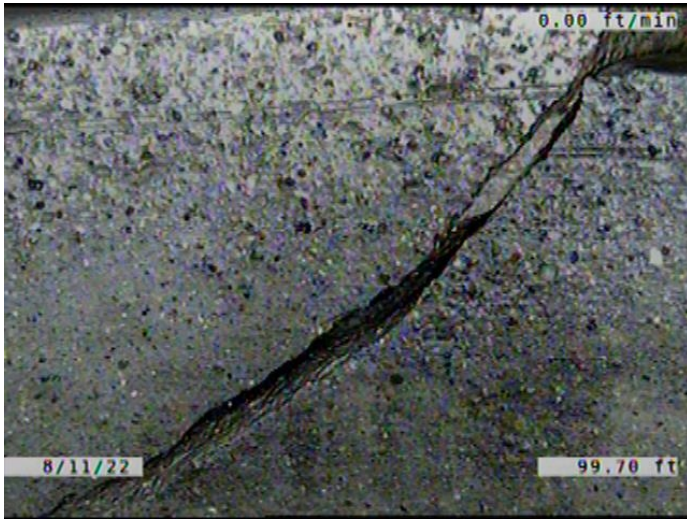
Code: **B**
Description: **Broken**

Distance (ft): **99.7**
Structural Grade: **4**
O&M Grade: **0**
Clock Start/From: **10**
Clock To: **2**
1st Value:
2nd Value:
Value Percent:
Continuous Index:
Within 8" of Joint: **YES**
Remarks:

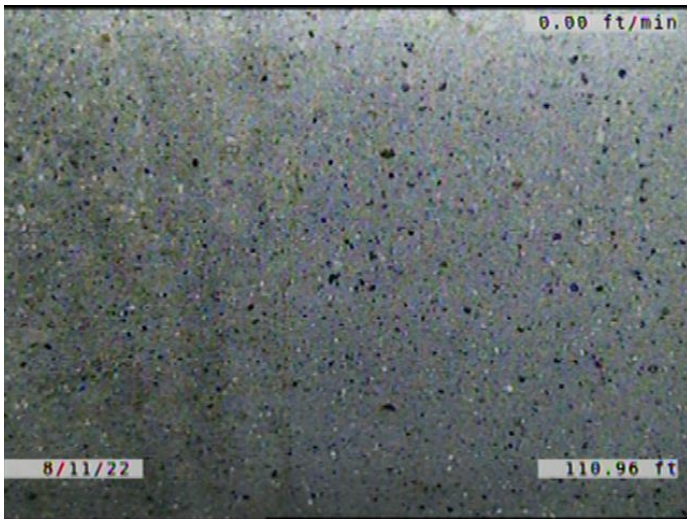
Code: **FM**
Description: **Fracture Multiple**

Distance (ft): **111.0**
Structural Grade: **4**
O&M Grade: **0**
Clock Start/From: **9**
Clock To: **4**
1st Value:
2nd Value:
Value Percent:
Continuous Index: **S05**
Within 8" of Joint: **YES**
Remarks:

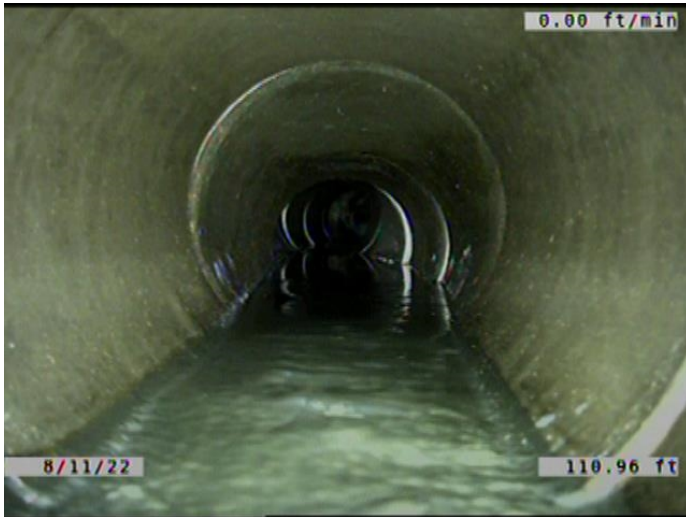
Code: **MWLS**
 Description: **Miscellaneous Water Level Sag**

Distance (ft): **111.0**
 Structural Grade: **2**
 O&M Grade: **0**
 Clock Start/From:
 Clock To:
 1st Value:
 2nd Value:
 Value Percent: **20.000**
 Continuous Index: **S06**
 Within 8" of Joint: **NO**
 Remarks:

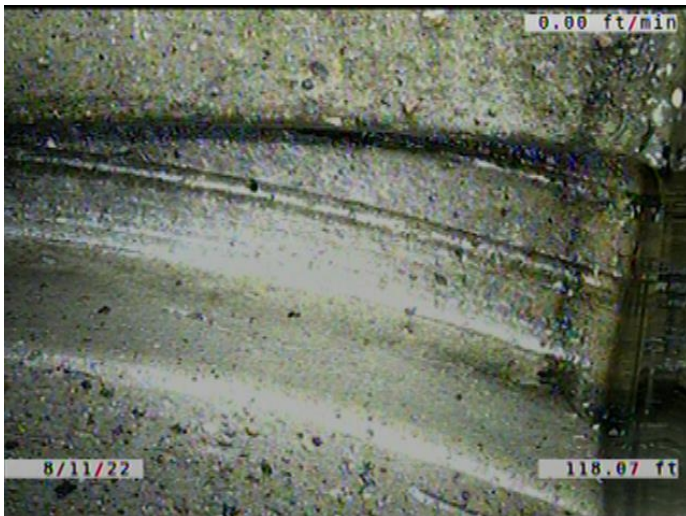
Code: **JAL**
 Description: **Joint Angular Large**

Distance (ft): **118.1**
 Structural Grade: **4**
 O&M Grade: **0**
 Clock Start/From:
 Clock To:
 1st Value:
 2nd Value:
 Value Percent:
 Continuous Index:
 Within 8" of Joint: **NO**
 Remarks:

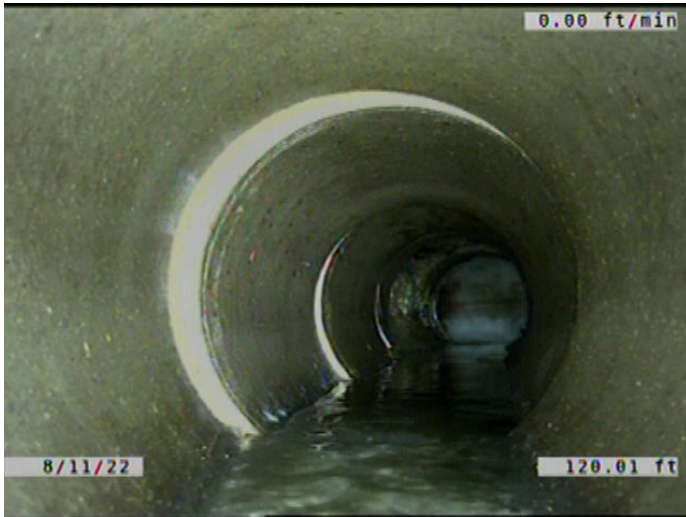
Code: **MWLS**
Description: **Miscellaneous Water Level Sag**

Distance (ft): **120.0**
Structural Grade: **2**
O&M Grade: **0**
Clock Start/From:
Clock To:
1st Value:
2nd Value:
Value Percent: **20.000**
Continuous Index: **F06**
Within 8" of Joint: **NO**
Remarks:

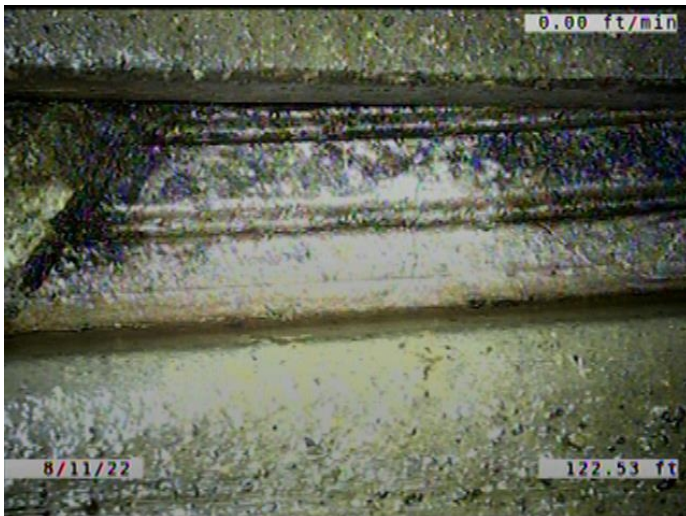
Code: **JAM**
Description: **Joint Angular Medium**

Distance (ft): **122.5**
Structural Grade: **3**
O&M Grade: **0**
Clock Start/From:
Clock To:
1st Value:
2nd Value:
Value Percent:
Continuous Index:
Within 8" of Joint: **NO**
Remarks:

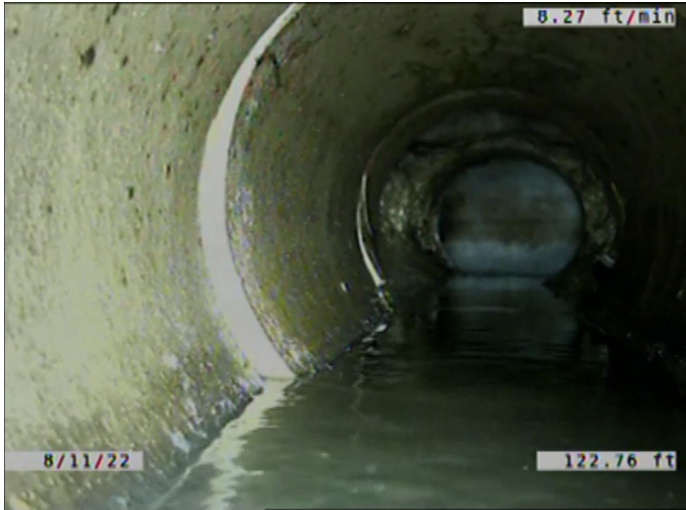
Code: **FM**
 Description: **Fracture Multiple**

Distance (ft): **122.6**
 Structural Grade: **4**
 O&M Grade: **0**
 Clock Start/From: **9**
 Clock To: **4**
 1st Value:
 2nd Value:
 Value Percent:
 Continuous Index: **F05**
 Within 8" of Joint: **YES**
 Remarks:

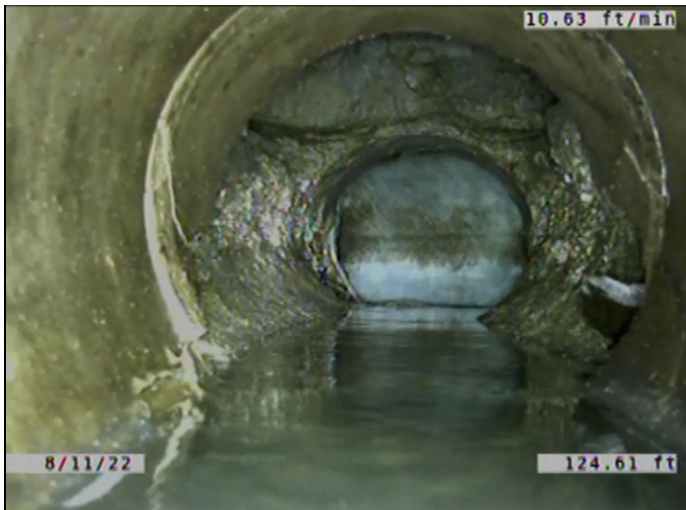
Code: **B**
 Description: **Broken**

Distance (ft): **124.6**
 Structural Grade: **4**
 O&M Grade: **0**
 Clock Start/From: **8**
 Clock To: **4**
 1st Value:
 2nd Value:
 Value Percent:
 Continuous Index:
 Within 8" of Joint: **NO**
 Remarks:

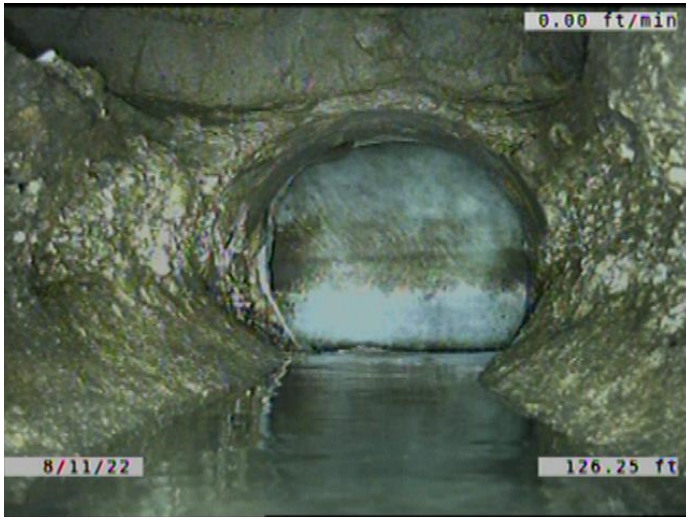
Code: **DAE**
 Description: **Deposits Attached Encrustation**

Distance (ft): **126.2**
 Structural Grade: **0**
 O&M Grade: **2**
 Clock Start/From: **12**
 Clock To: **12**
 1st Value:
 2nd Value:
 Value Percent: **5.000**
 Continuous Index: **F01**
 Within 8" of Joint: **YES**
 Remarks:
