Profile/Photo Observation Report

Street:	S ASH ST & COURT ST	Flow Control:	Not Controlled
City:	Hobart, IN	Year Renewed:	
Location:	Other	Tape/Media #:	
Purpose:	Not Known	Dia/Height:	12"
Use:	Sanitary	Material:	VCP
Drain Area:	NA	Lining:	
Category:	NA		
Comment:	Flow direction wrong. Debris at 1'.

Location Details:		Direction of Survey:	Downstream
US MH:	M-605-008	DS MH:	M-605-072
		Total Length Surveyed (ft):	2.3

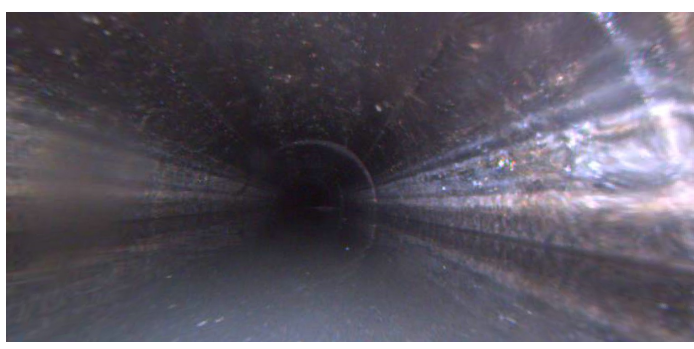
Code: **AMH**
Description: **Manhole**

Distance (ft): **.0**
Structural Grade: **0**
O&M Grade: **0**
Clock Start/From:
Clock To:
1st Value:
2nd Value:
Value Percent:
Continuous Index:
Within 8" of Joint: **NO**
Remarks: **M-605-008**

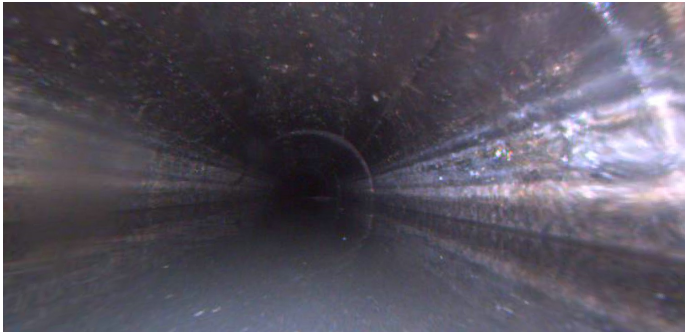
Code:	MWL
Description:	Water Level

Distance (ft):	.0
Structural Grade:	0
O&M Grade:	0
Clock Start/From:	
Clock To:	
1st Value:	
2nd Value:	
Value Percent:	40.000
Continuous Index:	
Within 8" of Joint:	NO
Remarks:

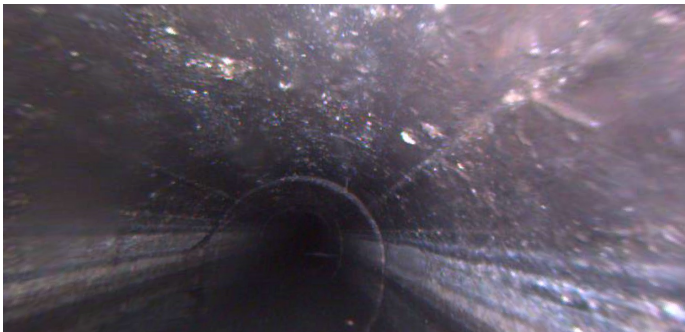
Code:	DAGS
Description:	Deposits Attached Grease

Distance (ft):	1.0
Structural Grade:	0
O&M Grade:	2
Clock Start/From:	8
Clock To:	4
1st Value:	
2nd Value:	
Value Percent:	5.000
Continuous Index:	
Within 8" of Joint:	NO
Remarks:

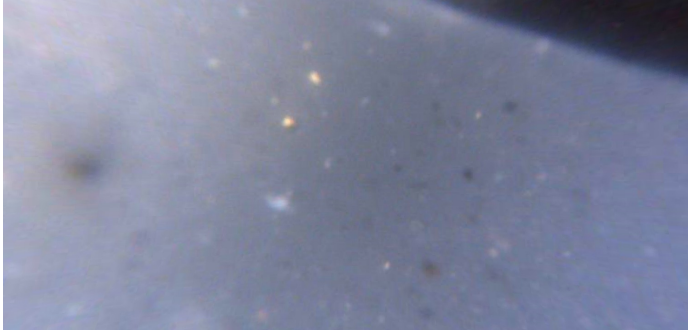
Code:	MSA
Description:	Abandoned Survey
Distance (ft):	2.3
Structural Grade:	0
O&M Grade:	0
Clock Start/From:	
Clock To:	
1st Value:	
2nd Value:	
Value Percent:	
Continuous Index:	
Within 8" of Joint:	NO
Remarks:	under water
