Profile/Photo Observation Report

Date:	04/25/2018	Weather:		Coding:	PACP 6.0
Pipe Length (ft):	212.9	Owner:	NA	Pre Clean:	Not Known
P.O.#:		Surveyor:	Jen Costello	PSR:	P-605-072-008
Customer:		Clean Date:	01/01/1900	Shape:	C

Street:	Ash	Flow Control:	Not Controlled
City:	Hobart, IN	Year Renewed:	
Location:	Other	Tape/Media #:	
Purpose:	Not Known	Dia/Height:	12"
Use:	Sanitary	Material:	VCP
Drain Area:	NA	Lining:	
Category:	NA		
Comment:	Flow direction wrong. Debris at 1'.

Location Details:		Direction of Survey:	Downstream
US MH:	M-605-008	DS MH:	M-605-072
		Total Length Surveyed (ft):	2.3

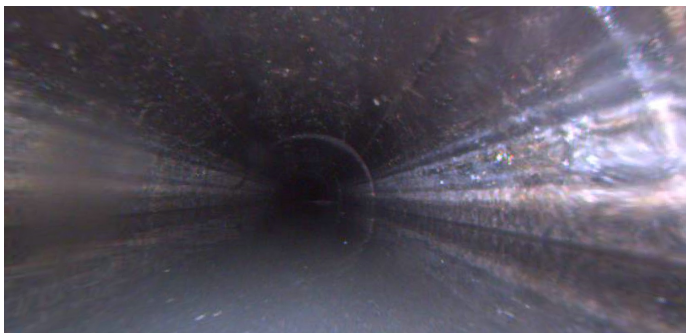
Code: **AMH**
Description: **Manhole**

Distance (ft): **.0**
Structural Grade: **0**
O&M Grade: **0**
Clock Start/From:
Clock To:
1st Value:
2nd Value:
Value Percent:
Continuous Index:
Within 8" of Joint: **NO**
Remarks: **M-605-008**

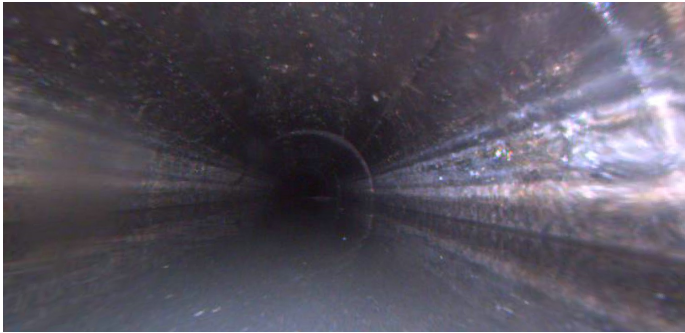
Code:	MWL
Description:	Water Level

Distance (ft):	.0
Structural Grade:	0
O&M Grade:	0
Clock Start/From:	
Clock To:	
1st Value:	
2nd Value:	
Value Percent:	40.000
Continuous Index:	
Within 8" of Joint:	NO
Remarks:

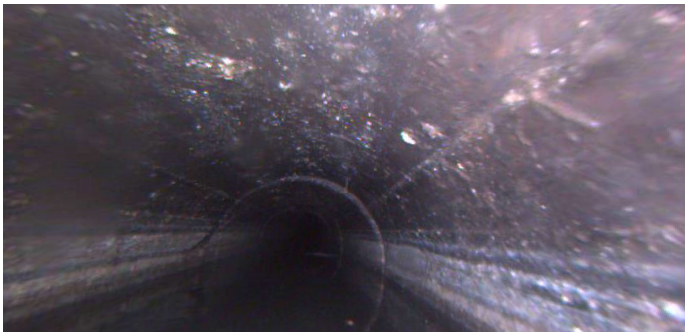
Code:	DAGS
Description:	Deposits Attached Grease

Distance (ft):	1.0
Structural Grade:	0
O&M Grade:	2
Clock Start/From:	8
Clock To:	4
1st Value:	
2nd Value:	
Value Percent:	5.000
Continuous Index:	
Within 8" of Joint:	NO
Remarks:

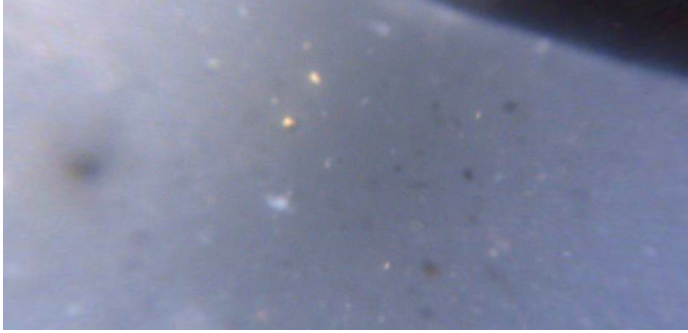
Code:	MSA
Description:	Abandoned Survey
Distance (ft):	2.3
Structural Grade:	0
O&M Grade:	0
Clock Start/From:	
Clock To:	
1st Value:	
2nd Value:	
Value Percent:	
Continuous Index:	
Within 8" of Joint:	NO
Remarks:	under water
