Profile/Photo Observation Report

Date:	11/16/2021	Weather:		Coding:	PACP 7.0
Pipe Length (ft):	208.9	Owner:	City of Hobart	Pre Clean:	Heavy Cleaning
P.O.#:	YES502259	Surveyor:	S. Bucklin	PSR:	P-605-072-008
Customer:	City of Hobart	Clean Date:	11/16/2021	Shape:	C

Street:	South Ash Street	Flow Control:	Not Controlled
City:	Hobart, IN	Year Renewed:	
Location:	Local rural streets with light traffic, t	Tape/Media #:	
Purpose:	Routine Assessment	Dia/Height:	12"
Use:	Sanitary Sewage Pipe	Material:	VCP
Drain Area:		Lining:	None
Category:	NA		
Comment:			
Location Details:		Direction of Survey:	Downstream
US MH:	M-605-008	DS MH:	M-605-072
		Total Length Surveyed (ft):	208.9

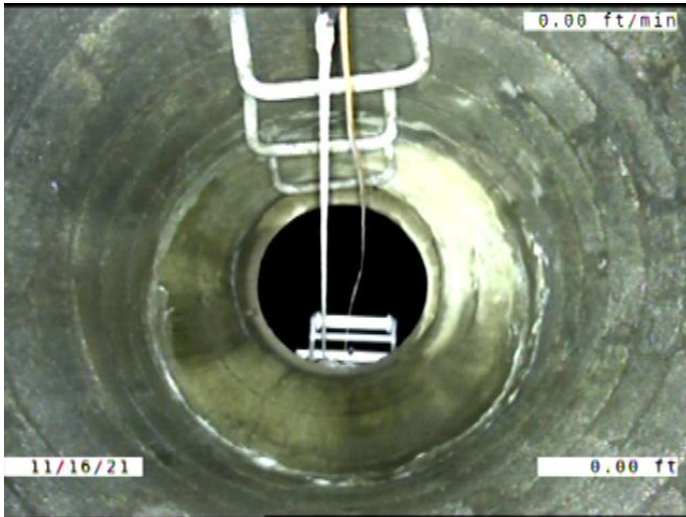
Code: **AMH**
Description: **Manhole**

Distance (ft): **.0**
Structural Grade: **0**
O&M Grade: **0**
Clock Start/From:
Clock To:
1st Value:
2nd Value:
Value Percent:
Continuous Index:
Within 8" of Joint: **NO**
Remarks: **M-605-008**

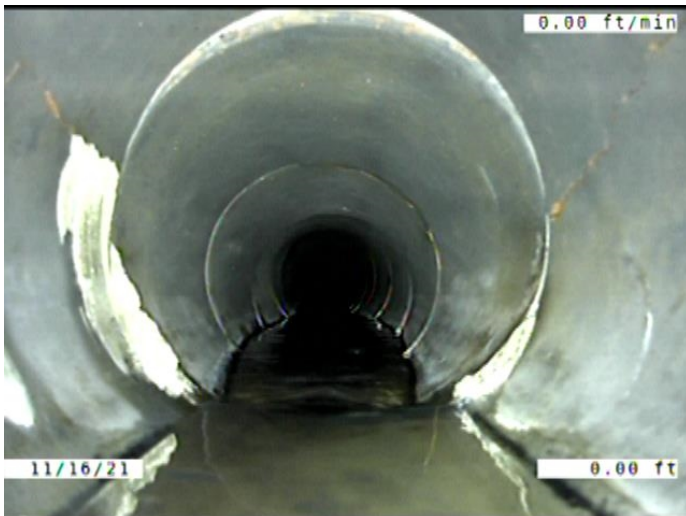
Code: **MWL**
Description: **Miscellaneous Water Level**

Distance (ft): **.0**
Structural Grade: **0**
O&M Grade: **0**
Clock Start/From:
Clock To:
1st Value:
2nd Value:
Value Percent: **5.000**
Continuous Index:
Within 8" of Joint: **NO**
Remarks:

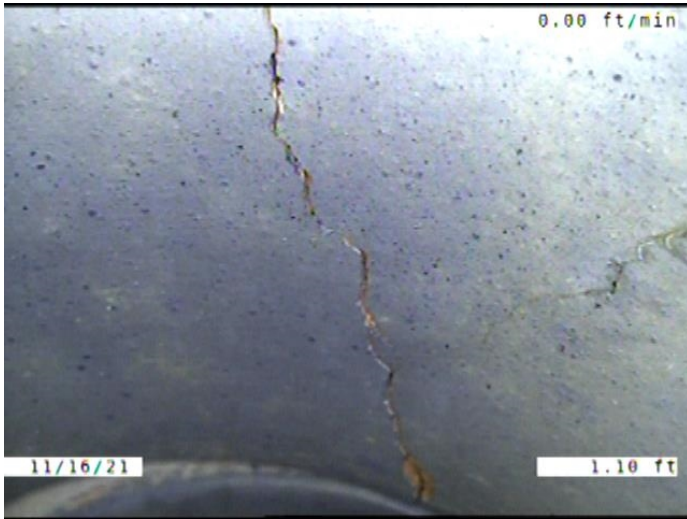
Code: **B**
Description: **Broken**

Distance (ft): **1.1**
Structural Grade: **4**
O&M Grade: **0**
Clock Start/From: **8**
Clock To: **4**
1st Value:
2nd Value:
Value Percent:
Continuous Index:
Within 8" of Joint: **YES**
Remarks:

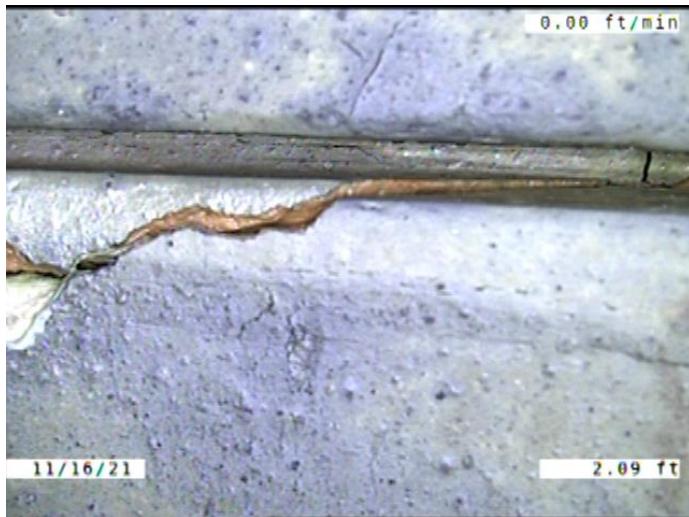
Code: **B**
 Description: **Broken**

Distance (ft): **2.1**
 Structural Grade: **4**
 O&M Grade: **0**
 Clock Start/From: **8**
 Clock To: **4**
 1st Value:
 2nd Value:
 Value Percent:
 Continuous Index:
 Within 8" of Joint: **YES**
 Remarks:

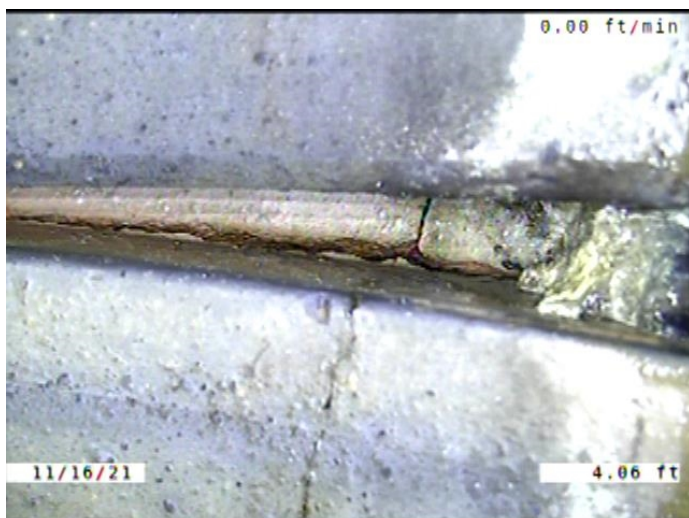
Code: **FM**
 Description: **Fracture Multiple**

Distance (ft): **4.1**
 Structural Grade: **4**
 O&M Grade: **0**
 Clock Start/From: **9**
 Clock To: **3**
 1st Value:
 2nd Value:
 Value Percent:
 Continuous Index:
 Within 8" of Joint: **YES**
 Remarks:

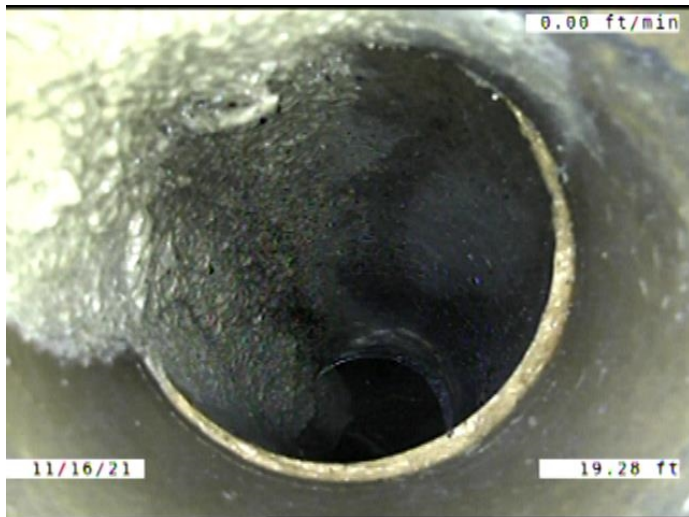
Code: **TF**
 Description: **Tap Factory**

Distance (ft): **19.3**
 Structural Grade: **0**
 O&M Grade: **0**
 Clock Start/From: **11**
 Clock To:
 1st Value: **4.000**

2nd Value:
 Value Percent:
 Continuous Index:
 Within 8" of Joint: **YES**
 Remarks: **ENCrustATION IN THE TAP AND COMING INTO THE MAIN.**

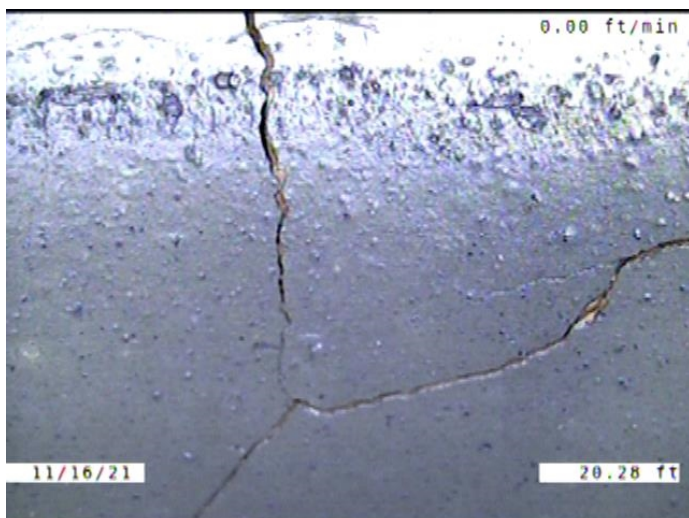
Code: **B**
 Description: **Broken**

Distance (ft): **20.3**
 Structural Grade: **4**
 O&M Grade: **0**
 Clock Start/From: **11**
 Clock To: **2**

1st Value:
 2nd Value:
 Value Percent:
 Continuous Index:
 Within 8" of Joint: **YES**
 Remarks:

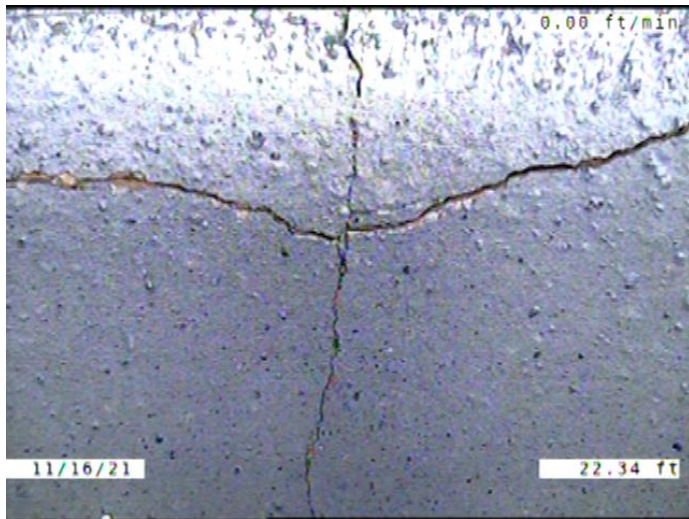
Code: **B**
Description: **Broken**

Distance (ft): **22.3**
Structural Grade: **4**
O&M Grade: **0**
Clock Start/From: **11**
Clock To: **2**
1st Value:
2nd Value:
Value Percent:
Continuous Index:
Within 8" of Joint: **YES**
Remarks:

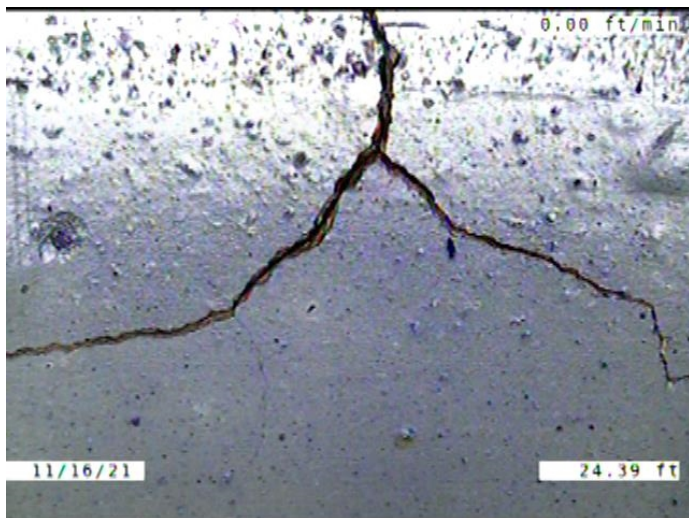
Code: **B**
Description: **Broken**

Distance (ft): **24.4**
Structural Grade: **4**
O&M Grade: **0**
Clock Start/From: **9**
Clock To: **4**
1st Value:
2nd Value:
Value Percent:
Continuous Index: **S01**
Within 8" of Joint: **YES**
Remarks:

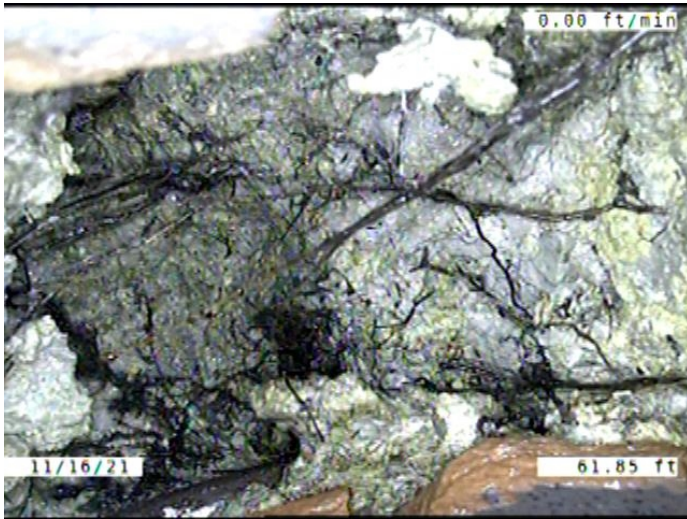
Code: **HSV**
Description: **Hole Soil Visible**

Distance (ft): **61.9**
Structural Grade: **5**
O&M Grade: **0**
Clock Start/From: **8**
Clock To: **11**
1st Value:
2nd Value:
Value Percent:
Continuous Index:
Within 8" of Joint: **YES**
Remarks:

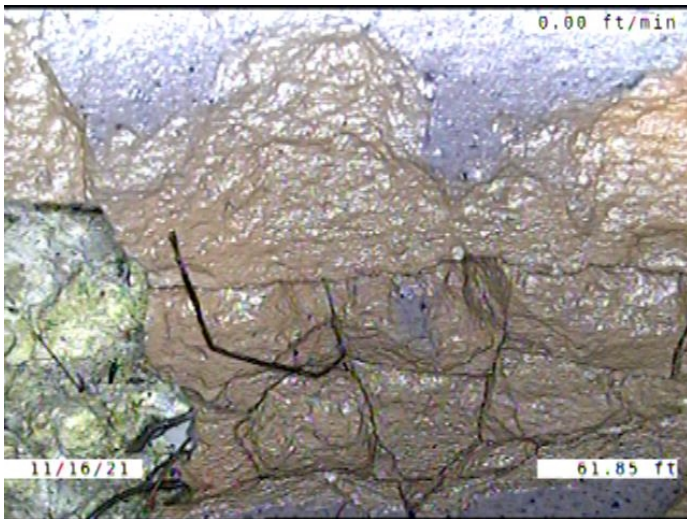
Code: **BSV**
Description: **Broken Soil Visible**

Distance (ft): **61.9**
Structural Grade: **5**
O&M Grade: **0**
Clock Start/From: **7**
Clock To: **12**
1st Value:
2nd Value:
Value Percent:
Continuous Index:
Within 8" of Joint: **YES**
Remarks:

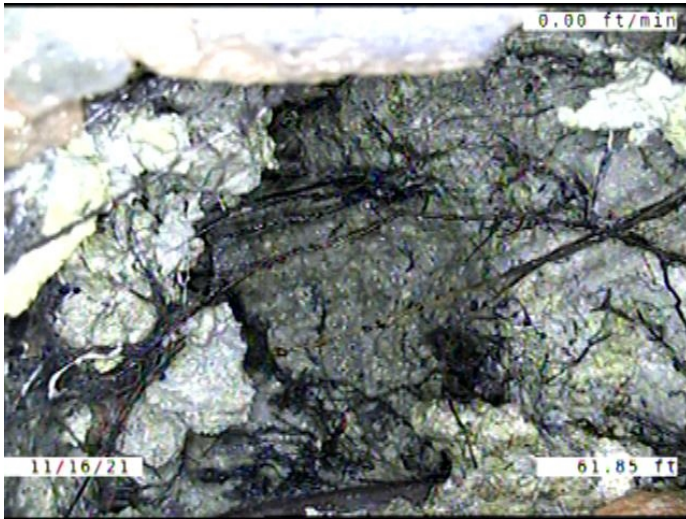
Code: **RFB**
 Description: **Roots Fine Barrel**

Distance (ft): **61.9**
 Structural Grade: **0**
 O&M Grade: **2**
 Clock Start/From: **8**
 Clock To: **12**
 1st Value:
 2nd Value:
 Value Percent:
 Continuous Index:
 Within 8" of Joint: **NO**
 Remarks:

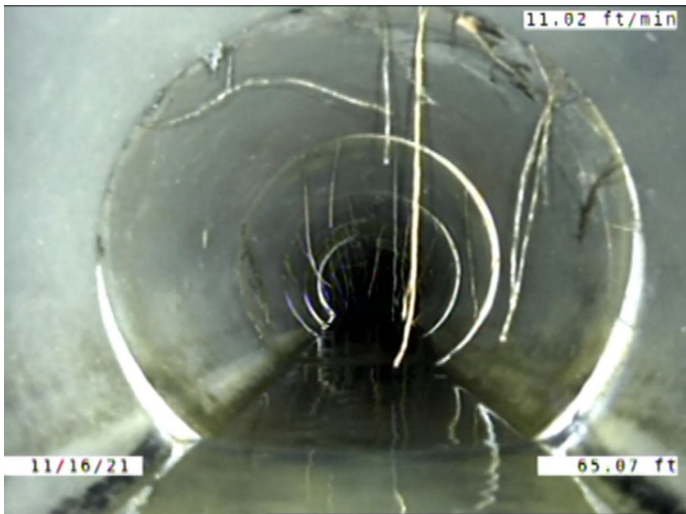
Code: **FM**
 Description: **Fracture Multiple**

Distance (ft): **65.1**
 Structural Grade: **4**
 O&M Grade: **0**
 Clock Start/From: **7**
 Clock To: **5**
 1st Value:
 2nd Value:
 Value Percent:
 Continuous Index: **S05**
 Within 8" of Joint: **YES**
 Remarks: **Wandering**

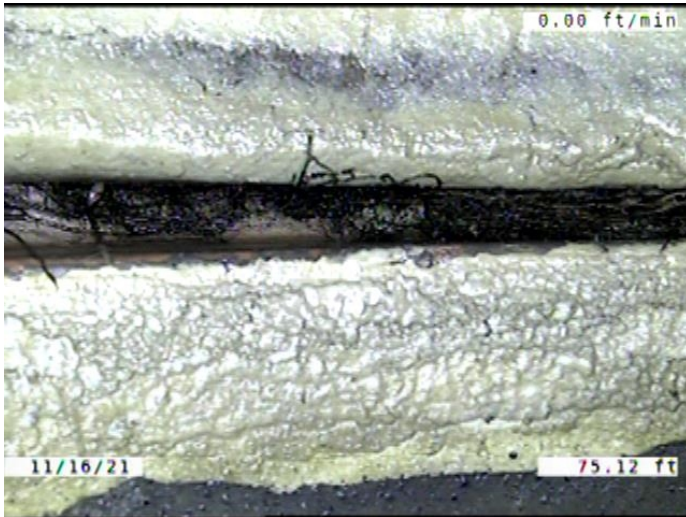
Code: **DAE**
Description: **Deposits Attached Encrustation**

Distance (ft): **75.1**
Structural Grade: **0**
O&M Grade: **2**
Clock Start/From: **8**
Clock To: **11**
1st Value:
2nd Value:
Value Percent: **5.000**
Continuous Index:
Within 8" of Joint: **YES**
Remarks:

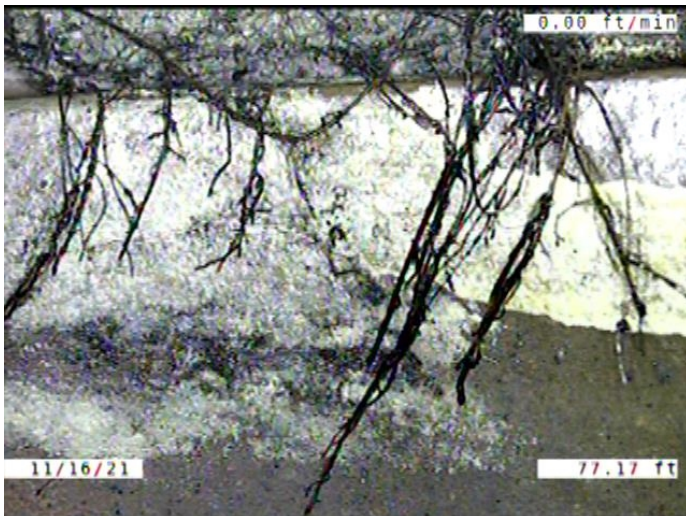
Code: **DAE**
Description: **Deposits Attached Encrustation**

Distance (ft): **77.2**
Structural Grade: **0**
O&M Grade: **2**
Clock Start/From: **2**
Clock To: **4**
1st Value:
2nd Value:
Value Percent: **5.000**
Continuous Index:
Within 8" of Joint: **YES**
Remarks:

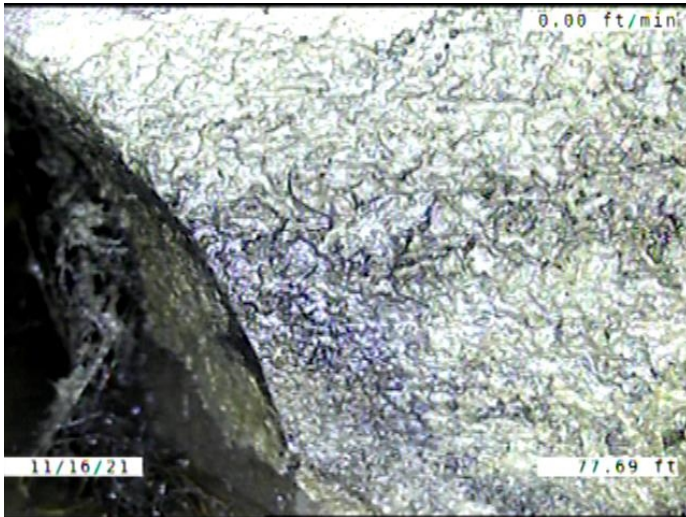
Code: **DAE**
Description: **Deposits Attached Encrustation**

Distance (ft): **77.7**
Structural Grade: **0**
O&M Grade: **2**
Clock Start/From: **2**
Clock To: **4**
1st Value:
2nd Value:
Value Percent: **5.000**
Continuous Index:
Within 8" of Joint: **YES**
Remarks:

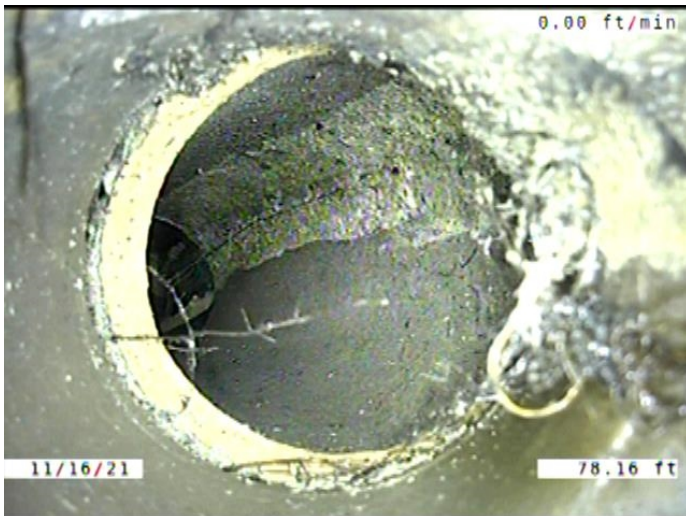
Code: **TFD**
Description: **Tap Factory Defective**

Distance (ft): **78.2**
Structural Grade: **0**
O&M Grade: **3**
Clock Start/From: **1**
Clock To:
1st Value: **4.000**
2nd Value:
Value Percent:
Continuous Index:
Within 8" of Joint: **YES**
Remarks: **OFFSET. SOIL VISIBLE. ROOTS GROWING FROM THE JOINT.**

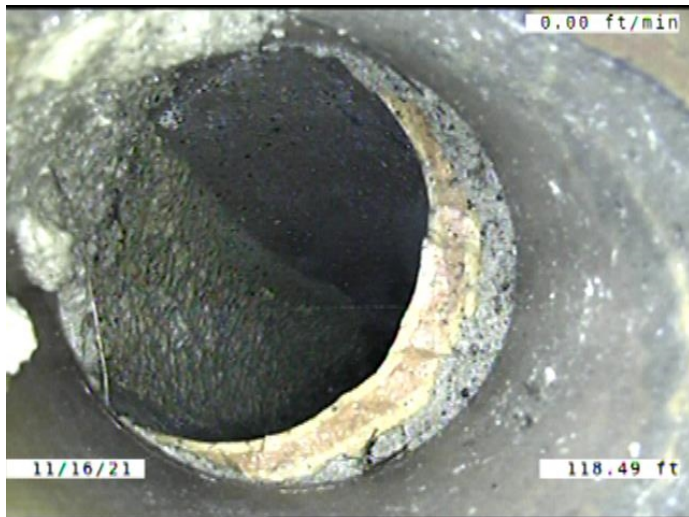
Code:	TFD
Description:	Tap Factory Defective
Distance (ft):	118.5
Structural Grade:	0
O&M Grade:	3
Clock Start/From:	11
Clock To:	
1st Value:	4.000
2nd Value:	
Value Percent:	
Continuous Index:	
Within 8" of Joint:	YES
Remarks:	ENCrustATION IN THE TAP. LARGE OFFSET. SOIL VISIBLE. ROOTS GROW

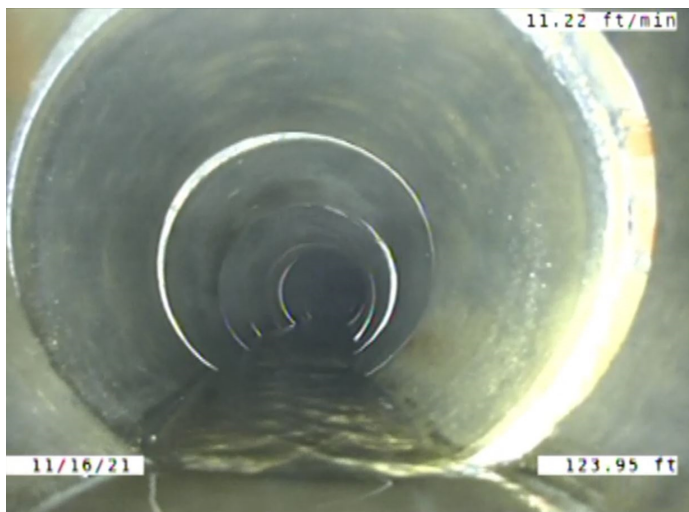
Code:	FM
Description:	Fracture Multiple
Distance (ft):	124.0
Structural Grade:	4
O&M Grade:	0
Clock Start/From:	7
Clock To:	5
1st Value:	
2nd Value:	
Value Percent:	
Continuous Index:	F05
Within 8" of Joint:	YES
Remarks:	Wandering

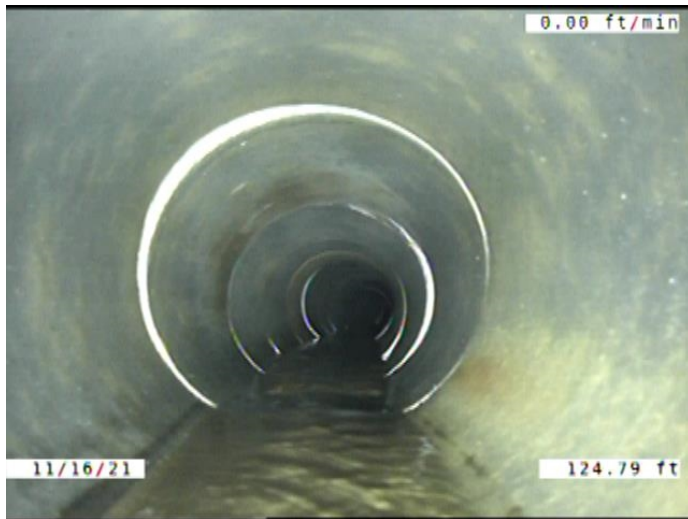
Code: **MWLS**
 Description: **Miscellaneous Water Level Sag**

Distance (ft): **124.8**
 Structural Grade: **2**
 O&M Grade: **0**
 Clock Start/From:
 Clock To:
 1st Value:
 2nd Value:
 Value Percent: **15.000**
 Continuous Index: **F03**
 Within 8" of Joint: **NO**
 Remarks:

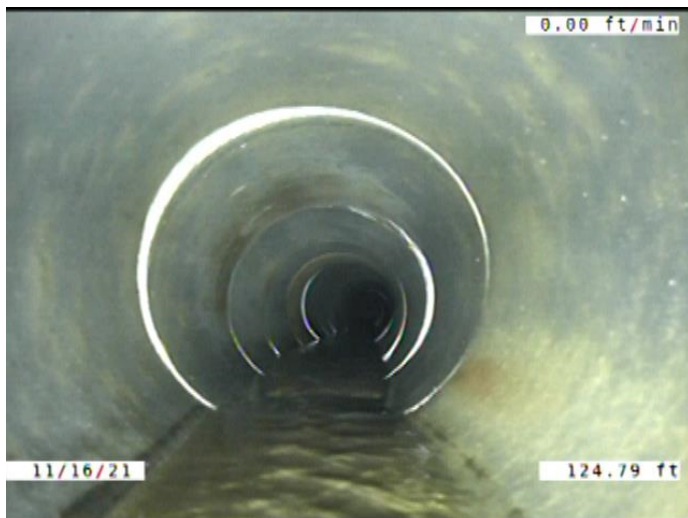
Code: **RFJ**
 Description: **Roots Fine Joint**

Distance (ft): **124.8**
 Structural Grade: **0**
 O&M Grade: **1**
 Clock Start/From: **9**
 Clock To: **4**
 1st Value:
 2nd Value:
 Value Percent:
 Continuous Index: **F02**
 Within 8" of Joint: **YES**
 Remarks:

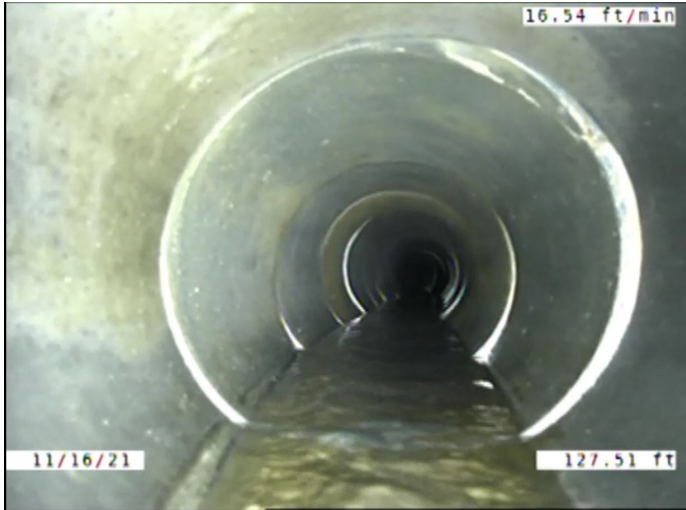
Code: **FM**
Description: **Fracture Multiple**

Distance (ft): **127.5**
Structural Grade: **4**
O&M Grade: **0**
Clock Start/From: **12**
Clock To: **2**
1st Value:
2nd Value:
Value Percent:
Continuous Index:
Within 8" of Joint: **YES**
Remarks:

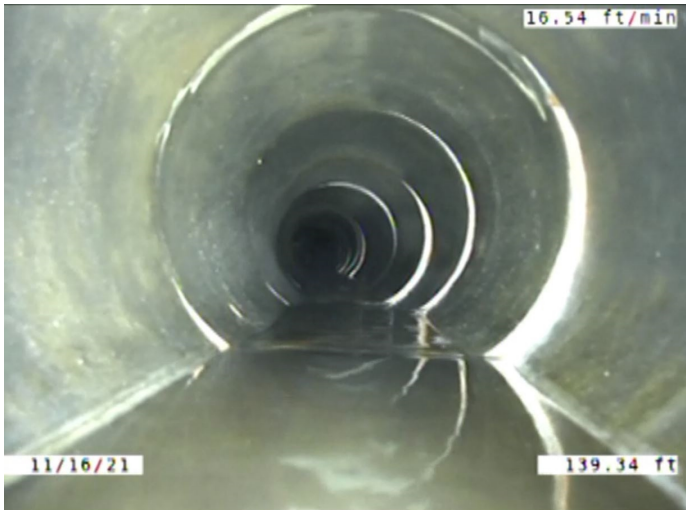
Code: **FM**
Description: **Fracture Multiple**

Distance (ft): **139.3**
Structural Grade: **4**
O&M Grade: **0**
Clock Start/From: **10**
Clock To: **2**
1st Value:
2nd Value:
Value Percent:
Continuous Index:
Within 8" of Joint: **YES**
Remarks:

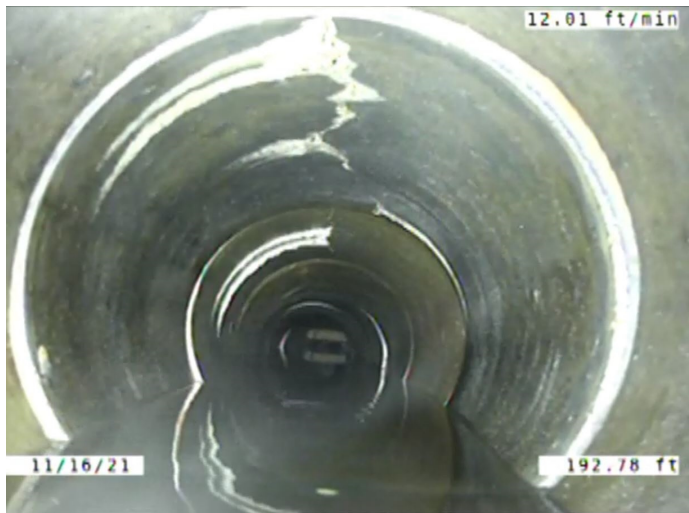
Code: **FM**
 Description: **Fracture Multiple**

Distance (ft): **192.8**
 Structural Grade: **4**
 O&M Grade: **0**
 Clock Start/From: **11**
 Clock To: **1**
 1st Value:
 2nd Value:
 Value Percent:
 Continuous Index: **S06**
 Within 8" of Joint: **YES**
 Remarks:

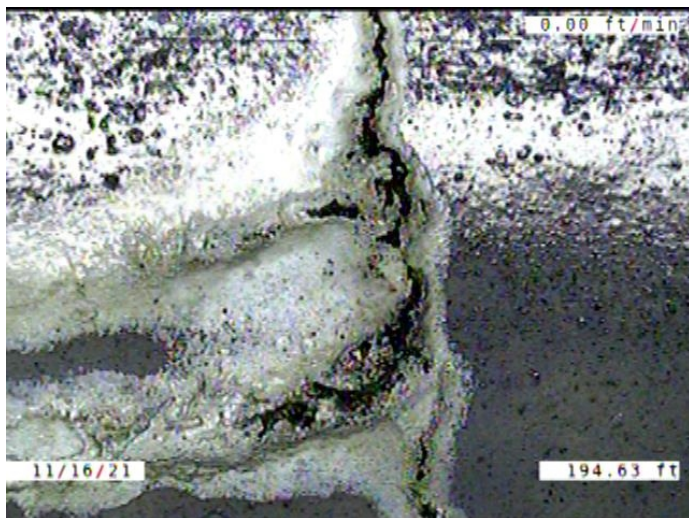
Code: **DAE**
 Description: **Deposits Attached Encrustation**

Distance (ft): **194.6**
 Structural Grade: **0**
 O&M Grade: **2**
 Clock Start/From: **9**
 Clock To: **3**
 1st Value:
 2nd Value:
 Value Percent: **5.000**
 Continuous Index: **S04**
 Within 8" of Joint: **YES**
 Remarks:

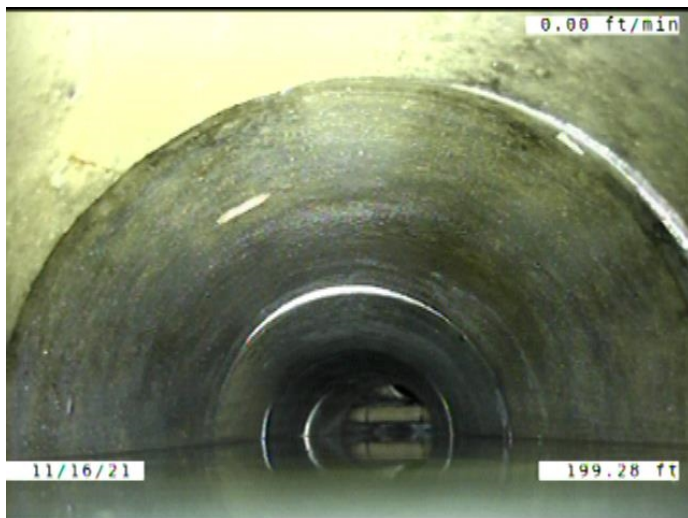
Code: **MWL**
 Description: **Miscellaneous Water Level**

Distance (ft): **199.3**
 Structural Grade: **0**
 O&M Grade: **0**
 Clock Start/From:
 Clock To:
 1st Value:
 2nd Value:
 Value Percent: **25.000**
 Continuous Index:
 Within 8" of Joint: **NO**
 Remarks:

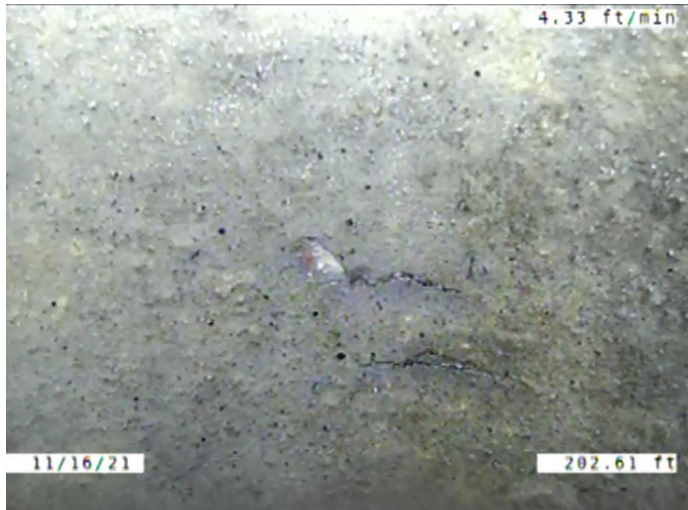
Code: **CM**
Description: **Crack Multiple**

Distance (ft): **202.6**
Structural Grade: **3**
O&M Grade: **0**
Clock Start/From: **12**
Clock To: **1**
1st Value:
2nd Value:
Value Percent:
Continuous Index:
Within 8" of Joint: **NO**
Remarks:

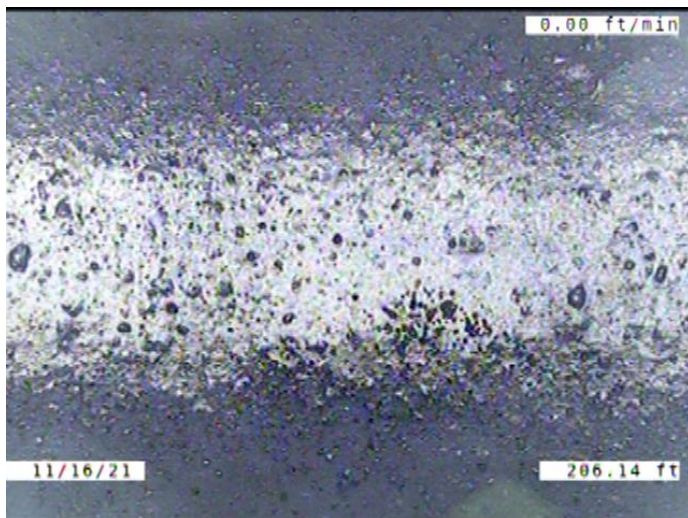
Code: **MCU**
Description: **Miscellaneous Camera Underwater**

Distance (ft): **206.1**
Structural Grade: **0**
O&M Grade: **4**
Clock Start/From:
Clock To:
1st Value:
2nd Value:
Value Percent:
Continuous Index:
Within 8" of Joint: **NO**
Remarks: **Out at 207.5**

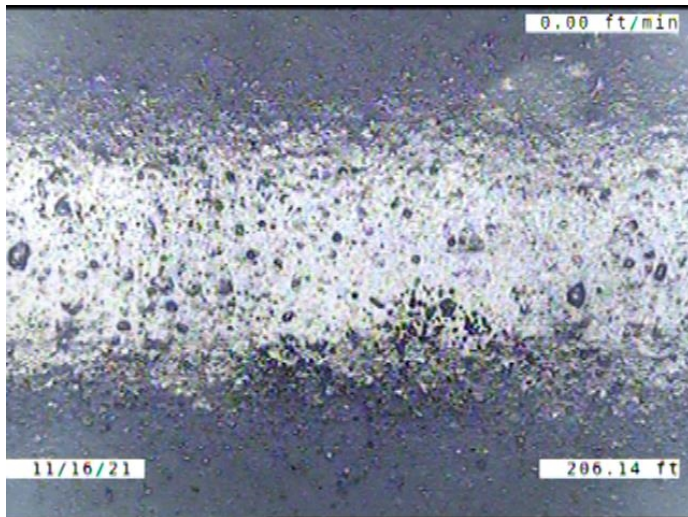
Code: **MWL**
Description: **Miscellaneous Water Level**

Distance (ft): **206.1**
Structural Grade: **0**
O&M Grade: **0**
Clock Start/From:
Clock To:
1st Value:
2nd Value:
Value Percent: **40.000**
Continuous Index:
Within 8" of Joint: **NO**
Remarks:

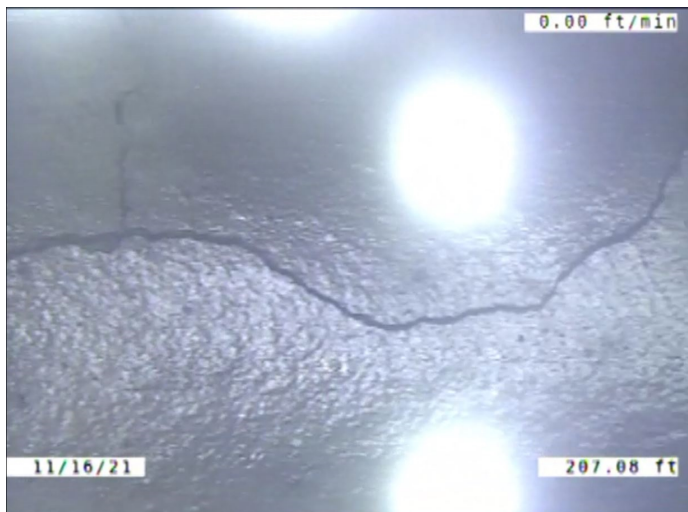
Code: **FM**
Description: **Fracture Multiple**

Distance (ft): **207.1**
Structural Grade: **4**
O&M Grade: **0**
Clock Start/From: **10**
Clock To: **2**
1st Value:
2nd Value:
Value Percent:
Continuous Index:
Within 8" of Joint: **YES**
Remarks: **Visible through water**

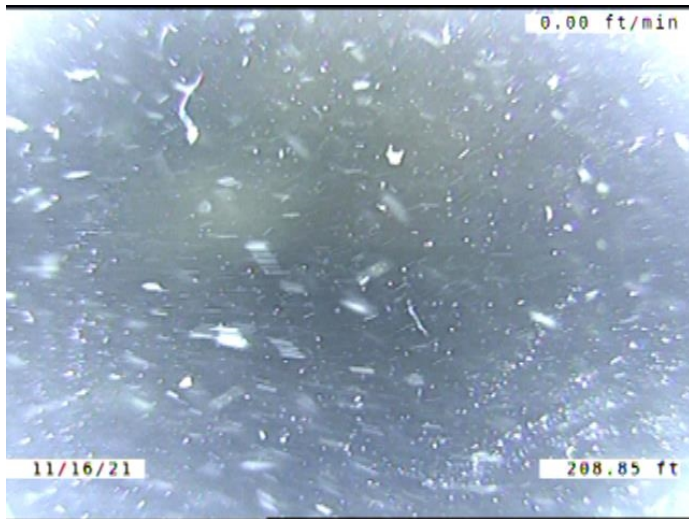
Code: **MGO**
Description: **Miscellaneous General Observation**

Distance (ft): **208.9**
Structural Grade: **0**
O&M Grade: **0**
Clock Start/From:
Clock To:
1st Value:
2nd Value:
Value Percent:
Continuous Index:
Within 8" of Joint: **NO**
Remarks: **CAMERA UNDER WATER. OPENED THE MANHOLE COVER AND VERIFIE**

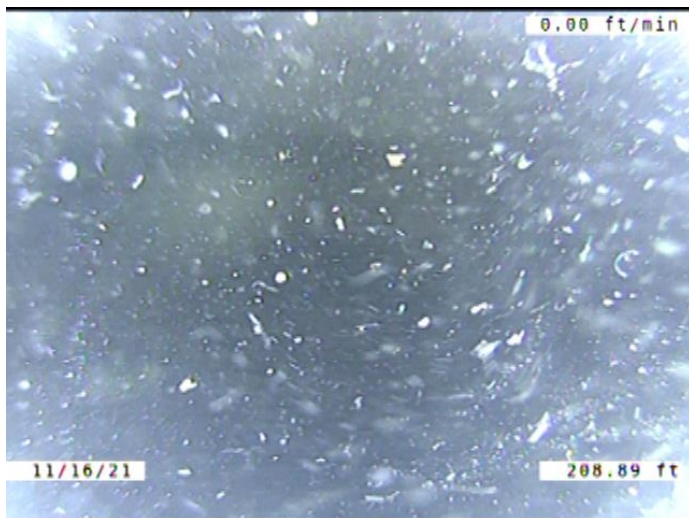
Code: **AMH**
Description: **Manhole**

Distance (ft): **208.9**
Structural Grade: **0**
O&M Grade: **0**
Clock Start/From:
Clock To:
1st Value:
2nd Value:
Value Percent:
Continuous Index:
Within 8" of Joint: **NO**
Remarks: **M-605-072**
