Profile/Photo Observation Report

Date:	11/16/2021	Weather:		Coding:	PACP 7.0
Pipe Length (ft):	208.9	Owner:	City of Hobart	Pre Clean:	Heavy Cleaning
P.O.#:	YES502259	Surveyor:	S. Bucklin	PSR:	P-605-072-008
Customer:	City of Hobart	Clean Date:	11/16/2021	Shape:	C

Street:	South Ash Street	Flow Control:	Not Controlled
City:	Hobart, IN	Year Renewed:	
Location:	Local rural streets with light traffic, t	Tape/Media #:	
Purpose:	Routine Assessment	Dia/Height:	12"
Use:	Sanitary Sewage Pipe	Material:	VCP
Drain Area:		Lining:	None
Category:	NA		
Comment:			
Location Details:		Direction of Survey:	Downstream
US MH:	M-605-008	DS MH:	M-605-072
		Total Length Surveyed (ft):	208.9

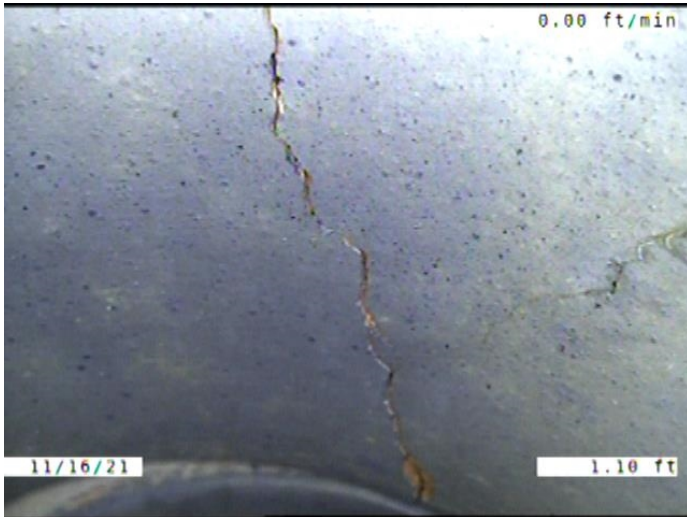
Code: **B**
Description: **Broken**

Distance (ft): **1.1**
Structural Grade: **4**
O&M Grade: **0**
Clock Start/From: **8**
Clock To: **4**
1st Value:
2nd Value:
Value Percent:
Continuous Index:
Within 8" of Joint: **YES**
Remarks:

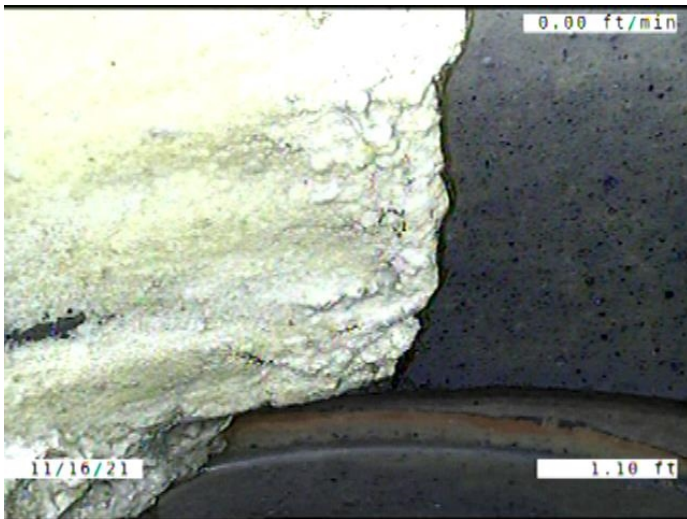
Code: **DAE**
Description: **Deposits Attached Encrustation**

Distance (ft): **1.1**
Structural Grade: **0**
O&M Grade: **2**
Clock Start/From: **3**
Clock To: **10**
1st Value:
2nd Value:
Value Percent: **5.000**
Continuous Index:
Within 8" of Joint: **YES**
Remarks:

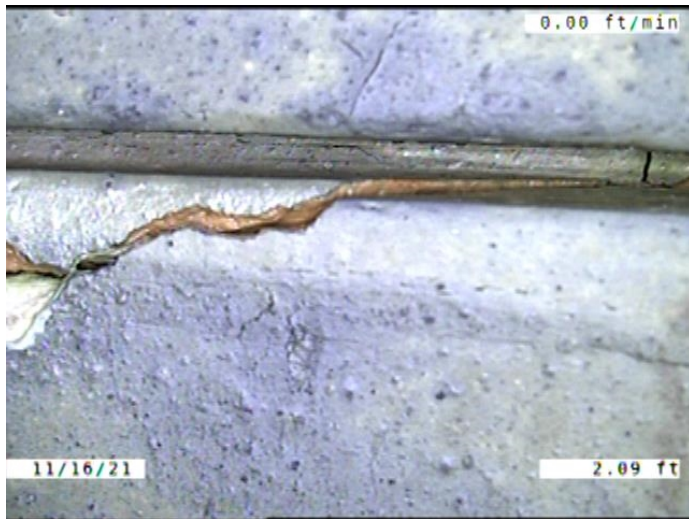
Code: **B**
 Description: **Broken**

Distance (ft): **2.1**
 Structural Grade: **4**
 O&M Grade: **0**
 Clock Start/From: **8**
 Clock To: **4**
 1st Value:
 2nd Value:
 Value Percent:
 Continuous Index:
 Within 8" of Joint: **YES**
 Remarks:

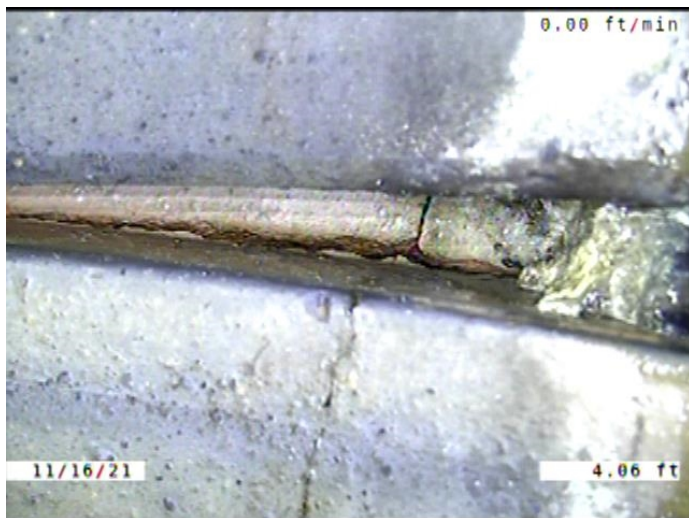
Code: **FM**
 Description: **Fracture Multiple**

Distance (ft): **4.1**
 Structural Grade: **4**
 O&M Grade: **0**
 Clock Start/From: **9**
 Clock To: **3**
 1st Value:
 2nd Value:
 Value Percent:
 Continuous Index:
 Within 8" of Joint: **YES**
 Remarks:

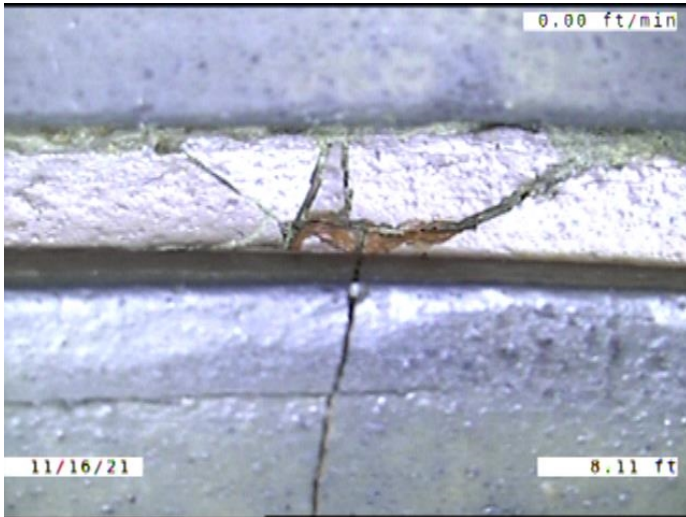
Code: **FM**
 Description: **Fracture Multiple**

Distance (ft): **8.1**
 Structural Grade: **4**
 O&M Grade: **0**
 Clock Start/From: **10**
 Clock To: **3**
 1st Value:
 2nd Value:
 Value Percent:
 Continuous Index:
 Within 8" of Joint: **YES**
 Remarks:

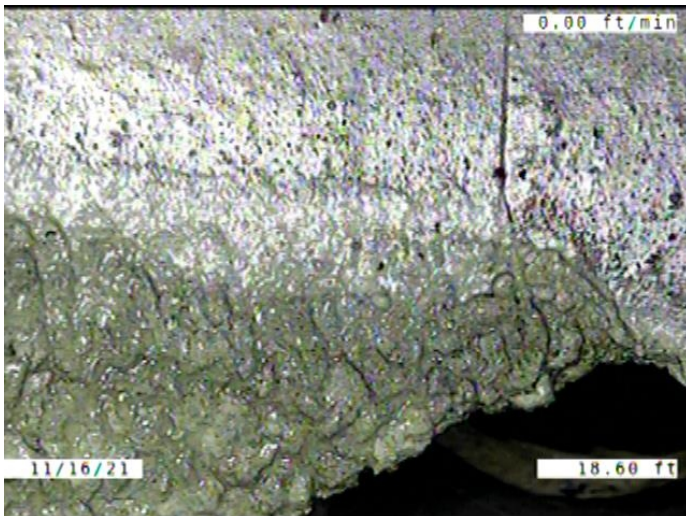
Code: **DAE**
 Description: **Deposits Attached Encrustation**

Distance (ft): **18.6**
 Structural Grade: **0**
 O&M Grade: **2**
 Clock Start/From: **9**
 Clock To: **11**
 1st Value:
 2nd Value:
 Value Percent: **5.000**
 Continuous Index:
 Within 8" of Joint: **YES**
 Remarks:

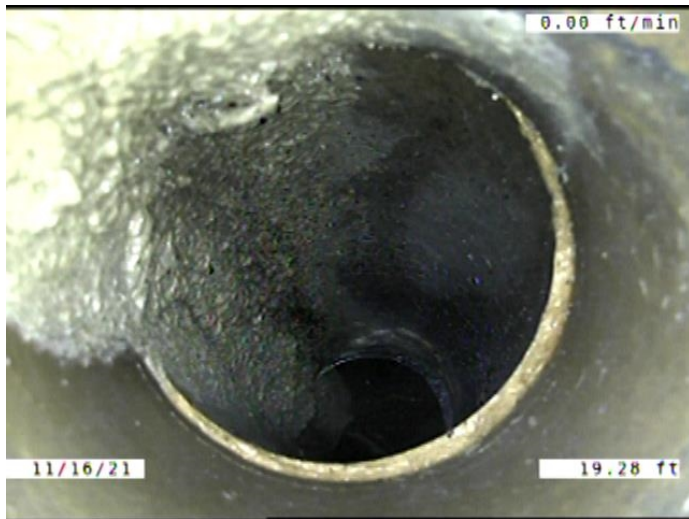
Code: **TF**
 Description: **Tap Factory**

Distance (ft): **19.3**
 Structural Grade: **0**
 O&M Grade: **0**
 Clock Start/From: **11**
 Clock To:
 1st Value: **4.000**

2nd Value:
 Value Percent:
 Continuous Index:
 Within 8" of Joint: **YES**
 Remarks: **ENCrustATION IN THE TAP AND COMING INTO THE MAIN.**

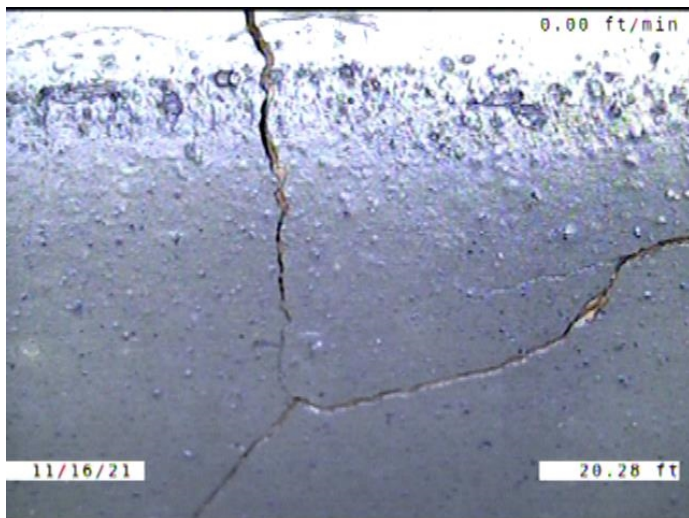
Code: **B**
 Description: **Broken**

Distance (ft): **20.3**
 Structural Grade: **4**
 O&M Grade: **0**
 Clock Start/From: **11**
 Clock To: **2**

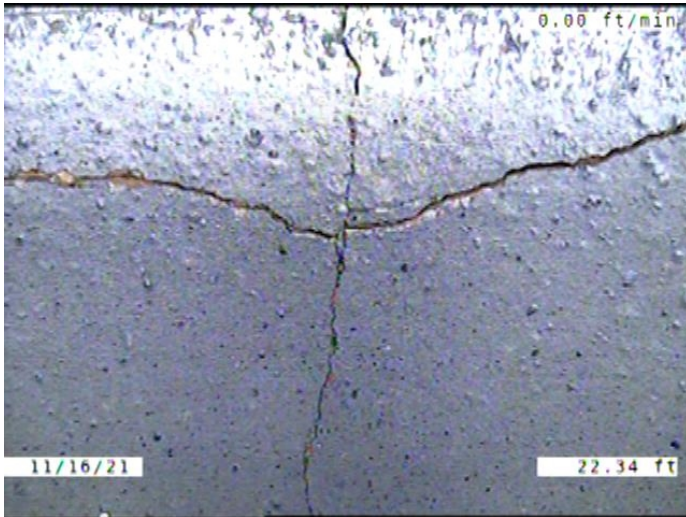
Code: **B**
 Description: **Broken**

Distance (ft): **22.3**
 Structural Grade: **4**
 O&M Grade: **0**
 Clock Start/From: **11**
 Clock To: **2**
 1st Value:
 2nd Value:
 Value Percent:
 Continuous Index:
 Within 8" of Joint: **YES**
 Remarks:

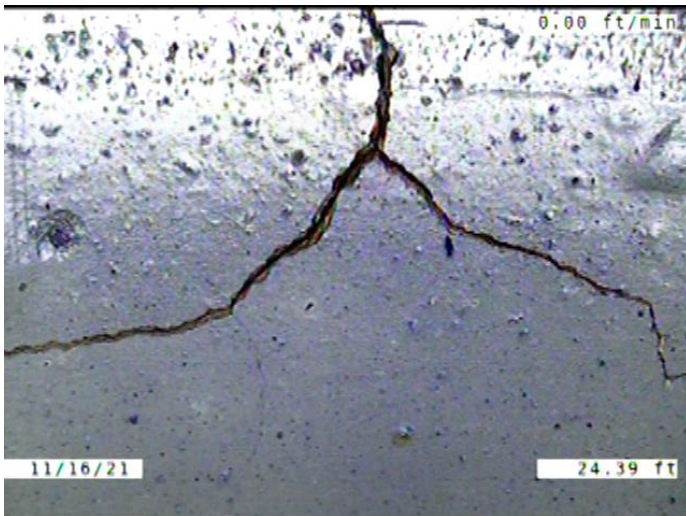
Code: **B**
 Description: **Broken**

Distance (ft): **24.4**
 Structural Grade: **4**
 O&M Grade: **0**
 Clock Start/From: **9**
 Clock To: **4**
 1st Value:
 2nd Value:
 Value Percent:
 Continuous Index: **S01**
 Within 8" of Joint: **YES**
 Remarks:

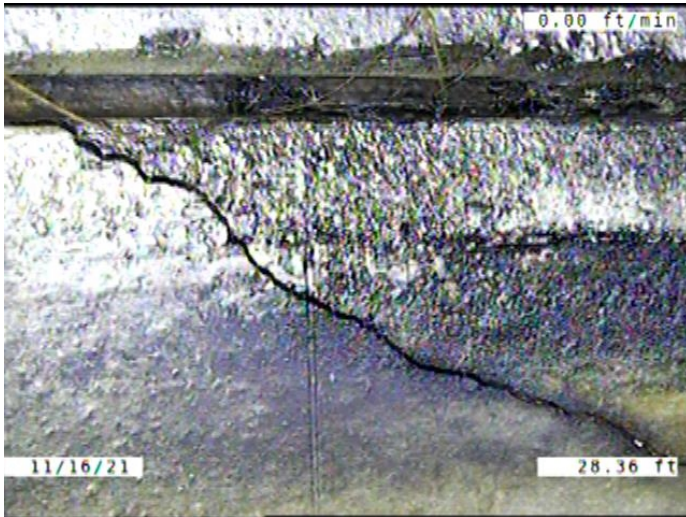
Code: **RFJ**
 Description: **Roots Fine Joint**

Distance (ft): **28.4**
 Structural Grade: **0**
 O&M Grade: **1**
 Clock Start/From: **9**
 Clock To: **1**
 1st Value:
 2nd Value:
 Value Percent:
 Continuous Index:
 Within 8" of Joint: **YES**
 Remarks:

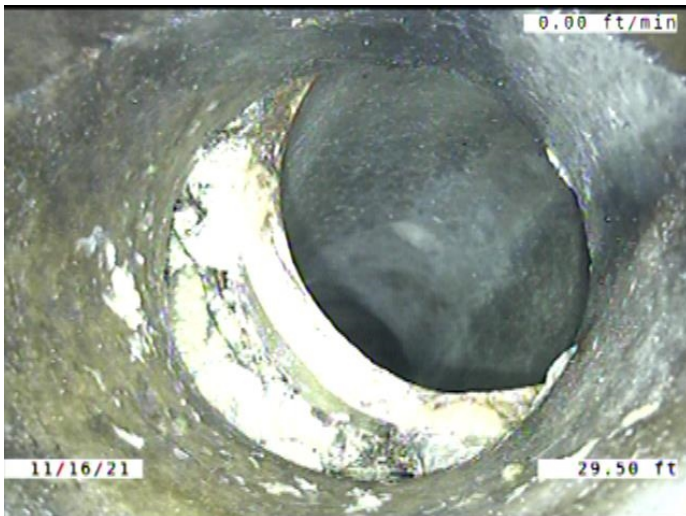
Code: **TFD**
 Description: **Tap Factory Defective**

Distance (ft): **29.5**
 Structural Grade: **0**
 O&M Grade: **3**
 Clock Start/From: **1**
 Clock To:
 1st Value: **4.000**
 2nd Value:
 Value Percent:
 Continuous Index:
 Within 8" of Joint: **YES**
 Remarks: **LARGE OFFSET. SOIL VISIBLE**

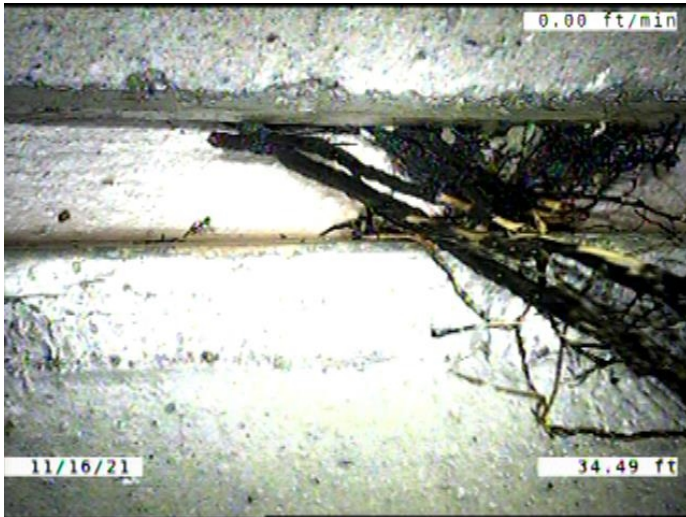
Code: **RFJ**
 Description: **Roots Fine Joint**

Distance (ft): **34.5**
 Structural Grade: **0**
 O&M Grade: **1**
 Clock Start/From: **1**
 Clock To: **4**
 1st Value:
 2nd Value:
 Value Percent:
 Continuous Index:
 Within 8" of Joint: **YES**
 Remarks:

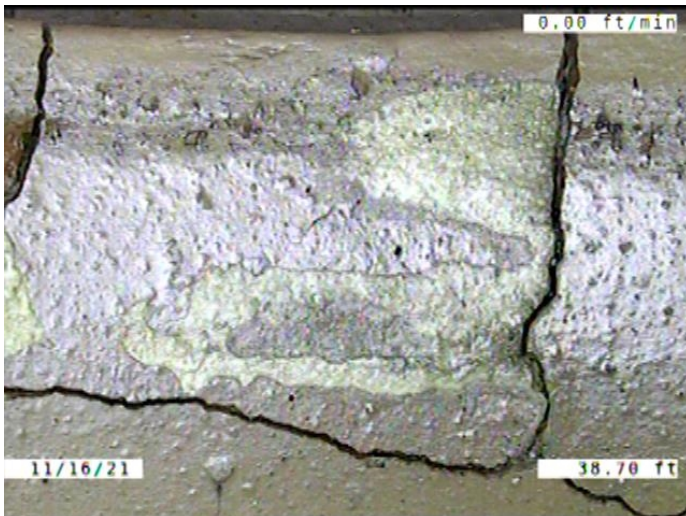
Code: **DAE**
 Description: **Deposits Attached Encrustation**

Distance (ft): **38.7**
 Structural Grade: **0**
 O&M Grade: **2**
 Clock Start/From: **9**
 Clock To: **11**
 1st Value:
 2nd Value:
 Value Percent: **5.000**
 Continuous Index:
 Within 8" of Joint: **YES**
 Remarks:

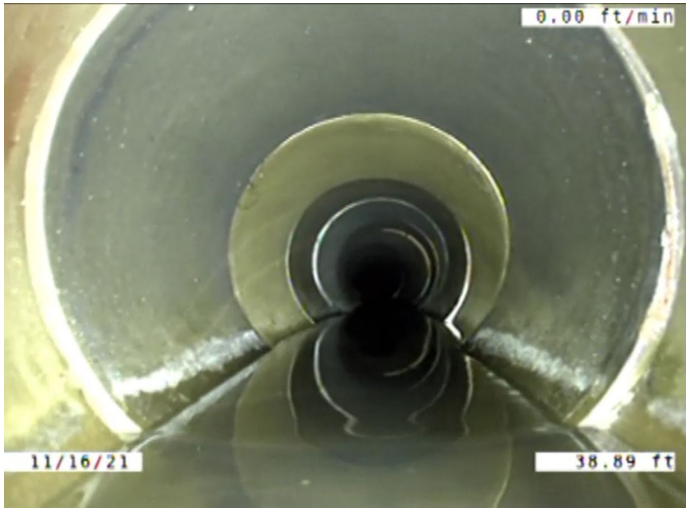
Code: **B**
Description: **Broken**

Distance (ft): **38.9**
Structural Grade: **4**
O&M Grade: **0**
Clock Start/From: **9**
Clock To: **4**
1st Value:
2nd Value:
Value Percent:
Continuous Index: **F01**
Within 8" of Joint: **YES**
Remarks:

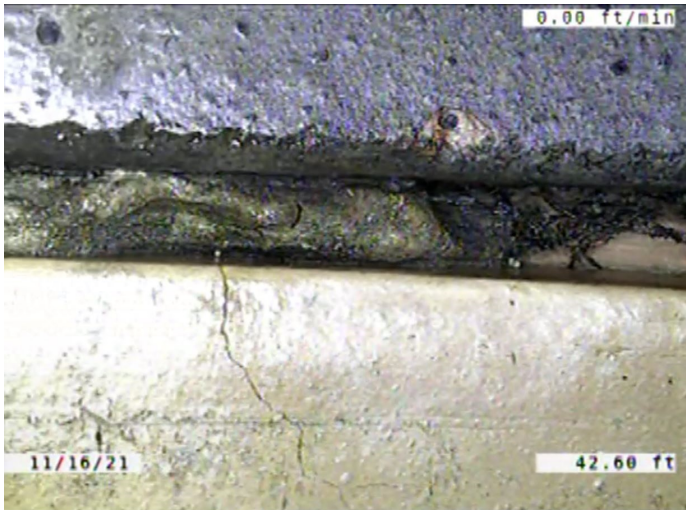
Code: **CM**
Description: **Crack Multiple**

Distance (ft): **42.6**
Structural Grade: **3**
O&M Grade: **0**
Clock Start/From: **9**
Clock To: **3**
1st Value:
2nd Value:
Value Percent:
Continuous Index:
Within 8" of Joint: **YES**
Remarks:

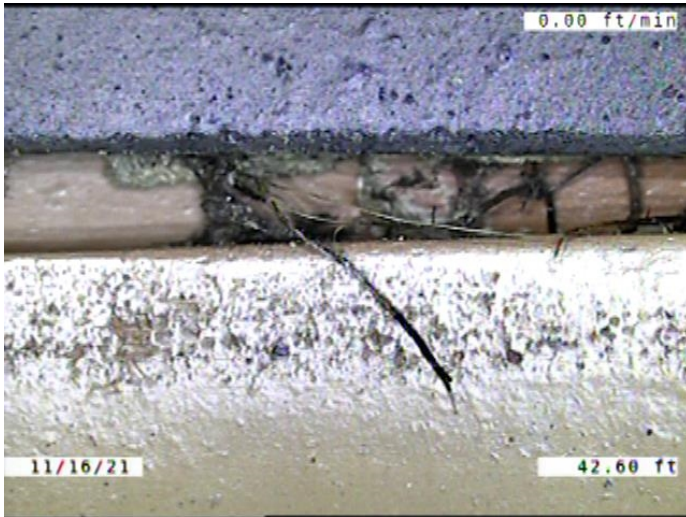
Code: **RFJ**
 Description: **Roots Fine Joint**

Distance (ft): **42.6**
 Structural Grade: **0**
 O&M Grade: **1**
 Clock Start/From: **9**
 Clock To: **4**
 1st Value:
 2nd Value:
 Value Percent:
 Continuous Index: **S02**
 Within 8" of Joint: **YES**
 Remarks:

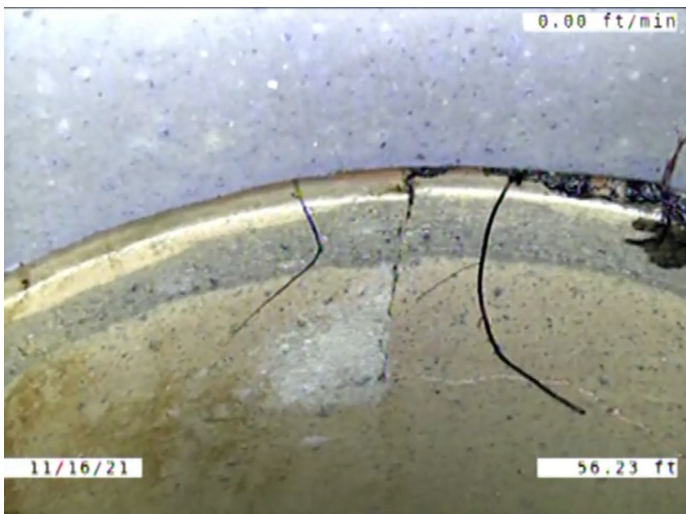
Code: **CM**
 Description: **Crack Multiple**

Distance (ft): **56.2**
 Structural Grade: **3**
 O&M Grade: **0**
 Clock Start/From: **10**
 Clock To: **2**
 1st Value:
 2nd Value:
 Value Percent:
 Continuous Index:
 Within 8" of Joint: **YES**
 Remarks:

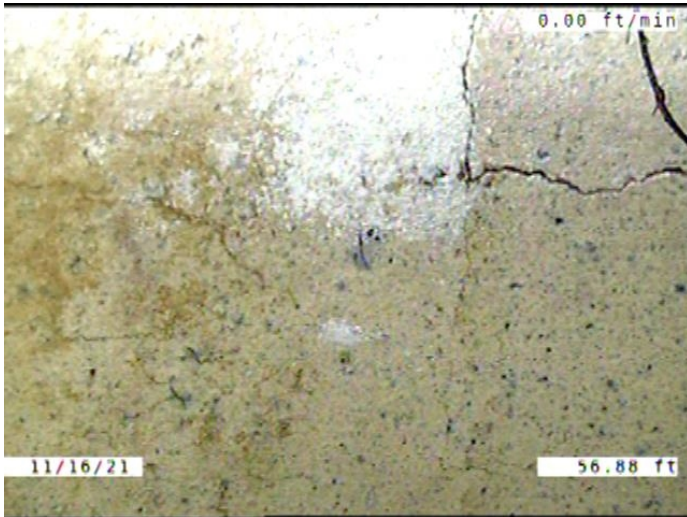
Code: **DAE**
 Description: **Deposits Attached Encrustation**

Distance (ft): **56.9**
 Structural Grade: **0**
 O&M Grade: **2**
 Clock Start/From: **8**
 Clock To: **10**
 1st Value:
 2nd Value:
 Value Percent: **5.000**
 Continuous Index:
 Within 8" of Joint: **YES**
 Remarks:

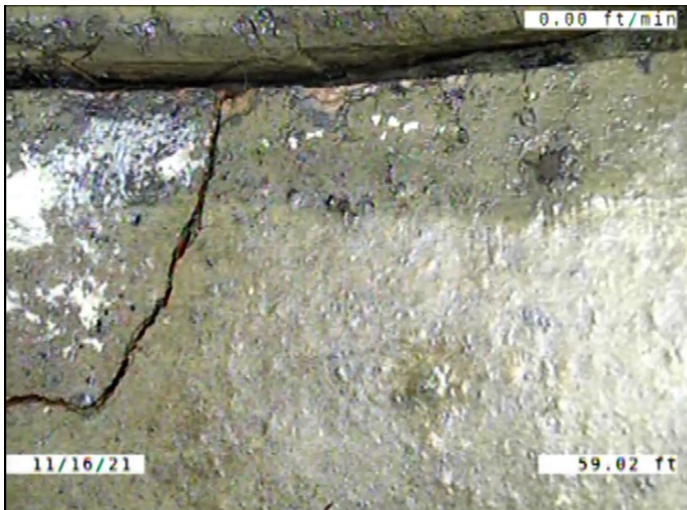
Code: **FM**
 Description: **Fracture Multiple**

Distance (ft): **59.0**
 Structural Grade: **4**
 O&M Grade: **0**
 Clock Start/From: **9**
 Clock To: **3**
 1st Value:
 2nd Value:
 Value Percent:
 Continuous Index:
 Within 8" of Joint: **YES**
 Remarks:

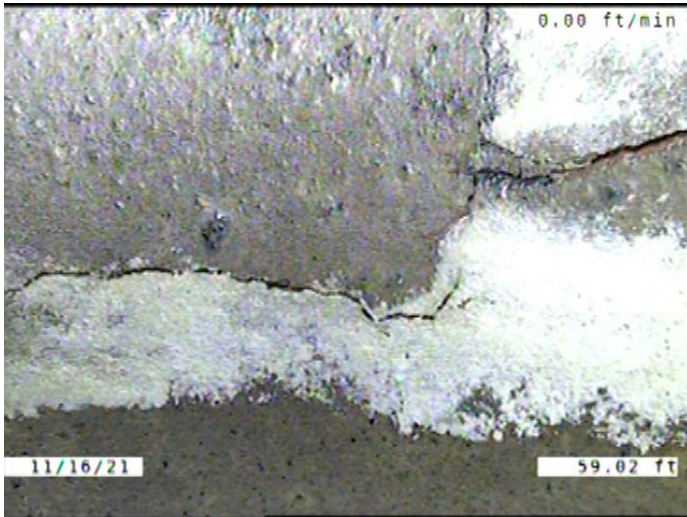
Code: **DAE**
 Description: **Deposits Attached Encrustation**

Distance (ft): **59.0**
 Structural Grade: **0**
 O&M Grade: **2**
 Clock Start/From: **1**
 Clock To: **4**
 1st Value:
 2nd Value:
 Value Percent: **5.000**
 Continuous Index:
 Within 8" of Joint: **YES**
 Remarks:

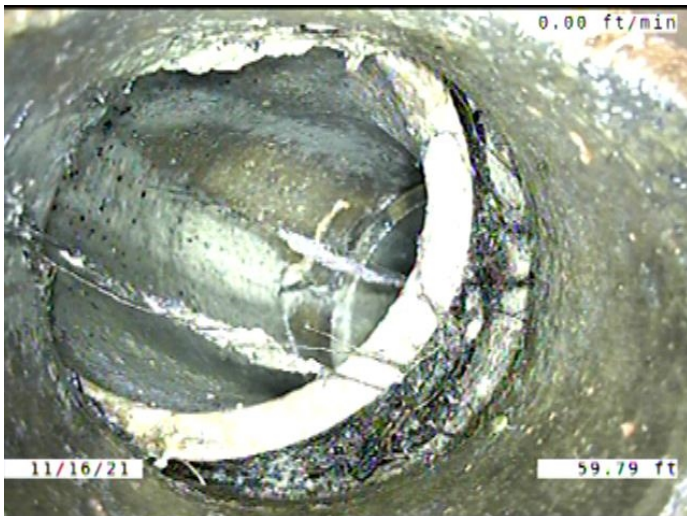
Code: **TFD**
 Description: **Tap Factory Defective**

Distance (ft): **59.8**
 Structural Grade: **0**
 O&M Grade: **3**
 Clock Start/From: **10**
 Clock To:
 1st Value: **4.000**
 2nd Value:
 Value Percent:
 Continuous Index:
 Within 8" of Joint: **YES**
 Remarks: **LARGE OFFSET. SOIL VISIBLE.
 BROKEN. ROOTS GROWING FROM T**

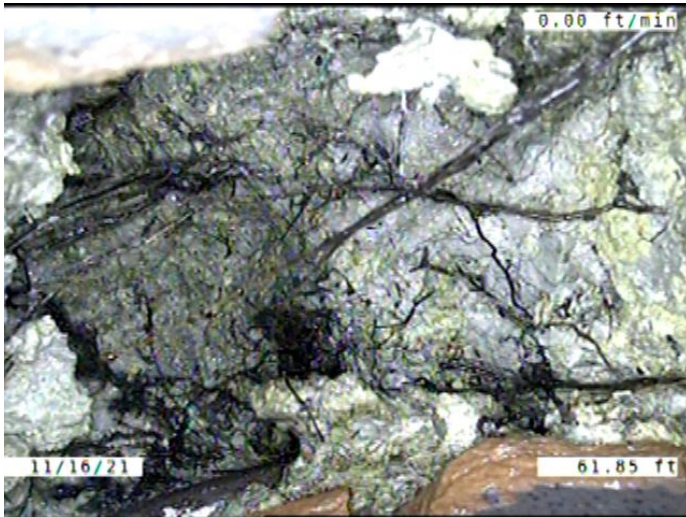
Code: **HSV**
 Description: **Hole Soil Visible**

Distance (ft): **61.9**
 Structural Grade: **5**
 O&M Grade: **0**
 Clock Start/From: **8**
 Clock To: **11**
 1st Value:
 2nd Value:
 Value Percent:
 Continuous Index:
 Within 8" of Joint: **YES**
 Remarks:

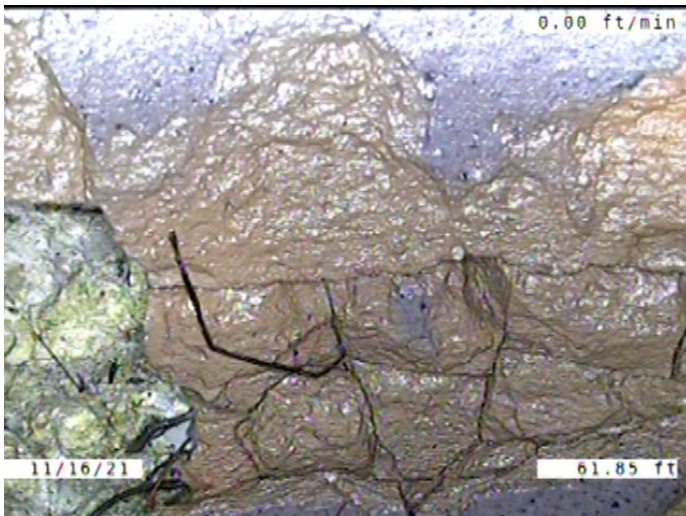
Code: **BSV**
 Description: **Broken Soil Visible**

Distance (ft): **61.9**
 Structural Grade: **5**
 O&M Grade: **0**
 Clock Start/From: **7**
 Clock To: **12**
 1st Value:
 2nd Value:
 Value Percent:
 Continuous Index:
 Within 8" of Joint: **YES**
 Remarks:

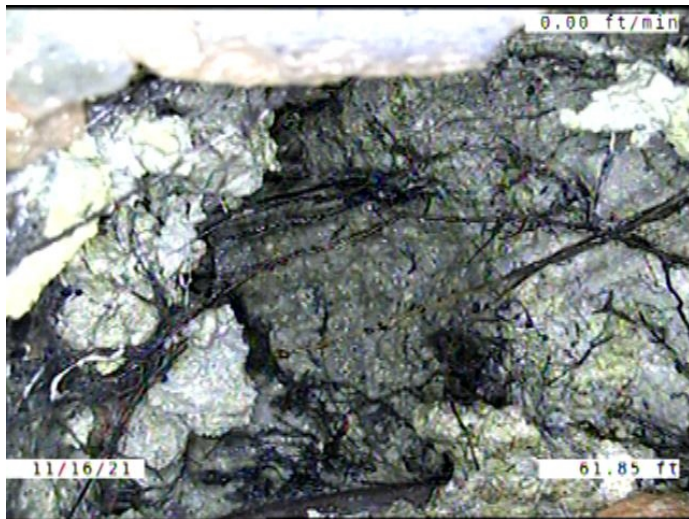
Code: **RFB**
 Description: **Roots Fine Barrel**

Distance (ft): **61.9**
 Structural Grade: **0**
 O&M Grade: **2**
 Clock Start/From: **8**
 Clock To: **12**
 1st Value:
 2nd Value:
 Value Percent:
 Continuous Index:
 Within 8" of Joint: **NO**
 Remarks:

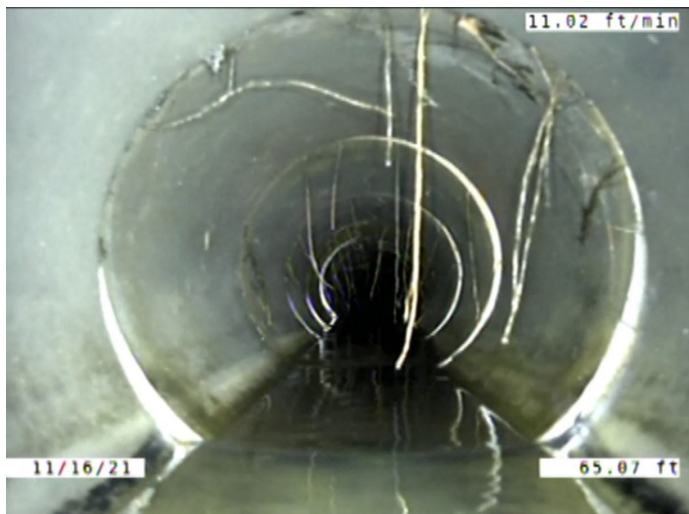
Code: **FM**
 Description: **Fracture Multiple**

Distance (ft): **65.1**
 Structural Grade: **4**
 O&M Grade: **0**
 Clock Start/From: **7**
 Clock To: **5**
 1st Value:
 2nd Value:
 Value Percent:
 Continuous Index: **S05**
 Within 8" of Joint: **YES**
 Remarks: **Wandering**

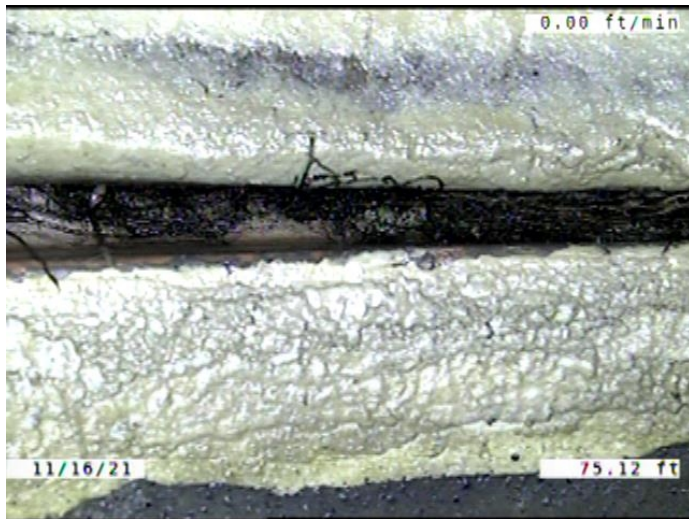
Code: **DAE**
 Description: **Deposits Attached Encrustation**

Distance (ft): **75.1**
 Structural Grade: **0**
 O&M Grade: **2**
 Clock Start/From: **8**
 Clock To: **11**
 1st Value:
 2nd Value:
 Value Percent: **5.000**
 Continuous Index:
 Within 8" of Joint: **YES**
 Remarks:

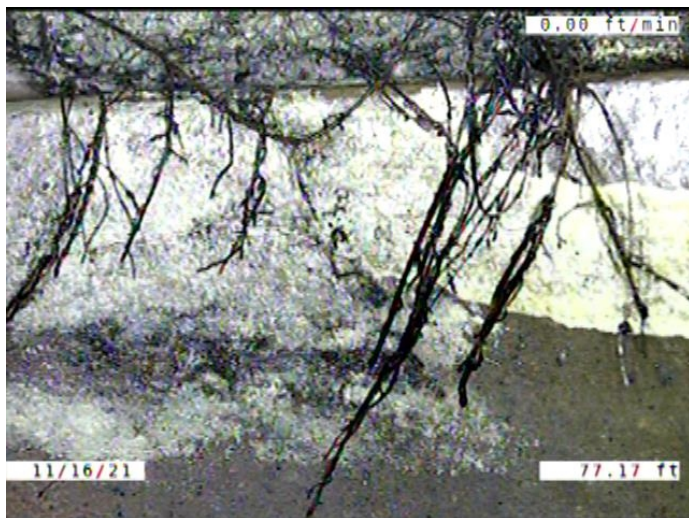
Code: **DAE**
 Description: **Deposits Attached Encrustation**

Distance (ft): **77.2**
 Structural Grade: **0**
 O&M Grade: **2**
 Clock Start/From: **2**
 Clock To: **4**
 1st Value:
 2nd Value:
 Value Percent: **5.000**
 Continuous Index:
 Within 8" of Joint: **YES**
 Remarks:

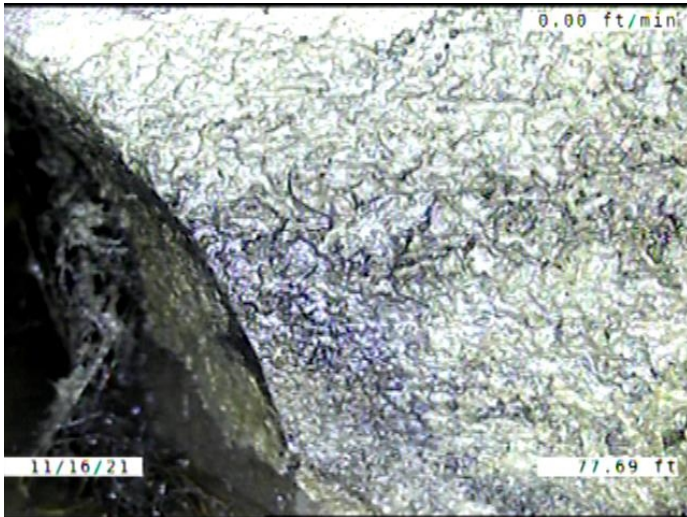
Code: **DAE**
Description: **Deposits Attached Encrustation**

Distance (ft): **77.7**
Structural Grade: **0**
O&M Grade: **2**
Clock Start/From: **2**
Clock To: **4**
1st Value:
2nd Value:
Value Percent: **5.000**
Continuous Index:
Within 8" of Joint: **YES**
Remarks:

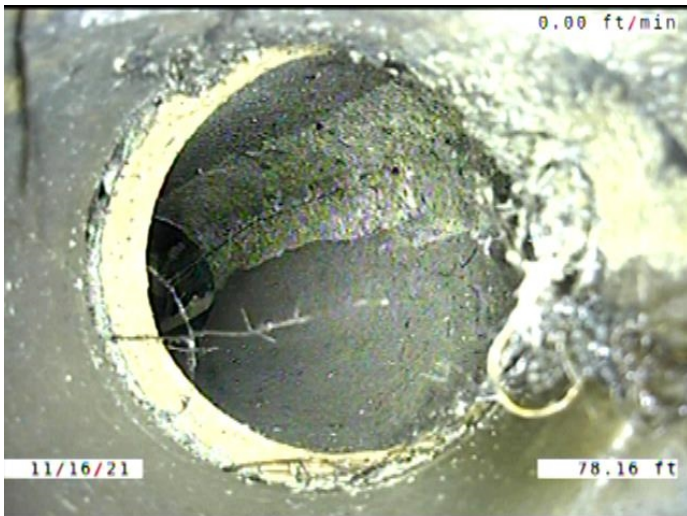
Code: **TFD**
Description: **Tap Factory Defective**

Distance (ft): **78.2**
Structural Grade: **0**
O&M Grade: **3**
Clock Start/From: **1**
Clock To:
1st Value: **4.000**
2nd Value:
Value Percent:
Continuous Index:
Within 8" of Joint: **YES**
Remarks: **OFFSET. SOIL VISIBLE. ROOTS GROWING FROM THE JOINT.**

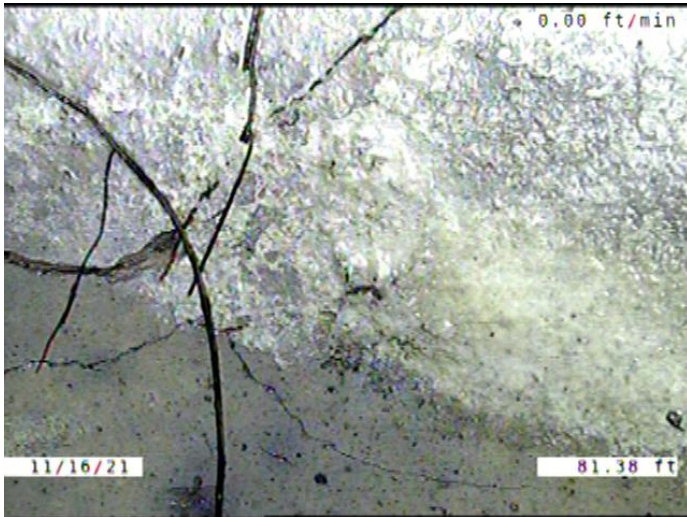
Code: **DAE**
 Description: **Deposits Attached Encrustation**

Distance (ft): **81.4**
 Structural Grade: **0**
 O&M Grade: **2**
 Clock Start/From: **1**
 Clock To: **3**
 1st Value:
 2nd Value:
 Value Percent: **5.000**
 Continuous Index:
 Within 8" of Joint: **YES**
 Remarks:

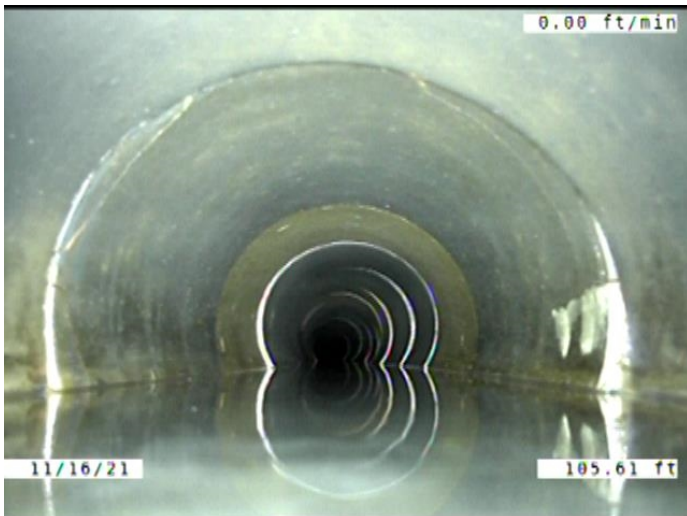
Code: **MWLS**
 Description: **Miscellaneous Water Level Sag**

Distance (ft): **105.6**
 Structural Grade: **2**
 O&M Grade: **0**
 Clock Start/From:
 Clock To:
 1st Value:
 2nd Value:
 Value Percent: **15.000**
 Continuous Index: **S03**
 Within 8" of Joint: **NO**
 Remarks:

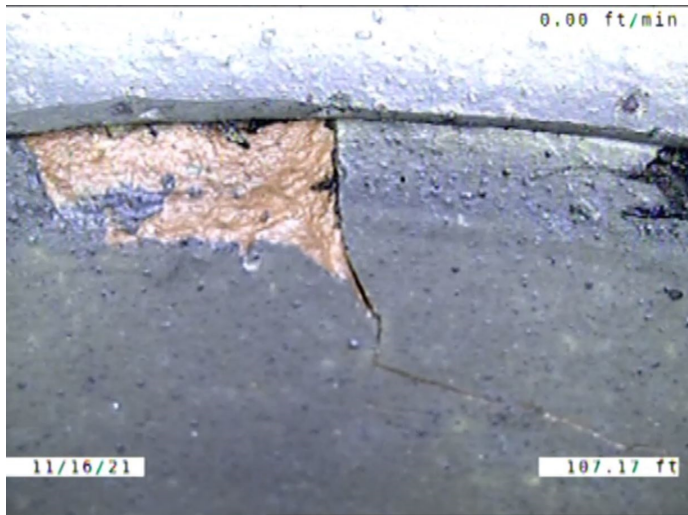
Code:	SSS
Description:	Surface Damage Surface Spalling
Distance (ft):	107.2
Structural Grade:	2
O&M Grade:	0
Clock Start/From:	12
Clock To:	
1st Value:	
2nd Value:	
Value Percent:	
Continuous Index:	
Within 8" of Joint:	YES
Remarks:

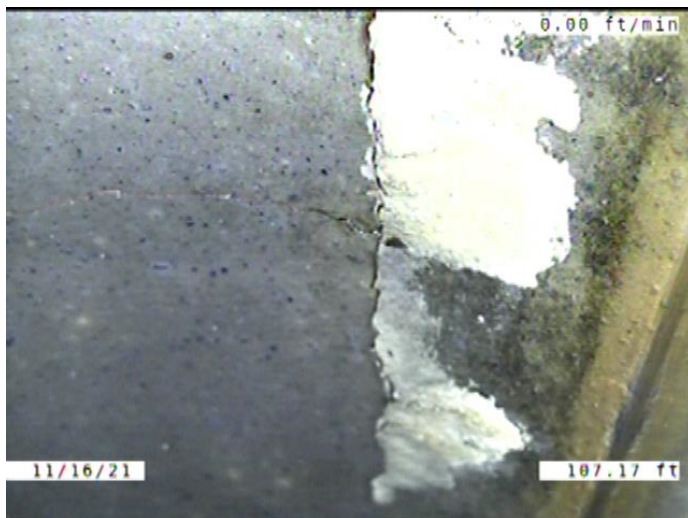
Code:	DAE
Description:	Deposits Attached Encrustation
Distance (ft):	107.2
Structural Grade:	0
O&M Grade:	2
Clock Start/From:	2
Clock To:	
1st Value:	
2nd Value:	
Value Percent:	5.000
Continuous Index:	
Within 8" of Joint:	YES
Remarks:

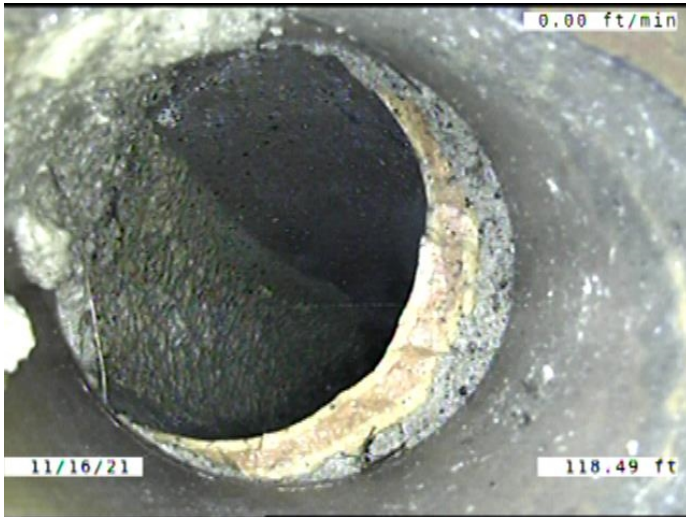
Code:	TFD
Description:	Tap Factory Defective
Distance (ft):	118.5
Structural Grade:	0
O&M Grade:	3
Clock Start/From:	11
Clock To:	
1st Value:	4.000
2nd Value:	
Value Percent:	
Continuous Index:	
Within 8" of Joint:	YES
Remarks:	ENCrustation IN THE TAP. LARGE OFFSET. SOIL VISIBLE. ROOTS GROW

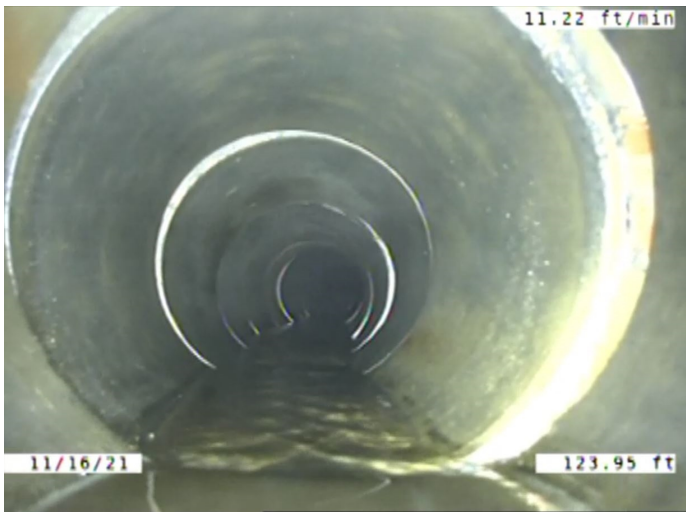
Code:	FM
Description:	Fracture Multiple
Distance (ft):	124.0
Structural Grade:	4
O&M Grade:	0
Clock Start/From:	7
Clock To:	5
1st Value:	
2nd Value:	
Value Percent:	
Continuous Index:	F05
Within 8" of Joint:	YES
Remarks:	Wandering

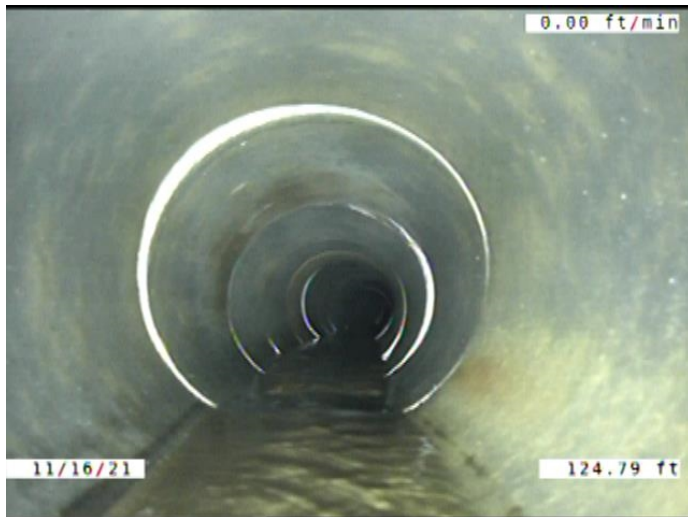
Code: **MWLS**
 Description: **Miscellaneous Water Level Sag**

Distance (ft): **124.8**
 Structural Grade: **2**
 O&M Grade: **0**
 Clock Start/From:
 Clock To:
 1st Value:
 2nd Value:
 Value Percent: **15.000**
 Continuous Index: **F03**
 Within 8" of Joint: **NO**
 Remarks:

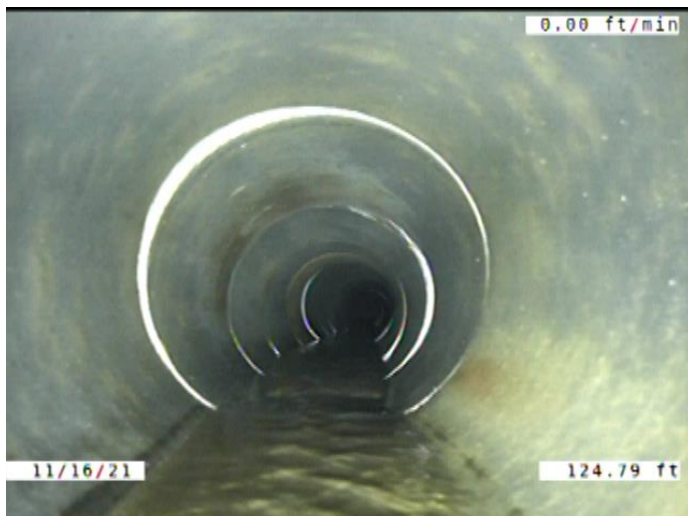
Code: **RFJ**
 Description: **Roots Fine Joint**

Distance (ft): **124.8**
 Structural Grade: **0**
 O&M Grade: **1**
 Clock Start/From: **9**
 Clock To: **4**
 1st Value:
 2nd Value:
 Value Percent:
 Continuous Index: **F02**
 Within 8" of Joint: **YES**
 Remarks:

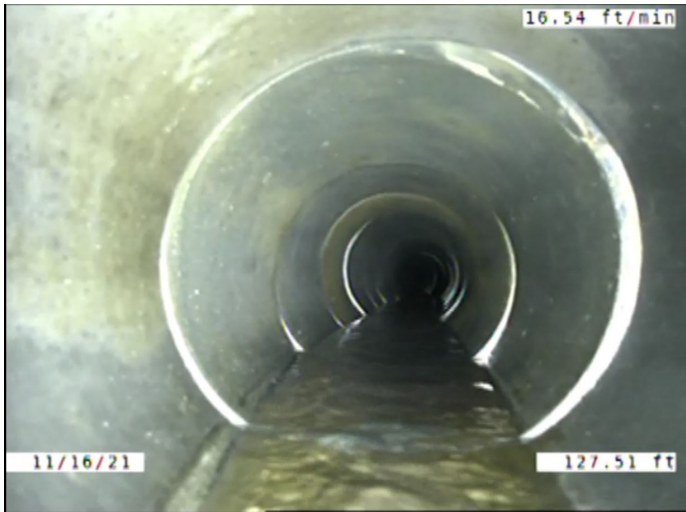
Code: **FM**
Description: **Fracture Multiple**

Distance (ft): **127.5**
Structural Grade: **4**
O&M Grade: **0**
Clock Start/From: **12**
Clock To: **2**
1st Value:
2nd Value:
Value Percent:
Continuous Index:
Within 8" of Joint: **YES**
Remarks:

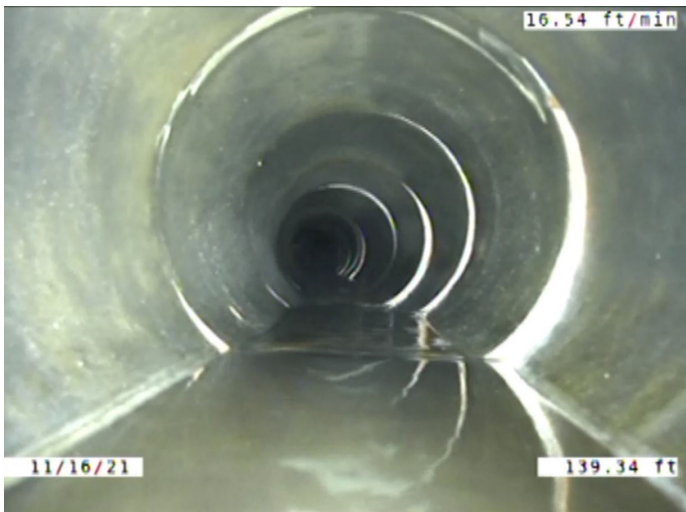
Code: **FM**
Description: **Fracture Multiple**

Distance (ft): **139.3**
Structural Grade: **4**
O&M Grade: **0**
Clock Start/From: **10**
Clock To: **2**
1st Value:
2nd Value:
Value Percent:
Continuous Index:
Within 8" of Joint: **YES**
Remarks:

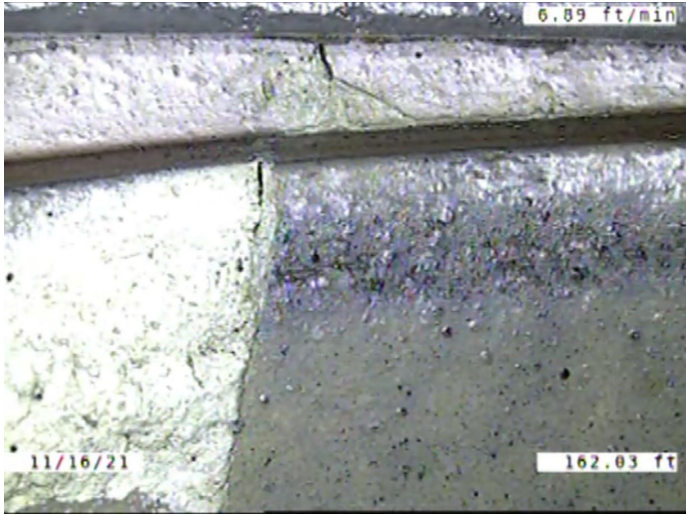
Code: **CM**
 Description: **Crack Multiple**

Distance (ft): **162.0**
 Structural Grade: **3**
 O&M Grade: **0**
 Clock Start/From: **9**
 Clock To: **10**
 1st Value:
 2nd Value:
 Value Percent:
 Continuous Index:
 Within 8" of Joint: **YES**
 Remarks:

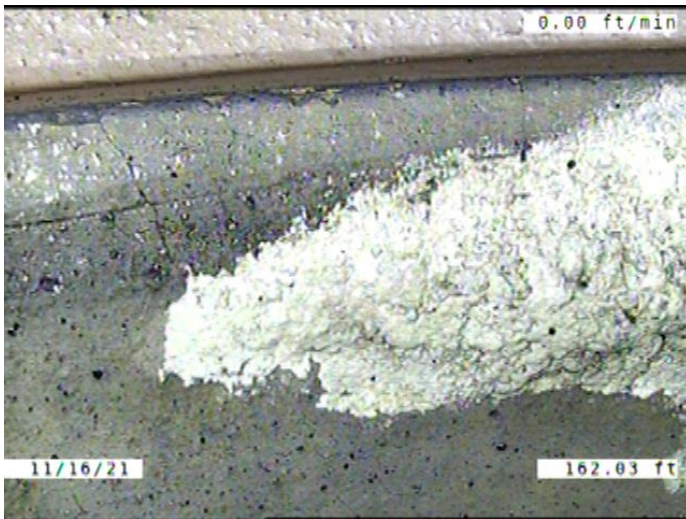
Code: **DAE**
 Description: **Deposits Attached Encrustation**

Distance (ft): **162.0**
 Structural Grade: **0**
 O&M Grade: **2**
 Clock Start/From: **9**
 Clock To: **11**
 1st Value:
 2nd Value:
 Value Percent: **5.000**
 Continuous Index:
 Within 8" of Joint: **YES**
 Remarks:

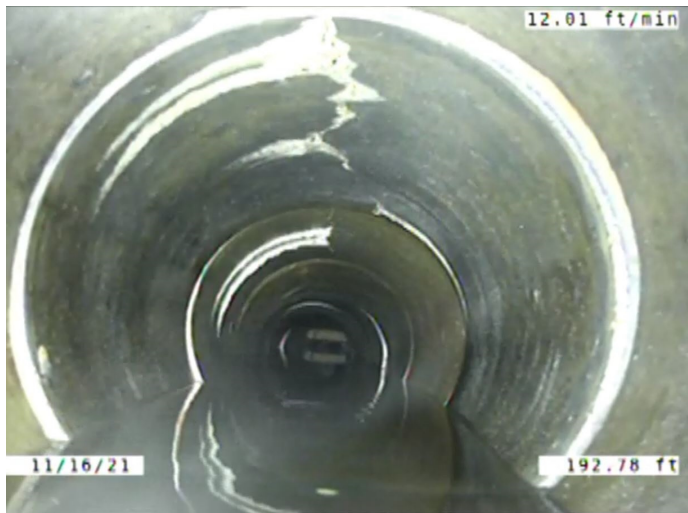
Code: **FM**
 Description: **Fracture Multiple**

Distance (ft): **192.8**
 Structural Grade: **4**
 O&M Grade: **0**
 Clock Start/From: **11**
 Clock To: **1**
 1st Value:
 2nd Value:
 Value Percent:
 Continuous Index: **S06**
 Within 8" of Joint: **YES**
 Remarks:

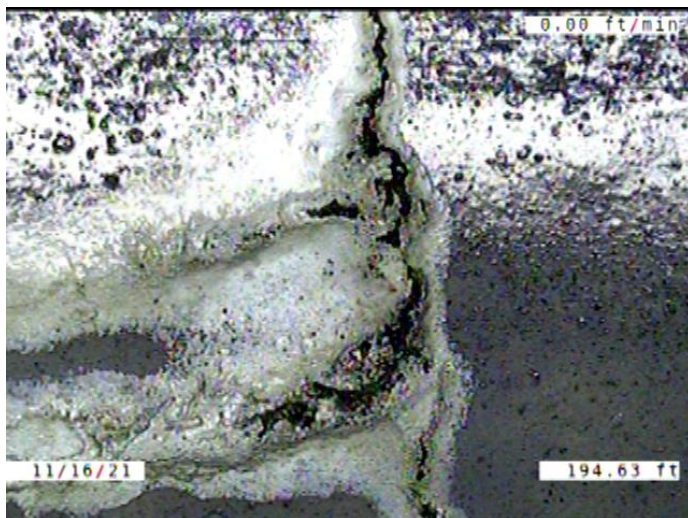
Code: **DAE**
 Description: **Deposits Attached Encrustation**

Distance (ft): **194.6**
 Structural Grade: **0**
 O&M Grade: **2**
 Clock Start/From: **9**
 Clock To: **3**
 1st Value:
 2nd Value:
 Value Percent: **5.000**
 Continuous Index: **S04**
 Within 8" of Joint: **YES**
 Remarks:

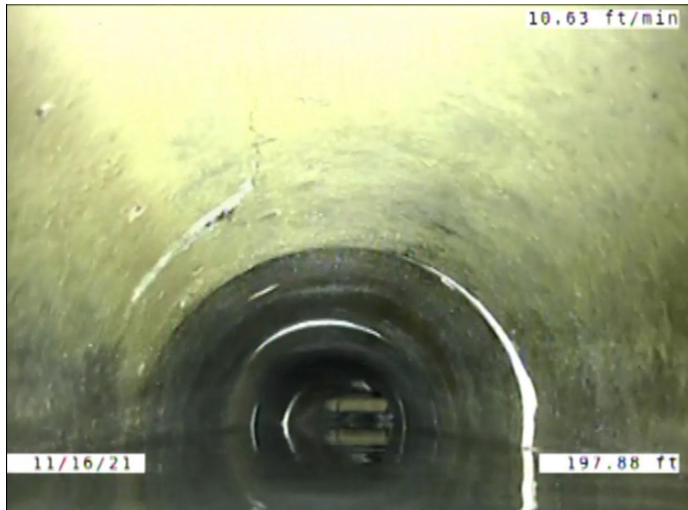
Code: **FM**
Description: **Fracture Multiple**

Distance (ft): **197.9**
Structural Grade: **4**
O&M Grade: **0**
Clock Start/From: **11**
Clock To: **1**
1st Value:
2nd Value:
Value Percent:
Continuous Index: **F06**
Within 8" of Joint: **YES**
Remarks:

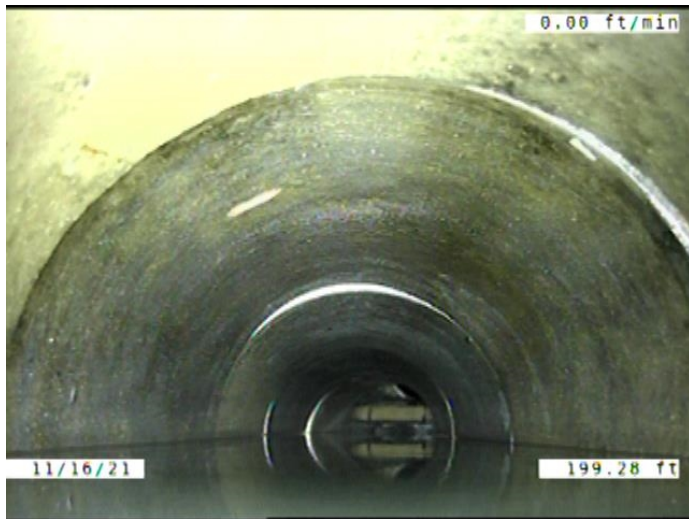
Code: **DAE**
 Description: **Deposits Attached Encrustation**

Distance (ft): **199.3**
 Structural Grade: **0**
 O&M Grade: **2**
 Clock Start/From: **9**
 Clock To: **3**
 1st Value:
 2nd Value:
 Value Percent: **5.000**
 Continuous Index: **F04**
 Within 8" of Joint: **YES**
 Remarks:

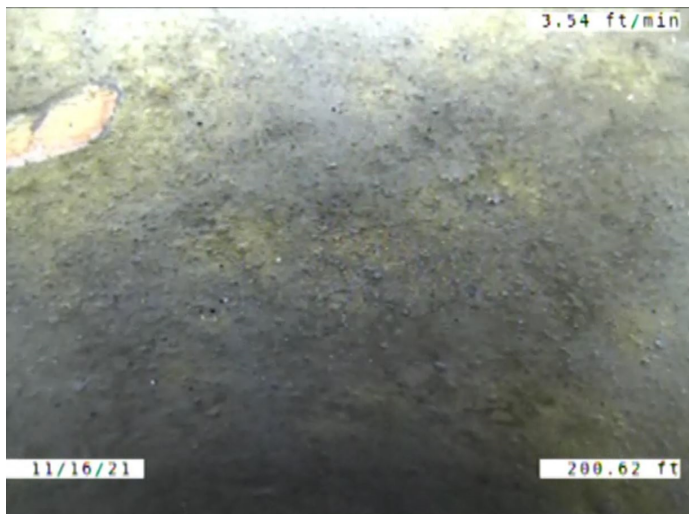
Code: **SSS**
 Description: **Surface Damage Surface Spalling**

Distance (ft): **200.6**
 Structural Grade: **2**
 O&M Grade: **0**
 Clock Start/From: **11**
 Clock To:
 1st Value:
 2nd Value:
 Value Percent:
 Continuous Index:
 Within 8" of Joint: **NO**
 Remarks:

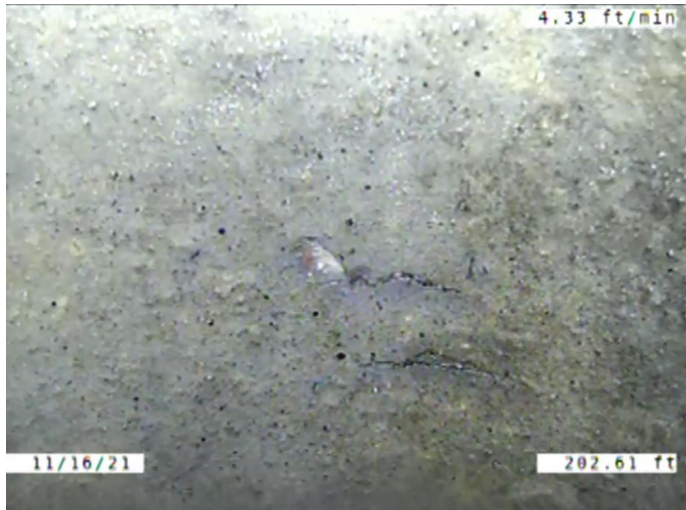
Code: **CM**
 Description: **Crack Multiple**

Distance (ft): **202.6**
 Structural Grade: **3**
 O&M Grade: **0**
 Clock Start/From: **12**
 Clock To: **1**
 1st Value:
 2nd Value:
 Value Percent:
 Continuous Index:
 Within 8" of Joint: **NO**
 Remarks:

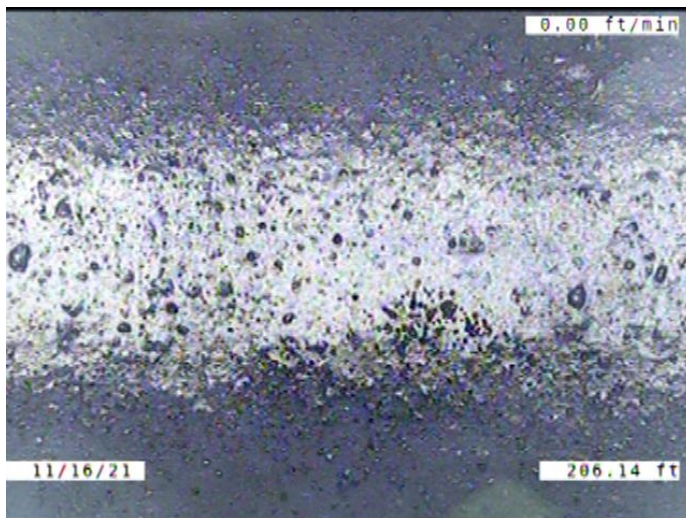
Code: **MCU**
 Description: **Miscellaneous Camera Underwater**

Distance (ft): **206.1**
 Structural Grade: **0**
 O&M Grade: **4**
 Clock Start/From:
 Clock To:
 1st Value:
 2nd Value:
 Value Percent:
 Continuous Index:
 Within 8" of Joint: **NO**
 Remarks: **Out at 207.5**

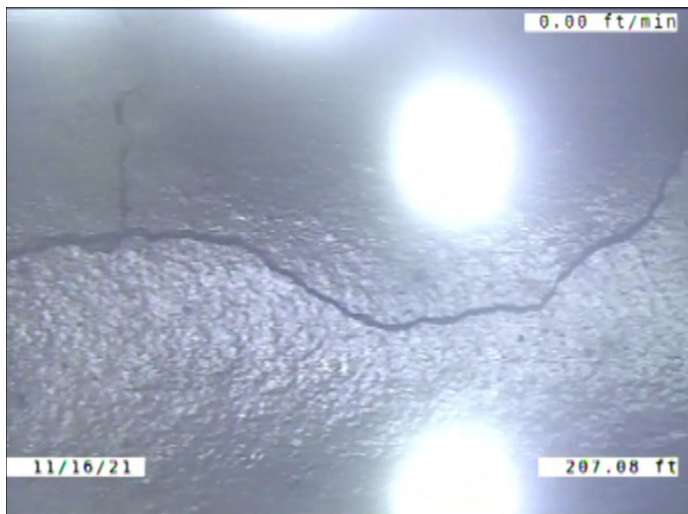
Code: **FM**
 Description: **Fracture Multiple**

Distance (ft): **207.1**
 Structural Grade: **4**
 O&M Grade: **0**
 Clock Start/From: **10**
 Clock To: **2**
 1st Value:
 2nd Value:
 Value Percent:
 Continuous Index:
 Within 8" of Joint: **YES**
 Remarks: **Visible through water**

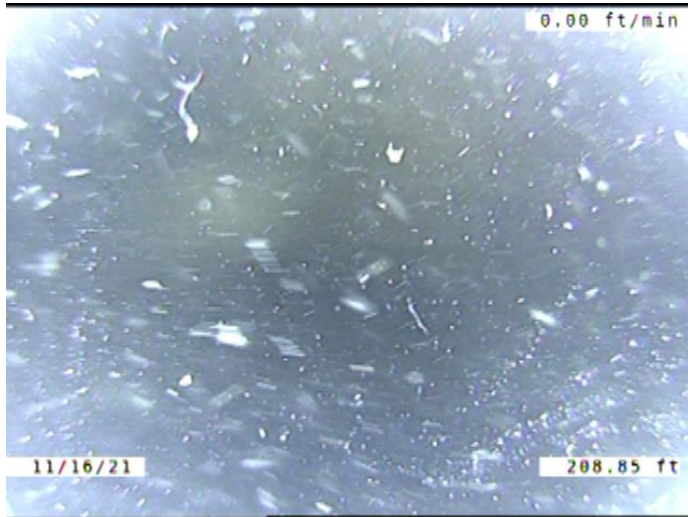
Code: **MGO**
 Description: **Miscellaneous General Observation**

Distance (ft): **208.9**
 Structural Grade: **0**
 O&M Grade: **0**
 Clock Start/From:
 Clock To:
 1st Value:
 2nd Value:
 Value Percent:
 Continuous Index:
 Within 8" of Joint: **NO**
 Remarks: **CAMERA UNDER WATER. OPENED THE MANHOLE COVER AND VERIFIE**
