Profile/Photo Observation Report

Date:	04/26/2018	Weather:		Coding:	PACP 6.0
Pipe Length (ft):		Owner:	City of Hobart	Pre Clean:	No Pre-Cleaning
P.O.#:	105	Surveyor:	M. Pielacha	PSR:	P-605-030-009
Customer:	City of Hobart	Clean Date:		Shape:	C

Street:	Connecticut Street	Flow Control:	Not Controlled
City:	Hobart, IN	Year Renewed:	
Location:	Light Highway	Tape/Media #:	DEP 105
Purpose:	Routine Assessment	Dia/Height:	18"
Use:	Sanitary	Material:	VCP
Drain Area:		Lining:	
Category:	NA		
Comment:	YES501824 Submittal 2		
Location Details:		Direction of Survey:	Downstream
US MH:	M-605-030	DS MH:	M-605-009
		Total Length Surveyed (ft):	60.2

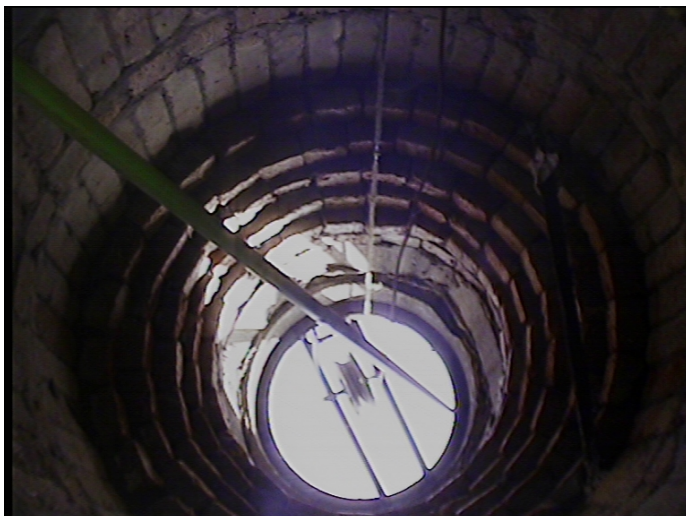
Code: **AMH**
 Description: **Manhole**

Distance (ft): **.0**
 Structural Grade: **0**
 O&M Grade: **0**
 Clock Start/From:
 Clock To:
 1st Value:
 2nd Value:
 Value Percent:
 Continuous Index:
 Within 8" of Joint: **NO**
 Remarks: **M-605-030**

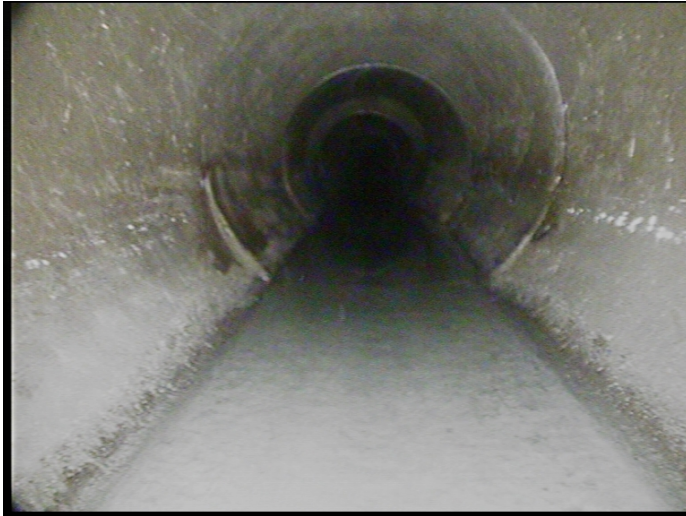
Code: **MWL**
Description: **Water Level**

Distance (ft): **.0**
Structural Grade: **0**
O&M Grade: **0**
Clock Start/From:
Clock To:
1st Value:
2nd Value:
Value Percent: **5.000**
Continuous Index:
Within 8" of Joint: **NO**
Remarks:

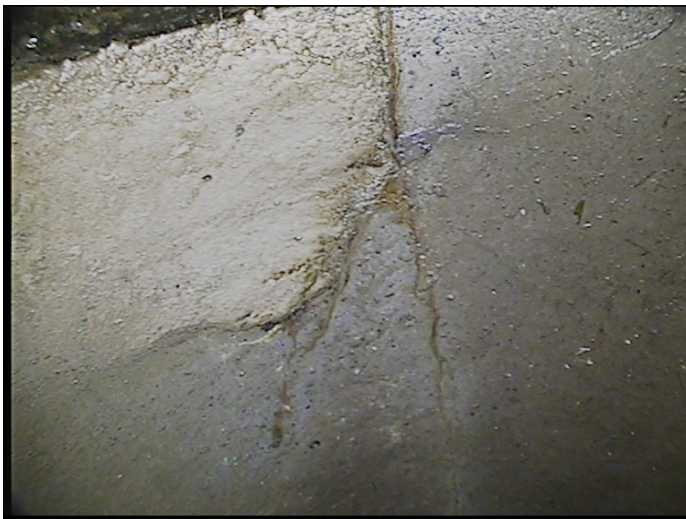
Code: **CL**
Description: **Crack Longitudinal**

Distance (ft): **6.7**
Structural Grade: **2**
O&M Grade: **0**
Clock Start/From: **10**
Clock To:
1st Value:
2nd Value:
Value Percent:
Continuous Index: **S01**
Within 8" of Joint: **YES**
Remarks:

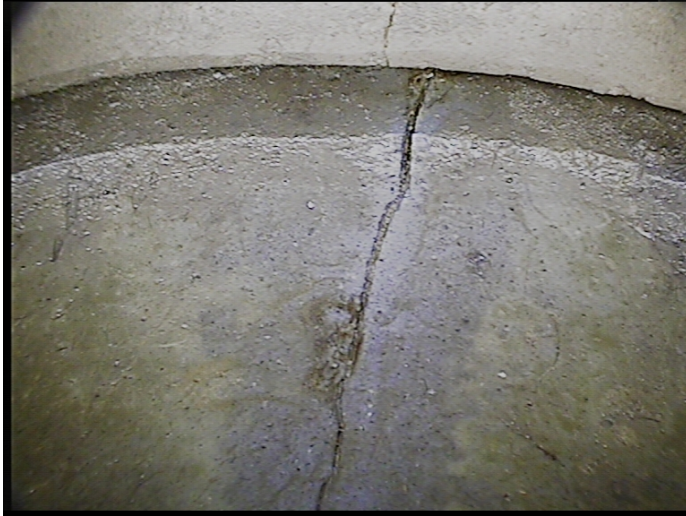
Code:	FL
Description:	Fracture Longitudinal
Distance (ft):	12.6
Structural Grade:	3
O&M Grade:	0
Clock Start/From:	12
Clock To:	
1st Value:	
2nd Value:	
Value Percent:	
Continuous Index:	
Within 8" of Joint:	YES
Remarks:

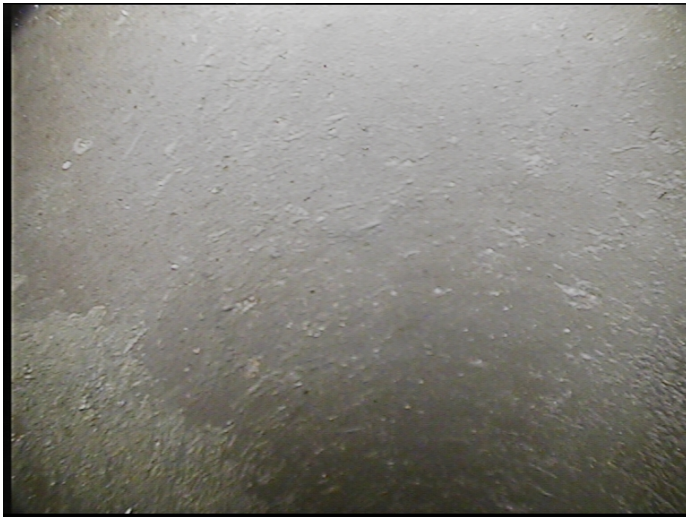
Code:	CL
Description:	Crack Longitudinal
Distance (ft):	18.8
Structural Grade:	2
O&M Grade:	0
Clock Start/From:	10
Clock To:	
1st Value:	
2nd Value:	
Value Percent:	
Continuous Index:	F01
Within 8" of Joint:	NO
Remarks:

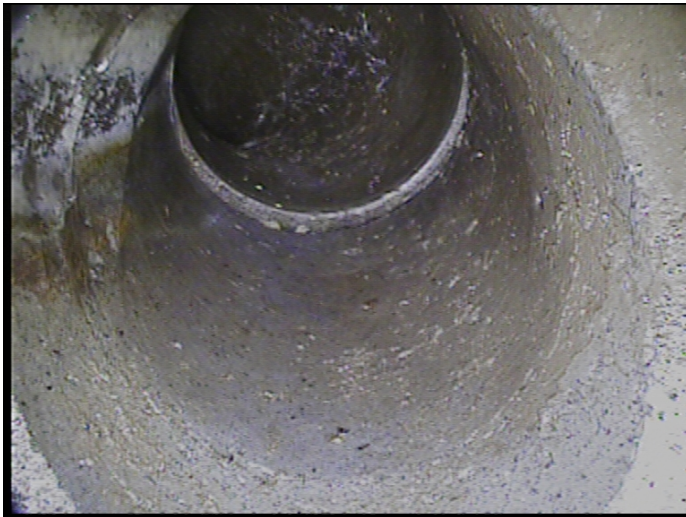
Code: **TF**
Description: **Tap Factory**

Distance (ft): **23.4**
Structural Grade: **0**
O&M Grade: **0**
Clock Start/From: **9**
Clock To:
1st Value: **4.000**
2nd Value:
Value Percent:
Continuous Index:
Within 8" of Joint: **NO**
Remarks:

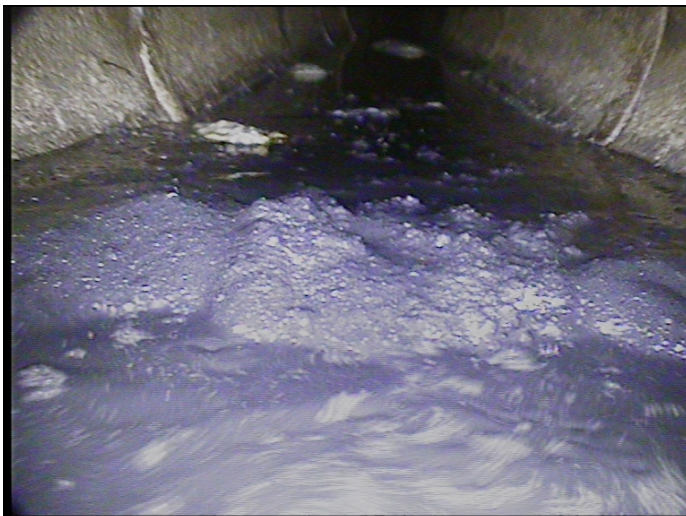
Code: **DSF**
Description: **Deposits Settled Fine**

Distance (ft): **38.3**
Structural Grade: **0**
O&M Grade: **3**
Clock Start/From: **5**
Clock To: **7**
1st Value:
2nd Value:
Value Percent: **15.000**
Continuous Index: **S02**
Within 8" of Joint: **YES**
Remarks:

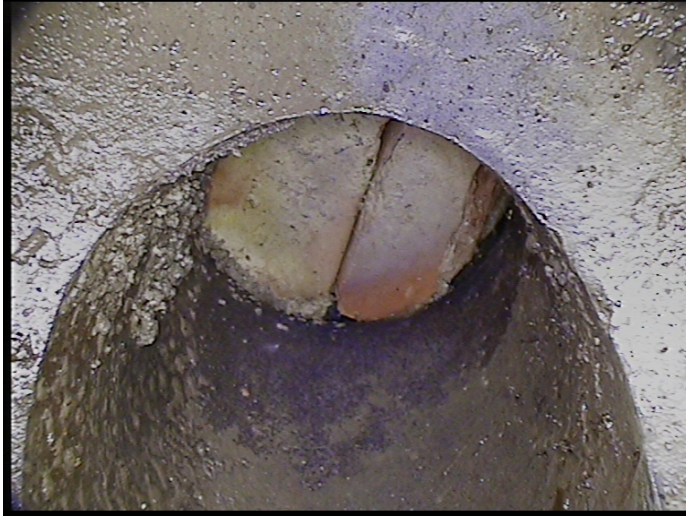
Code: **TFC**
Description: **Tap Factory Capped**

Distance (ft): **45.8**
Structural Grade: **0**
O&M Grade: **0**
Clock Start/From: **10**
Clock To:
1st Value: **4.000**
2nd Value:
Value Percent:
Continuous Index:
Within 8" of Joint: **NO**
Remarks:

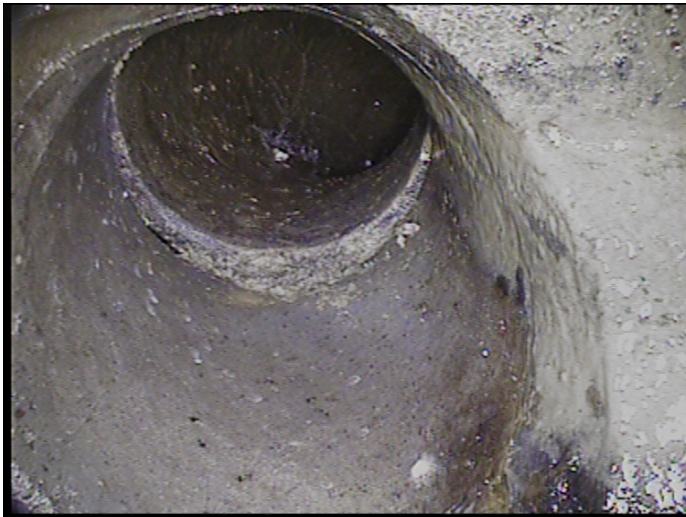
Code: **TF**
Description: **Tap Factory**

Distance (ft): **48.4**
Structural Grade: **0**
O&M Grade: **0**
Clock Start/From: **2**
Clock To:
1st Value: **4.000**
2nd Value:
Value Percent:
Continuous Index:
Within 8" of Joint: **NO**
Remarks:

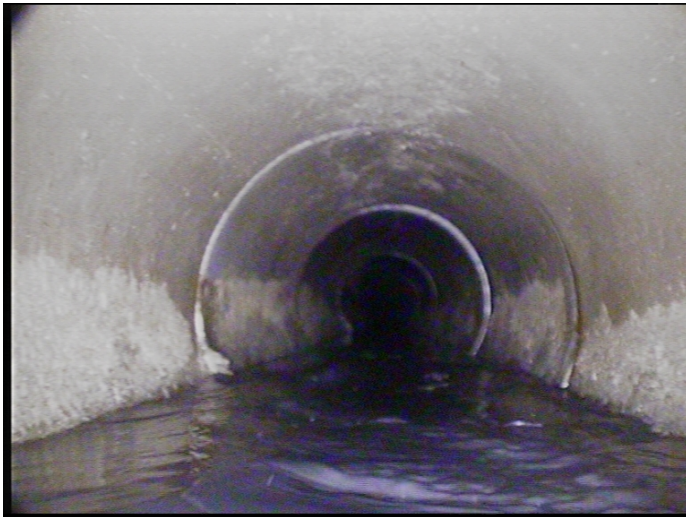
Code: **DSF**
Description: **Deposits Settled Fine**

Distance (ft): **60.2**
Structural Grade: **0**
O&M Grade: **3**
Clock Start/From: **5**
Clock To: **7**
1st Value:
2nd Value:
Value Percent: **15.000**
Continuous Index: **F02**
Within 8" of Joint: **NO**
Remarks:

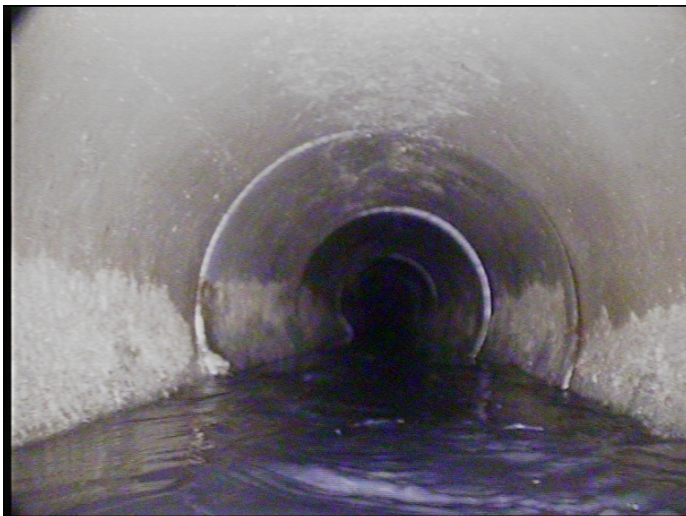
Code: **MSA**
Description: **Abandoned Survey**

Distance (ft): **60.2**
Structural Grade: **0**
O&M Grade: **0**
Clock Start/From:
Clock To:
1st Value:
2nd Value:
Value Percent:
Continuous Index:
Within 8" of Joint: **NO**
Remarks: **sediment**
