## Profile/Photo Observation Report

Date:	<b>04/29/2018</b>	Weather:		Coding:	<b>PACP 6.0</b>
Pipe Length (ft):		Owner:	<b>City of Hobart</b>	Pre Clean:	<b>No Pre-Cleaning</b>
P.O.#:	<b>137</b>	Surveyor:	<b>M. Pielacha</b>	PSR:	<b>P-605-030-009</b>
Customer:	<b>City of Hobart</b>	Clean Date:		Shape:	<b>C</b>

Street:	<b>West 3rd. Street</b>	Flow Control:	<b>Not Controlled</b>
City:	<b>Hobart, IN</b>	Year Renewed:	
Location:	<b>Light Highway</b>	Tape/Media #:	<b>DEP 137</b>
Purpose:	<b>Routine Assessment</b>	Dia/Height:	<b>18"</b>
Use:	<b>Sanitary</b>	Material:	<b>VCP</b>
Drain Area:		Lining:	
Category:	<b>NA</b>		
Comment:	<b>5-21-2018</b>		
Location Details:		Direction of Survey:	<b>Upstream</b>
US MH:	<b>M-605-009</b>	DS MH:	<b>M-605-030</b>
		Total Length Surveyed (ft):	<b>160.9</b>

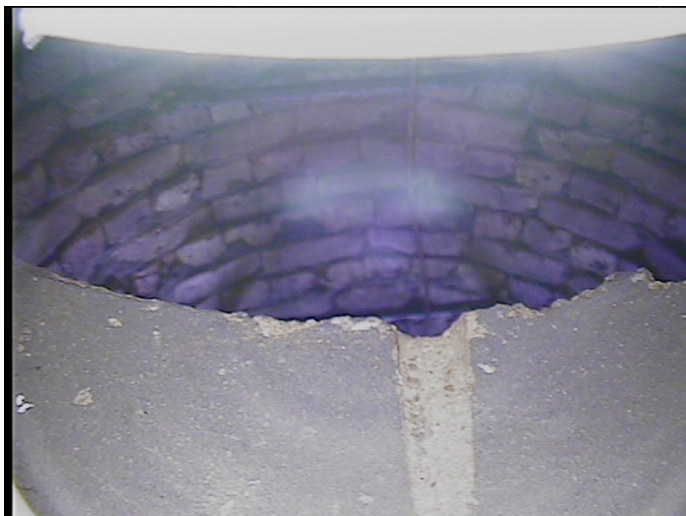
Code: **AMH**  
 Description: **Manhole**

Distance (ft): **.0**  
 Structural Grade: **0**  
 O&M Grade: **0**  
 Clock Start/From:  
 Clock To:  
 1st Value:  
 2nd Value:  
 Value Percent:  
 Continuous Index:  
 Within 8" of Joint: **NO**  
 Remarks: **M-605-009**

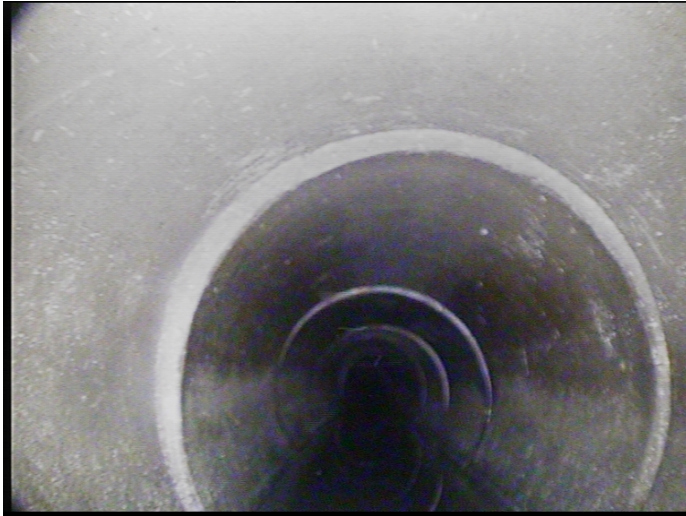
Code:	<b>MWL</b>
Description:	<b>Water Level</b>
Distance (ft):	<b>.0</b>
Structural Grade:	<b>0</b>
O&M Grade:	<b>0</b>
Clock Start/From:	
Clock To:	
1st Value:	
2nd Value:	
Value Percent:	<b>10.000</b>
Continuous Index:	
Within 8" of Joint:	<b>NO</b>
Remarks:

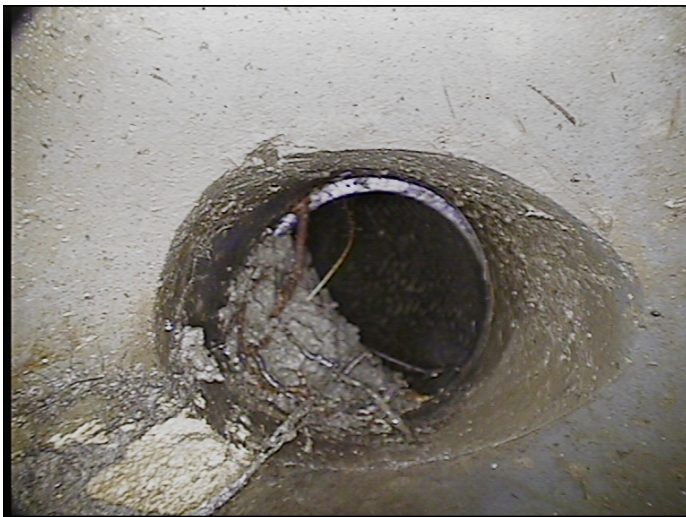
Code:	<b>TF</b>
Description:	<b>Tap Factory</b>
Distance (ft):	<b>101.4</b>
Structural Grade:	<b>0</b>
O&M Grade:	<b>0</b>
Clock Start/From:	<b>10</b>
Clock To:	
1st Value:	<b>4.000</b>
2nd Value:	
Value Percent:	
Continuous Index:	
Within 8" of Joint:	<b>NO</b>
Remarks:

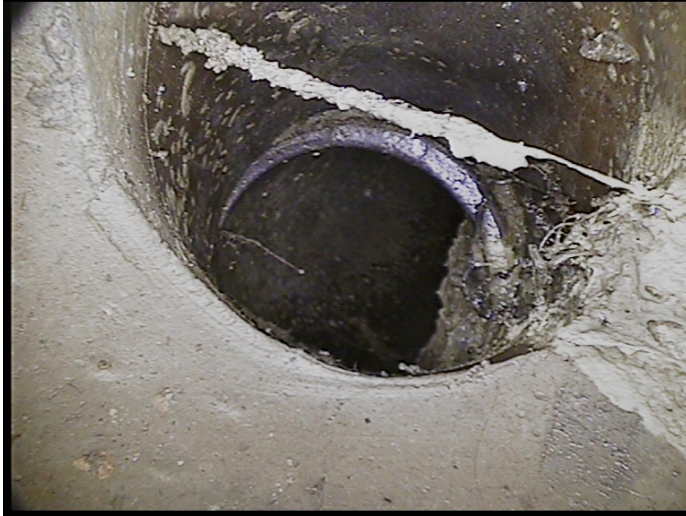
Code: **TF**  
Description: **Tap Factory**

Distance (ft): **104.7**  
Structural Grade: **0**  
O&M Grade: **0**  
Clock Start/From: **2**  
Clock To:  
1st Value: **4.000**  
2nd Value:  
Value Percent:  
Continuous Index:  
Within 8" of Joint: **NO**  
Remarks:

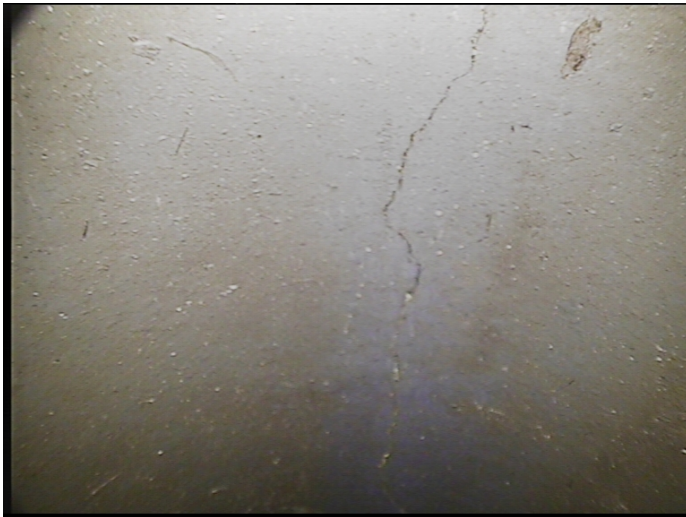
Code: **FL**  
Description: **Fracture Longitudinal**

Distance (ft): **105.7**  
Structural Grade: **3**  
O&M Grade: **0**  
Clock Start/From: **12**  
Clock To:  
1st Value:  
2nd Value:  
Value Percent:  
Continuous Index: **S01**  
Within 8" of Joint: **YES**  
Remarks:

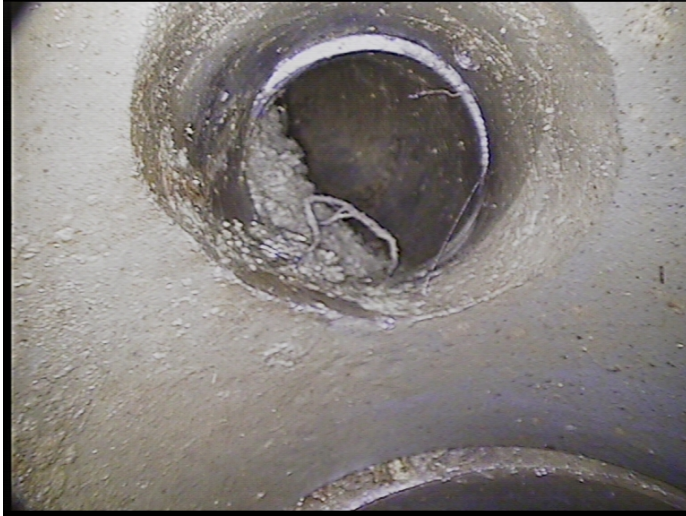
Code: **TF**  
Description: **Tap Factory**

Distance (ft): **145.6**  
Structural Grade: **0**  
O&M Grade: **0**  
Clock Start/From: **10**  
Clock To:  
1st Value: **4.000**  
2nd Value:  
Value Percent:  
Continuous Index:  
Within 8" of Joint: **NO**  
Remarks:

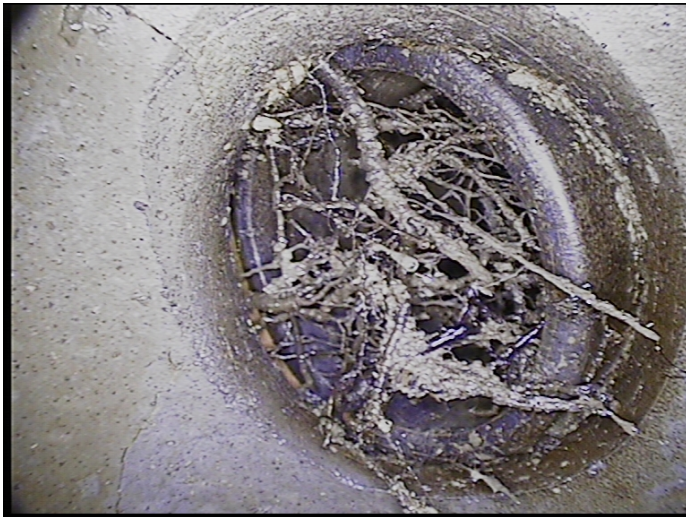
Code: **TBD**  
Description: **Tap Break-in Defective**

Distance (ft): **148.3**  
Structural Grade: **0**  
O&M Grade: **3**  
Clock Start/From: **2**  
Clock To:  
1st Value: **4.000**  
2nd Value:  
Value Percent:  
Continuous Index:  
Within 8" of Joint: **NO**  
Remarks: **Defective**

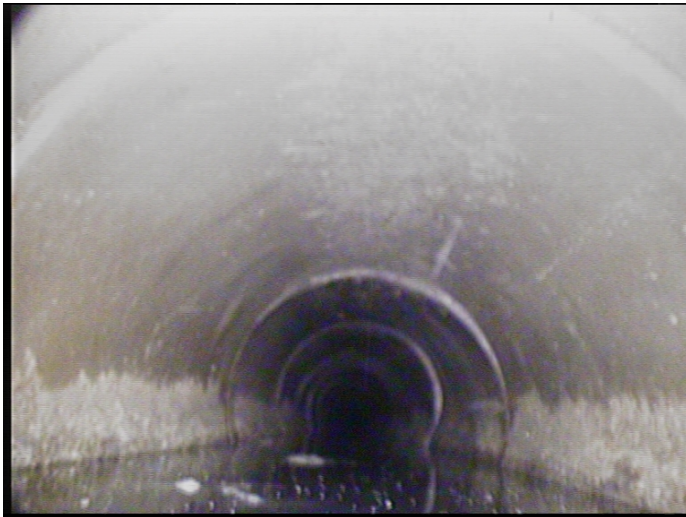
Code: **FL**  
Description: **Fracture Longitudinal**

Distance (ft): **158.8**  
Structural Grade: **3**  
O&M Grade: **0**  
Clock Start/From: **12**  
Clock To:  
1st Value:  
2nd Value:  
Value Percent:  
Continuous Index: **F01**  
Within 8" of Joint: **NO**  
Remarks:

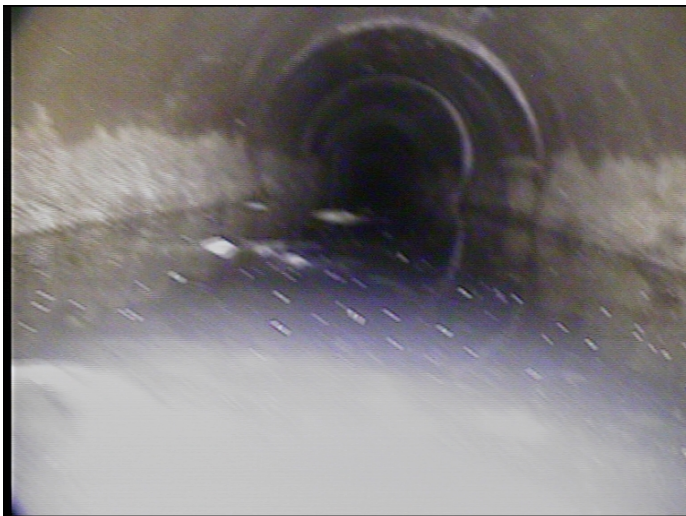
Code: **DSF**  
Description: **Deposits Settled Fine**

Distance (ft): **158.9**  
Structural Grade: **0**  
O&M Grade: **3**  
Clock Start/From: **4**  
Clock To: **8**  
1st Value:  
2nd Value:  
Value Percent: **15.000**  
Continuous Index:  
Within 8" of Joint: **YES**  
Remarks:

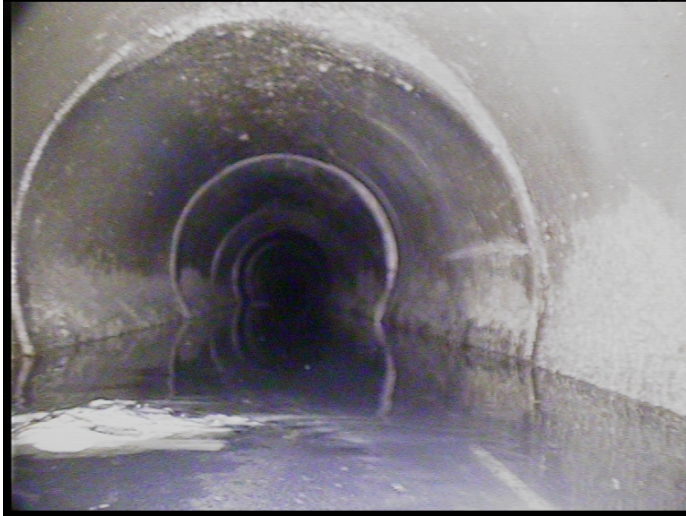
Code:	<b>MSA</b>
Description:	<b>Abandoned Survey</b>
Distance (ft):	<b>160.9</b>
Structural Grade:	<b>0</b>
O&M Grade:	<b>0</b>
Clock Start/From:	
Clock To:	
1st Value:	
2nd Value:	
Value Percent:	
Continuous Index:	
Within 8" of Joint:	<b>NO</b>
Remarks:	<b>sediment</b>
