Profile/Photo Observation Report

Date:	08/09/2022	Weather:		Coding:	PACP 7.0
Pipe Length (ft):	227.0	Owner:	City of Hobart	Pre Clean:	Heavy Cleaning
P.O.#:	YES502259	Surveyor:	S. Bucklin	PSR:	P-605-030-009
Customer:	City of Hobart	Clean Date:	07/29/2022	Shape:	C

Street:	South Connection Street	Flow Control:	Not Controlled
City:	Hobart, IN	Year Renewed:	
Location:	Local rural streets with light traffic, t	Tape/Media #:	
Purpose:	Routine Assessment	Dia/Height:	18"
Use:	Sanitary Sewage Pipe	Material:	VCP
Drain Area:		Lining:	None
Category:	NA		
Comment:			
Location Details:		Direction of Survey:	Downstream
US MH:	M-605-009	DS MH:	M-605-030
		Total Length Surveyed (ft):	225.5

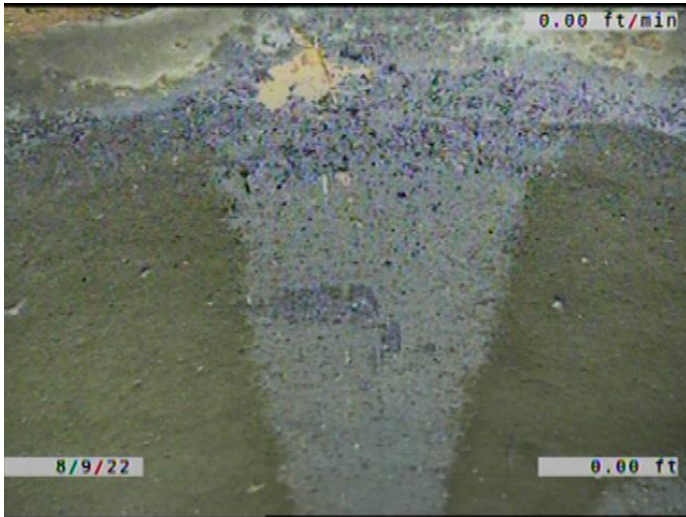
Code: **B**
 Description: **Broken**

Distance (ft): **.0**
 Structural Grade: **4**
 O&M Grade: **0**
 Clock Start/From: **12**
 Clock To:
 1st Value:
 2nd Value:
 Value Percent:
 Continuous Index:
 Within 8" of Joint: **YES**
 Remarks:

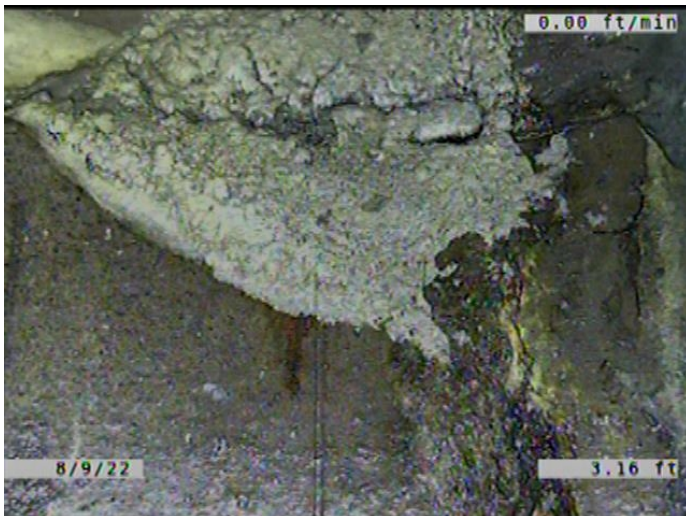
Code: **DAE**
 Description: **Deposits Attached Encrustation**

Distance (ft): **3.2**
 Structural Grade: **0**
 O&M Grade: **2**
 Clock Start/From: **7**
 Clock To: **5**
 1st Value:
 2nd Value:
 Value Percent: **5.000**
 Continuous Index: **S02**
 Within 8" of Joint: **YES**
 Remarks:

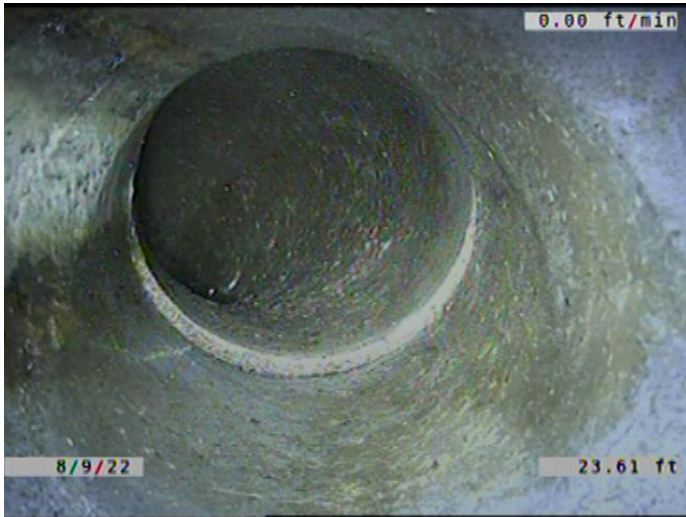
Code: **TFD**
 Description: **Tap Factory Defective**

Distance (ft): **23.6**
 Structural Grade: **0**
 O&M Grade: **3**
 Clock Start/From: **10**
 Clock To:
 1st Value: **6.000**
 2nd Value:
 Value Percent:
 Continuous Index:
 Within 8" of Joint: **YES**
 Remarks: **TAP CRACKED.**

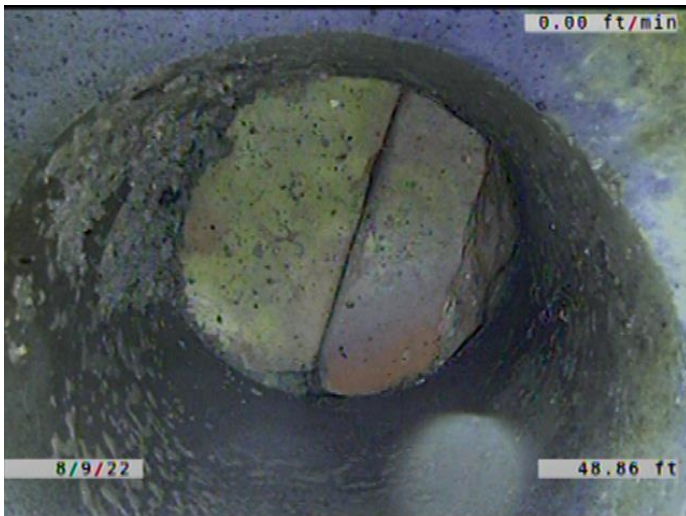
Code: **TFD**
 Description: **Tap Factory Defective**

Distance (ft): **48.9**
 Structural Grade: **0**
 O&M Grade: **3**
 Clock Start/From: **10**
 Clock To:
 1st Value: **6.000**
 2nd Value:
 Value Percent:
 Continuous Index:
 Within 8" of Joint: **YES**
 Remarks: **BRICKED OFF. BRICKS BREAKING DOWN. SOIL VISIBLE.**

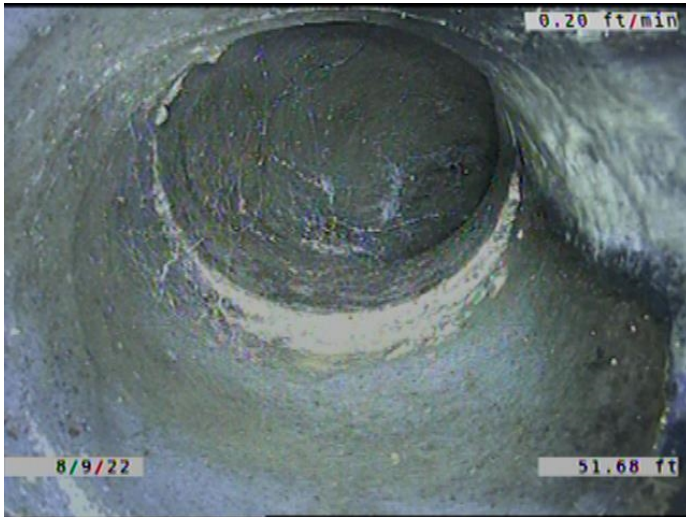
Code: **TF**
Description: **Tap Factory**

Distance (ft): **51.7**
Structural Grade: **0**
O&M Grade: **0**
Clock Start/From: **2**
Clock To:
1st Value: **6.000**
2nd Value:
Value Percent:
Continuous Index:
Within 8" of Joint: **YES**
Remarks: **CONSTANTLY RUNNING WATER.**

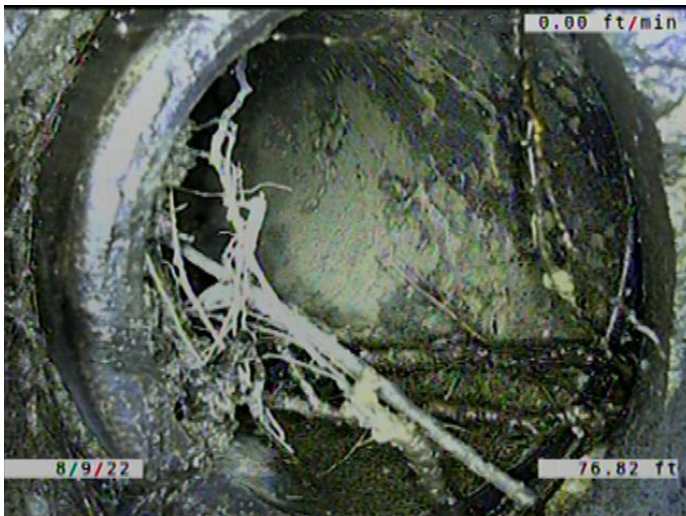
Code: **TFI**
Description: **Tap Factory Intruding**

Distance (ft): **76.8**
Structural Grade: **0**
O&M Grade: **2**
Clock Start/From: **10**
Clock To:
1st Value: **6.000**
2nd Value: **1.000**
Value Percent:
Continuous Index:
Within 8" of Joint: **YES**
Remarks: **TAP BROKEN. SERVICE PUSHED INTO THE MAIN. ROOTS GROWING IN AN**

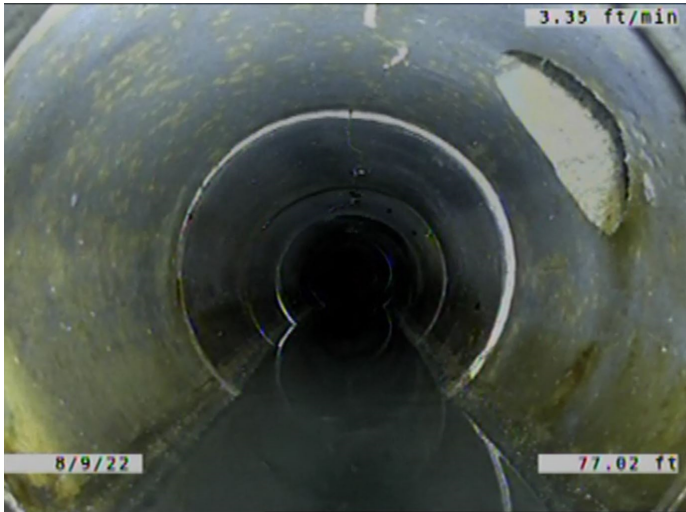
Code: **FM**
Description: **Fracture Multiple**

Distance (ft): **77.0**
Structural Grade: **4**
O&M Grade: **0**
Clock Start/From: **8**
Clock To: **4**
1st Value:
2nd Value:
Value Percent:
Continuous Index: **S01**
Within 8" of Joint: **YES**
Remarks:

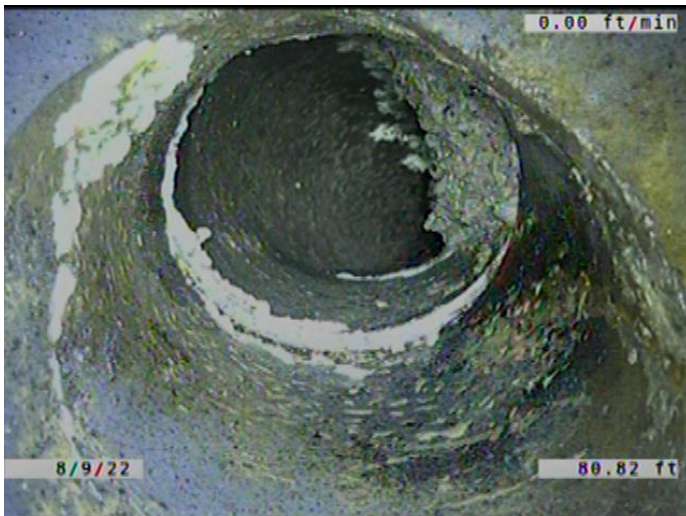
Code: **TFD**
Description: **Tap Factory Defective**

Distance (ft): **80.8**
Structural Grade: **0**
O&M Grade: **3**
Clock Start/From: **2**
Clock To:
1st Value: **6.000**
2nd Value:
Value Percent:
Continuous Index:
Within 8" of Joint: **YES**
Remarks: **TAP BROKEN.**

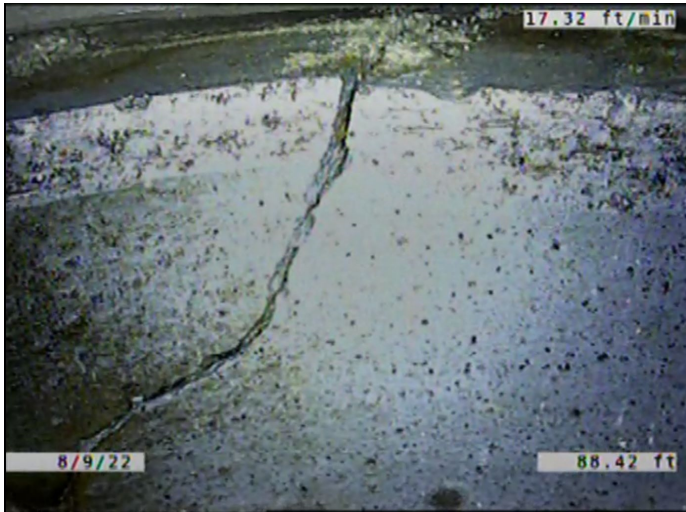
Code: **B**
Description: **Broken**

Distance (ft): **88.4**
Structural Grade: **4**
O&M Grade: **0**
Clock Start/From: **8**
Clock To: **4**
1st Value:
2nd Value:
Value Percent:
Continuous Index:
Within 8" of Joint: **YES**
Remarks:

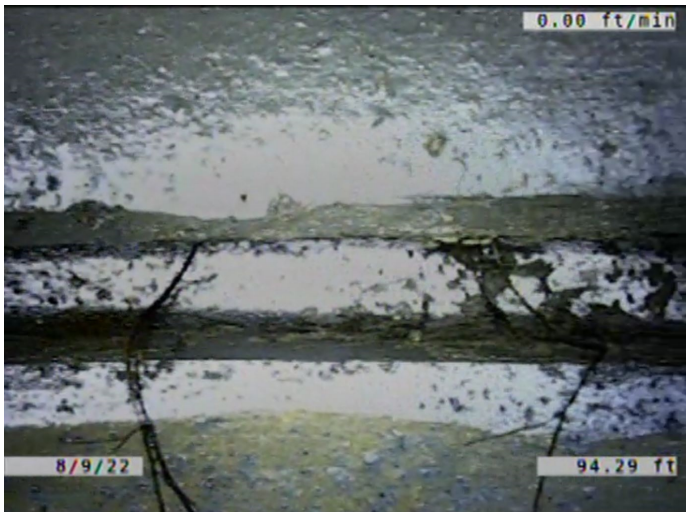
Code: **B**
Description: **Broken**

Distance (ft): **94.3**
Structural Grade: **4**
O&M Grade: **0**
Clock Start/From: **10**
Clock To: **11**
1st Value:
2nd Value:
Value Percent:
Continuous Index:
Within 8" of Joint: **YES**
Remarks:

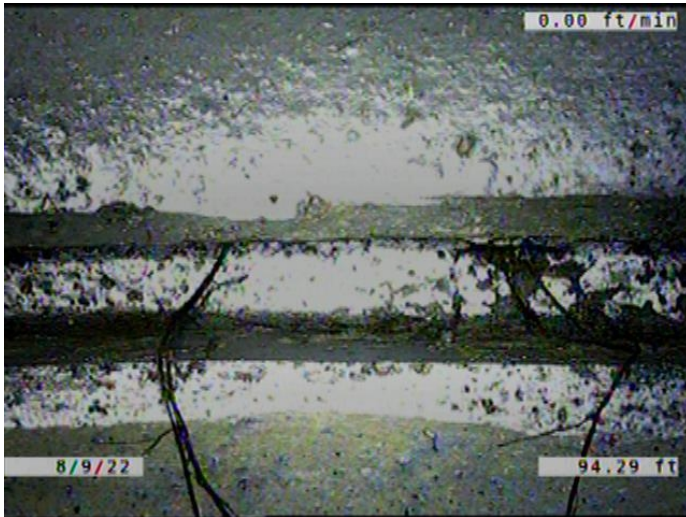
Code: **RFJ**
 Description: **Roots Fine Joint**

Distance (ft): **94.3**
 Structural Grade: **0**
 O&M Grade: **1**
 Clock Start/From: **10**
 Clock To: **11**
 1st Value:
 2nd Value:
 Value Percent:
 Continuous Index:
 Within 8" of Joint: **YES**
 Remarks:

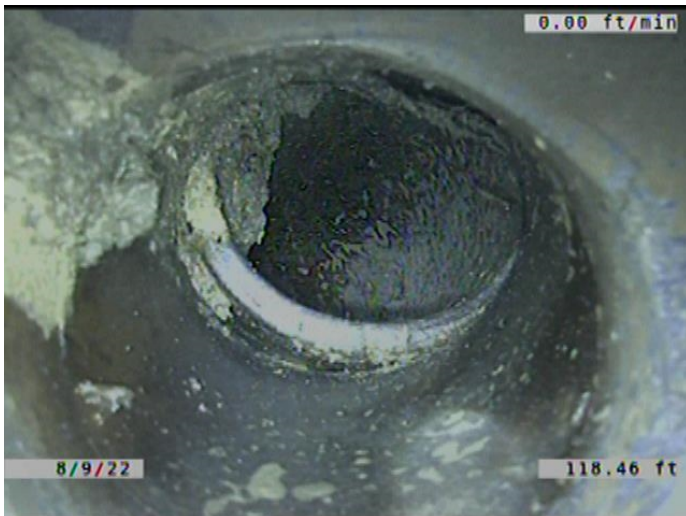
Code: **TFD**
 Description: **Tap Factory Defective**

Distance (ft): **118.5**
 Structural Grade: **0**
 O&M Grade: **3**
 Clock Start/From: **10**
 Clock To:
 1st Value: **6.000**
 2nd Value:
 Value Percent:
 Continuous Index:
 Within 8" of Joint: **YES**
 Remarks: **SERVICE OFFSET. TAP BROKEN.**

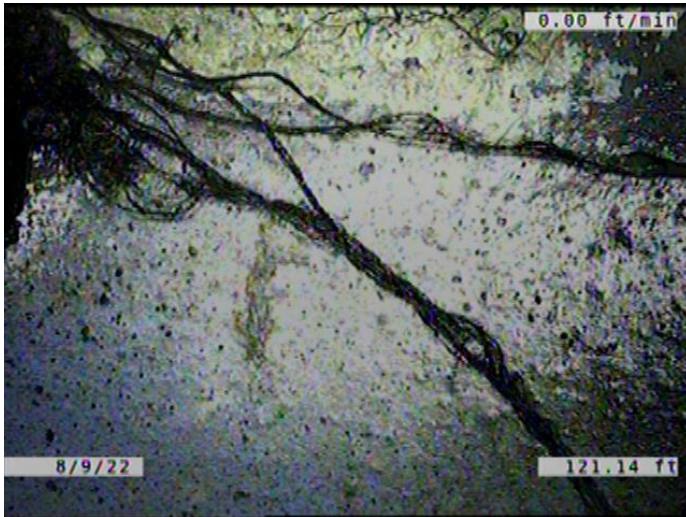
Code: **RFL**
 Description: **Roots Fine Lateral**

Distance (ft): **121.1**
 Structural Grade: **0**
 O&M Grade: **1**
 Clock Start/From: **2**
 Clock To: **3**
 1st Value:
 2nd Value:
 Value Percent:
 Continuous Index:
 Within 8" of Joint: **NO**
 Remarks:

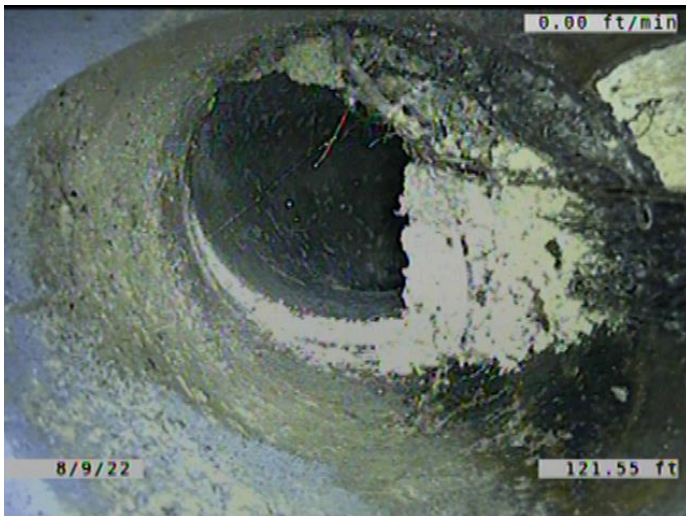
Code: **TFD**
 Description: **Tap Factory Defective**

Distance (ft): **121.5**
 Structural Grade: **0**
 O&M Grade: **3**
 Clock Start/From: **2**
 Clock To:
 1st Value: **6.000**
 2nd Value:
 Value Percent:
 Continuous Index:
 Within 8" of Joint: **YES**
 Remarks: **TAP BROKEN. ROOTS GROWING FROM THE JOINT INTO THE MAIN.**

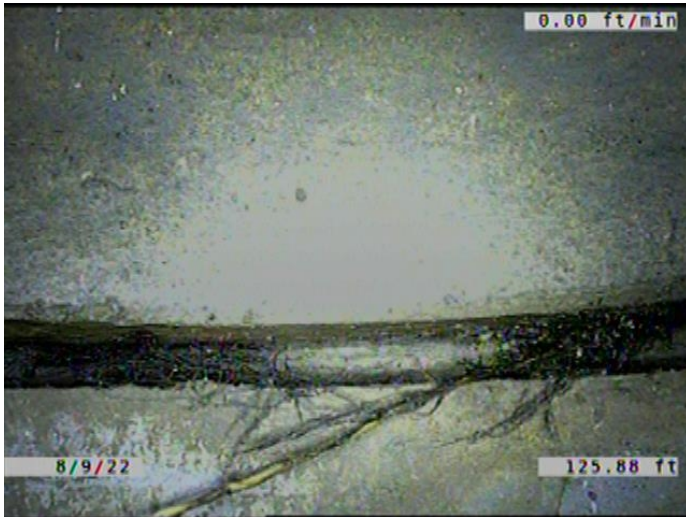
Code: **RFJ**
Description: **Roots Fine Joint**

Distance (ft): **125.9**
Structural Grade: **0**
O&M Grade: **1**
Clock Start/From: **9**
Clock To: **11**
1st Value:
2nd Value:
Value Percent:
Continuous Index:
Within 8" of Joint: **YES**
Remarks:

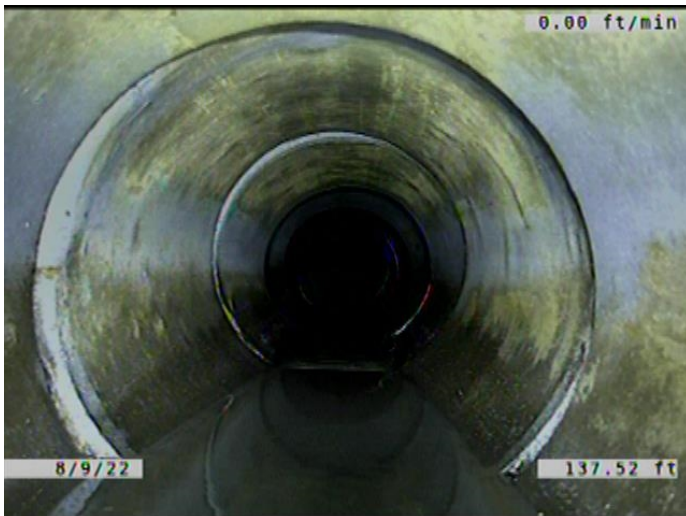
Code: **MWLS**
Description: **Miscellaneous Water Level Sag**

Distance (ft): **137.5**
Structural Grade: **2**
O&M Grade: **0**
Clock Start/From:
Clock To:
1st Value:
2nd Value:
Value Percent: **10.000**
Continuous Index:
Within 8" of Joint: **NO**
Remarks:

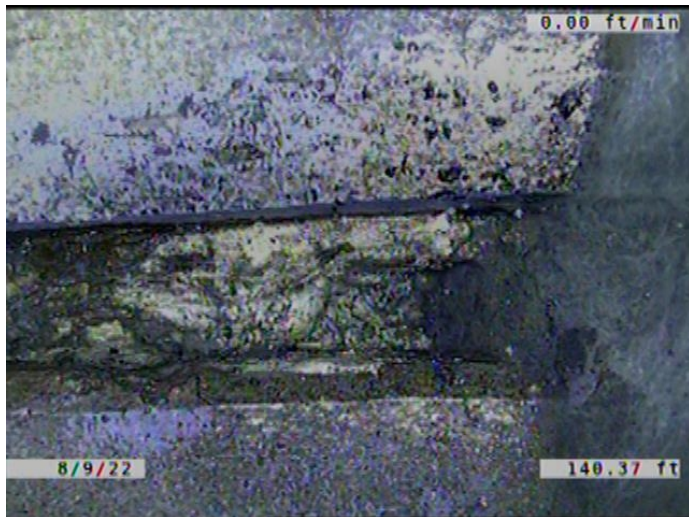
Code: **JAM**
Description: **Joint Angular Medium**

Distance (ft): **140.4**
Structural Grade: **3**
O&M Grade: **0**
Clock Start/From:
Clock To:
1st Value:
2nd Value:
Value Percent:
Continuous Index:
Within 8" of Joint: **NO**
Remarks:

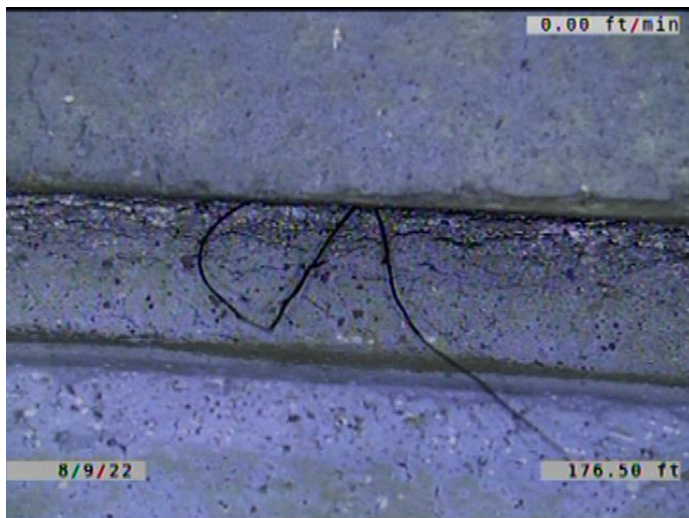
Code: **RFJ**
Description: **Roots Fine Joint**

Distance (ft): **176.5**
Structural Grade: **0**
O&M Grade: **1**
Clock Start/From: **1**
Clock To: **3**
1st Value:
2nd Value:
Value Percent:
Continuous Index:
Within 8" of Joint: **YES**
Remarks:

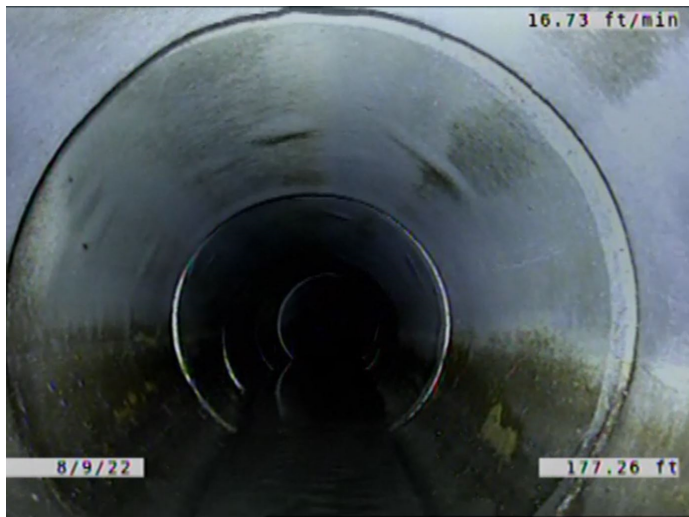
Code: **SZ**
 Description: **Surface Damage Other**

Distance (ft): **177.3**
 Structural Grade: **0**
 O&M Grade: **0**
 Clock Start/From: **10**
 Clock To: **2**
 1st Value:
 2nd Value:
 Value Percent:
 Continuous Index:
 Within 8" of Joint: **NO**
 Remarks: **Indentations factory defect.**

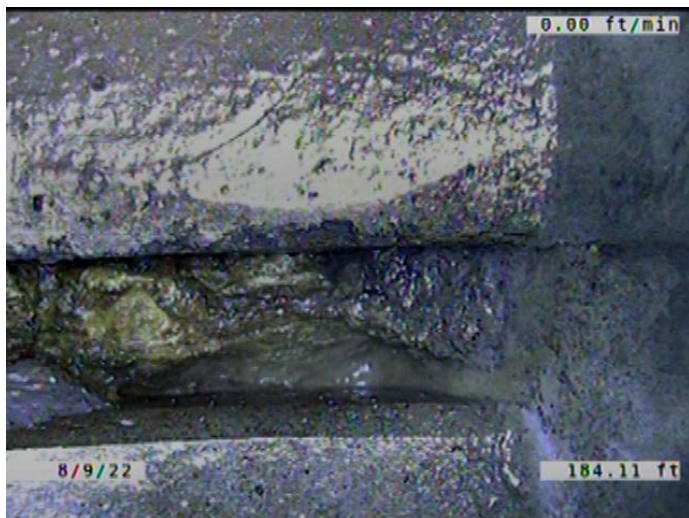
Code: **JAM**
 Description: **Joint Angular Medium**

Distance (ft): **184.1**
 Structural Grade: **3**
 O&M Grade: **0**
 Clock Start/From:
 Clock To:
 1st Value:
 2nd Value:
 Value Percent:
 Continuous Index:
 Within 8" of Joint: **NO**
 Remarks:

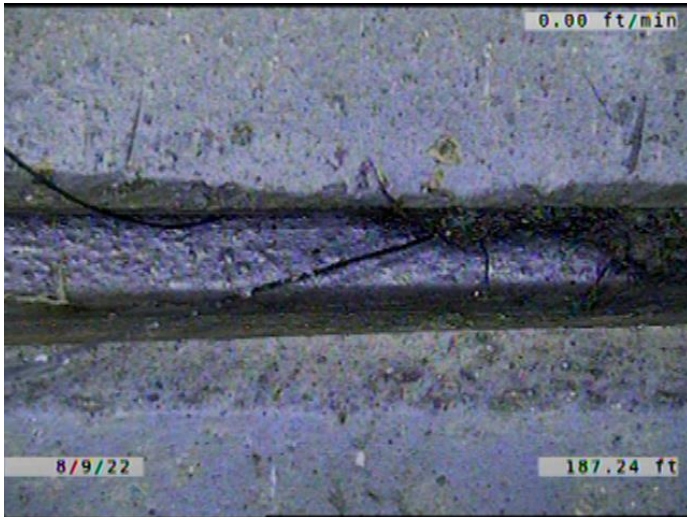
Code: **RFJ**
Description: **Roots Fine Joint**

Distance (ft): **187.2**
Structural Grade: **0**
O&M Grade: **1**
Clock Start/From: **10**
Clock To: **1**
1st Value:
2nd Value:
Value Percent:
Continuous Index:
Within 8" of Joint: **YES**
Remarks:

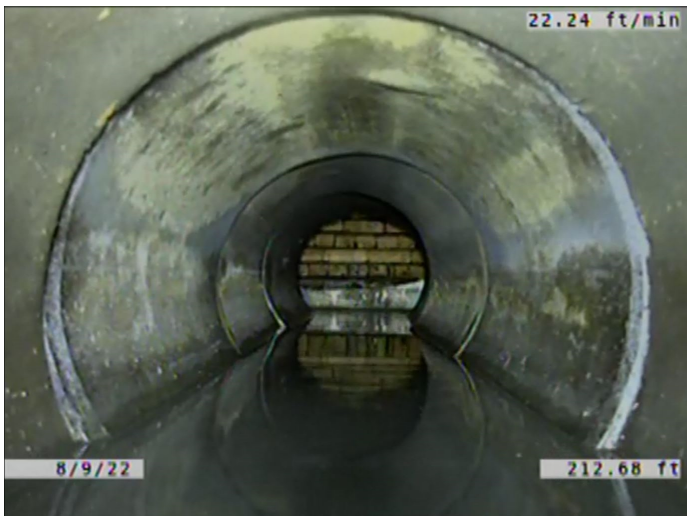
Code: **SZ**
Description: **Surface Damage Other**

Distance (ft): **212.7**
Structural Grade: **0**
O&M Grade: **0**
Clock Start/From: **12**
Clock To: **1**
1st Value:
2nd Value:
Value Percent:
Continuous Index:
Within 8" of Joint: **NO**
Remarks: **Indentations factory defect.**

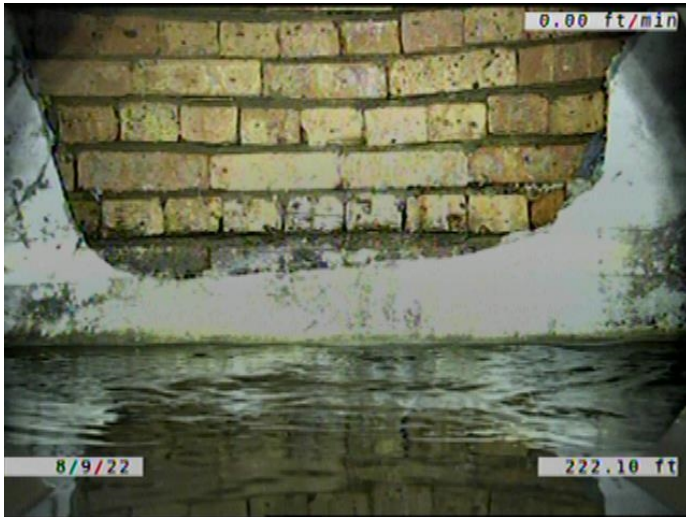
Code: **FM**
 Description: **Fracture Multiple**

Distance (ft): **222.1**
 Structural Grade: **4**
 O&M Grade: **0**
 Clock Start/From: **8**
 Clock To: **4**
 1st Value:
 2nd Value:
 Value Percent:
 Continuous Index: **F01**
 Within 8" of Joint: **YES**
 Remarks:

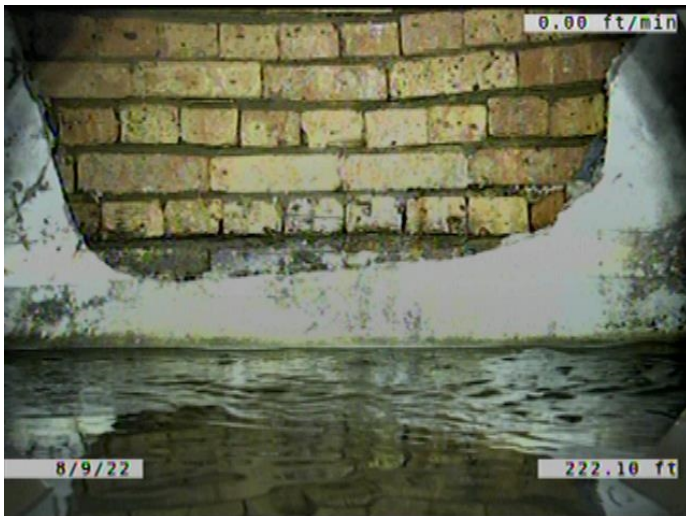
Code: **DAE**
 Description: **Deposits Attached Encrustation**

Distance (ft): **222.1**
 Structural Grade: **0**
 O&M Grade: **2**
 Clock Start/From: **7**
 Clock To: **5**
 1st Value:
 2nd Value:
 Value Percent: **5.000**
 Continuous Index: **F02**
 Within 8" of Joint: **YES**
 Remarks:
