Profile/Photo Observation Report

Date:	11/18/2021	Weather:		Coding:	PACP 7.0
Pipe Length (ft):	231.4	Owner:	City of Hobart	Pre Clean:	Heavy Cleaning
P.O.#:	YES502259	Surveyor:	S. Bucklin	PSR:	P-605-036-010
Customer:	City of Hobart	Clean Date:	11/17/2021	Shape:	C

Street:	South Pennsylvania Street	Flow Control:	Not Controlled
City:	Hobart, IN	Year Renewed:	
Location:	Local rural streets with light traffic, t	Tape/Media #:	
Purpose:	Routine Assessment	Dia/Height:	12"
Use:	Sanitary Sewage Pipe	Material:	VCP
Drain Area:		Lining:	None
Category:	NA		
Comment:			
Location Details:		Direction of Survey:	Downstream
US MH:	M-605-010	DS MH:	M-605-036
		Total Length Surveyed (ft):	231.4

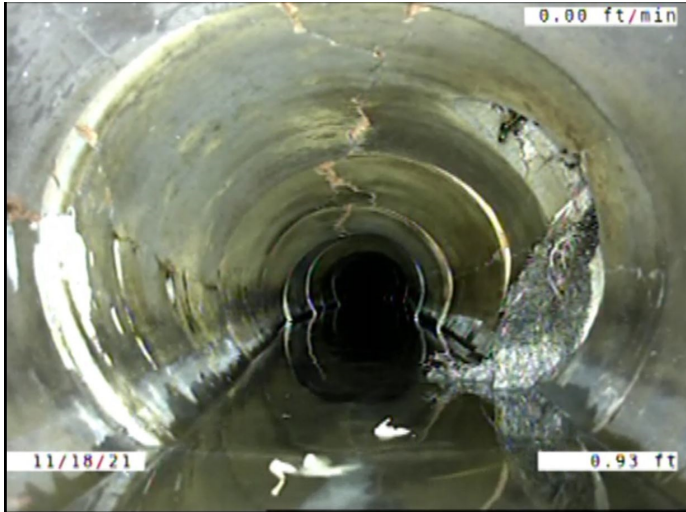
Code: **DR**
Description: **Deformed Rigid**

Distance (ft): **.9**
Structural Grade: **4**
O&M Grade: **0**
Clock Start/From:
Clock To:
1st Value:
2nd Value:
Value Percent: **5.000**
Continuous Index: **S06**
Within 8" of Joint: **NO**
Remarks:

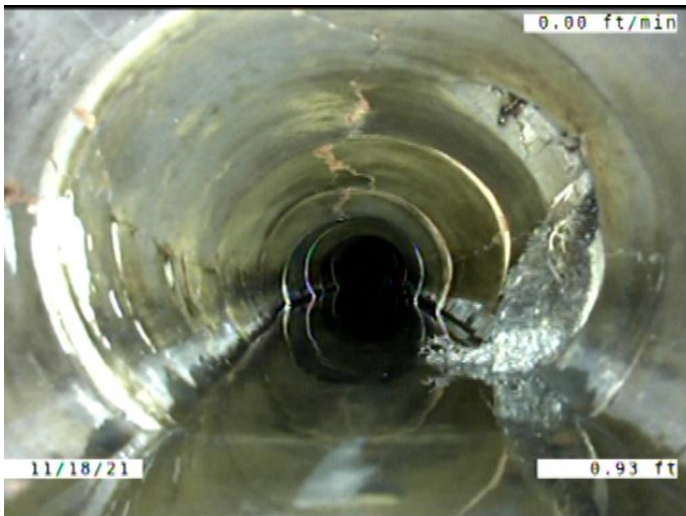
Code: **FM**
Description: **Fracture Multiple**

Distance (ft): **.9**
Structural Grade: **4**
O&M Grade: **0**
Clock Start/From: **12**
Clock To: **12**
1st Value:
2nd Value:
Value Percent:
Continuous Index: **S01**
Within 8" of Joint: **YES**
Remarks:

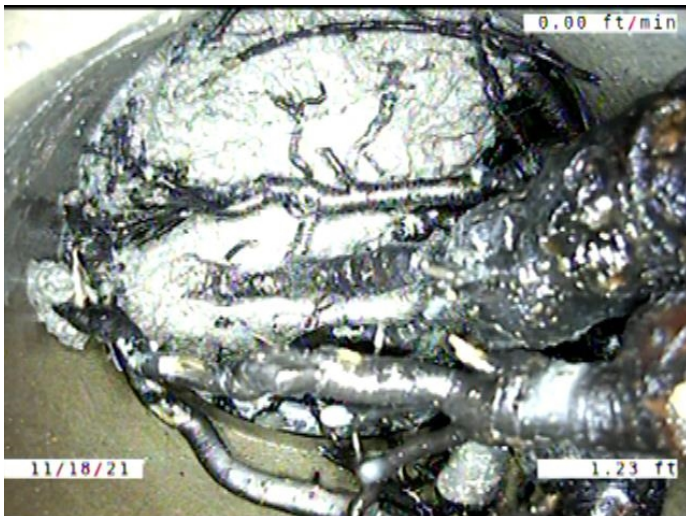
Code: **TFD**
 Description: **Tap Factory Defective**

Distance (ft): **1.2**
 Structural Grade: **0**
 O&M Grade: **3**
 Clock Start/From: **11**
 Clock To:
 1st Value: **4.000**
 2nd Value:
 Value Percent:
 Continuous Index:
 Within 8" of Joint: **YES**
 Remarks: **BROKEN. 95% PLUGGED WITH ROOTS.**

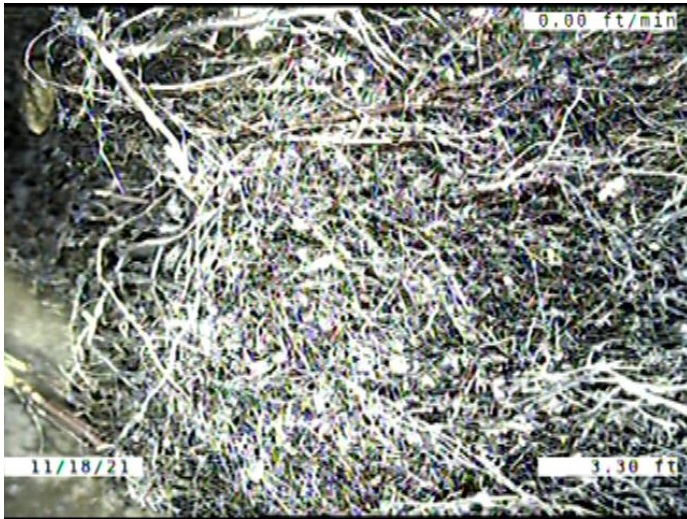
Code: **RML**
Description: **Roots Medium Lateral**

Distance (ft): **3.3**
Structural Grade: **0**
O&M Grade: **3**
Clock Start/From: **2**
Clock To: **5**
1st Value:
2nd Value:
Value Percent: **5.000**
Continuous Index:
Within 8" of Joint: **NO**
Remarks:

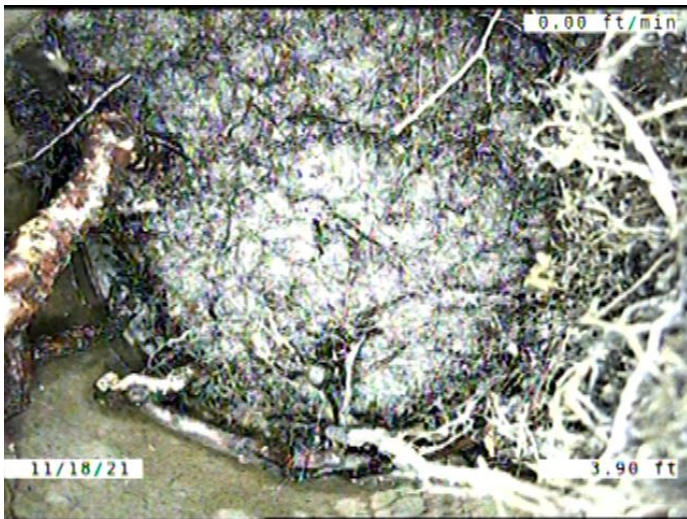
Code: **TFD**
Description: **Tap Factory Defective**

Distance (ft): **3.9**
Structural Grade: **0**
O&M Grade: **3**
Clock Start/From: **2**
Clock To:
1st Value: **4.000**
2nd Value:
Value Percent:
Continuous Index:
Within 8" of Joint: **YES**
Remarks: **BROKEN. LOOKS TO BE 100% PLUGGED WITH ROOTS.**

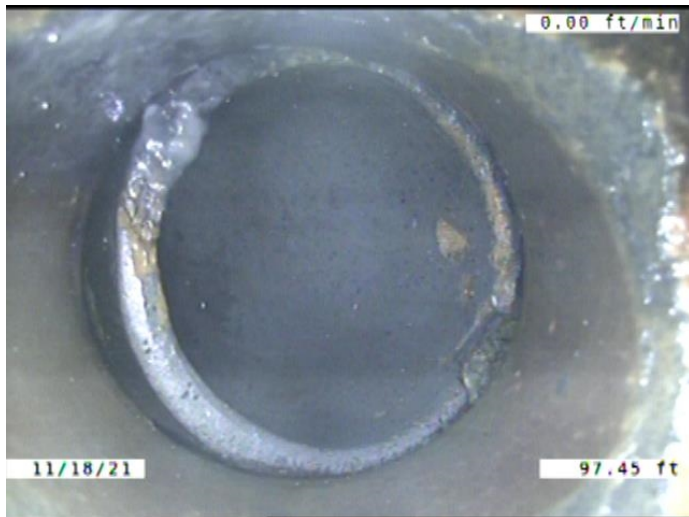
Code: **TFD**
 Description: **Tap Factory Defective**

Distance (ft): **97.4**
 Structural Grade: **0**
 O&M Grade: **3**
 Clock Start/From: **11**
 Clock To:
 1st Value: **4.000**
 2nd Value:
 Value Percent:
 Continuous Index:
 Within 8" of Joint: **YES**
 Remarks: **BROKEN., CONSTANTLY DRIPPING WATER. ANGLED JOINT**

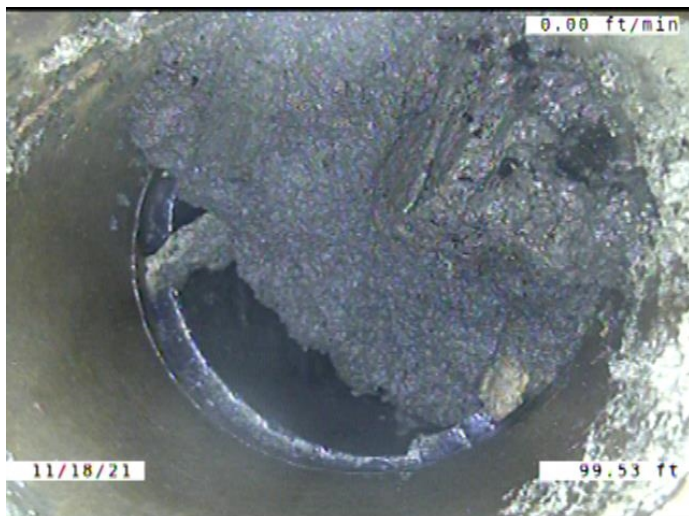
Code: **TFD**
 Description: **Tap Factory Defective**

Distance (ft): **99.5**
 Structural Grade: **0**
 O&M Grade: **3**
 Clock Start/From: **1**
 Clock To:
 1st Value: **4.000**
 2nd Value:
 Value Percent:
 Continuous Index:
 Within 8" of Joint: **YES**
 Remarks: **BROKEN., CONSTANTLY DRIPPING WATER. 95% PLUGGED.**

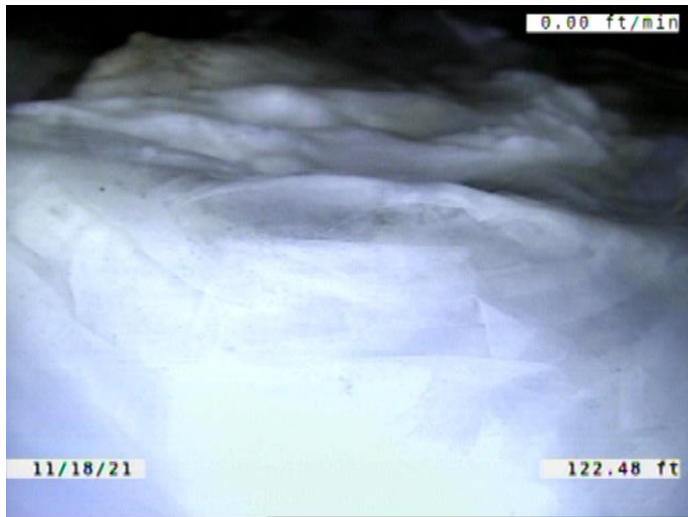
Code: **OBZ**
Description: **Obstruction Other**

Distance (ft): **122.5**
Structural Grade: **0**
O&M Grade: **2**
Clock Start/From: **6**
Clock To:
1st Value:
2nd Value:
Value Percent: **5.000**
Continuous Index:
Within 8" of Joint: **YES**
Remarks: **ENCrustATION THAT HAS BEEN KNOCKED OFF**

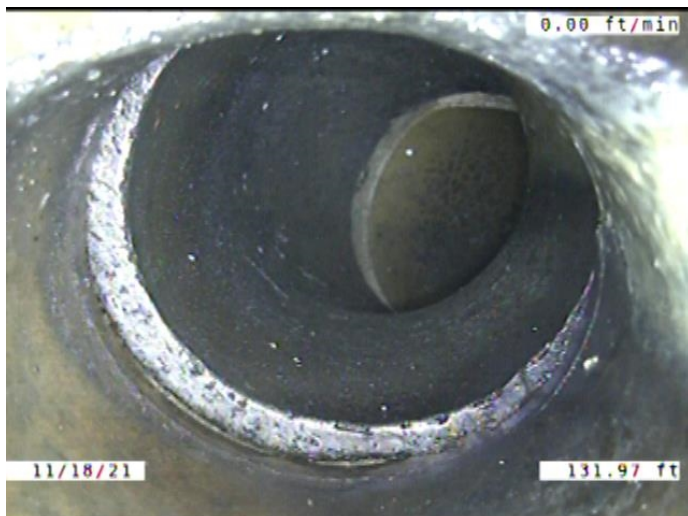
Code: **TF**
Description: **Tap Factory**

Distance (ft): **132.0**
Structural Grade: **0**
O&M Grade: **0**
Clock Start/From: **1**
Clock To:
1st Value: **4.000**
2nd Value:
Value Percent:
Continuous Index:
Within 8" of Joint: **YES**
Remarks: **OFFSET.**

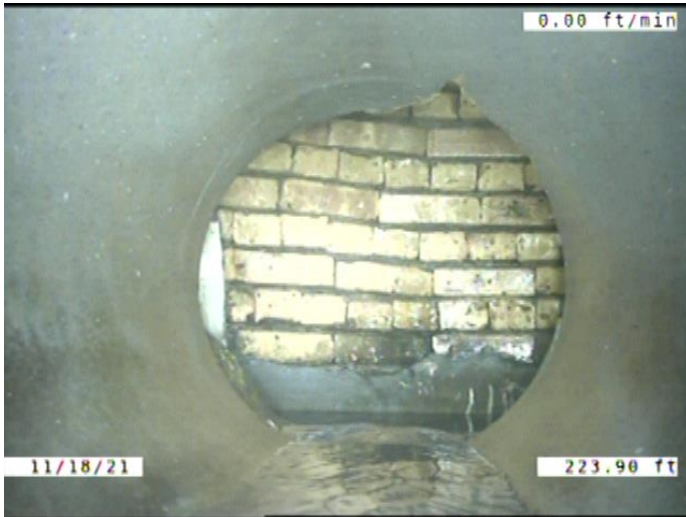
Code: **DAE**
Description: **Deposits Attached Encrustation**

Distance (ft): **223.9**
Structural Grade: **0**
O&M Grade: **2**
Clock Start/From: **9**
Clock To: **3**
1st Value:
2nd Value:
Value Percent: **5.000**
Continuous Index: **F03**
Within 8" of Joint: **YES**
Remarks:

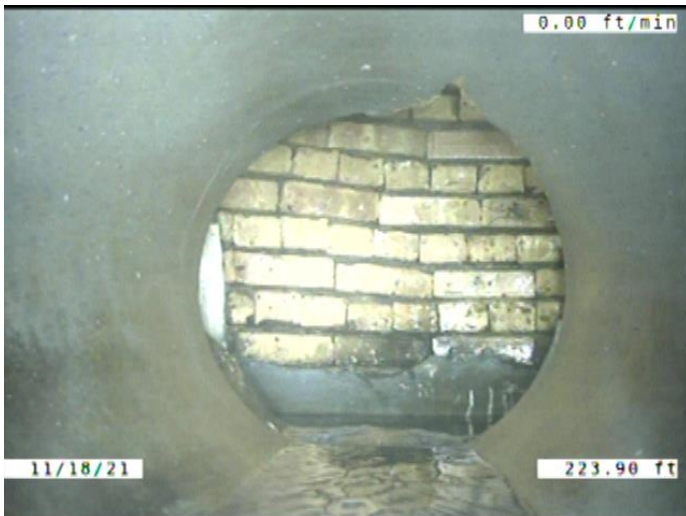
Code: **MWLS**
Description: **Miscellaneous Water Level Sag**

Distance (ft): **223.9**
Structural Grade: **2**
O&M Grade: **0**
Clock Start/From:
Clock To:
1st Value:
2nd Value:
Value Percent: **15.000**
Continuous Index: **F05**
Within 8" of Joint: **NO**
Remarks:
