Profile/Photo Observation Report

Date:	11/18/2021	Weather:		Coding:	PACP 7.0
Pipe Length (ft):	231.4	Owner:	City of Hobart	Pre Clean:	Heavy Cleaning
P.O.#:	YES502259	Surveyor:	S. Bucklin	PSR:	P-605-036-010
Customer:	City of Hobart	Clean Date:	11/17/2021	Shape:	C

Street:	South Pennsylvania Street	Flow Control:	Not Controlled
City:	Hobart, IN	Year Renewed:	
Location:	Local rural streets with light traffic, t	Tape/Media #:	
Purpose:	Routine Assessment	Dia/Height:	12"
Use:	Sanitary Sewage Pipe	Material:	VCP
Drain Area:		Lining:	None
Category:	NA		
Comment:			
Location Details:		Direction of Survey:	Downstream
US MH:	M-605-010	DS MH:	M-605-036
		Total Length Surveyed (ft):	231.4

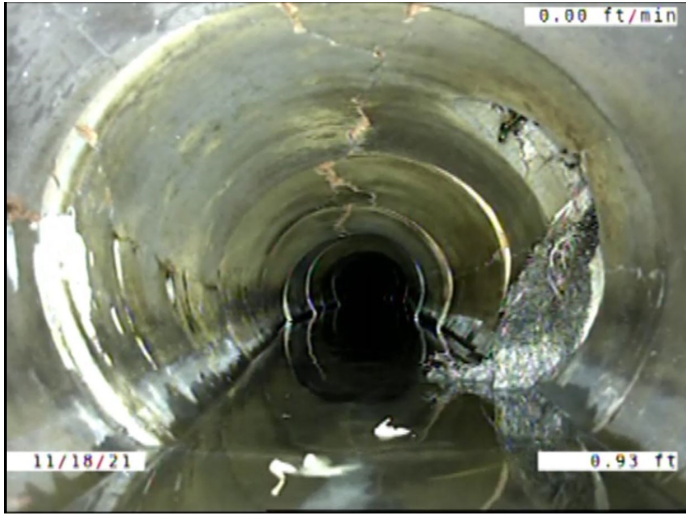
Code: **DR**
Description: **Deformed Rigid**

Distance (ft): **.9**
Structural Grade: **4**
O&M Grade: **0**
Clock Start/From:
Clock To:
1st Value:
2nd Value:
Value Percent: **5.000**
Continuous Index: **S06**
Within 8" of Joint: **NO**
Remarks:

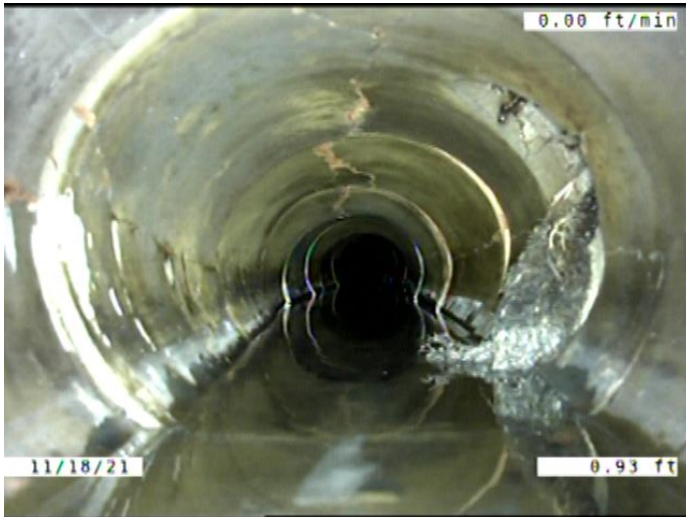
Code: **FM**
Description: **Fracture Multiple**

Distance (ft): **.9**
Structural Grade: **4**
O&M Grade: **0**
Clock Start/From: **12**
Clock To: **12**
1st Value:
2nd Value:
Value Percent:
Continuous Index: **S01**
Within 8" of Joint: **YES**
Remarks:

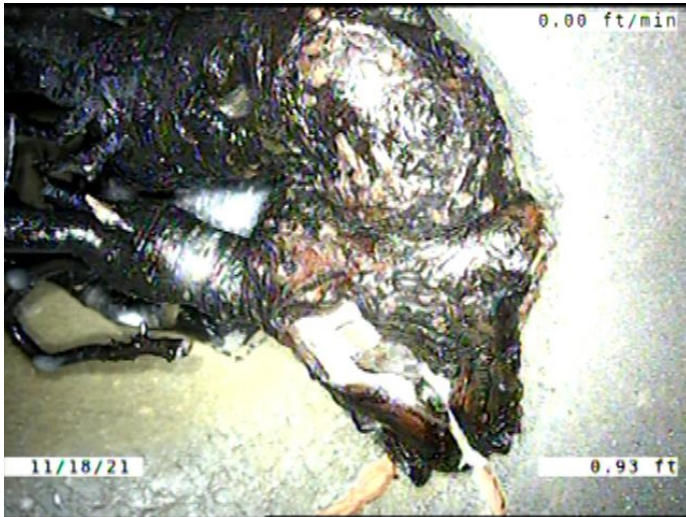
Code: **RTB**
 Description: **Roots Tap Barrel**

Distance (ft): **.9**
 Structural Grade: **0**
 O&M Grade: **3**
 Clock Start/From: **10**
 Clock To: **11**
 1st Value:
 2nd Value:
 Value Percent: **5.000**
 Continuous Index:
 Within 8" of Joint: **NO**
 Remarks: **GROWING INTO THE SERVICE**

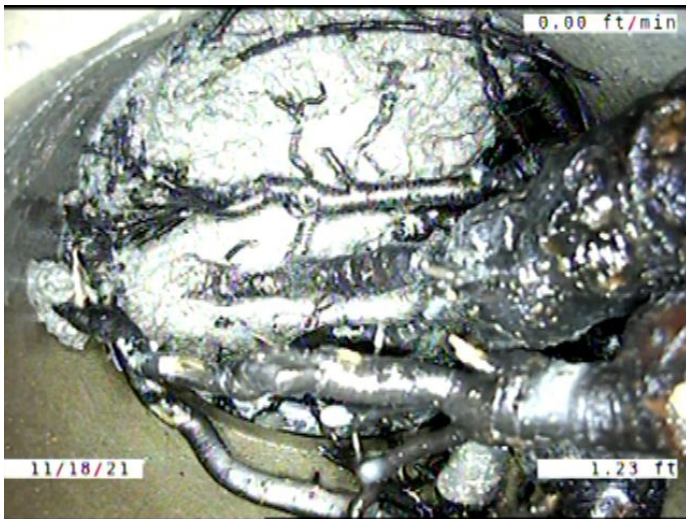
Code: **TFD**
 Description: **Tap Factory Defective**

Distance (ft): **1.2**
 Structural Grade: **0**
 O&M Grade: **3**
 Clock Start/From: **11**
 Clock To:
 1st Value: **4.000**
 2nd Value:
 Value Percent:
 Continuous Index:
 Within 8" of Joint: **YES**
 Remarks: **BROKEN. 95% PLUGGED WITH ROOTS.**

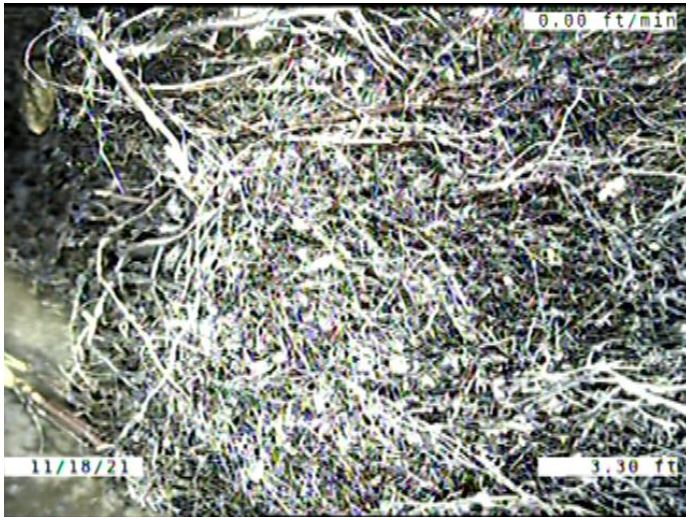
Code: **RML**
 Description: **Roots Medium Lateral**

Distance (ft): **3.3**
 Structural Grade: **0**
 O&M Grade: **3**
 Clock Start/From: **2**
 Clock To: **5**
 1st Value:
 2nd Value:
 Value Percent: **5.000**
 Continuous Index:
 Within 8" of Joint: **NO**
 Remarks:

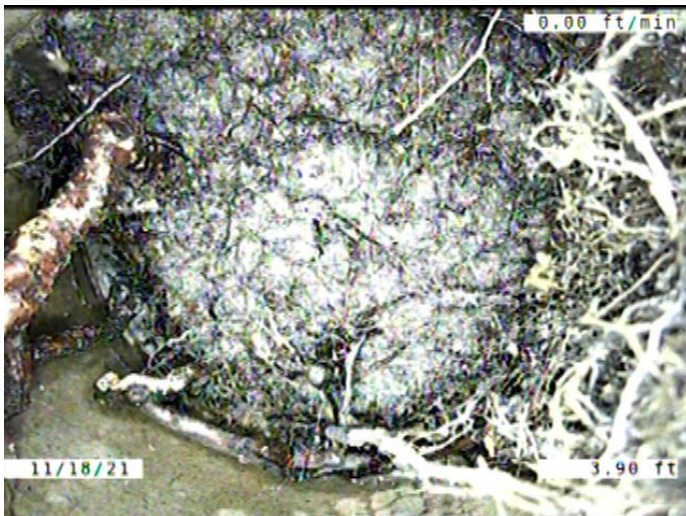
Code: **TFD**
 Description: **Tap Factory Defective**

Distance (ft): **3.9**
 Structural Grade: **0**
 O&M Grade: **3**
 Clock Start/From: **2**
 Clock To:
 1st Value: **4.000**
 2nd Value:
 Value Percent:
 Continuous Index:
 Within 8" of Joint: **YES**
 Remarks: **BROKEN. LOOKS TO BE 100% PLUGGED WITH ROOTS.**

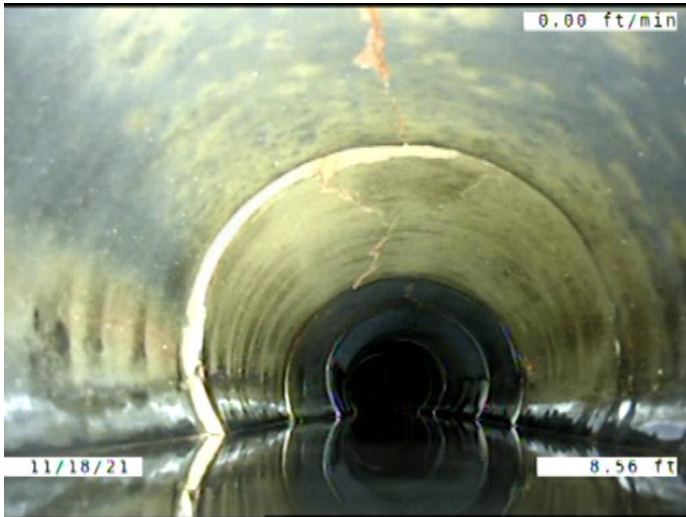
Code: **MWLS**
 Description: **Miscellaneous Water Level Sag**

Distance (ft): **8.6**
 Structural Grade: **2**
 O&M Grade: **0**
 Clock Start/From:
 Clock To:
 1st Value:
 2nd Value:
 Value Percent: **15.000**
 Continuous Index: **S02**
 Within 8" of Joint: **NO**
 Remarks:

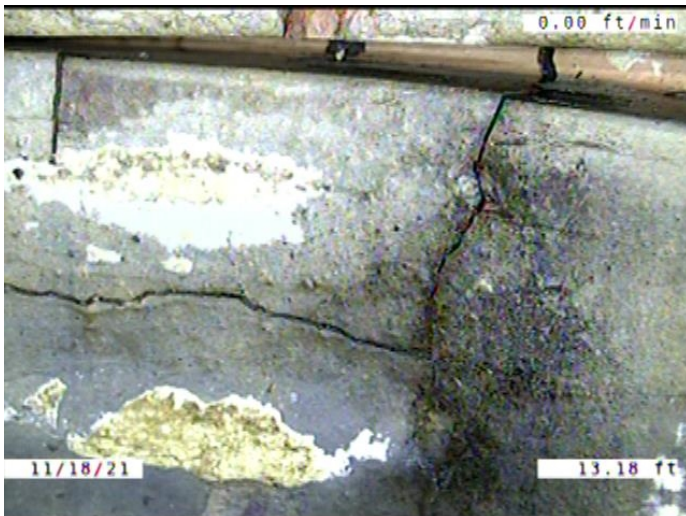
Code: **DAE**
 Description: **Deposits Attached Encrustation**

Distance (ft): **13.2**
 Structural Grade: **0**
 O&M Grade: **2**
 Clock Start/From: **9**
 Clock To: **3**
 1st Value:
 2nd Value:
 Value Percent: **5.000**
 Continuous Index: **S03**
 Within 8" of Joint: **YES**
 Remarks:

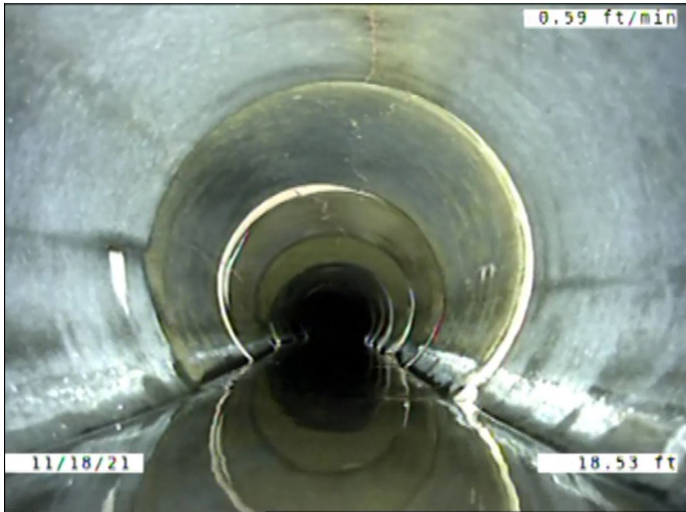
Code: **DR**
Description: **Deformed Rigid**

Distance (ft): **18.5**
Structural Grade: **4**
O&M Grade: **0**
Clock Start/From:
Clock To:
1st Value:
2nd Value:
Value Percent: **5.000**
Continuous Index: **F06**
Within 8" of Joint: **NO**
Remarks:

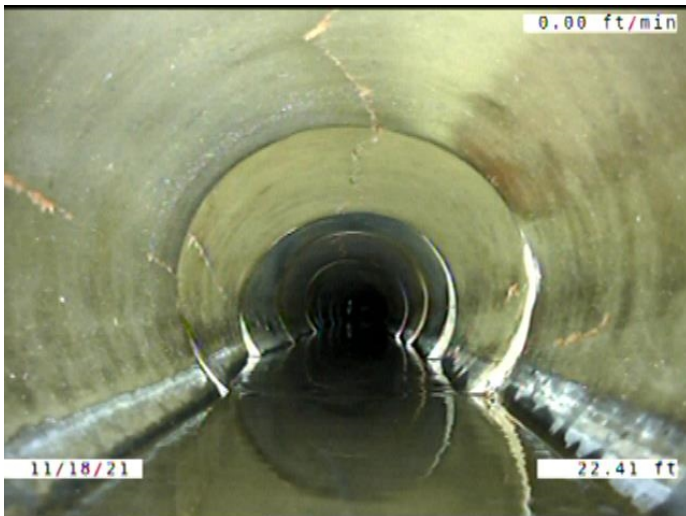
Code: **MWLS**
Description: **Miscellaneous Water Level Sag**

Distance (ft): **22.4**
Structural Grade: **2**
O&M Grade: **0**
Clock Start/From:
Clock To:
1st Value:
2nd Value:
Value Percent: **15.000**
Continuous Index: **F02**
Within 8" of Joint: **NO**
Remarks:

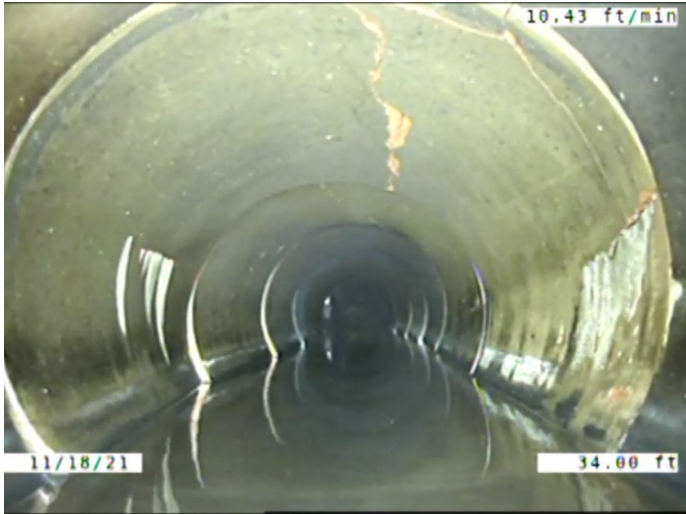
Code: **SSS**
Description: **Surface Damage Surface Spalling**

Distance (ft): **34.0**
Structural Grade: **2**
O&M Grade: **0**
Clock Start/From: **1**
Clock To:
1st Value:
2nd Value:
Value Percent:
Continuous Index:
Within 8" of Joint: **NO**
Remarks:

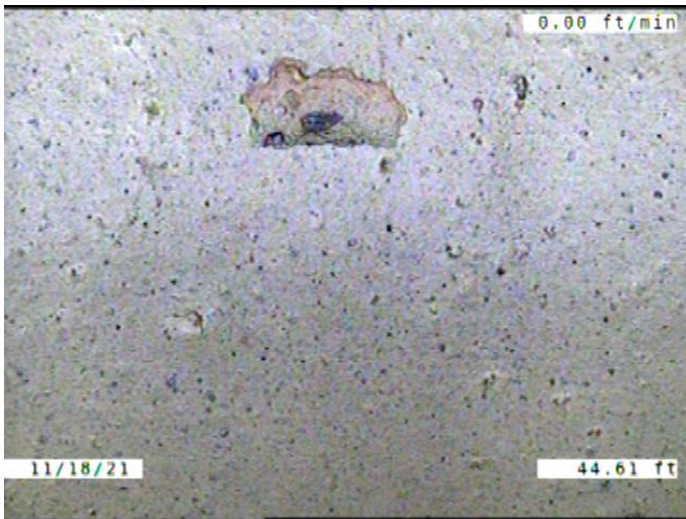
Code: **SSS**
Description: **Surface Damage Surface Spalling**

Distance (ft): **44.6**
Structural Grade: **2**
O&M Grade: **0**
Clock Start/From: **10**
Clock To: **12**
1st Value:
2nd Value:
Value Percent:
Continuous Index:
Within 8" of Joint: **NO**
Remarks:

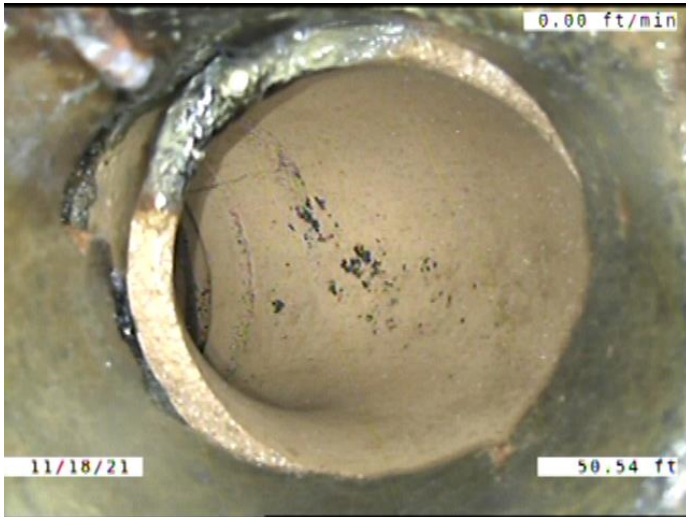
Code: **TFD**
 Description: **Tap Factory Defective**

Distance (ft): **50.5**
 Structural Grade: **0**
 O&M Grade: **3**
 Clock Start/From: **11**
 Clock To:
 1st Value: **4.000**
 2nd Value:
 Value Percent:
 Continuous Index:
 Within 8" of Joint: **YES**
 Remarks: **BROKEN. CONSTANTLY RUNNING WATER. LOOKS LIKE WATER IS COMI**

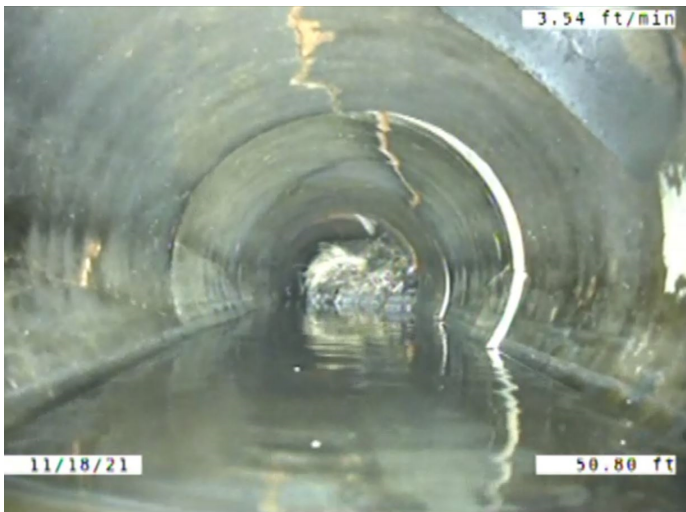
Code: **SSS**
 Description: **Surface Damage Surface Spalling**

Distance (ft): **50.8**
 Structural Grade: **2**
 O&M Grade: **0**
 Clock Start/From: **12**
 Clock To: **1**
 1st Value:
 2nd Value:
 Value Percent:
 Continuous Index:
 Within 8" of Joint: **NO**
 Remarks:

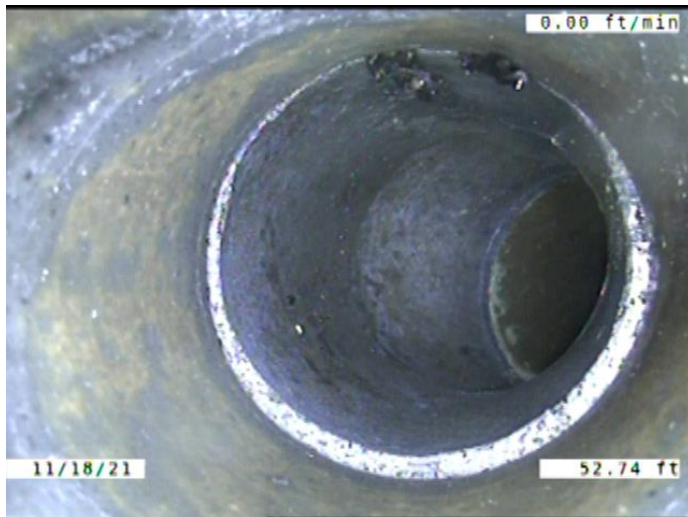
Code:	TF
Description:	Tap Factory
Distance (ft):	52.7
Structural Grade:	0
O&M Grade:	0
Clock Start/From:	1
Clock To:	
1st Value:	4.000
2nd Value:	
Value Percent:	
Continuous Index:	
Within 8" of Joint:	YES
Remarks:	ROOTS GROWING OUT OF THE JOINT.

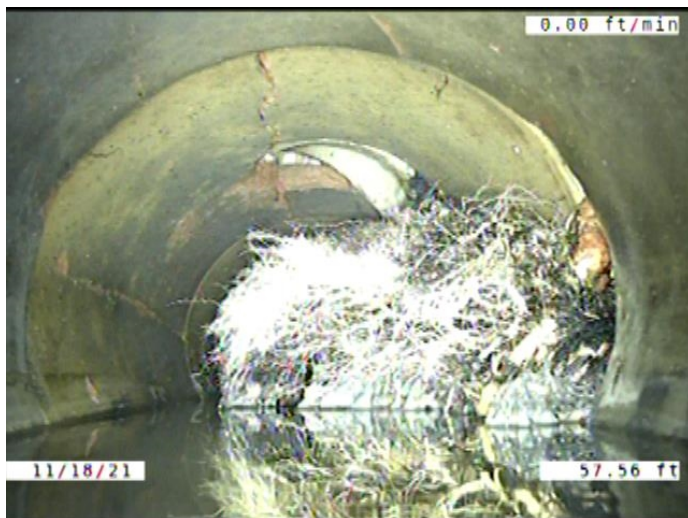
Code:	RBJ
Description:	Roots Ball Joint
Distance (ft):	57.6
Structural Grade:	0
O&M Grade:	4
Clock Start/From:	2
Clock To:	4
1st Value:	
2nd Value:	
Value Percent:	65.000
Continuous Index:	
Within 8" of Joint:	YES
Remarks:

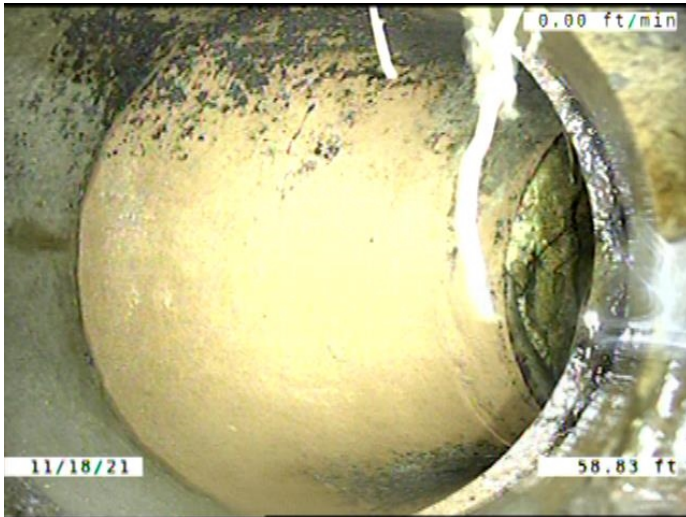
Code: **TBI**
 Description: **Tap Break-in Intruding**

Distance (ft): **58.8**
 Structural Grade: **0**
 O&M Grade: **2**
 Clock Start/From: **1**
 Clock To:
 1st Value: **4.000**
 2nd Value: **1.000**
 Value Percent:
 Continuous Index:
 Within 8" of Joint: **YES**
 Remarks:

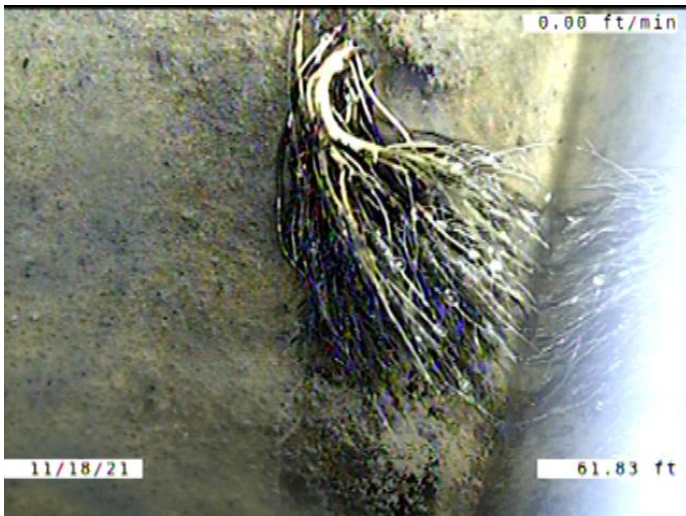
Code: **RFB**
 Description: **Roots Fine Barrel**

Distance (ft): **61.8**
 Structural Grade: **0**
 O&M Grade: **2**
 Clock Start/From: **3**
 Clock To:
 1st Value:
 2nd Value:
 Value Percent:
 Continuous Index:
 Within 8" of Joint: **NO**
 Remarks:

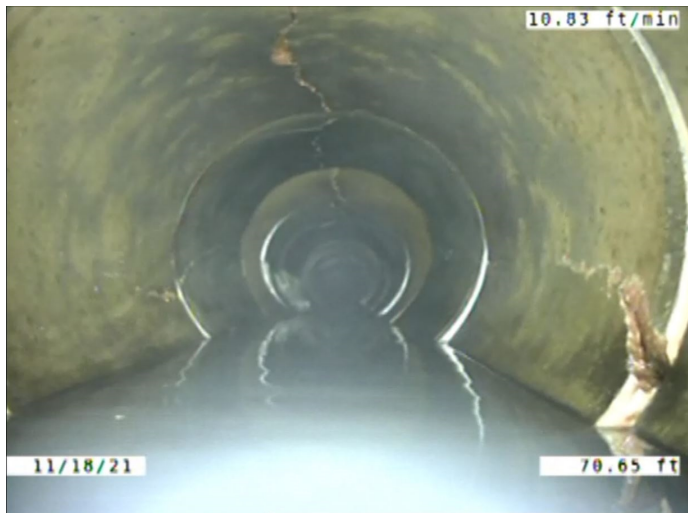
Code: **B**
 Description: **Broken**

Distance (ft): **70.7**
 Structural Grade: **4**
 O&M Grade: **0**
 Clock Start/From: **4**
 Clock To: **5**
 1st Value:
 2nd Value:
 Value Percent:
 Continuous Index:
 Within 8" of Joint: **YES**
 Remarks:

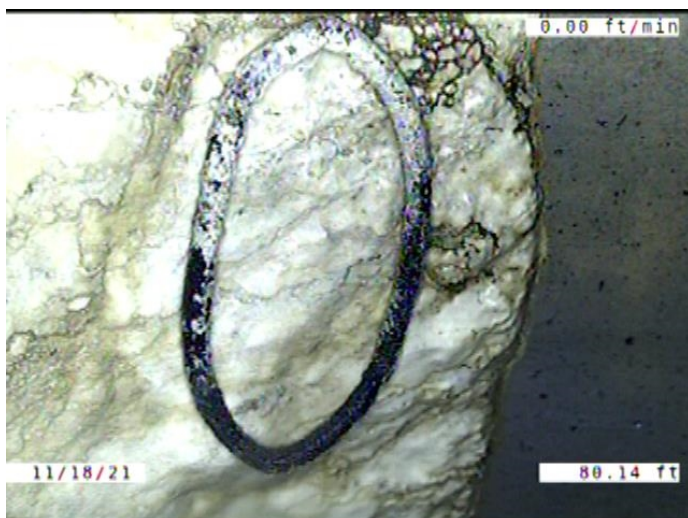
Code: **OBZ**
 Description: **Obstruction Other**

Distance (ft): **80.1**
 Structural Grade: **0**
 O&M Grade: **2**
 Clock Start/From: **9**
 Clock To:
 1st Value:
 2nd Value:
 Value Percent: **5.000**
 Continuous Index:
 Within 8" of Joint: **YES**
 Remarks: **ORING**

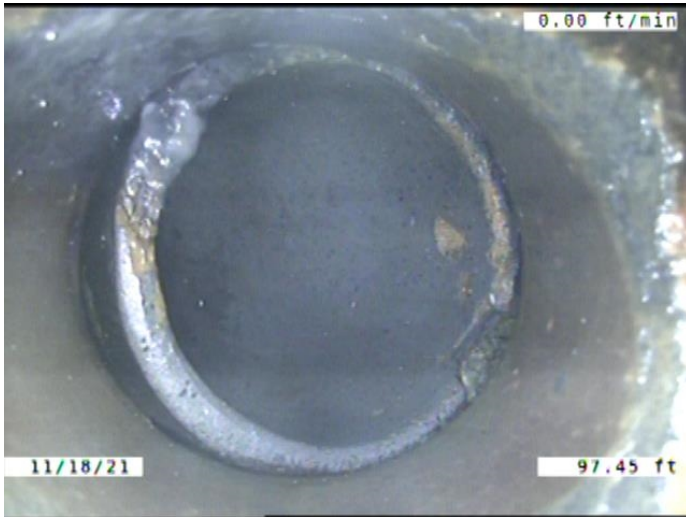
Code: **TFD**
Description: **Tap Factory Defective**

Distance (ft): **97.4**
Structural Grade: **0**
O&M Grade: **3**
Clock Start/From: **11**
Clock To:
1st Value: **4.000**
2nd Value:
Value Percent:
Continuous Index:
Within 8" of Joint: **YES**
Remarks: **BROKEN., CONSTANTLY DRIPPING WATER. ANGLED JOINT**

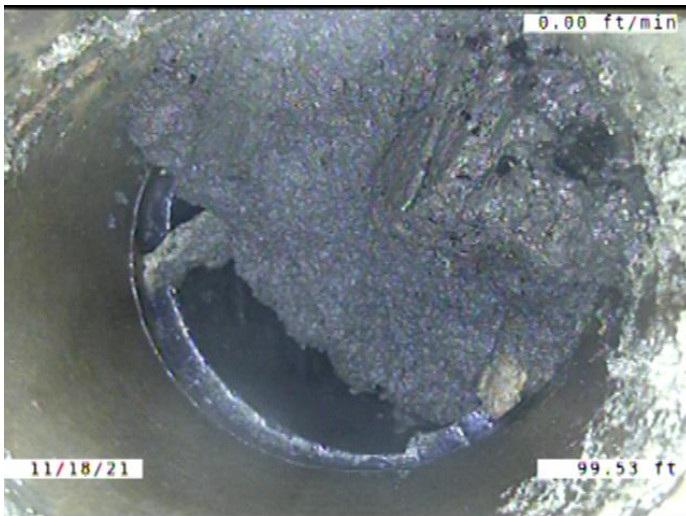
Code: **TFD**
Description: **Tap Factory Defective**

Distance (ft): **99.5**
Structural Grade: **0**
O&M Grade: **3**
Clock Start/From: **1**
Clock To:
1st Value: **4.000**
2nd Value:
Value Percent:
Continuous Index:
Within 8" of Joint: **YES**
Remarks: **BROKEN., CONSTANTLY DRIPPING WATER. 95% PLUGGED.**

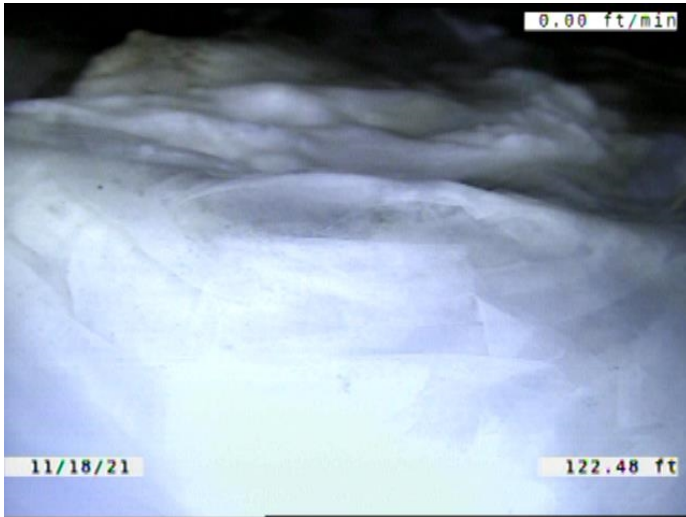
Code: **OBZ**
Description: **Obstruction Other**

Distance (ft): **122.5**
Structural Grade: **0**
O&M Grade: **2**
Clock Start/From: **6**
Clock To:
1st Value:
2nd Value:
Value Percent: **5.000**
Continuous Index:
Within 8" of Joint: **YES**
Remarks: **ENCrustATION THAT HAS BEEN KNOCKED OFF**

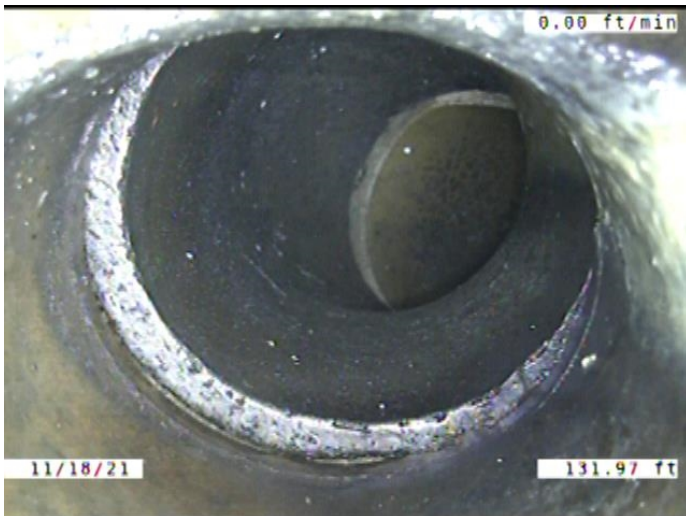
Code: **TF**
Description: **Tap Factory**

Distance (ft): **132.0**
Structural Grade: **0**
O&M Grade: **0**
Clock Start/From: **1**
Clock To:
1st Value: **4.000**
2nd Value:
Value Percent:
Continuous Index:
Within 8" of Joint: **YES**
Remarks: **OFFSET.**

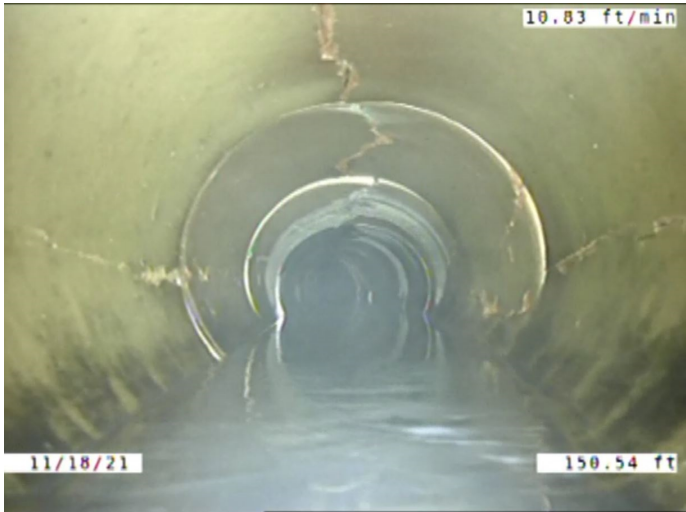
Code: **SSS**
Description: **Surface Damage Surface Spalling**

Distance (ft): **150.5**
Structural Grade: **2**
O&M Grade: **0**
Clock Start/From: **9**
Clock To: **4**
1st Value:
2nd Value:
Value Percent:
Continuous Index: **S07**
Within 8" of Joint: **YES**
Remarks:

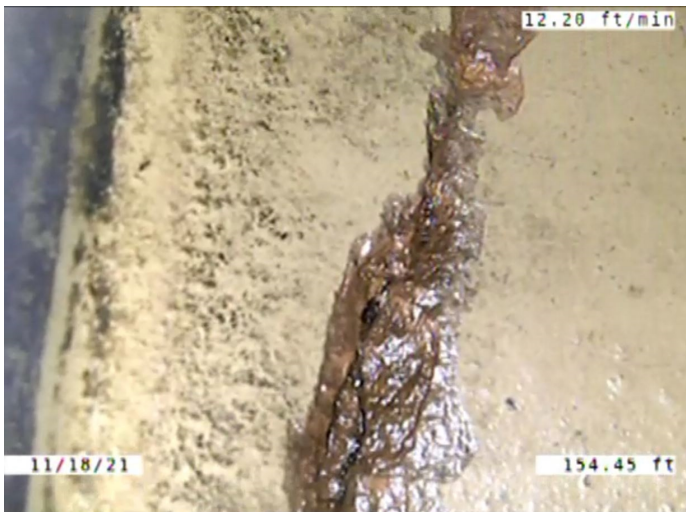
Code: **SSS**
Description: **Surface Damage Surface Spalling**

Distance (ft): **154.5**
Structural Grade: **2**
O&M Grade: **0**
Clock Start/From: **9**
Clock To: **4**
1st Value:
2nd Value:
Value Percent:
Continuous Index: **F07**
Within 8" of Joint: **YES**
Remarks:

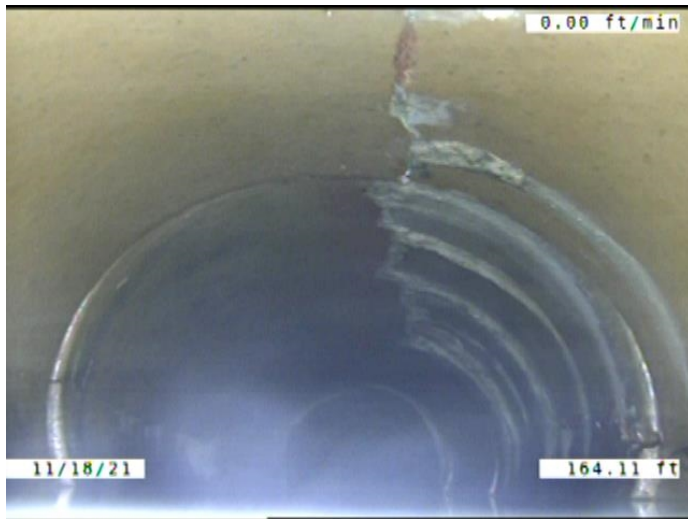
Code: **MWLS**
 Description: **Miscellaneous Water Level Sag**

Distance (ft): **164.1**
 Structural Grade: **2**
 O&M Grade: **0**
 Clock Start/From:
 Clock To:
 1st Value:
 2nd Value:
 Value Percent: **15.000**
 Continuous Index: **S04**
 Within 8" of Joint: **NO**
 Remarks:

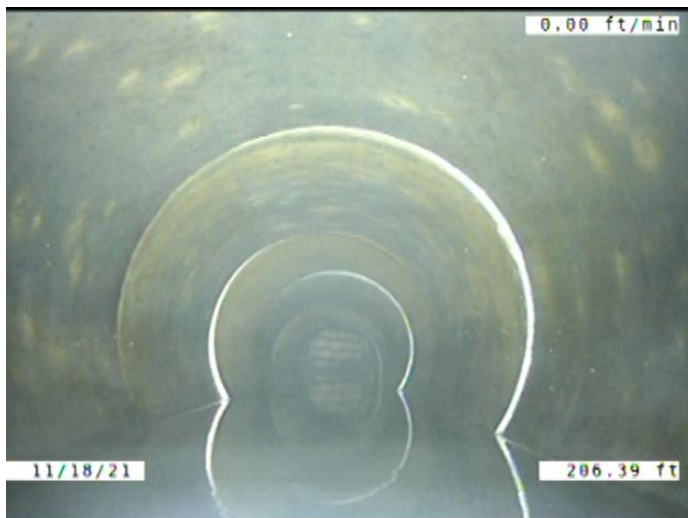
Code: **MWLS**
 Description: **Miscellaneous Water Level Sag**

Distance (ft): **206.4**
 Structural Grade: **2**
 O&M Grade: **0**
 Clock Start/From:
 Clock To:
 1st Value:
 2nd Value:
 Value Percent: **15.000**
 Continuous Index: **F04**
 Within 8" of Joint: **NO**
 Remarks:

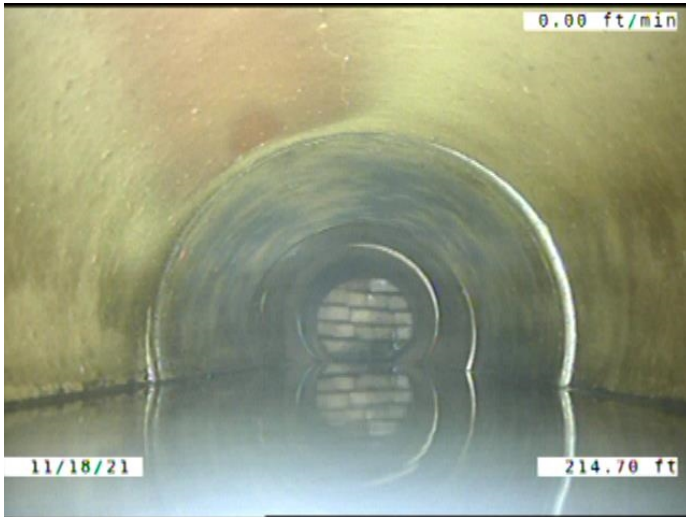
Code: **MWLS**
 Description: **Miscellaneous Water Level Sag**

Distance (ft): **214.7**
 Structural Grade: **2**
 O&M Grade: **0**
 Clock Start/From:
 Clock To:
 1st Value:
 2nd Value:
 Value Percent: **15.000**
 Continuous Index: **S05**
 Within 8" of Joint: **NO**
 Remarks:

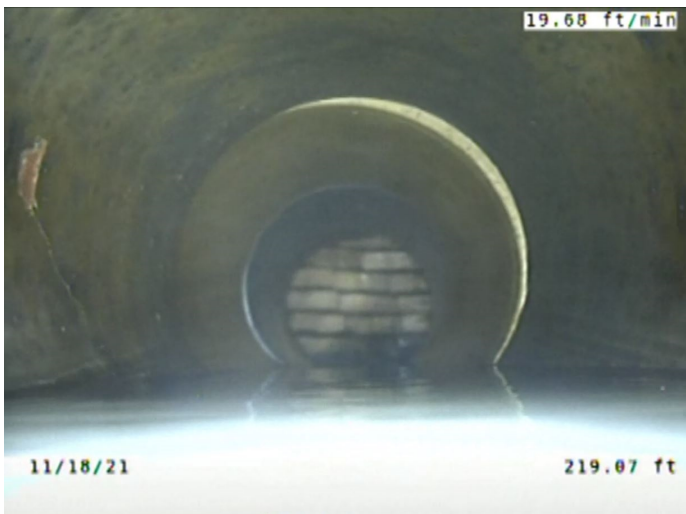
Code: **SSS**
 Description: **Surface Damage Surface Spalling**

Distance (ft): **219.1**
 Structural Grade: **2**
 O&M Grade: **0**
 Clock Start/From: **9**
 Clock To:
 1st Value:
 2nd Value:
 Value Percent:
 Continuous Index:
 Within 8" of Joint: **NO**
 Remarks:

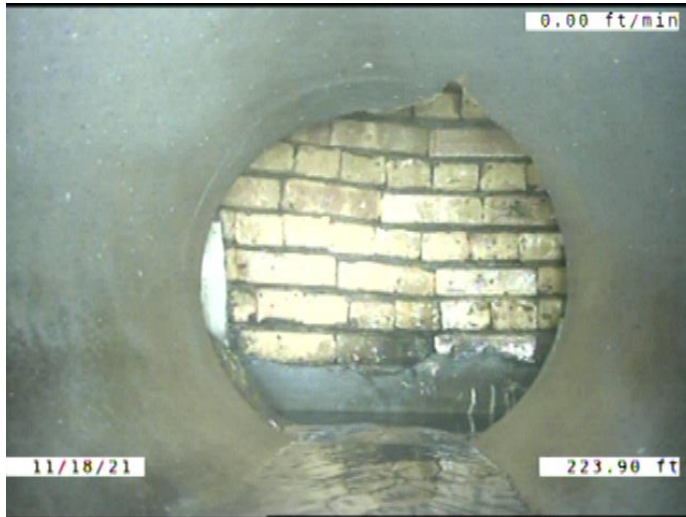
Code: **DAE**
Description: **Deposits Attached Encrustation**

Distance (ft): **223.9**
Structural Grade: **0**
O&M Grade: **2**
Clock Start/From: **9**
Clock To: **3**
1st Value:
2nd Value:
Value Percent: **5.000**
Continuous Index: **F03**
Within 8" of Joint: **YES**
Remarks:

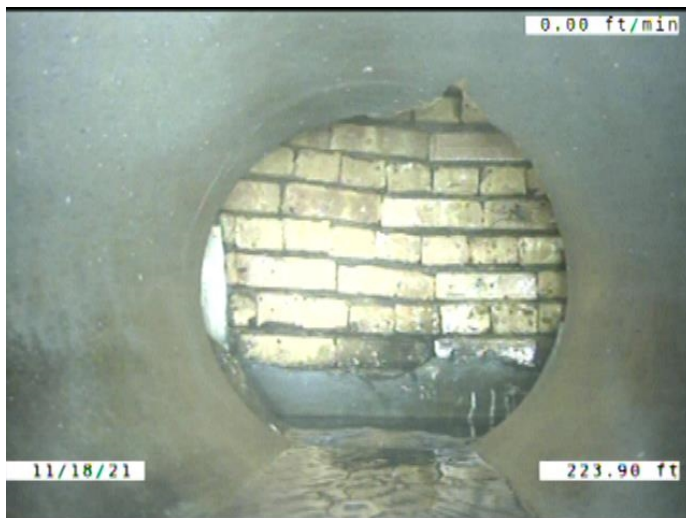
Code: **MWLS**
Description: **Miscellaneous Water Level Sag**

Distance (ft): **223.9**
Structural Grade: **2**
O&M Grade: **0**
Clock Start/From:
Clock To:
1st Value:
2nd Value:
Value Percent: **15.000**
Continuous Index: **F05**
Within 8" of Joint: **NO**
Remarks:

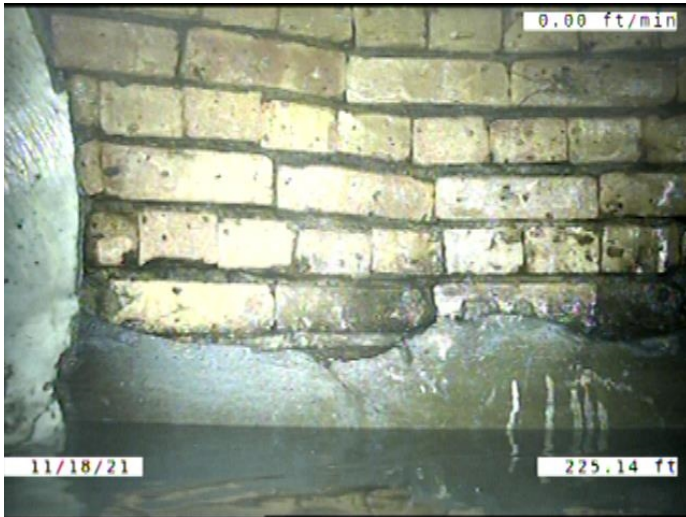
Code: **FM**
 Description: **Fracture Multiple**

Distance (ft): **225.1**
 Structural Grade: **4**
 O&M Grade: **0**
 Clock Start/From: **12**
 Clock To: **12**
 1st Value:
 2nd Value:
 Value Percent:
 Continuous Index: **F01**
 Within 8" of Joint: **YES**
 Remarks:
