Profile/Photo Observation Report

Street:	S WASHINGTON ST & W 3RD ST	Flow Control:	Not Controlled
City:	Hobart, IN	Year Renewed:	
Location:	Other	Tape/Media #:	
Purpose:	Not Known	Dia/Height:	12"
Use:	Sanitary	Material:	VCP
Drain Area:	NA	Lining:	
Category:	NA		
Comment:	Flow direction wrong. Debris at 118'.		
Location Details:		Direction of Survey:	Upstream
US MH:	M-605-011	DS MH:	M-605-042
		Total Length Surveyed (ft):	120.2

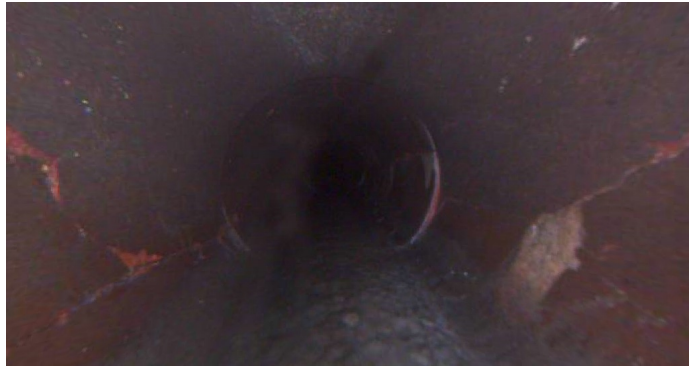
Code: **MWL**
Description: **Water Level**

Distance (ft): **.0**
Structural Grade: **0**
O&M Grade: **0**
Clock Start/From:
Clock To:
1st Value:
2nd Value:
Value Percent: **10.000**
Continuous Index:
Within 8" of Joint: **NO**
Remarks:

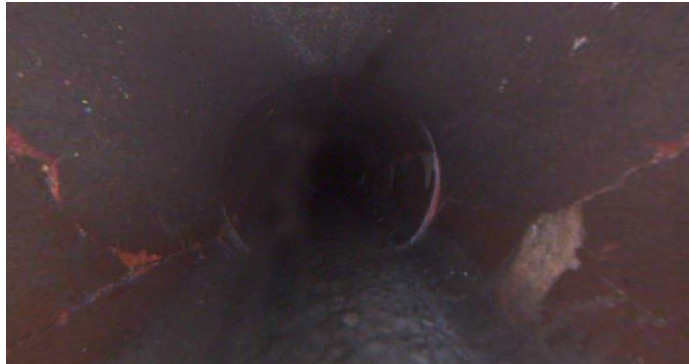
Code: **FM**
Description: **Fracture Multiple**

Distance (ft): **.0**
Structural Grade: **4**
O&M Grade: **0**
Clock Start/From: **7**
Clock To: **5**
1st Value:
2nd Value:
Value Percent:
Continuous Index: **S01**
Within 8" of Joint:
Remarks:

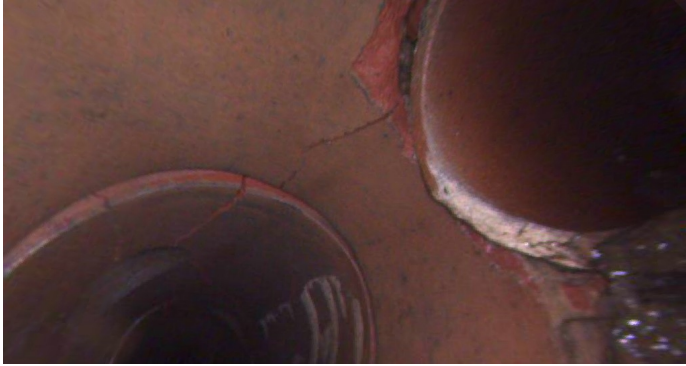
Code: **TB**
Description: **Tap Break-in**

Distance (ft): **21.6**
Structural Grade: **0**
O&M Grade: **0**
Clock Start/From: **2**
Clock To:
1st Value: **4.000**
2nd Value:
Value Percent:
Continuous Index:
Within 8" of Joint:
Remarks:

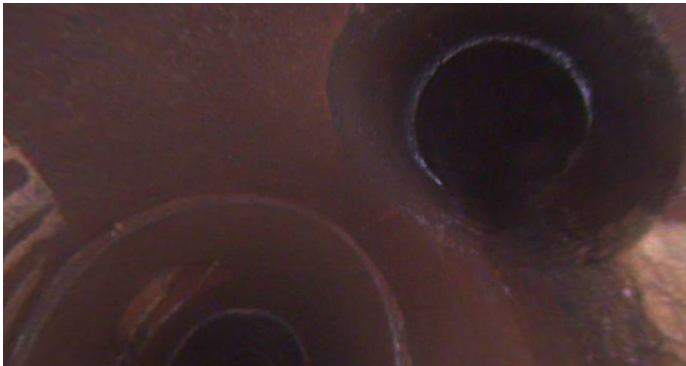
Code: **TF**
Description: **Tap Factory**

Distance (ft): **23.8**
Structural Grade: **0**
O&M Grade: **0**
Clock Start/From: **10**
Clock To:
1st Value: **4.000**
2nd Value:
Value Percent:
Continuous Index:
Within 8" of Joint:
Remarks:

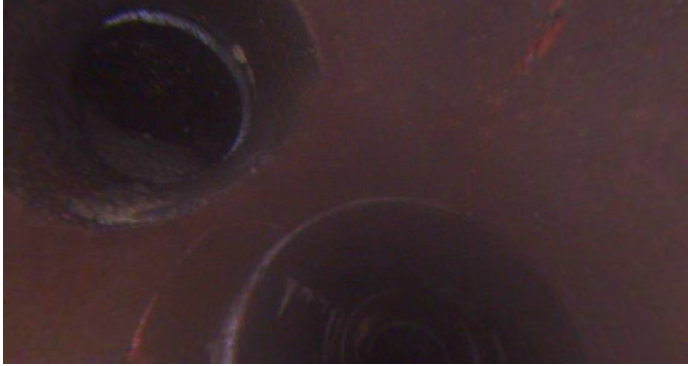
Code: **TF**
Description: **Tap Factory**

Distance (ft): **25.9**
Structural Grade: **0**
O&M Grade: **0**
Clock Start/From: **2**
Clock To:
1st Value: **4.000**
2nd Value:
Value Percent:
Continuous Index:
Within 8" of Joint:
Remarks:

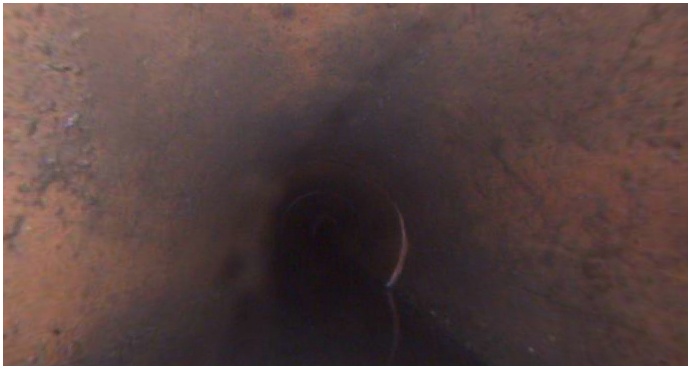
Code: **FM**
Description: **Fracture Multiple**

Distance (ft): **72.3**
Structural Grade: **4**
O&M Grade: **0**
Clock Start/From: **7**
Clock To: **5**
1st Value:
2nd Value:
Value Percent:
Continuous Index: **F01**
Within 8" of Joint:
Remarks:

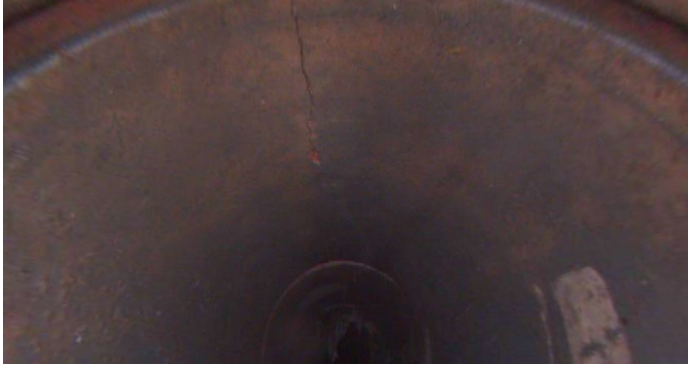
Code: **CL**
Description: **Crack Longitudinal**

Distance (ft): **76.2**
Structural Grade: **2**
O&M Grade: **0**
Clock Start/From: **11**
Clock To:
1st Value:
2nd Value:
Value Percent:
Continuous Index:
Within 8" of Joint: **YES**
Remarks:

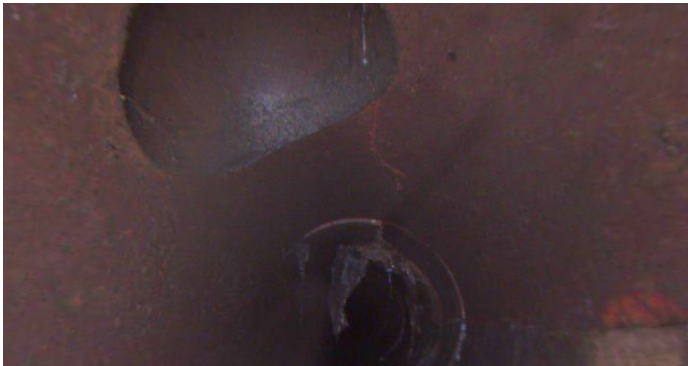
Code: **CM**
Description: **Crack Multiple**

Distance (ft): **78.8**
Structural Grade: **3**
O&M Grade: **0**
Clock Start/From: **12**
Clock To: **5**
1st Value:
2nd Value:
Value Percent:
Continuous Index:
Within 8" of Joint:
Remarks:

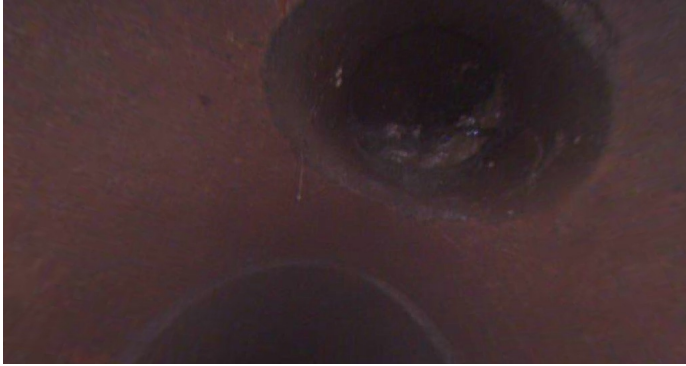
Code: **TF**
Description: **Tap Factory**

Distance (ft): **79.8**
Structural Grade: **0**
O&M Grade: **0**
Clock Start/From: **11**
Clock To:
1st Value: **4.000**
2nd Value:
Value Percent:
Continuous Index:
Within 8" of Joint:
Remarks:

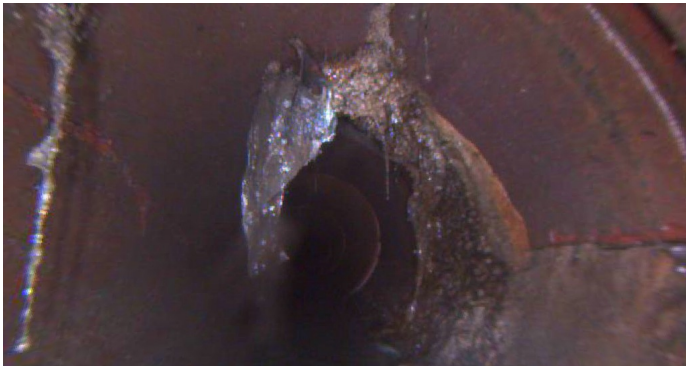
Code: **FM**
Description: **Fracture Multiple**

Distance (ft): **80.3**
Structural Grade: **4**
O&M Grade: **0**
Clock Start/From: **7**
Clock To: **5**
1st Value:
2nd Value:
Value Percent:
Continuous Index: **S02**
Within 8" of Joint:
Remarks:

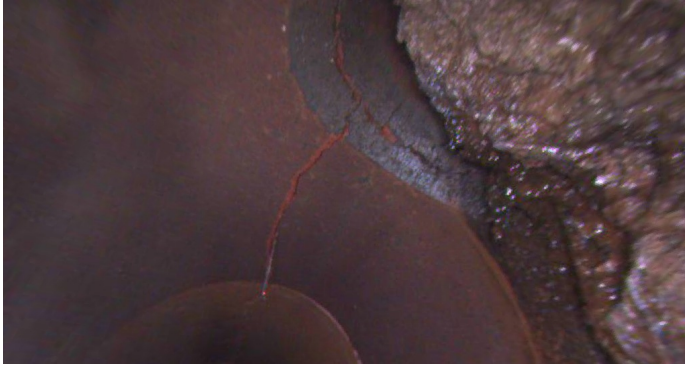
Code: **TFD**
Description: **Tap Factory Defective**

Distance (ft): **81.3**
Structural Grade: **0**
O&M Grade: **2**
Clock Start/From: **2**
Clock To:
1st Value: **4.000**
2nd Value:
Value Percent:
Continuous Index:
Within 8" of Joint:
Remarks: **Debris**

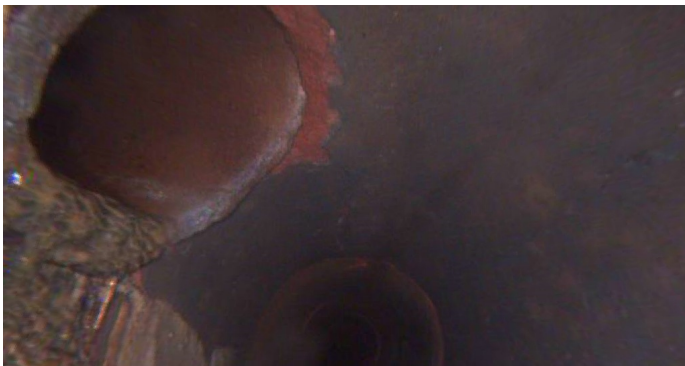
Code: **TB**
Description: **Tap Break-in**

Distance (ft): **91.0**
Structural Grade: **0**
O&M Grade: **0**
Clock Start/From: **10**
Clock To:
1st Value: **4.000**
2nd Value:
Value Percent:
Continuous Index:
Within 8" of Joint:
Remarks:

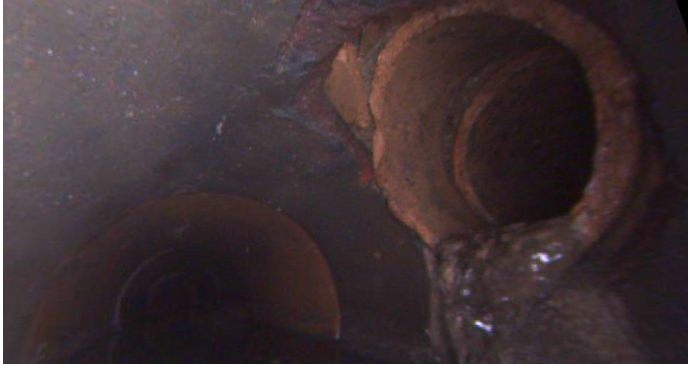
Code: **TB**
Description: **Tap Break-in**

Distance (ft): **118.8**
Structural Grade: **0**
O&M Grade: **0**
Clock Start/From: **2**
Clock To:
1st Value: **4.000**
2nd Value:
Value Percent:
Continuous Index:
Within 8" of Joint:
Remarks:

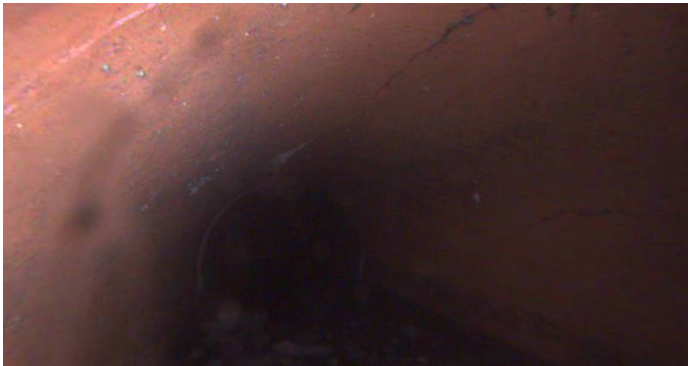
Code: **FM**
Description: **Fracture Multiple**

Distance (ft): **120.2**
Structural Grade: **4**
O&M Grade: **0**
Clock Start/From: **7**
Clock To: **5**
1st Value:
2nd Value:
Value Percent:
Continuous Index: **F02**
Within 8" of Joint:
Remarks:

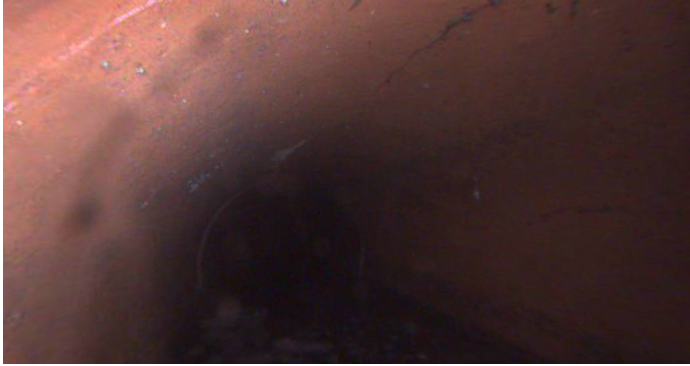
Code:	MSA
Description:	Abandoned Survey
Distance (ft):	120.2
Structural Grade:	0
O&M Grade:	0
Clock Start/From:	
Clock To:	
1st Value:	
2nd Value:	
Value Percent:	
Continuous Index:	
Within 8" of Joint:	NO
Remarks:	Debris
