Profile/Photo Observation Report

Date:	04/26/2018	Weather:		Coding:	PACP 6.0
Pipe Length (ft):	232.6	Owner:	NA	Pre Clean:	Not Known
P.O.#:		Surveyor:	Mark Ruby	PSR:	P-605-042-011
Customer:		Clean Date:	01/01/1900	Shape:	C

Street:	Washington	Flow Control:	Not Controlled
City:	Hobart, IN	Year Renewed:	
Location:	Other	Tape/Media #:	
Purpose:	Not Known	Dia/Height:	12"
Use:	Sanitary	Material:	VCP
Drain Area:	NA	Lining:	
Category:	NA		
Comment:	Flow direction wrong. Debris at 118'.		
Location Details:		Direction of Survey:	Upstream
US MH:	M-605-011	DS MH:	M-605-042
		Total Length Surveyed (ft):	120.2

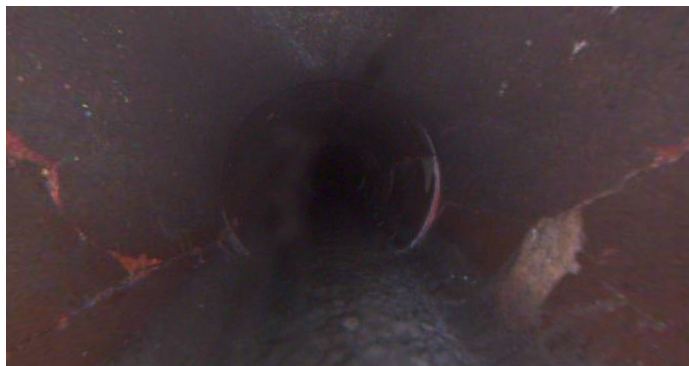
Code: **AMH**
 Description: **Manhole**

Distance (ft): **.0**
 Structural Grade: **0**
 O&M Grade: **0**
 Clock Start/From:
 Clock To:
 1st Value:
 2nd Value:
 Value Percent:
 Continuous Index:
 Within 8" of Joint: **NO**
 Remarks: **M-605-042**

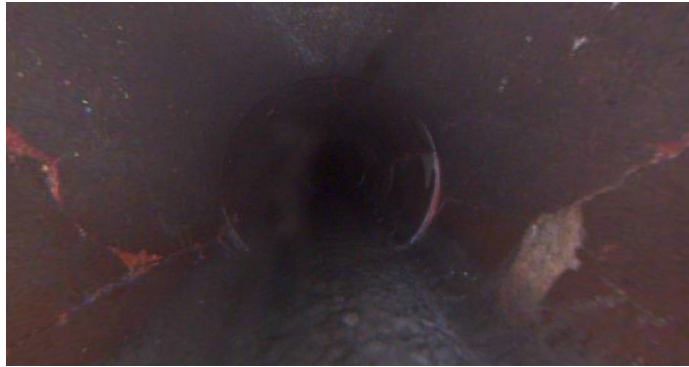
Code: **MWL**
Description: **Water Level**

Distance (ft): **.0**
Structural Grade: **0**
O&M Grade: **0**
Clock Start/From:
Clock To:
1st Value:
2nd Value:
Value Percent: **10.000**
Continuous Index:
Within 8" of Joint: **NO**
Remarks:

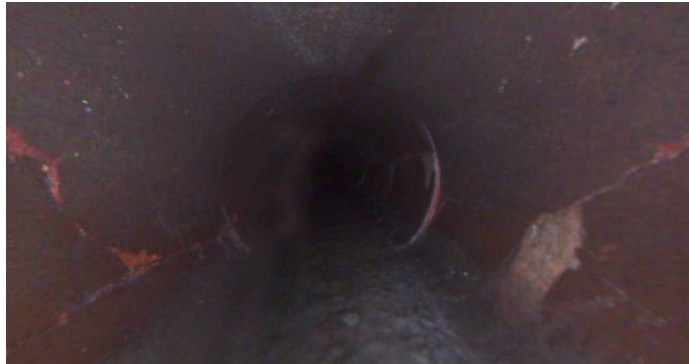
Code: **FM**
Description: **Fracture Multiple**

Distance (ft): **.0**
Structural Grade: **4**
O&M Grade: **0**
Clock Start/From: **7**
Clock To: **5**
1st Value:
2nd Value:
Value Percent:
Continuous Index: **S01**
Within 8" of Joint:
Remarks:

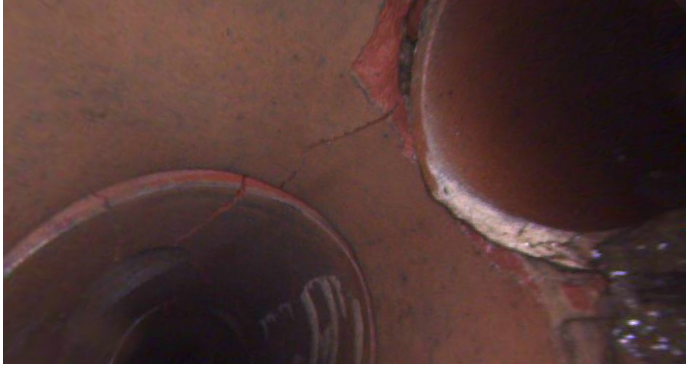
Code: **TB**
Description: **Tap Break-in**

Distance (ft): **21.6**
Structural Grade: **0**
O&M Grade: **0**
Clock Start/From: **2**
Clock To:
1st Value: **4.000**
2nd Value:
Value Percent:
Continuous Index:
Within 8" of Joint:
Remarks:

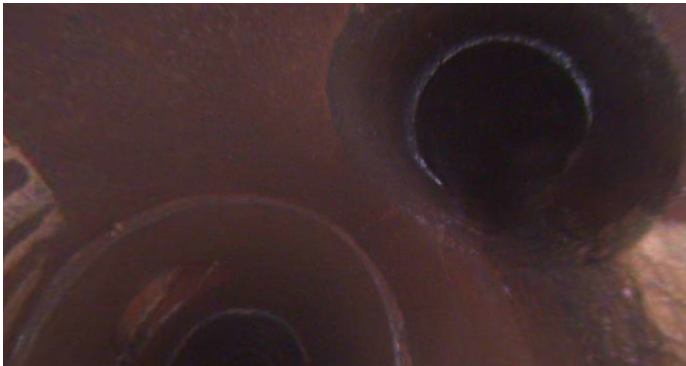
Code: **TF**
Description: **Tap Factory**

Distance (ft): **23.8**
Structural Grade: **0**
O&M Grade: **0**
Clock Start/From: **10**
Clock To:
1st Value: **4.000**
2nd Value:
Value Percent:
Continuous Index:
Within 8" of Joint:
Remarks:

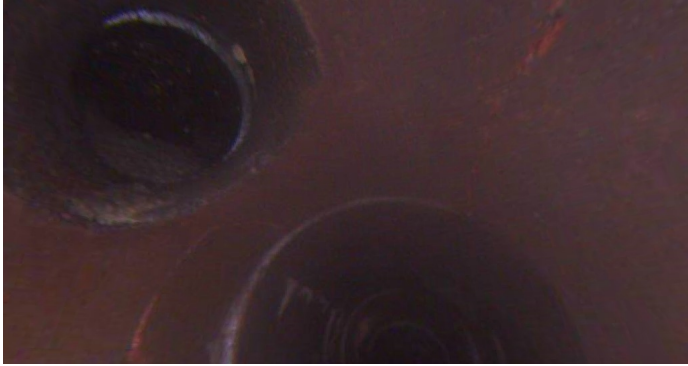
Code: **TF**
Description: **Tap Factory**

Distance (ft): **25.9**
Structural Grade: **0**
O&M Grade: **0**
Clock Start/From: **2**
Clock To:
1st Value: **4.000**
2nd Value:
Value Percent:
Continuous Index:
Within 8" of Joint:
Remarks:

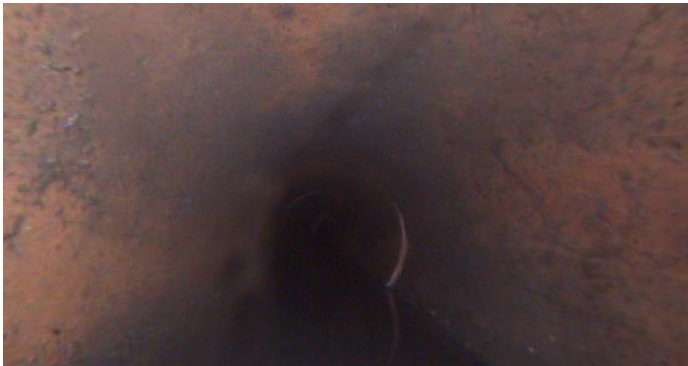
Code: **FM**
Description: **Fracture Multiple**

Distance (ft): **72.3**
Structural Grade: **4**
O&M Grade: **0**
Clock Start/From: **7**
Clock To: **5**
1st Value:
2nd Value:
Value Percent:
Continuous Index: **F01**
Within 8" of Joint:
Remarks:

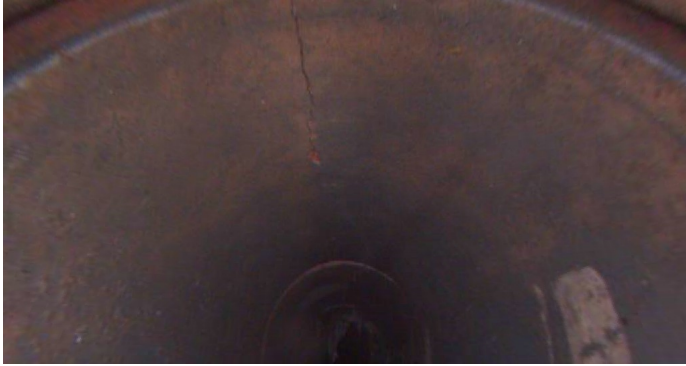
Code: **CL**
Description: **Crack Longitudinal**

Distance (ft): **76.2**
Structural Grade: **2**
O&M Grade: **0**
Clock Start/From: **11**
Clock To:
1st Value:
2nd Value:
Value Percent:
Continuous Index:
Within 8" of Joint: **YES**
Remarks:

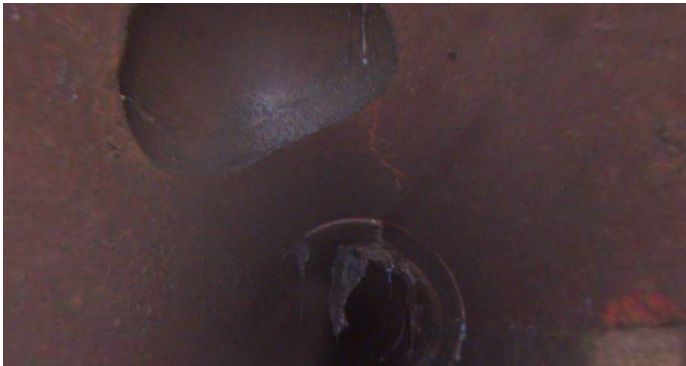
Code: **CM**
Description: **Crack Multiple**

Distance (ft): **78.8**
Structural Grade: **3**
O&M Grade: **0**
Clock Start/From: **12**
Clock To: **5**
1st Value:
2nd Value:
Value Percent:
Continuous Index:
Within 8" of Joint:
Remarks:

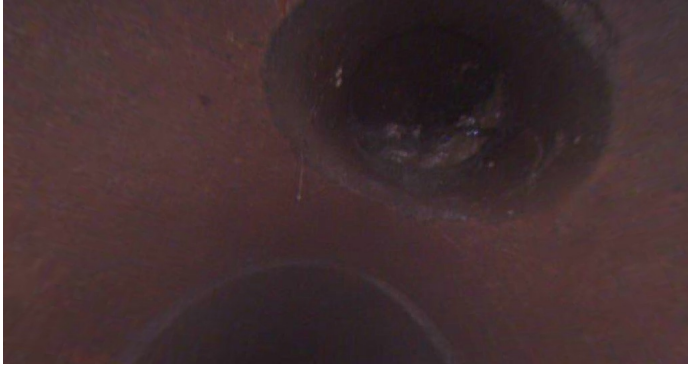
Code: **TF**
Description: **Tap Factory**

Distance (ft): **79.8**
Structural Grade: **0**
O&M Grade: **0**
Clock Start/From: **11**
Clock To:
1st Value: **4.000**
2nd Value:
Value Percent:
Continuous Index:
Within 8" of Joint:
Remarks:

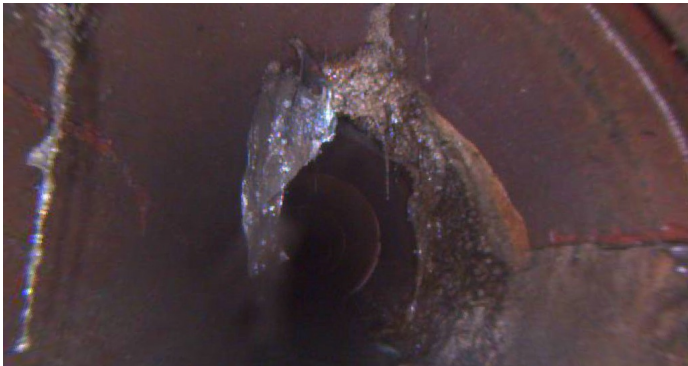
Code: **FM**
Description: **Fracture Multiple**

Distance (ft): **80.3**
Structural Grade: **4**
O&M Grade: **0**
Clock Start/From: **7**
Clock To: **5**
1st Value:
2nd Value:
Value Percent:
Continuous Index: **S02**
Within 8" of Joint:
Remarks:

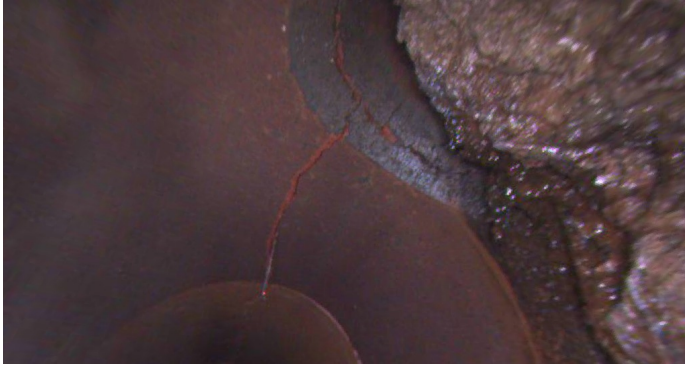
Code: **TFD**
Description: **Tap Factory Defective**

Distance (ft): **81.3**
Structural Grade: **0**
O&M Grade: **2**
Clock Start/From: **2**
Clock To:
1st Value: **4.000**
2nd Value:
Value Percent:
Continuous Index:
Within 8" of Joint:
Remarks: **Debris**

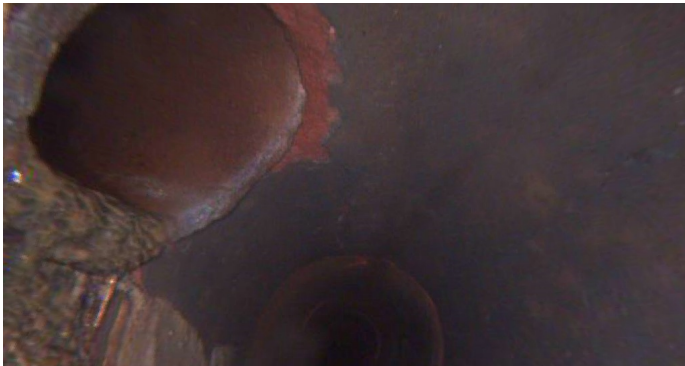
Code: **TB**
Description: **Tap Break-in**

Distance (ft): **91.0**
Structural Grade: **0**
O&M Grade: **0**
Clock Start/From: **10**
Clock To:
1st Value: **4.000**
2nd Value:
Value Percent:
Continuous Index:
Within 8" of Joint:
Remarks:

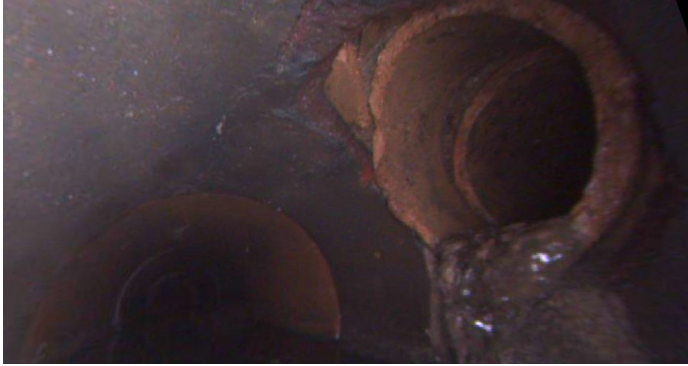
Code: **TB**
Description: **Tap Break-in**

Distance (ft): **118.8**
Structural Grade: **0**
O&M Grade: **0**
Clock Start/From: **2**
Clock To:
1st Value: **4.000**
2nd Value:
Value Percent:
Continuous Index:
Within 8" of Joint:
Remarks:

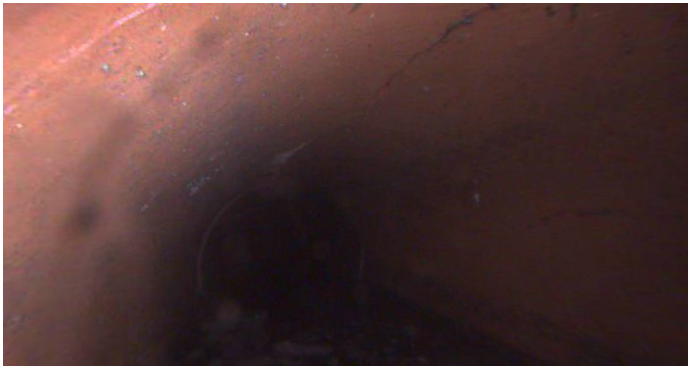
Code: **FM**
Description: **Fracture Multiple**

Distance (ft): **120.2**
Structural Grade: **4**
O&M Grade: **0**
Clock Start/From: **7**
Clock To: **5**
1st Value:
2nd Value:
Value Percent:
Continuous Index: **F02**
Within 8" of Joint:
Remarks:

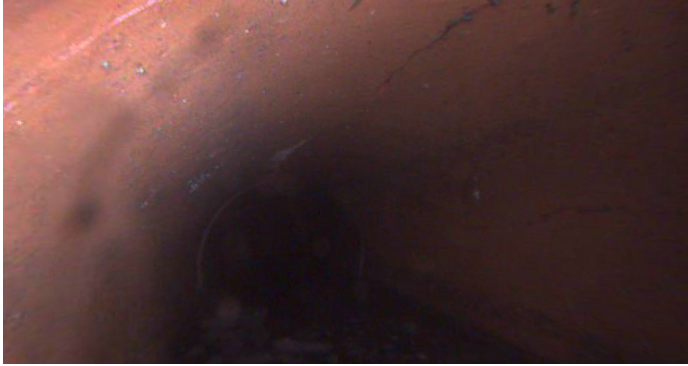
Code:	MSA
Description:	Abandoned Survey
Distance (ft):	120.2
Structural Grade:	0
O&M Grade:	0
Clock Start/From:	
Clock To:	
1st Value:	
2nd Value:	
Value Percent:	
Continuous Index:	
Within 8" of Joint:	NO
Remarks:	Debris
