Profile/Photo Observation Report

Date:	11/17/2021	Weather:		Coding:	PACP 7.0
Pipe Length (ft):	233.0	Owner:	City of Hobart	Pre Clean:	Heavy Cleaning
P.O.#:	YES502259	Surveyor:	S. Bucklin	PSR:	P-605-042-011
Customer:	City of Hobart	Clean Date:	11/17/2021	Shape:	C

Street:	South Washington Street	Flow Control:	Not Controlled
City:	Hobart, IN	Year Renewed:	
Location:	Local rural streets with light traffic, t	Tape/Media #:	
Purpose:	Routine Assessment	Dia/Height:	12"
Use:	Sanitary Sewage Pipe	Material:	VCP
Drain Area:		Lining:	None
Category:	NA		
Comment:			
Location Details:		Direction of Survey:	Downstream
US MH:	M-605-011	DS MH:	M-605-042
		Total Length Surveyed (ft):	127.6

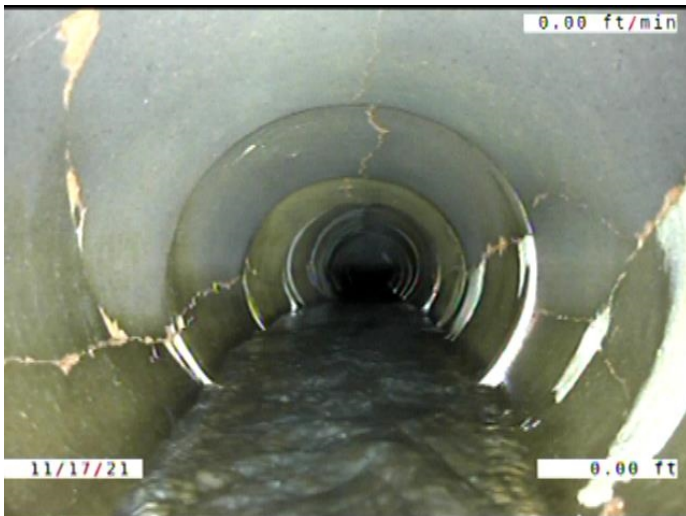
Code: **MWL**
Description: **Miscellaneous Water Level**

Distance (ft): **.0**
Structural Grade: **0**
O&M Grade: **0**
Clock Start/From:
Clock To:
1st Value:
2nd Value:
Value Percent: **10.000**
Continuous Index:
Within 8" of Joint: **NO**
Remarks:

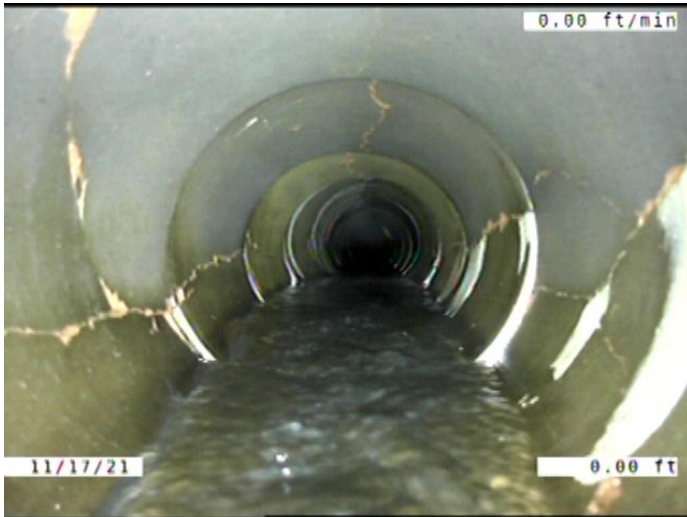
Code: **B**
 Description: **Broken**

Distance (ft): **.0**
 Structural Grade: **4**
 O&M Grade: **0**
 Clock Start/From: **12**
 Clock To: **12**
 1st Value:
 2nd Value:
 Value Percent:
 Continuous Index: **S01**
 Within 8" of Joint: **YES**
 Remarks:

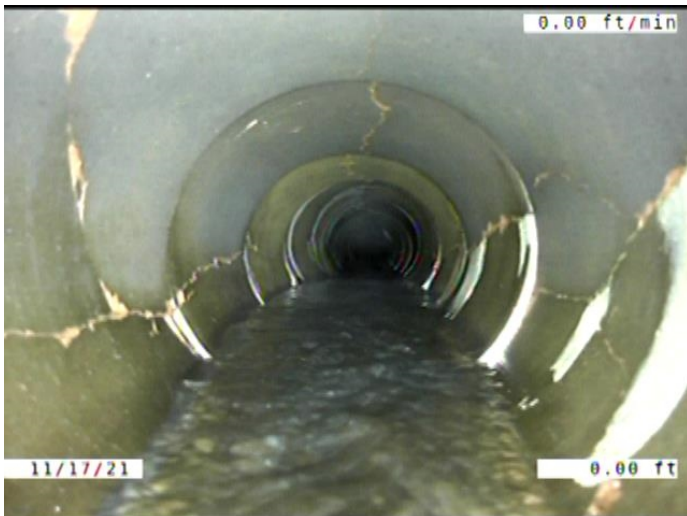
Code: **DAE**
 Description: **Deposits Attached Encrustation**

Distance (ft): **.0**
 Structural Grade: **0**
 O&M Grade: **2**
 Clock Start/From: **7**
 Clock To: **5**
 1st Value:
 2nd Value:
 Value Percent: **5.000**
 Continuous Index: **S02**
 Within 8" of Joint: **YES**
 Remarks:

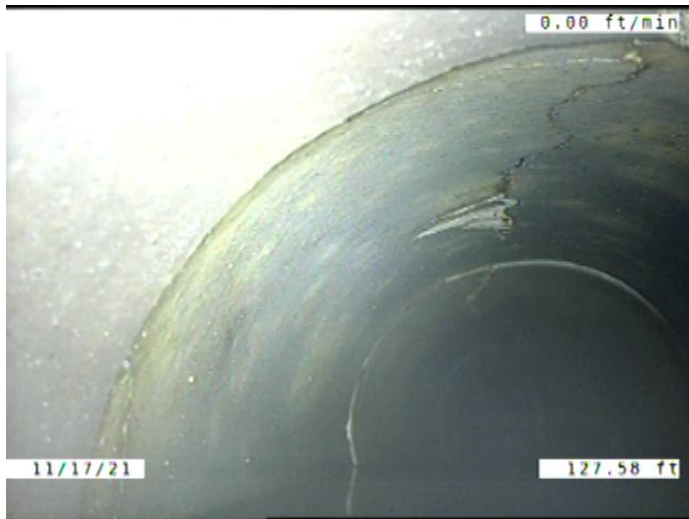
Code: **B**
Description: **Broken**

Distance (ft): **8.6**
Structural Grade: **4**
O&M Grade: **0**
Clock Start/From: **12**
Clock To: **12**
1st Value:
2nd Value:
Value Percent:
Continuous Index: **F01**
Within 8" of Joint: **YES**
Remarks:

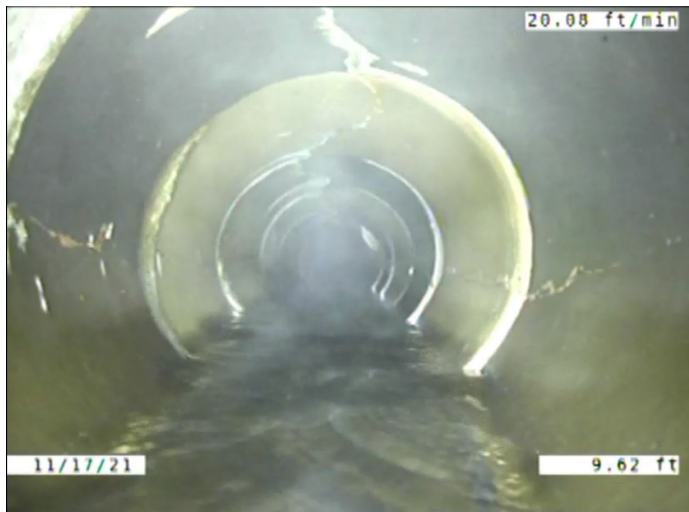
Code: **FM**
Description: **Fracture Multiple**

Distance (ft): **9.6**
Structural Grade: **4**
O&M Grade: **0**
Clock Start/From: **8**
Clock To: **4**
1st Value:
2nd Value:
Value Percent:
Continuous Index: **S03**
Within 8" of Joint: **YES**
Remarks:

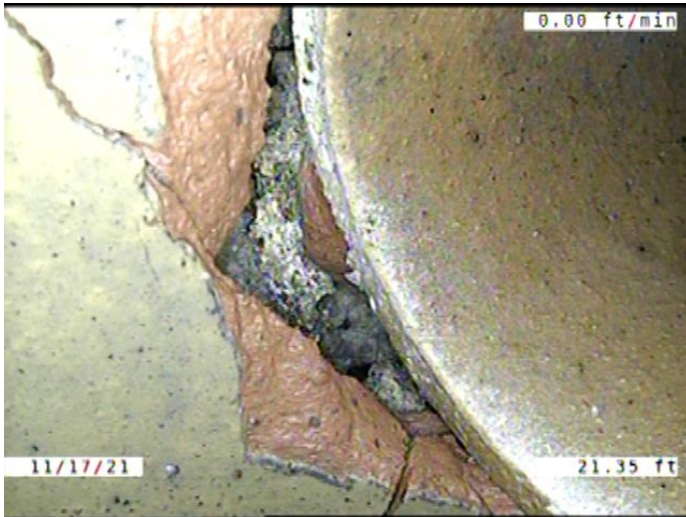
Code: **SSS**
 Description: **Surface Damage Surface Spalling**

Distance (ft): **21.4**
 Structural Grade: **2**
 O&M Grade: **0**
 Clock Start/From: **1**
 Clock To: **3**
 1st Value:
 2nd Value:
 Value Percent:
 Continuous Index:
 Within 8" of Joint: **NO**
 Remarks:

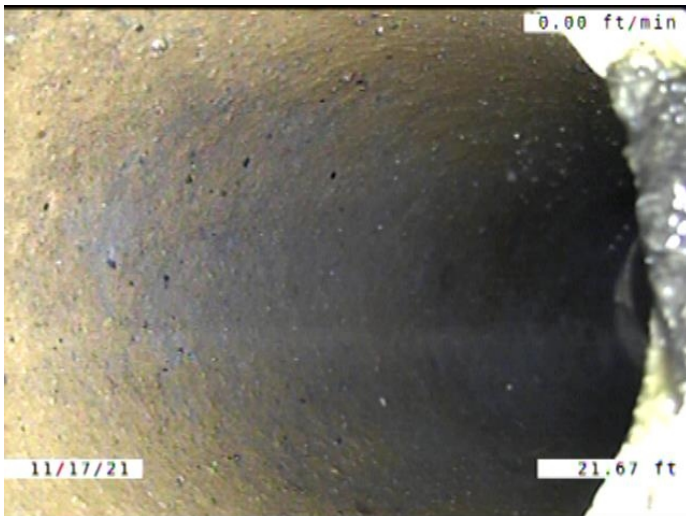
Code: **TBI**
 Description: **Tap Break-in Intruding**

Distance (ft): **21.7**
 Structural Grade: **0**
 O&M Grade: **2**
 Clock Start/From: **1**
 Clock To:
 1st Value: **4.000**
 2nd Value: **1.000**
 Value Percent:
 Continuous Index:
 Within 8" of Joint: **YES**
 Remarks:

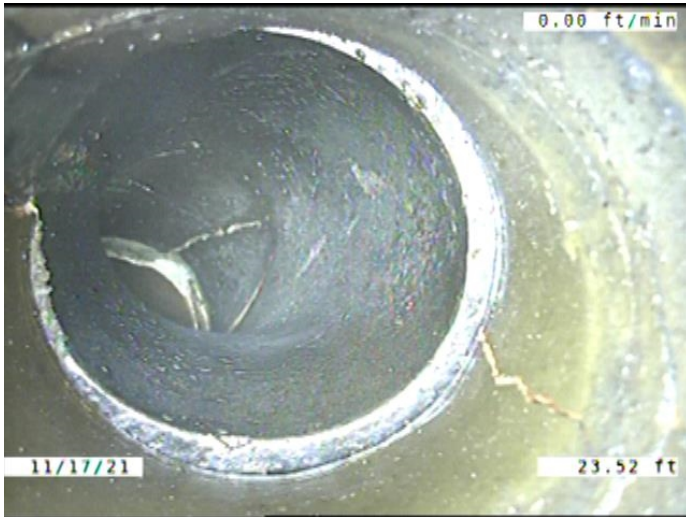
Code: **TFD**
 Description: **Tap Factory Defective**

Distance (ft): **23.5**
 Structural Grade: **0**
 O&M Grade: **3**
 Clock Start/From: **11**
 Clock To:
 1st Value: **4.000**
 2nd Value:
 Value Percent:
 Continuous Index:
 Within 8" of Joint: **YES**
 Remarks: **BROKEN.**

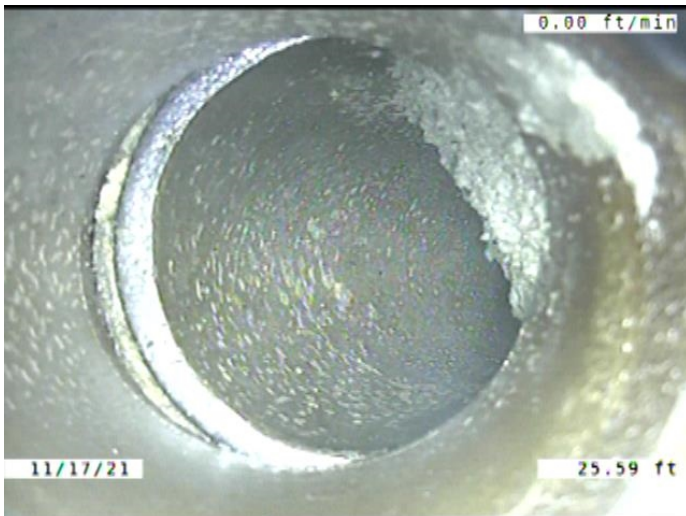
Code: **TFD**
 Description: **Tap Factory Defective**

Distance (ft): **25.6**
 Structural Grade: **0**
 O&M Grade: **3**
 Clock Start/From: **2**
 Clock To:
 1st Value: **4.000**
 2nd Value:
 Value Percent:
 Continuous Index:
 Within 8" of Joint: **YES**
 Remarks: **OFFSET.**

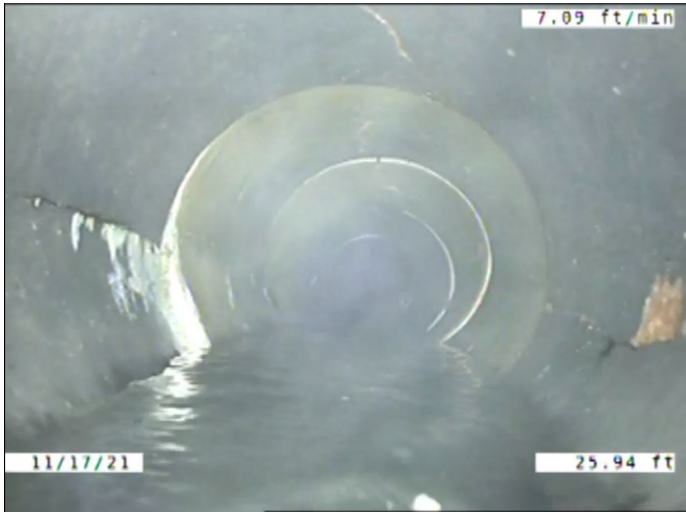
Code: **SSS**
Description: **Surface Damage Surface Spalling**

Distance (ft): **25.9**
Structural Grade: **2**
O&M Grade: **0**
Clock Start/From: **3**
Clock To:
1st Value:
2nd Value:
Value Percent:
Continuous Index:
Within 8" of Joint: **NO**
Remarks:

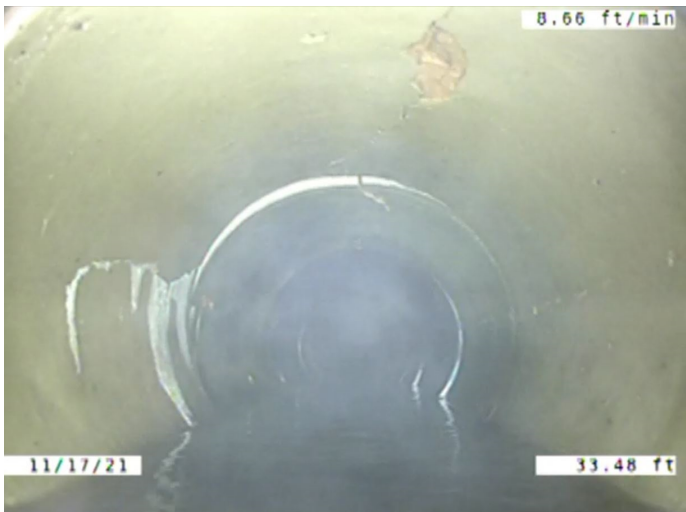
Code: **SSS**
Description: **Surface Damage Surface Spalling**

Distance (ft): **33.5**
Structural Grade: **2**
O&M Grade: **0**
Clock Start/From: **12**
Clock To:
1st Value:
2nd Value:
Value Percent:
Continuous Index:
Within 8" of Joint: **NO**
Remarks:

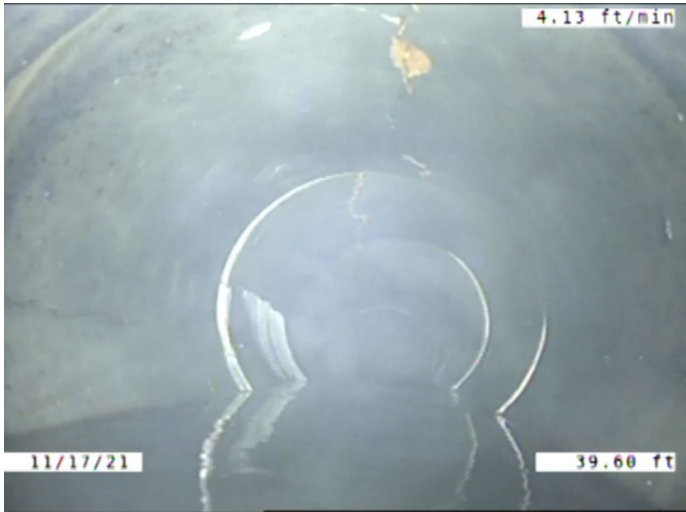
Code: **SSS**
Description: **Surface Damage Surface Spalling**

Distance (ft): **39.6**
Structural Grade: **2**
O&M Grade: **0**
Clock Start/From: **12**
Clock To:
1st Value:
2nd Value:
Value Percent:
Continuous Index:
Within 8" of Joint: **NO**
Remarks:

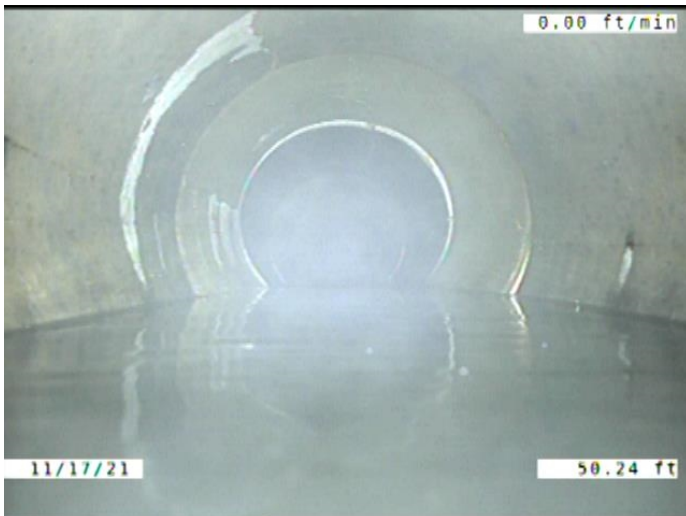
Code: **MWLS**
Description: **Miscellaneous Water Level Sag**

Distance (ft): **50.2**
Structural Grade: **2**
O&M Grade: **0**
Clock Start/From:
Clock To:
1st Value:
2nd Value:
Value Percent: **15.000**
Continuous Index:
Within 8" of Joint: **NO**
Remarks:

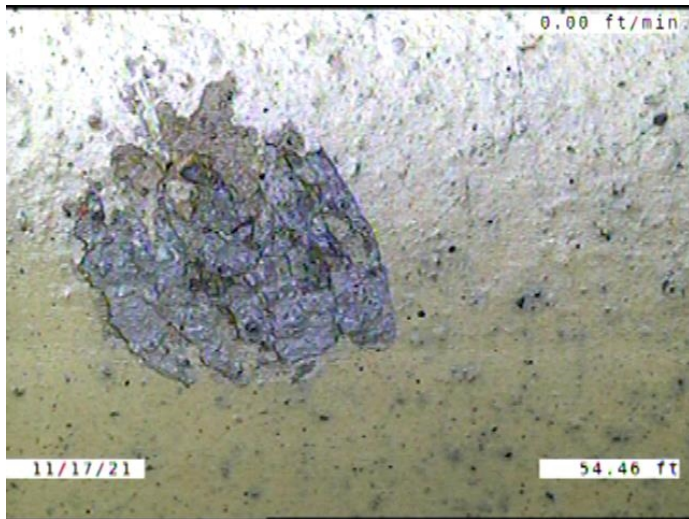
Code: **SSS**
Description: **Surface Damage Surface Spalling**

Distance (ft): **54.5**
Structural Grade: **2**
O&M Grade: **0**
Clock Start/From: **11**
Clock To:
1st Value:
2nd Value:
Value Percent:
Continuous Index:
Within 8" of Joint: **YES**
Remarks:

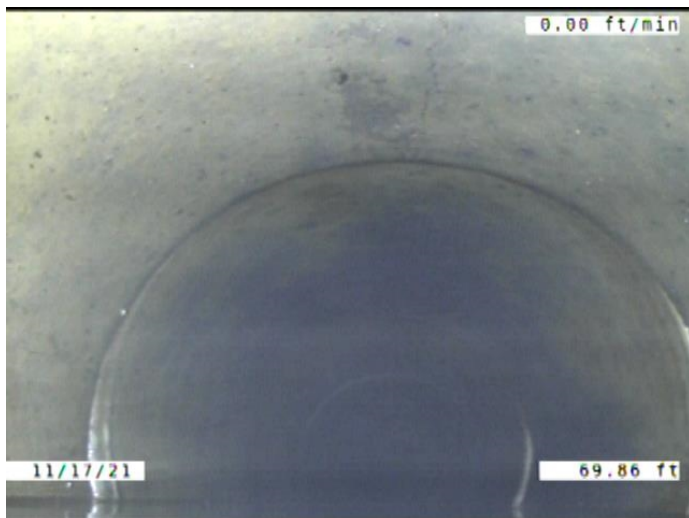
Code: **MWLS**
Description: **Miscellaneous Water Level Sag**

Distance (ft): **69.9**
Structural Grade: **2**
O&M Grade: **0**
Clock Start/From:
Clock To:
1st Value:
2nd Value:
Value Percent: **15.000**
Continuous Index:
Within 8" of Joint: **NO**
Remarks:

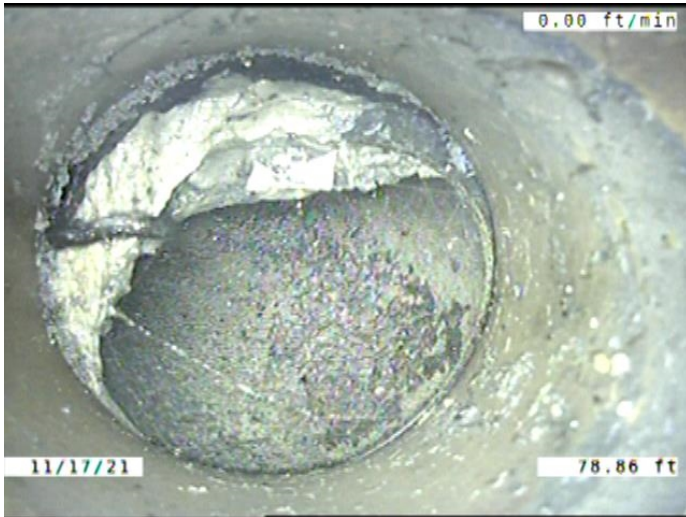
Code: **TFD**
Description: **Tap Factory Defective**

Distance (ft): **78.9**
Structural Grade: **0**
O&M Grade: **3**
Clock Start/From: **11**
Clock To:
1st Value: **4.000**
2nd Value:
Value Percent:
Continuous Index:
Within 8" of Joint: **YES**
Remarks: **BROKEN. OFFSET. ROOTS GROWING FROM THE JOINT.**

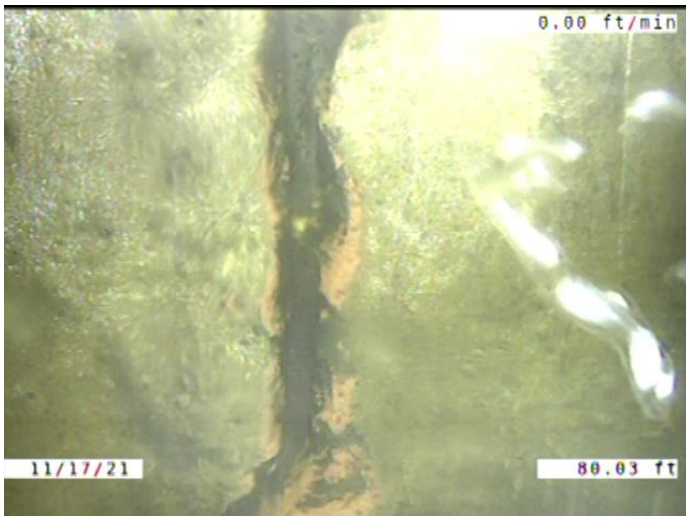
Code: **B**
Description: **Broken**

Distance (ft): **80.0**
Structural Grade: **4**
O&M Grade: **0**
Clock Start/From: **5**
Clock To:
1st Value:
2nd Value:
Value Percent:
Continuous Index:
Within 8" of Joint: **YES**
Remarks:

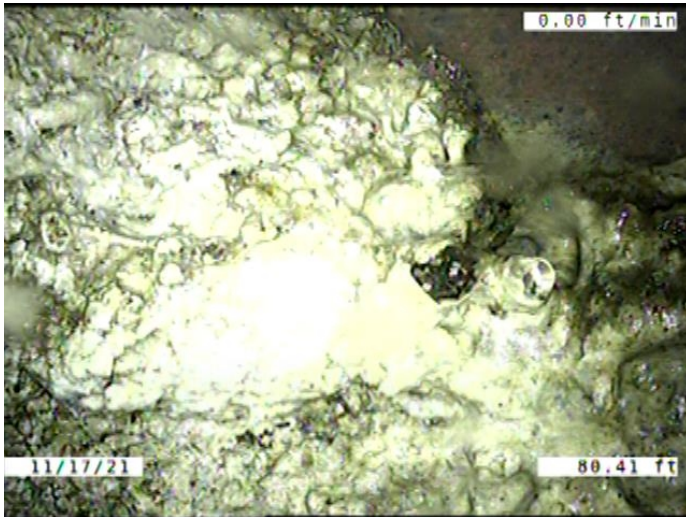
Code: **IDC**
 Description: **Infiltration Dripper Connection**

Distance (ft): **80.4**
 Structural Grade: **0**
 O&M Grade: **3**
 Clock Start/From: **1**
 Clock To:
 1st Value:
 2nd Value:
 Value Percent:
 Continuous Index:
 Within 8" of Joint: **YES**
 Remarks:

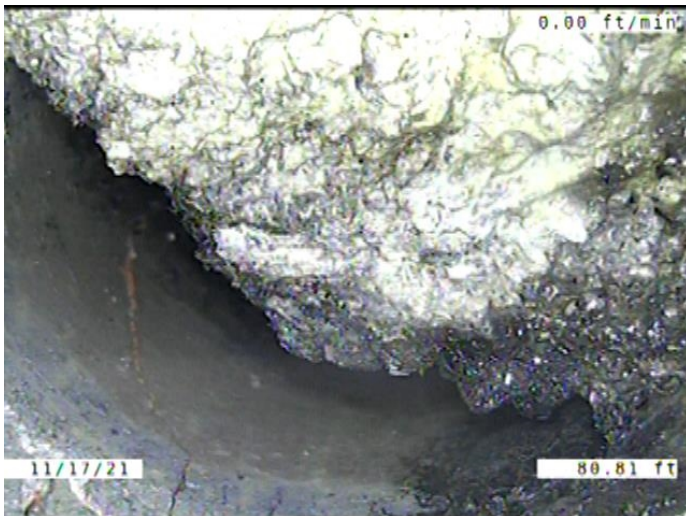
Code: **TFD**
 Description: **Tap Factory Defective**

Distance (ft): **80.8**
 Structural Grade: **0**
 O&M Grade: **3**
 Clock Start/From: **1**
 Clock To:
 1st Value: **4.000**
 2nd Value:
 Value Percent:
 Continuous Index:
 Within 8" of Joint: **YES**
 Remarks: **BROKEN. 85% PLUGGED WITH ENCRUSTATION.**

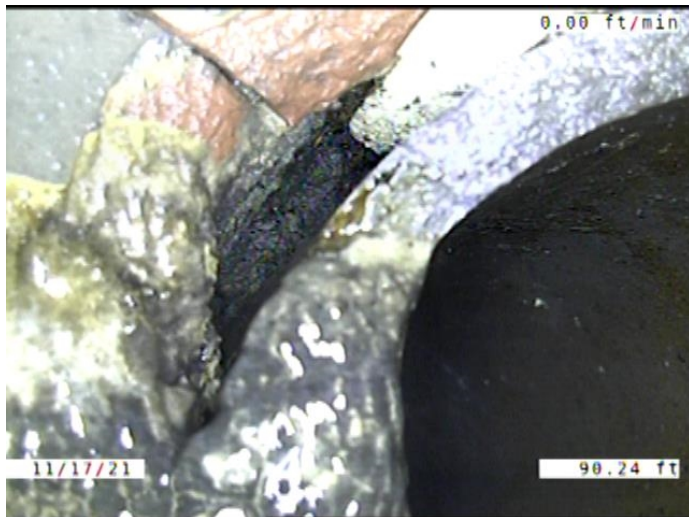
Code: **BSV**
 Description: **Broken Soil Visible**

Distance (ft): **90.2**
 Structural Grade: **5**
 O&M Grade: **0**
 Clock Start/From: **10**
 Clock To: **12**
 1st Value:
 2nd Value:
 Value Percent:
 Continuous Index:
 Within 8" of Joint: **YES**
 Remarks:

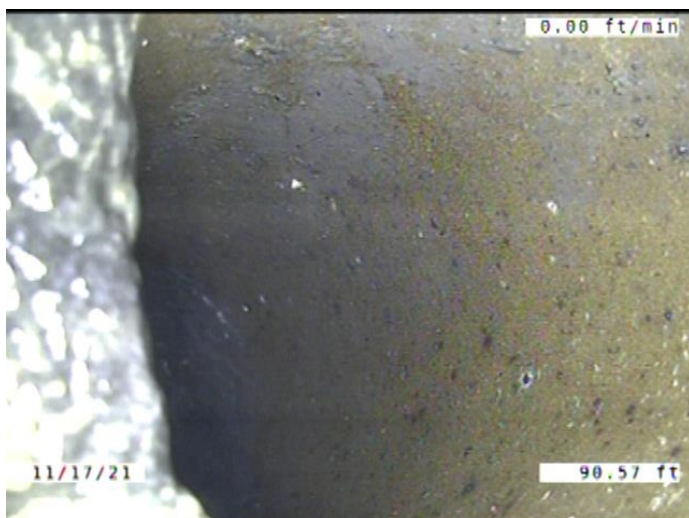
Code: **TBI**
 Description: **Tap Break-in Intruding**

Distance (ft): **90.6**
 Structural Grade: **0**
 O&M Grade: **2**
 Clock Start/From: **11**
 Clock To:
 1st Value: **4.000**
 2nd Value: **1.000**
 Value Percent:
 Continuous Index:
 Within 8" of Joint: **YES**
 Remarks: **CONSTANTLY RUNNING WATER.**

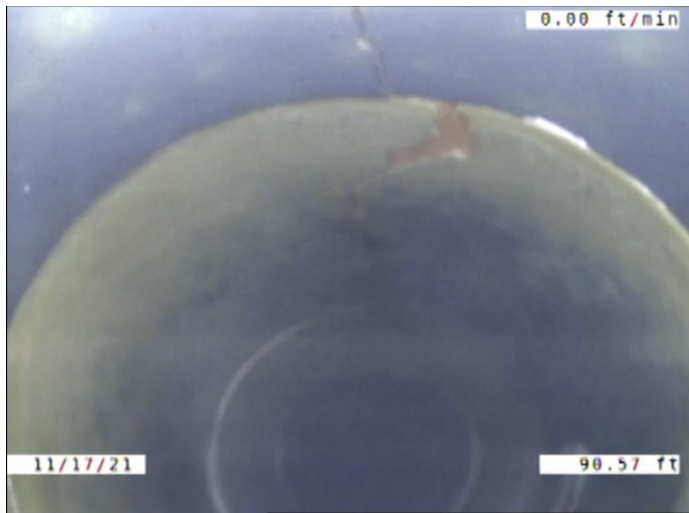
Code: **SSS**
 Description: **Surface Damage Surface Spalling**

Distance (ft): **90.6**
 Structural Grade: **2**
 O&M Grade: **0**
 Clock Start/From: **12**
 Clock To:
 1st Value:
 2nd Value:
 Value Percent:
 Continuous Index:
 Within 8" of Joint: **YES**
 Remarks:

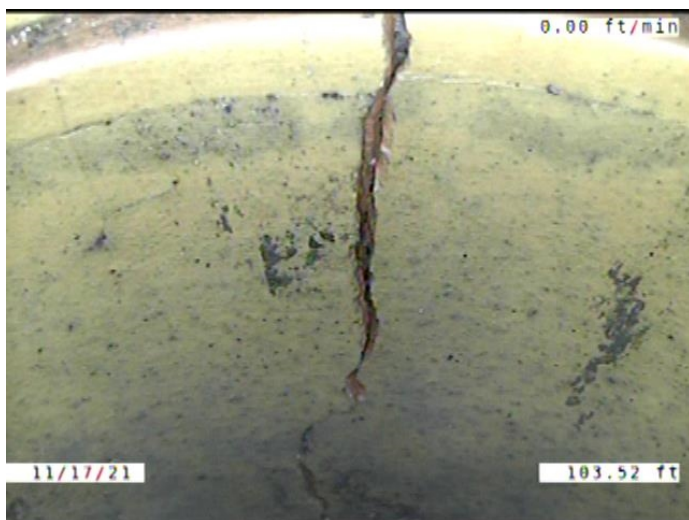
Code: **DR**
 Description: **Deformed Rigid**

Distance (ft): **103.5**
 Structural Grade: **4**
 O&M Grade: **0**
 Clock Start/From:
 Clock To:
 1st Value:
 2nd Value:
 Value Percent: **5.000**
 Continuous Index:
 Within 8" of Joint: **NO**
 Remarks:

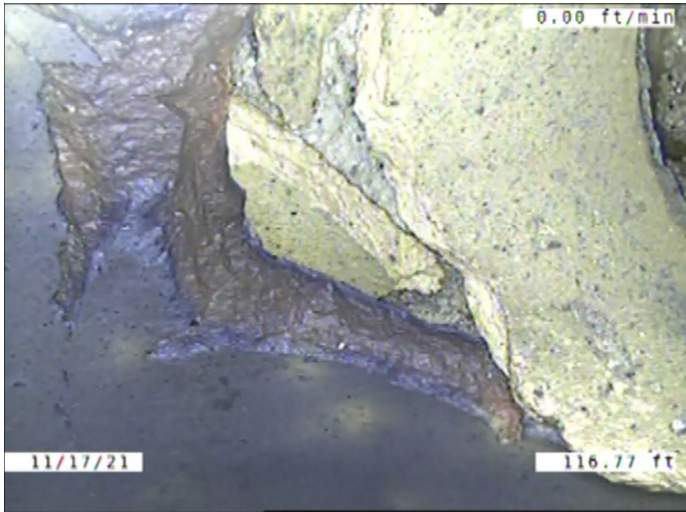
Code: **SSS**
 Description: **Surface Damage Surface Spalling**

Distance (ft): **116.8**
 Structural Grade: **2**
 O&M Grade: **0**
 Clock Start/From: **1**
 Clock To: **3**
 1st Value:
 2nd Value:
 Value Percent:
 Continuous Index:
 Within 8" of Joint: **NO**
 Remarks:

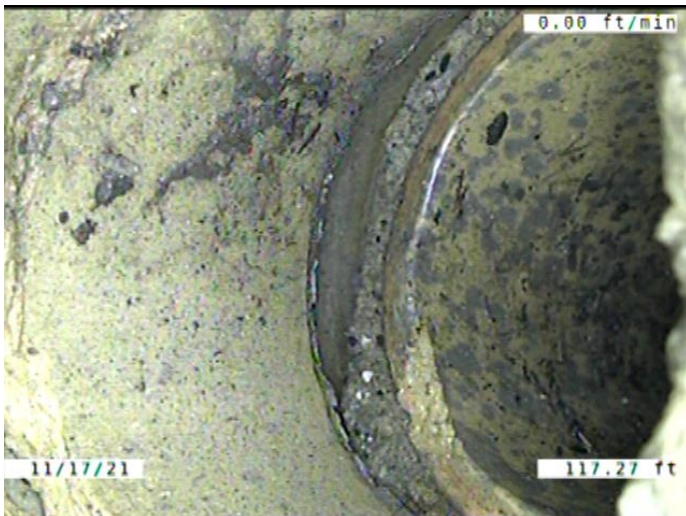
Code: **TBI**
 Description: **Tap Break-in Intruding**

Distance (ft): **117.3**
 Structural Grade: **0**
 O&M Grade: **2**
 Clock Start/From: **1**
 Clock To:
 1st Value: **4.000**
 2nd Value: **2.000**
 Value Percent:
 Continuous Index:
 Within 8" of Joint: **YES**
 Remarks: **ANGLED JOINT. ENCRUSTATION
 COMING OUT OF THE TAP AND INTO**

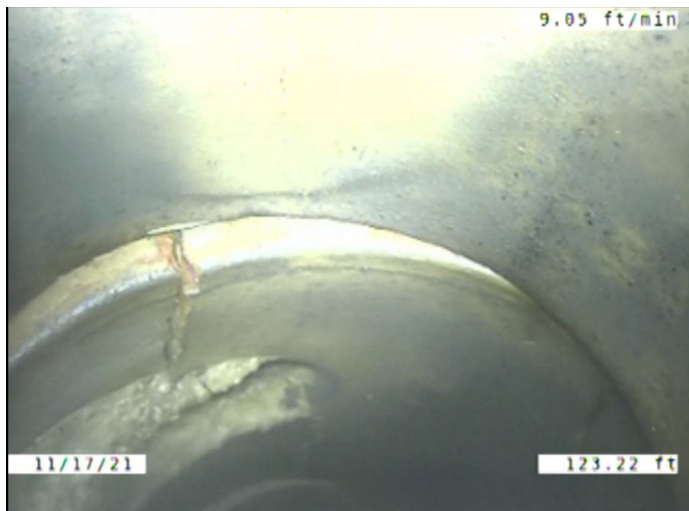
Code: **B**
 Description: **Broken**

Distance (ft): **123.2**
 Structural Grade: **4**
 O&M Grade: **0**
 Clock Start/From: **12**
 Clock To:
 1st Value:
 2nd Value:
 Value Percent:
 Continuous Index:
 Within 8" of Joint: **YES**
 Remarks:

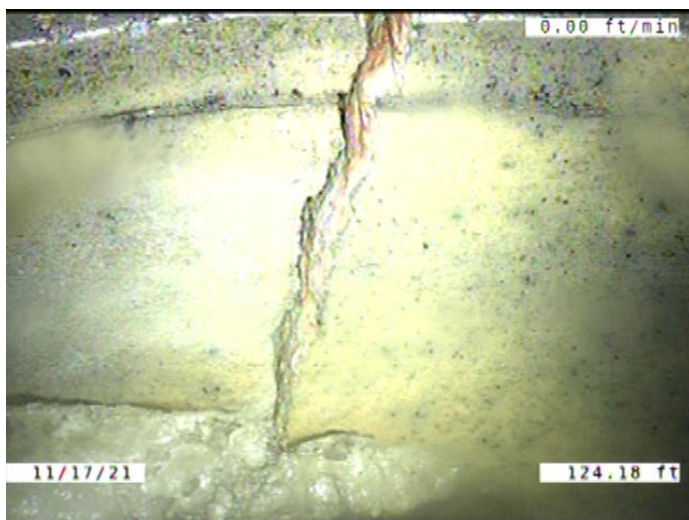
Code: **DR**
 Description: **Deformed Rigid**

Distance (ft): **124.2**
 Structural Grade: **4**
 O&M Grade: **0**
 Clock Start/From:
 Clock To:
 1st Value:
 2nd Value:
 Value Percent: **5.000**
 Continuous Index:
 Within 8" of Joint: **NO**
 Remarks:

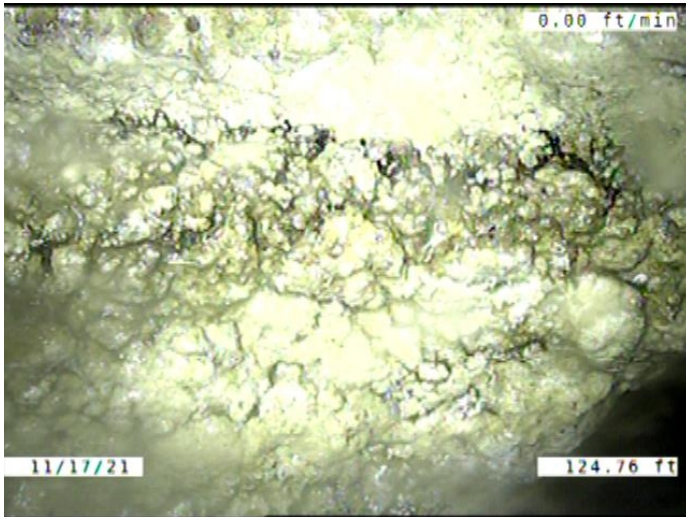
Code:	DAE
Description:	Deposits Attached Encrustation
Distance (ft):	124.8
Structural Grade:	0
O&M Grade:	2
Clock Start/From:	10
Clock To:	12
1st Value:	
2nd Value:	
Value Percent:	10.000
Continuous Index:	
Within 8" of Joint:	YES
Remarks:

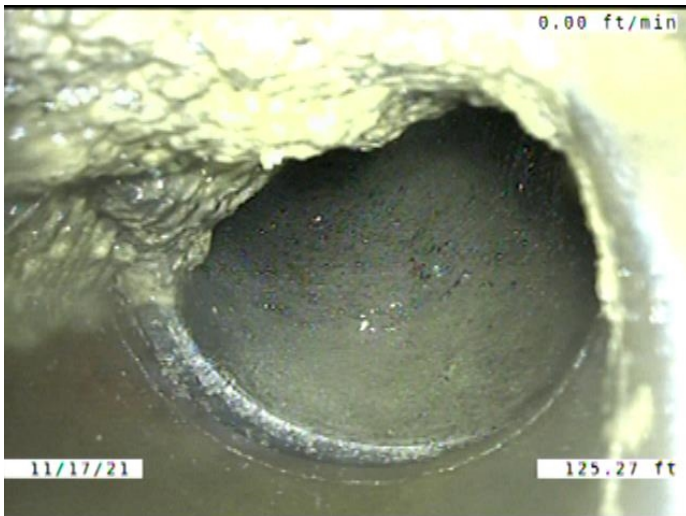
Code:	TFD
Description:	Tap Factory Defective
Distance (ft):	125.3
Structural Grade:	0
O&M Grade:	3
Clock Start/From:	11
Clock To:	
1st Value:	4.000
2nd Value:	
Value Percent:	
Continuous Index:	
Within 8" of Joint:	YES
Remarks:	BROKEN. ENCRUSTATION COMING OUT OF THE TAP INTO THE MAIN.

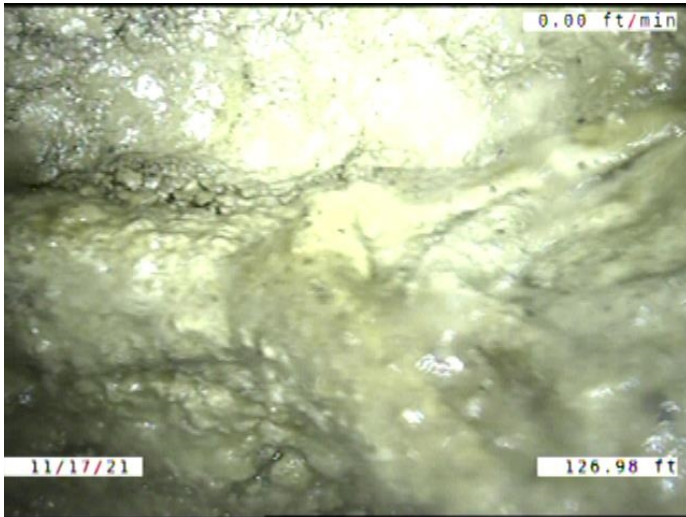
Code: **DAE**
 Description: **Deposits Attached Encrustation**

Distance (ft): **127.0**
 Structural Grade: **0**
 O&M Grade: **2**
 Clock Start/From: **12**
 Clock To: **3**
 1st Value:
 2nd Value:
 Value Percent: **10.000**
 Continuous Index:
 Within 8" of Joint: **YES**
 Remarks:

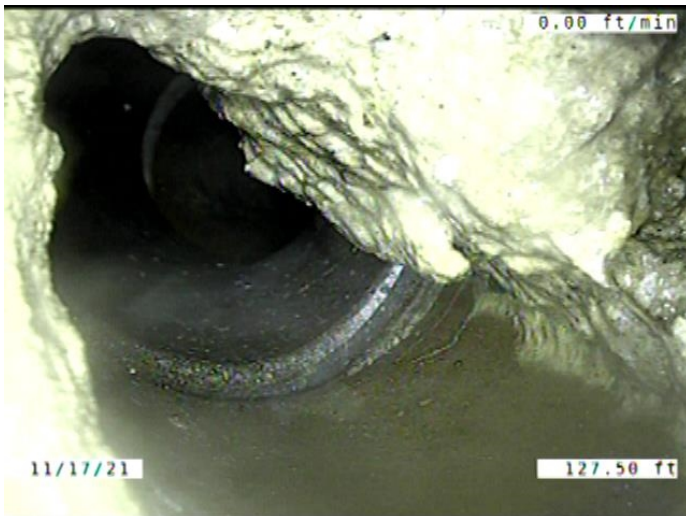
Code: **TFD**
 Description: **Tap Factory Defective**

Distance (ft): **127.5**
 Structural Grade: **0**
 O&M Grade: **3**
 Clock Start/From: **1**
 Clock To:
 1st Value: **4.000**
 2nd Value:
 Value Percent:
 Continuous Index:
 Within 8" of Joint: **YES**
 Remarks: **CONNECTION 50%+ PLUGGED WITH ENCRUSTATION**

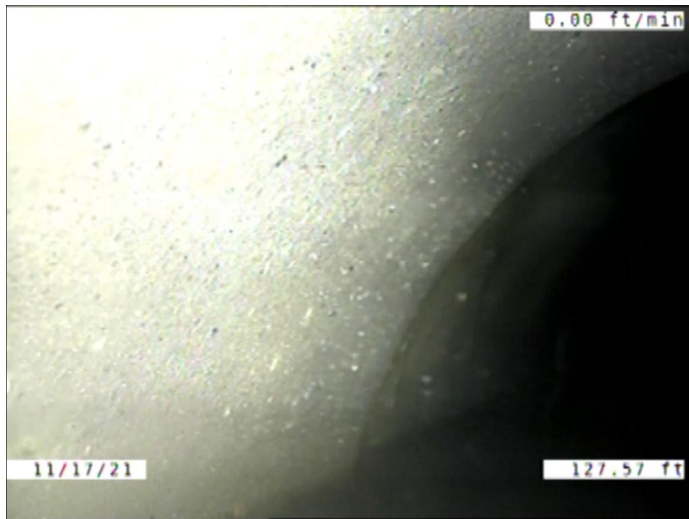
Code: **FM**
 Description: **Fracture Multiple**

Distance (ft): **127.6**
 Structural Grade: **4**
 O&M Grade: **0**
 Clock Start/From: **8**
 Clock To: **4**
 1st Value:
 2nd Value:
 Value Percent:
 Continuous Index: **F03**
 Within 8" of Joint: **NO**
 Remarks:

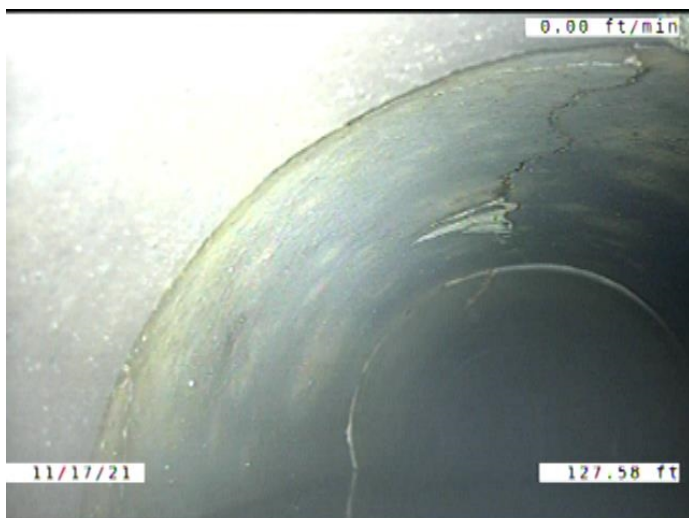
Code: **DAE**
 Description: **Deposits Attached Encrustation**

Distance (ft): **127.6**
 Structural Grade: **0**
 O&M Grade: **2**
 Clock Start/From: **7**
 Clock To: **5**
 1st Value:
 2nd Value:
 Value Percent: **5.000**
 Continuous Index: **F02**
 Within 8" of Joint: **YES**
 Remarks:
