## Profile/Photo Observation Report

Date:	<b>11/17/2021</b>	Weather:		Coding:	<b>PACP 7.0</b>
Pipe Length (ft):	<b>233.0</b>	Owner:	<b>City of Hobart</b>	Pre Clean:	<b>Heavy Cleaning</b>
P.O.#:	<b>YES502259</b>	Surveyor:	<b>S. Bucklin</b>	PSR:	<b>P-605-042-011</b>
Customer:	<b>City of Hobart</b>	Clean Date:	<b>11/17/2021</b>	Shape:	<b>C</b>

Street:	<b>South Washington Street</b>	Flow Control:	<b>Not Controlled</b>
City:	<b>Hobart, IN</b>	Year Renewed:	
Location:	<b>Local rural streets with light traffic, t</b>	Tape/Media #:	
Purpose:	<b>Routine Assessment</b>	Dia/Height:	<b>12"</b>
Use:	<b>Sanitary Sewage Pipe</b>	Material:	<b>VCP</b>
Drain Area:		Lining:	<b>None</b>
Category:	<b>NA</b>		
Comment:			
Location Details:		Direction of Survey:	<b>Downstream</b>
US MH:	<b>M-605-011</b>	DS MH:	<b>M-605-042</b>
		Total Length Surveyed (ft):	<b>127.6</b>

O&M Index:	<b>2.18</b>	O&M Quick:	<b>372E</b>	O&M Rating:	<b>83.00</b>
Structural Index:	<b>3.58</b>	Structural Quick:	<b>514E</b>	Structural Rating:	<b>143.00</b>
Overall Index:	<b>2.90</b>	Overall Quick:	<b>514E</b>	Overall Rating:	<b>226.00</b>

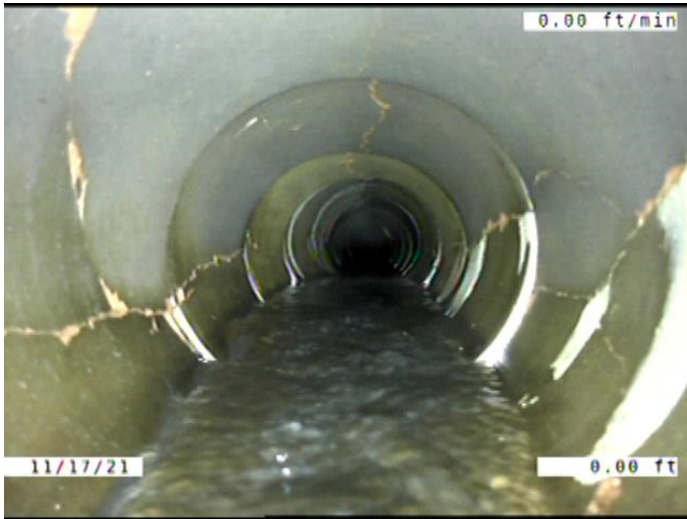
Code: **B**  
Description: **Broken**

Distance (ft): **.0**  
Structural Grade: **4**  
O&M Grade: **0**  
Clock Start/From: **12**  
Clock To: **12**  
1st Value:  
2nd Value:  
Value Percent:  
Continuous Index: **S01**  
Within 8" of Joint: **YES**  
Remarks:

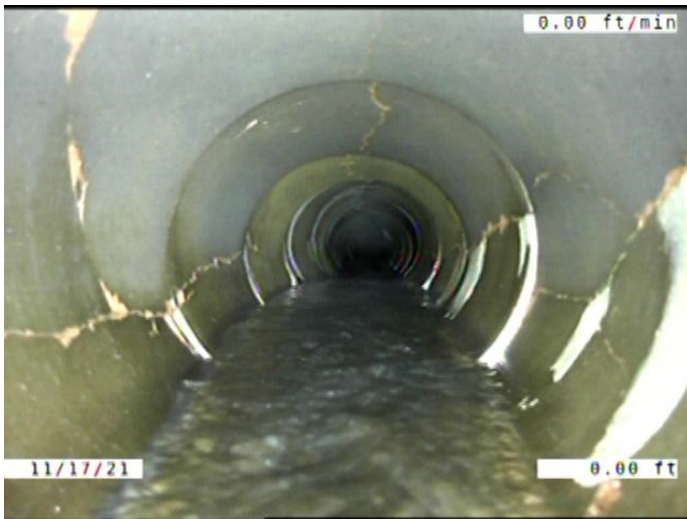
Code: **DAE**  
Description: **Deposits Attached Encrustation**

Distance (ft): **.0**  
Structural Grade: **0**  
O&M Grade: **2**  
Clock Start/From: **7**  
Clock To: **5**  
1st Value:  
2nd Value:  
Value Percent: **5.000**  
Continuous Index: **S02**  
Within 8" of Joint: **YES**  
Remarks:

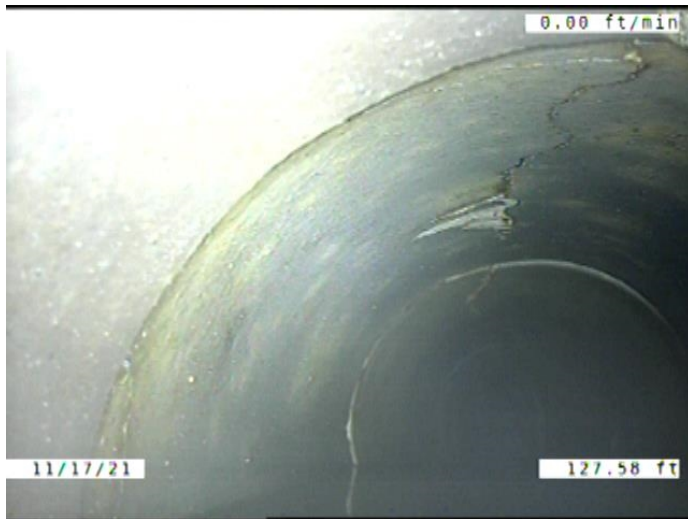
Code: **B**  
Description: **Broken**

Distance (ft): **8.6**  
Structural Grade: **4**  
O&M Grade: **0**  
Clock Start/From: **12**  
Clock To: **12**  
1st Value:  
2nd Value:  
Value Percent:  
Continuous Index: **F01**  
Within 8" of Joint: **YES**  
Remarks:

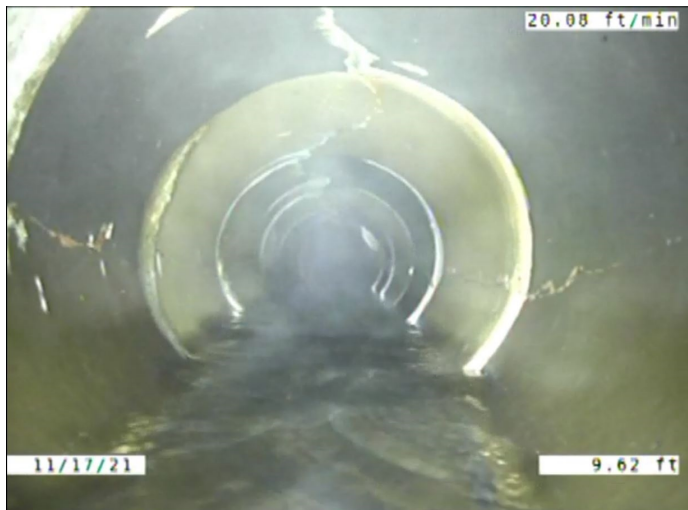
Code: **FM**  
Description: **Fracture Multiple**

Distance (ft): **9.6**  
Structural Grade: **4**  
O&M Grade: **0**  
Clock Start/From: **8**  
Clock To: **4**  
1st Value:  
2nd Value:  
Value Percent:  
Continuous Index: **S03**  
Within 8" of Joint: **YES**  
Remarks:

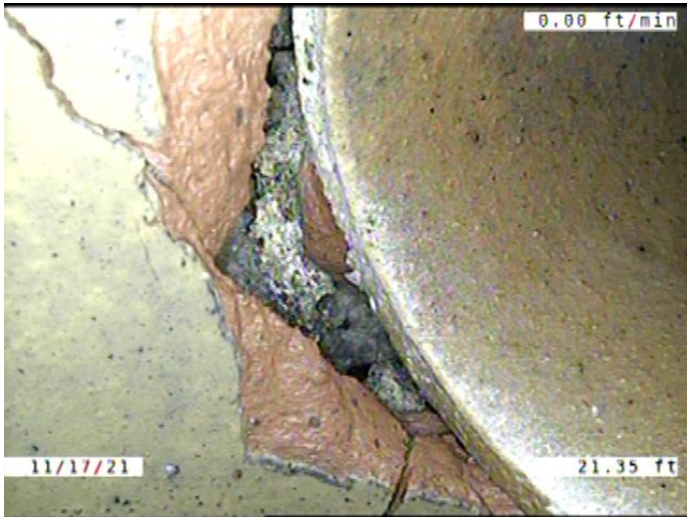
Code:	<b>SSS</b>
Description:	<b>Surface Damage Surface Spalling</b>
Distance (ft):	<b>21.4</b>
Structural Grade:	<b>2</b>
O&M Grade:	<b>0</b>
Clock Start/From:	<b>1</b>
Clock To:	<b>3</b>
1st Value:	
2nd Value:	
Value Percent:	
Continuous Index:	
Within 8" of Joint:	<b>NO</b>
Remarks:

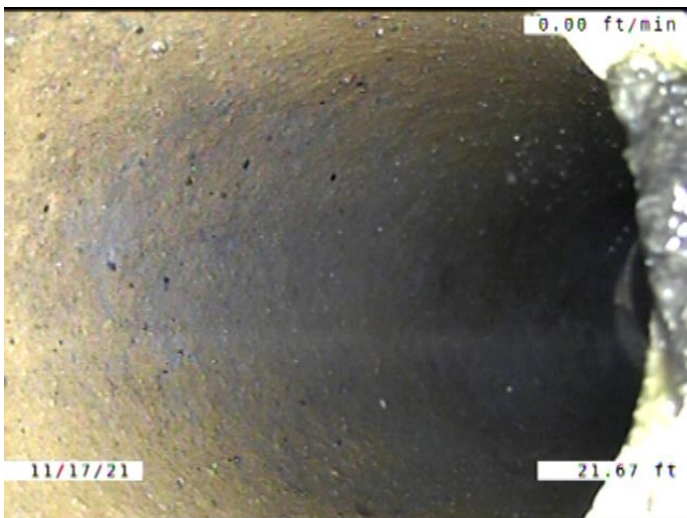
Code:	<b>TBI</b>
Description:	<b>Tap Break-in Intruding</b>
Distance (ft):	<b>21.7</b>
Structural Grade:	<b>0</b>
O&M Grade:	<b>2</b>
Clock Start/From:	<b>1</b>
Clock To:	
1st Value:	<b>4.000</b>
2nd Value:	<b>1.000</b>
Value Percent:	
Continuous Index:	
Within 8" of Joint:	<b>YES</b>
Remarks:

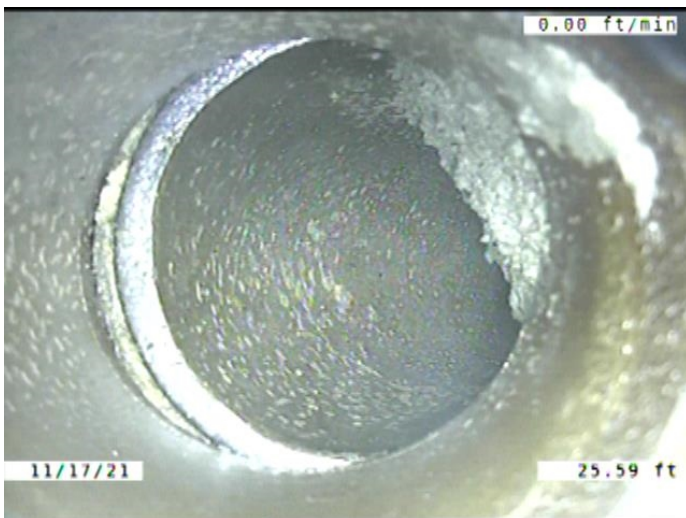
Code: **TFD**  
Description: **Tap Factory Defective**

Distance (ft): **25.6**  
Structural Grade: **0**  
O&M Grade: **3**  
Clock Start/From: **2**  
Clock To:  
1st Value: **4.000**  
2nd Value:  
Value Percent:  
Continuous Index:  
Within 8" of Joint: **YES**  
Remarks: **OFFSET.**

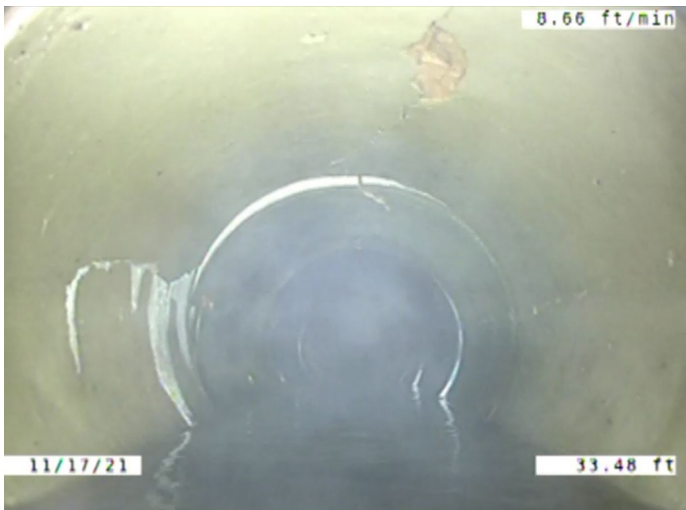
Code: **SSS**  
Description: **Surface Damage Surface Spalling**

Distance (ft): **33.5**  
Structural Grade: **2**  
O&M Grade: **0**  
Clock Start/From: **12**  
Clock To:  
1st Value:  
2nd Value:  
Value Percent:  
Continuous Index:  
Within 8" of Joint: **NO**  
Remarks:

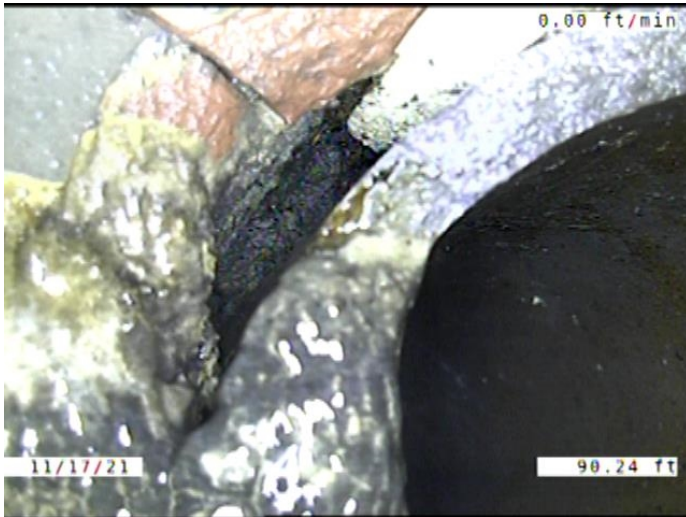
Code: **BSV**  
 Description: **Broken Soil Visible**

Distance (ft): **90.2**  
 Structural Grade: **5**  
 O&M Grade: **0**  
 Clock Start/From: **10**  
 Clock To: **12**  
 1st Value:  
 2nd Value:  
 Value Percent:  
 Continuous Index:  
 Within 8" of Joint: **YES**  
 Remarks:

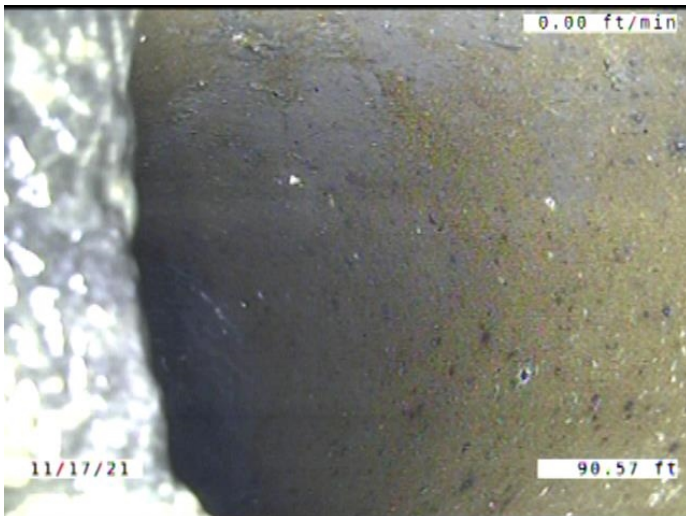
Code: **TBI**  
 Description: **Tap Break-in Intruding**

Distance (ft): **90.6**  
 Structural Grade: **0**  
 O&M Grade: **2**  
 Clock Start/From: **11**  
 Clock To:  
 1st Value: **4.000**  
 2nd Value: **1.000**  
 Value Percent:  
 Continuous Index:  
 Within 8" of Joint: **YES**  
 Remarks: **CONSTANTLY RUNNING WATER.**

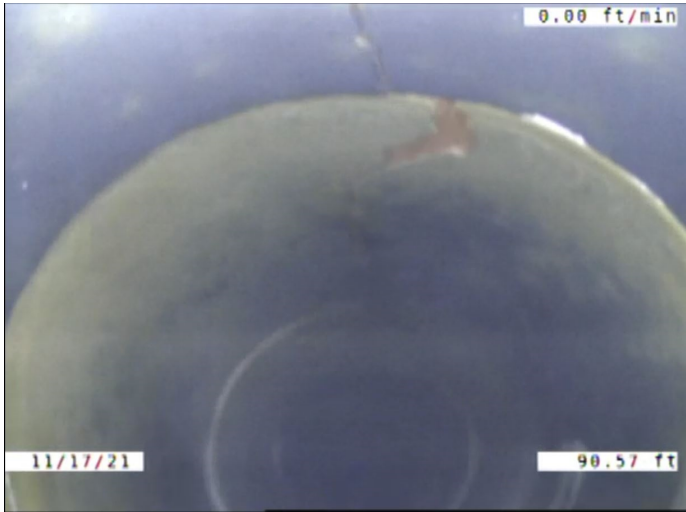
Code: **SSS**  
Description: **Surface Damage Surface Spalling**

Distance (ft): **90.6**  
Structural Grade: **2**  
O&M Grade: **0**  
Clock Start/From: **12**  
Clock To:  
1st Value:  
2nd Value:  
Value Percent:  
Continuous Index:  
Within 8" of Joint: **YES**  
Remarks:

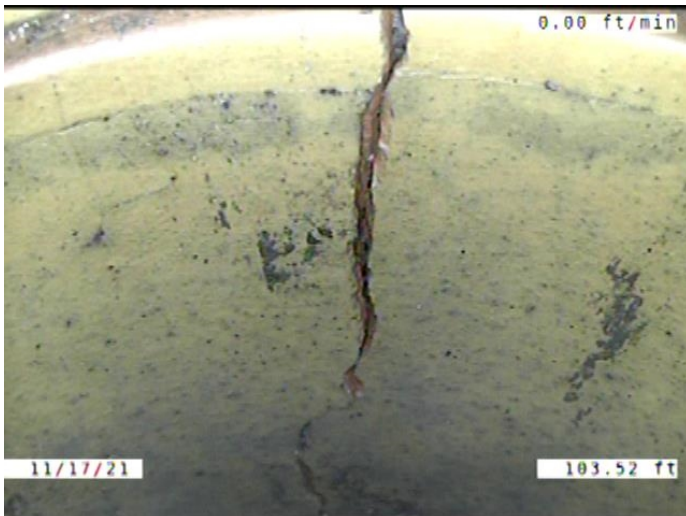
Code: **DR**  
Description: **Deformed Rigid**

Distance (ft): **103.5**  
Structural Grade: **4**  
O&M Grade: **0**  
Clock Start/From:  
Clock To:  
1st Value:  
2nd Value:  
Value Percent: **5.000**  
Continuous Index:  
Within 8" of Joint: **NO**  
Remarks:

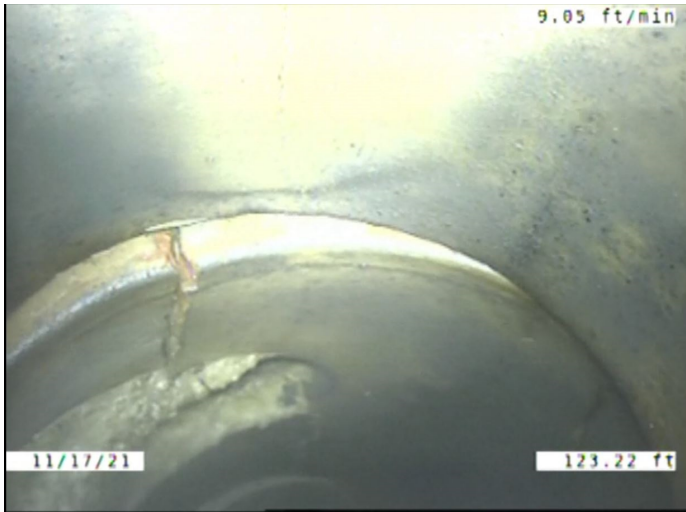
Code: **B**  
Description: **Broken**

Distance (ft): **123.2**  
Structural Grade: **4**  
O&M Grade: **0**  
Clock Start/From: **12**  
Clock To:  
1st Value:  
2nd Value:  
Value Percent:  
Continuous Index:  
Within 8" of Joint: **YES**  
Remarks:

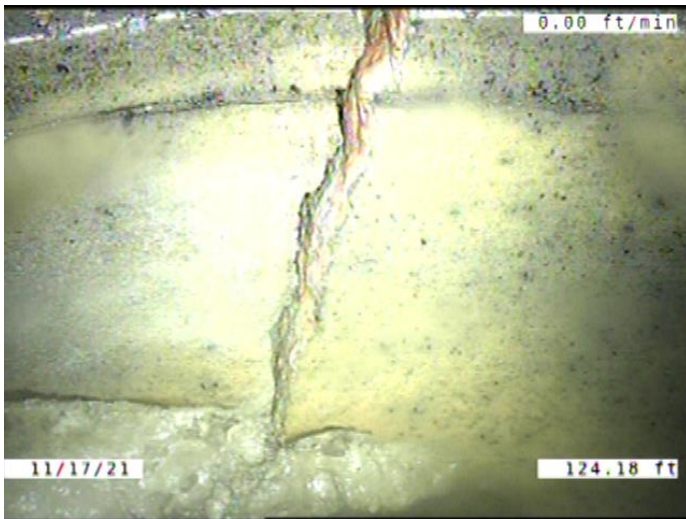
Code: **DR**  
Description: **Deformed Rigid**

Distance (ft): **124.2**  
Structural Grade: **4**  
O&M Grade: **0**  
Clock Start/From:  
Clock To:  
1st Value:  
2nd Value:  
Value Percent: **5.000**  
Continuous Index:  
Within 8" of Joint: **NO**  
Remarks:
