Profile/Photo Observation Report

Date:	11/18/2021	Weather:		Coding:	PACP 7.0
Pipe Length (ft):	233.0	Owner:	City of Hobart	Pre Clean:	Heavy Cleaning
P.O.#:	YES502259	Surveyor:	S. Bucklin	PSR:	P-605-042-011
Customer:	City of Hobart	Clean Date:	11/17/2021	Shape:	C

Street:	South Washington Street	Flow Control:	Not Controlled
City:	Hobart, IN	Year Renewed:	
Location:	Local rural streets with light traffic, t	Tape/Media #:	
Purpose:	Routine Assessment	Dia/Height:	12"
Use:	Sanitary Sewage Pipe	Material:	VCP
Drain Area:		Lining:	None
Category:	NA		
Comment:			
Location Details:		Direction of Survey:	Upstream
US MH:	M-605-011	DS MH:	M-605-042
		Total Length Surveyed (ft):	98.0

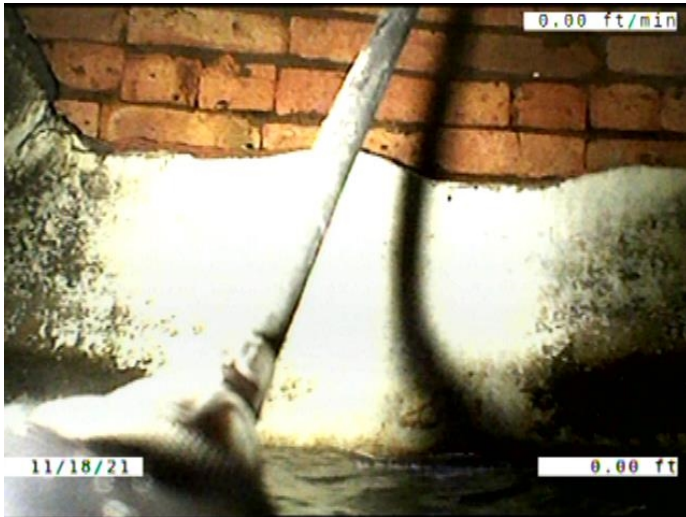
Code: **AMH**
Description: **Manhole**

Distance (ft): **.0**
Structural Grade: **0**
O&M Grade: **0**
Clock Start/From:
Clock To:
1st Value:
2nd Value:
Value Percent:
Continuous Index:
Within 8" of Joint: **NO**
Remarks: **M-605-042**

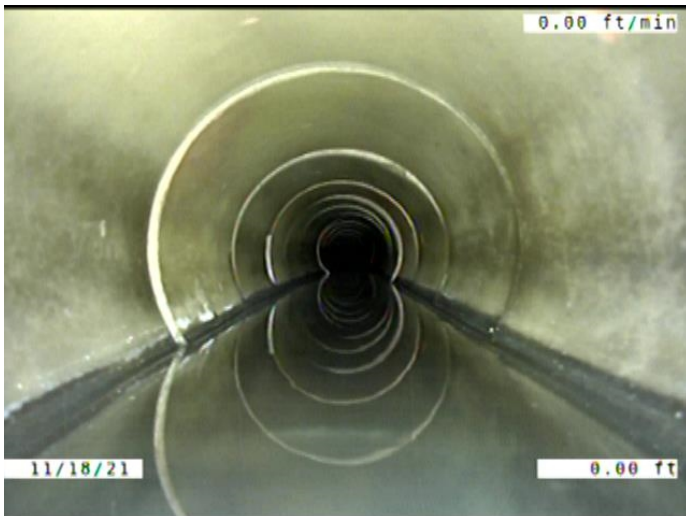
Code: **MWL**
Description: **Miscellaneous Water Level**

Distance (ft): **.0**
Structural Grade: **0**
O&M Grade: **0**
Clock Start/From:
Clock To:
1st Value:
2nd Value:
Value Percent: **5.000**
Continuous Index:
Within 8" of Joint: **NO**
Remarks:

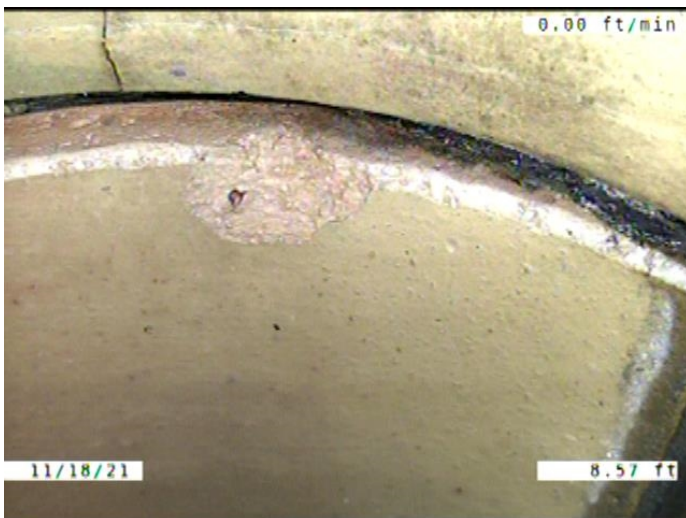
Code: **SZ**
Description: **Surface Damage Other**

Distance (ft): **8.6**
Structural Grade: **0**
O&M Grade: **0**
Clock Start/From: **2**
Clock To:
1st Value:
2nd Value:
Value Percent:
Continuous Index:
Within 8" of Joint: **YES**
Remarks: **A PIECE CHIPPED AWAY FROM THE JOINT**

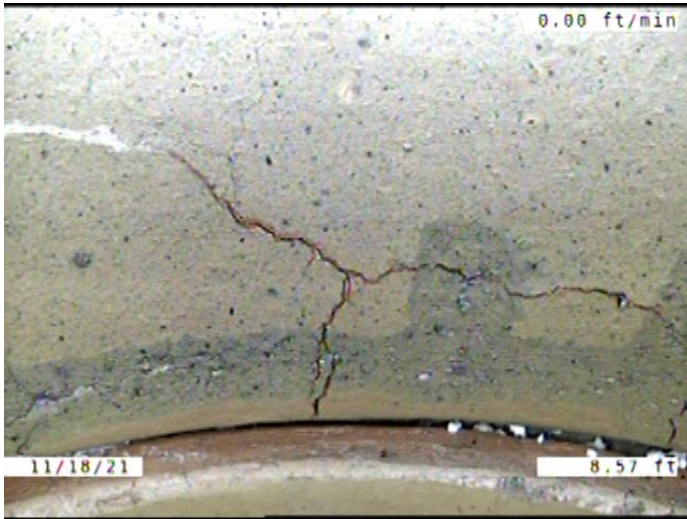
Code: **CM**
Description: **Crack Multiple**

Distance (ft): **8.6**
Structural Grade: **3**
O&M Grade: **0**
Clock Start/From: **9**
Clock To: **4**
1st Value:
2nd Value:
Value Percent:
Continuous Index:
Within 8" of Joint: **YES**
Remarks:

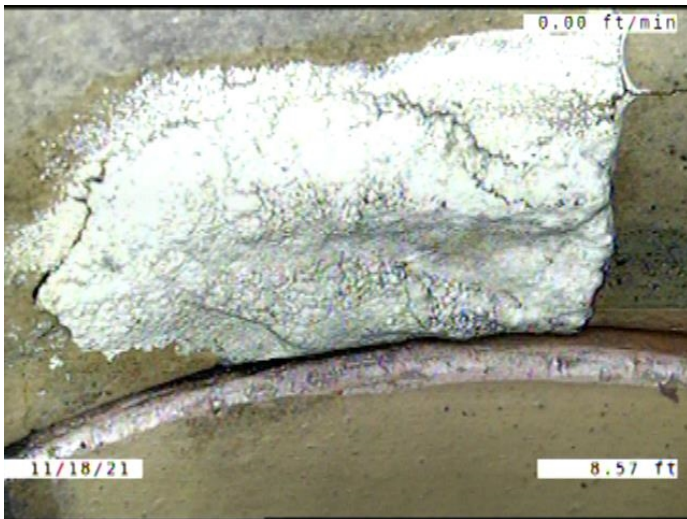
Code: **DAE**
Description: **Deposits Attached Encrustation**

Distance (ft): **8.6**
Structural Grade: **0**
O&M Grade: **2**
Clock Start/From: **8**
Clock To: **11**
1st Value:
2nd Value:
Value Percent: **5.000**
Continuous Index:
Within 8" of Joint: **YES**
Remarks:

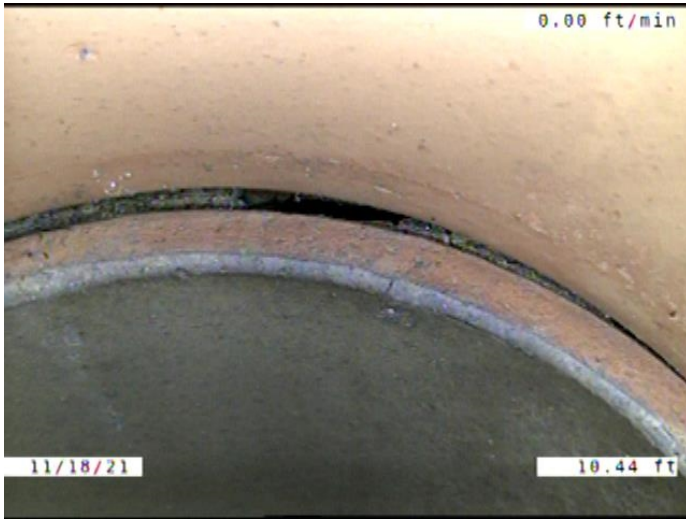
Code: **JOMD**
Description: **Joint Offset Medium Defective**

Distance (ft): **10.4**
Structural Grade: **3**
O&M Grade: **0**
Clock Start/From:
Clock To:
1st Value:
2nd Value:
Value Percent:
Continuous Index:
Within 8" of Joint: **NO**
Remarks: **SOIL VISIBLE**

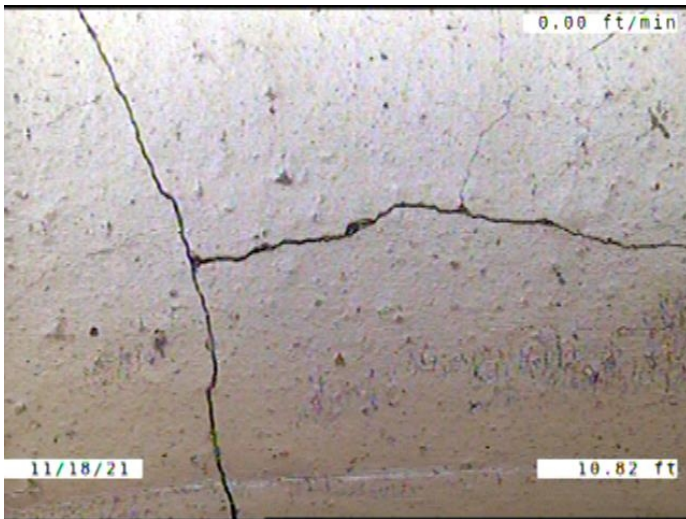
Code: **CM**
Description: **Crack Multiple**

Distance (ft): **10.8**
Structural Grade: **3**
O&M Grade: **0**
Clock Start/From: **10**
Clock To: **1**
1st Value:
2nd Value:
Value Percent:
Continuous Index:
Within 8" of Joint: **YES**
Remarks:

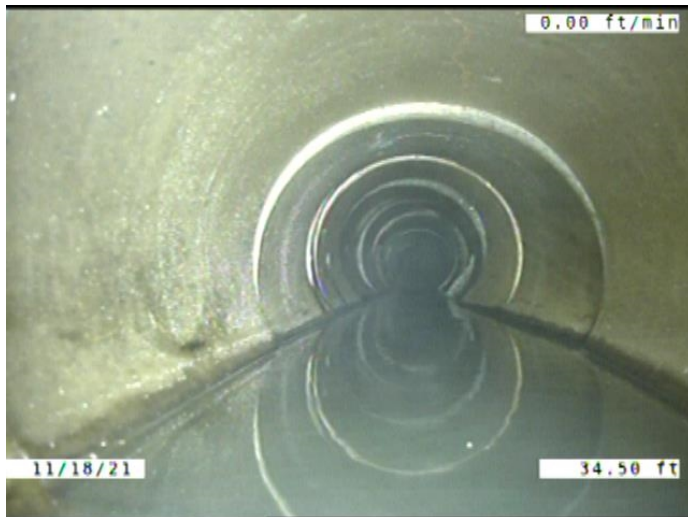
Code: **CM**
 Description: **Crack Multiple**

Distance (ft): **34.5**
 Structural Grade: **3**
 O&M Grade: **0**
 Clock Start/From: **11**
 Clock To: **1**
 1st Value:
 2nd Value:
 Value Percent:
 Continuous Index: **F01**
 Within 8" of Joint: **YES**
 Remarks:

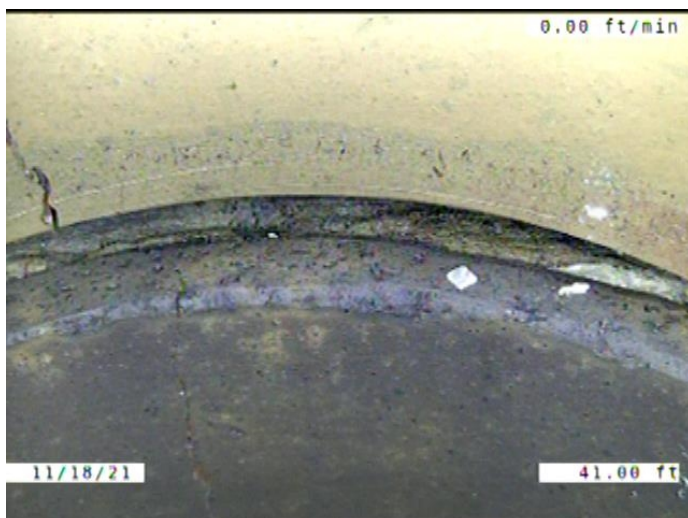
Code: **JOMD**
 Description: **Joint Offset Medium Defective**

Distance (ft): **41.0**
 Structural Grade: **3**
 O&M Grade: **0**
 Clock Start/From:
 Clock To:
 1st Value:
 2nd Value:
 Value Percent:
 Continuous Index:
 Within 8" of Joint: **NO**
 Remarks:

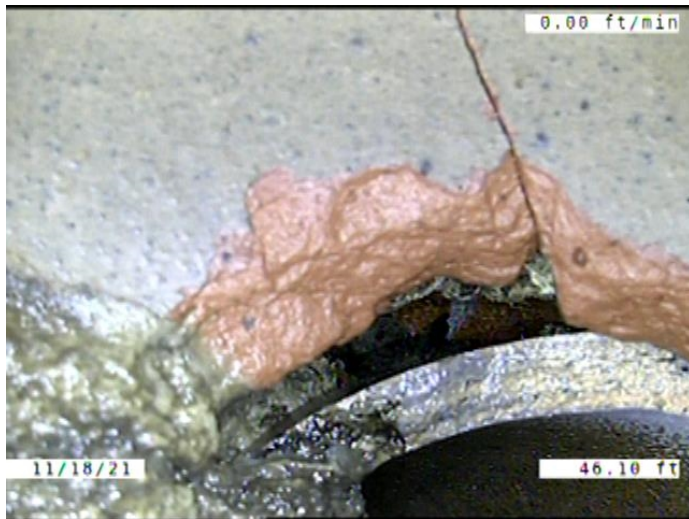
Code: **BSV**
 Description: **Broken Soil Visible**

Distance (ft): **46.1**
 Structural Grade: **5**
 O&M Grade: **0**
 Clock Start/From: **10**
 Clock To: **12**
 1st Value:
 2nd Value:
 Value Percent:
 Continuous Index:
 Within 8" of Joint: **YES**
 Remarks:

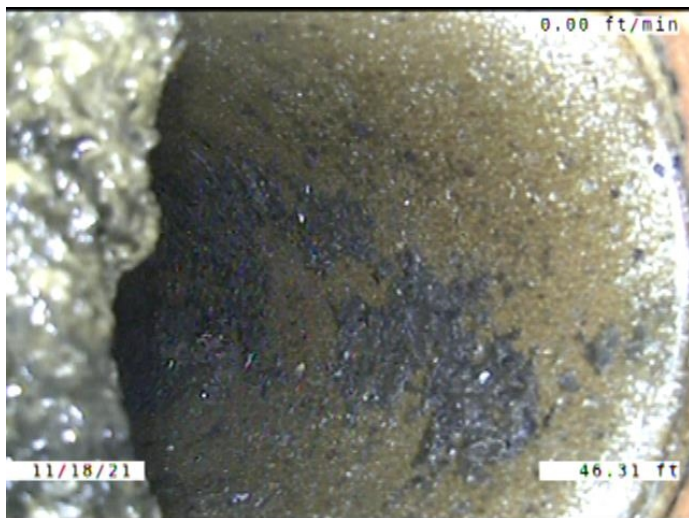
Code: **TBD**
 Description: **Tap Break-in/Hammer Defective**

Distance (ft): **46.3**
 Structural Grade: **0**
 O&M Grade: **3**
 Clock Start/From: **11**
 Clock To:
 1st Value: **4.000**
 2nd Value:
 Value Percent:
 Continuous Index:
 Within 8" of Joint: **YES**
 Remarks: **ENCrustATION COMING OUT OF THE TAP INTO THE MAIN.**

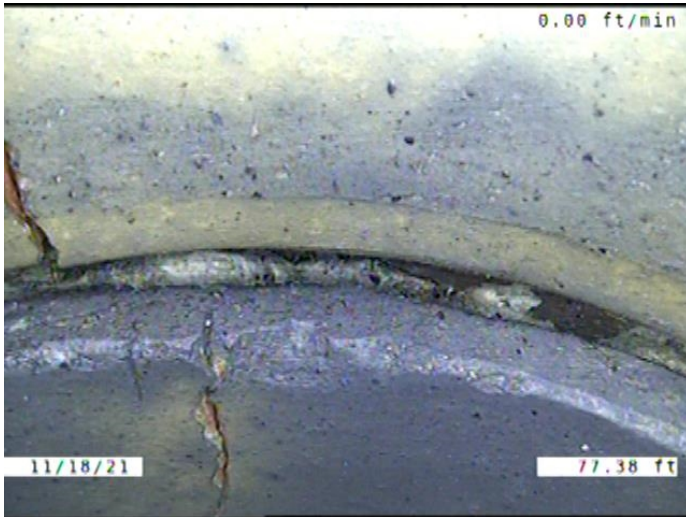
Code: **JOMD**
 Description: **Joint Offset Medium Defective**

Distance (ft): **77.4**
 Structural Grade: **3**
 O&M Grade: **0**
 Clock Start/From:
 Clock To:
 1st Value:
 2nd Value:
 Value Percent:
 Continuous Index:
 Within 8" of Joint: **NO**
 Remarks:

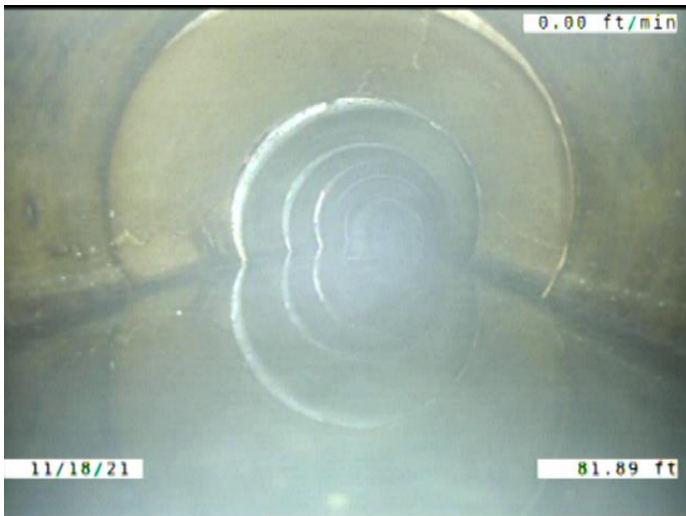
Code: **MWLS**
 Description: **Miscellaneous Water Level Sag**

Distance (ft): **81.9**
 Structural Grade: **2**
 O&M Grade: **0**
 Clock Start/From:
 Clock To:
 1st Value:
 2nd Value:
 Value Percent: **15.000**
 Continuous Index: **S05**
 Within 8" of Joint: **NO**
 Remarks:

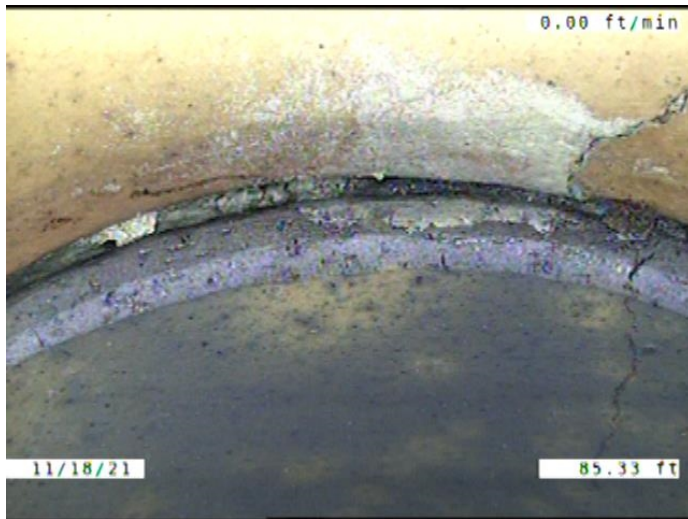
Code: **JOMD**
 Description: **Joint Offset Medium Defective**

Distance (ft): **85.3**
 Structural Grade: **3**
 O&M Grade: **0**
 Clock Start/From:
 Clock To:
 1st Value:
 2nd Value:
 Value Percent:
 Continuous Index:
 Within 8" of Joint: **NO**
 Remarks:

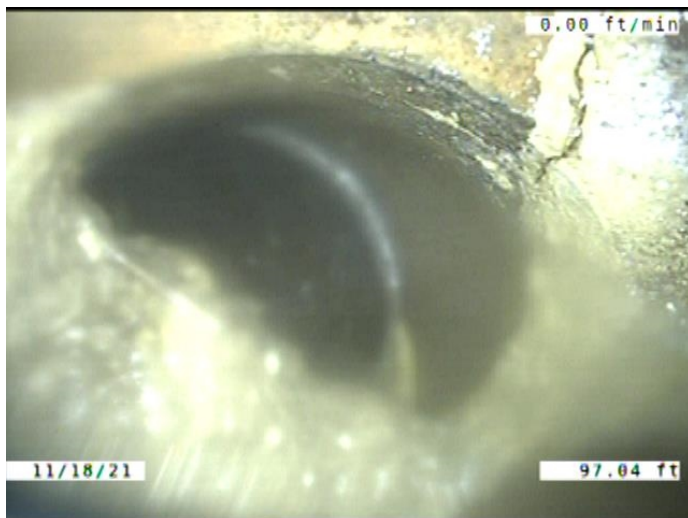
Code: **TFD**
 Description: **Tap Factory Defective**

Distance (ft): **97.0**
 Structural Grade: **0**
 O&M Grade: **3**
 Clock Start/From: **11**
 Clock To:
 1st Value: **4.000**
 2nd Value:
 Value Percent:
 Continuous Index:
 Within 8" of Joint: **YES**
 Remarks: **BROKEN. ENCRUSTATION COMING OUT OF THE TAP INTO THE MAIN.**

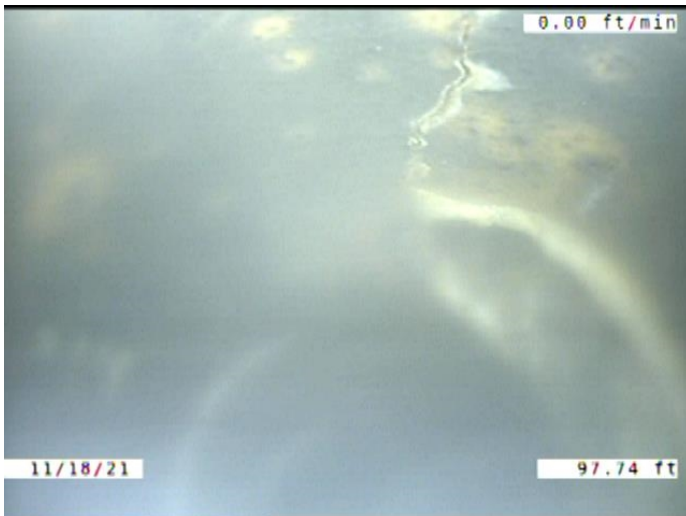
Code: **DAE**
Description: **Deposits Attached Encrustation**

Distance (ft): **97.7**
Structural Grade: **0**
O&M Grade: **2**
Clock Start/From: **1**
Clock To: **5**
1st Value:
2nd Value:
Value Percent: **5.000**
Continuous Index: **F04**
Within 8" of Joint: **YES**
Remarks:

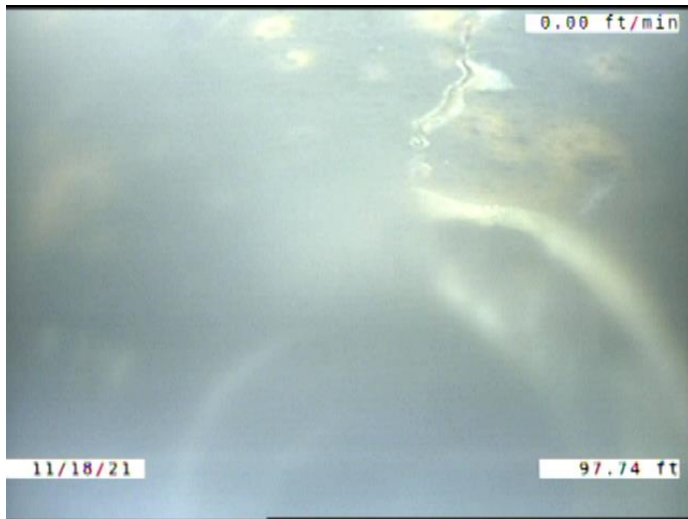
Code: **MWLS**
 Description: **Miscellaneous Water Level Sag**

Distance (ft): **97.7**
 Structural Grade: **2**
 O&M Grade: **0**
 Clock Start/From:
 Clock To:
 1st Value:
 2nd Value:
 Value Percent: **15.000**
 Continuous Index: **F05**
 Within 8" of Joint: **NO**
 Remarks:

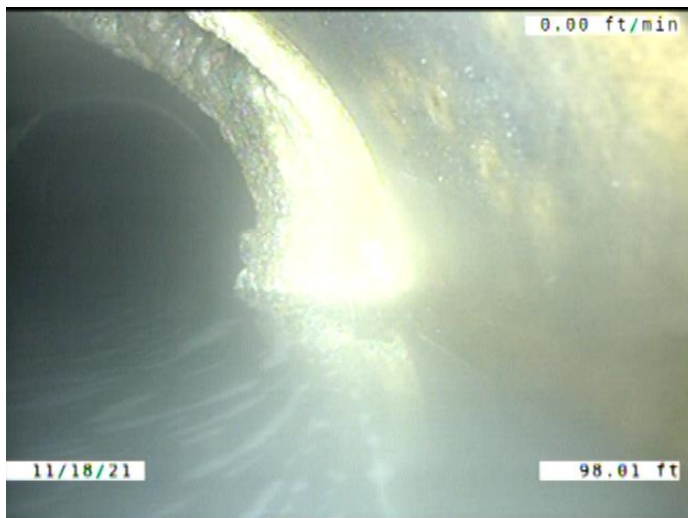
Code: **MSA**
 Description: **Miscellaneous Survey Abandoned**

Distance (ft): **98.0**
 Structural Grade: **0**
 O&M Grade: **0**
 Clock Start/From:
 Clock To:
 1st Value:
 2nd Value:
 Value Percent:
 Continuous Index:
 Within 8" of Joint: **NO**
 Remarks: **MADE IT TO THE POINT OF OVERLAP. REVERSAL COMPLETE.**
