## Profile/Photo Observation Report

Date:	<b>11/18/2021</b>	Weather:		Coding:	<b>PACP 7.0</b>
Pipe Length (ft):	<b>233.0</b>	Owner:	<b>City of Hobart</b>	Pre Clean:	<b>Heavy Cleaning</b>
P.O.#:	<b>YES502259</b>	Surveyor:	<b>S. Bucklin</b>	PSR:	<b>P-605-042-011</b>
Customer:	<b>City of Hobart</b>	Clean Date:	<b>11/17/2021</b>	Shape:	<b>C</b>

Street:	<b>South Washington Street</b>	Flow Control:	<b>Not Controlled</b>
City:	<b>Hobart, IN</b>	Year Renewed:	
Location:	<b>Local rural streets with light traffic, t</b>	Tape/Media #:	
Purpose:	<b>Routine Assessment</b>	Dia/Height:	<b>12"</b>
Use:	<b>Sanitary Sewage Pipe</b>	Material:	<b>VCP</b>
Drain Area:		Lining:	<b>None</b>
Category:	<b>NA</b>		
Comment:			
Location Details:		Direction of Survey:	<b>Upstream</b>
US MH:	<b>M-605-011</b>	DS MH:	<b>M-605-042</b>
		Total Length Surveyed (ft):	<b>98.0</b>

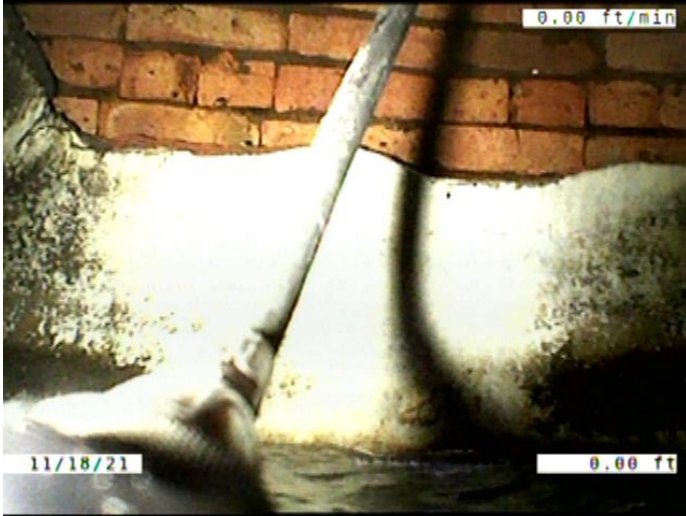
Code: **AMH**  
Description: **Manhole**

Distance (ft): **.0**  
Structural Grade: **0**  
O&M Grade: **0**  
Clock Start/From:  
Clock To:  
1st Value:  
2nd Value:  
Value Percent:  
Continuous Index:  
Within 8" of Joint: **NO**  
Remarks: **M-605-042**

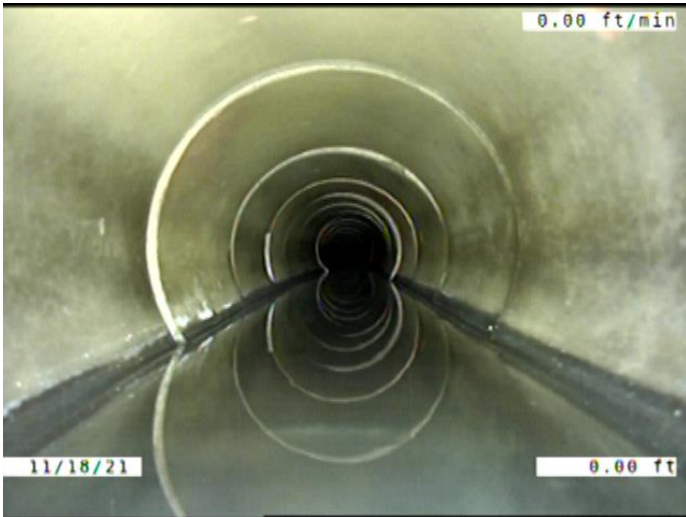
Code: **MWL**  
Description: **Miscellaneous Water Level**

Distance (ft): **.0**  
Structural Grade: **0**  
O&M Grade: **0**  
Clock Start/From:  
Clock To:  
1st Value:  
2nd Value:  
Value Percent: **5.000**  
Continuous Index:  
Within 8" of Joint: **NO**  
Remarks:

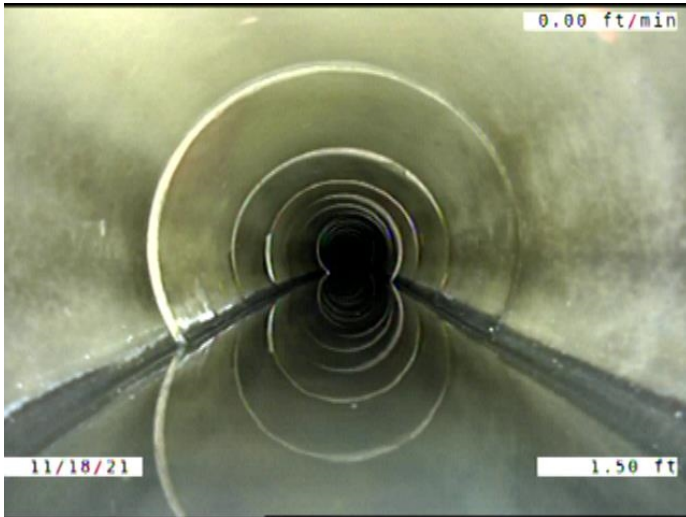
Code:	<b>MGO</b>
Description:	<b>Miscellaneous General Observation</b>
Distance (ft):	<b>1.5</b>
Structural Grade:	<b>0</b>
O&M Grade:	<b>0</b>
Clock Start/From:	
Clock To:	
1st Value:	
2nd Value:	
Value Percent:	
Continuous Index:	
Within 8" of Joint:	<b>NO</b>
Remarks:	<b>NOT ENOUGH ROOM ON THE BENCH. HAD TO START IN THE PIPE.</b>

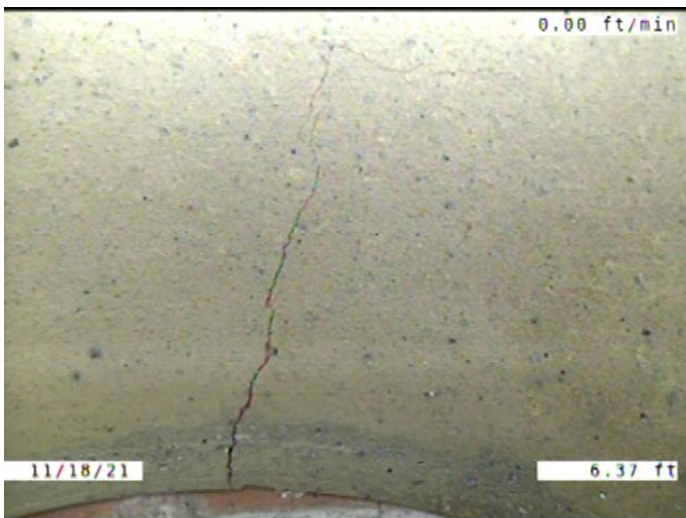
Code:	<b>CM</b>
Description:	<b>Crack Multiple</b>
Distance (ft):	<b>6.4</b>
Structural Grade:	<b>3</b>
O&M Grade:	<b>0</b>
Clock Start/From:	<b>1</b>
Clock To:	<b>2</b>
1st Value:	
2nd Value:	
Value Percent:	
Continuous Index:	
Within 8" of Joint:	<b>YES</b>
Remarks:

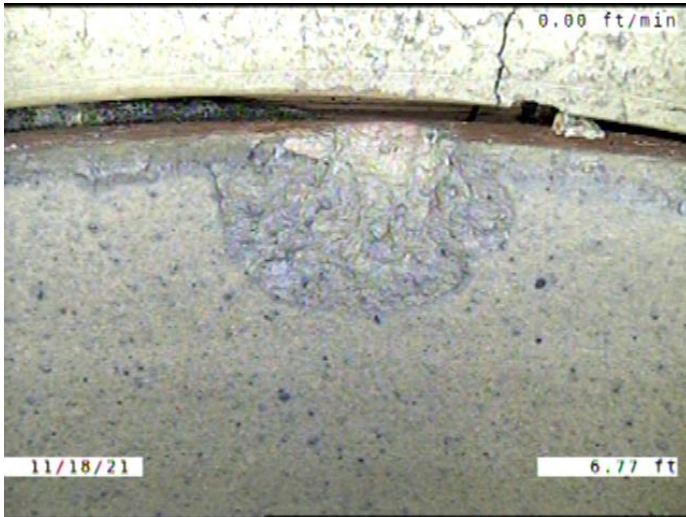
Code:	<b>SZ</b>
Description:	<b>Surface Damage Other</b>
Distance (ft):	<b>6.8</b>
Structural Grade:	<b>0</b>
O&M Grade:	<b>0</b>
Clock Start/From:	<b>1</b>
Clock To:	
1st Value:	
2nd Value:	
Value Percent:	
Continuous Index:	
Within 8" of Joint:	<b>YES</b>
Remarks:	<b>A PIECE CHIPPED AWAY FROM THE JOINT</b>

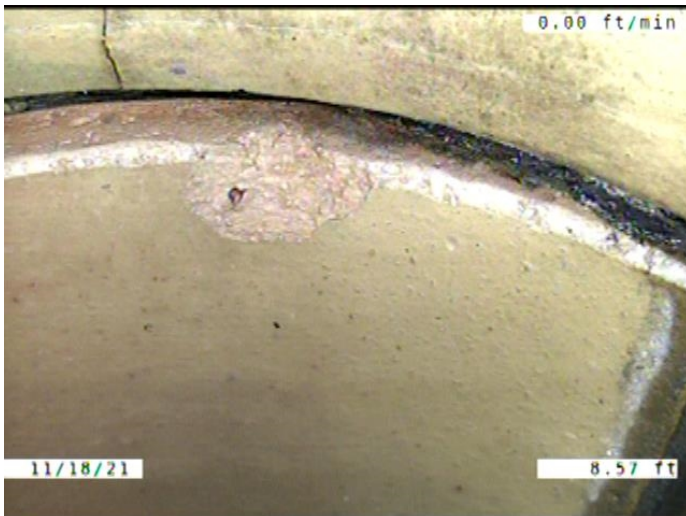
Code:	<b>SZ</b>
Description:	<b>Surface Damage Other</b>
Distance (ft):	<b>8.6</b>
Structural Grade:	<b>0</b>
O&M Grade:	<b>0</b>
Clock Start/From:	<b>2</b>
Clock To:	
1st Value:	
2nd Value:	
Value Percent:	
Continuous Index:	
Within 8" of Joint:	<b>YES</b>
Remarks:	<b>A PIECE CHIPPED AWAY FROM THE JOINT</b>

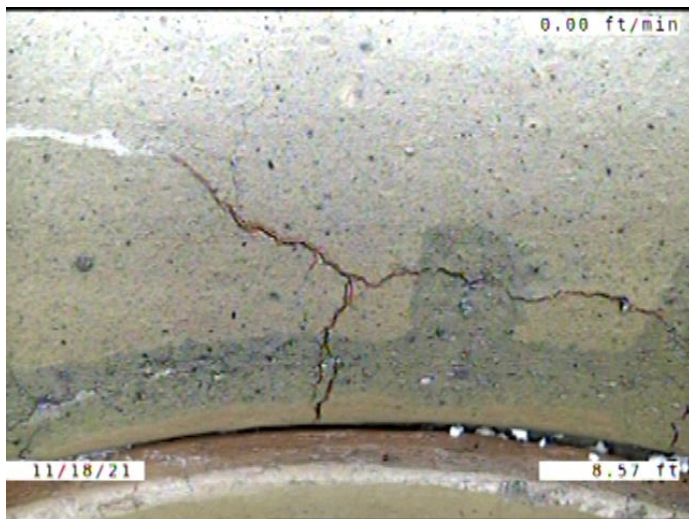
Code: **CM**  
 Description: **Crack Multiple**

Distance (ft): **8.6**  
 Structural Grade: **3**  
 O&M Grade: **0**  
 Clock Start/From: **9**  
 Clock To: **4**  
 1st Value:  
 2nd Value:  
 Value Percent:  
 Continuous Index:  
 Within 8" of Joint: **YES**  
 Remarks:

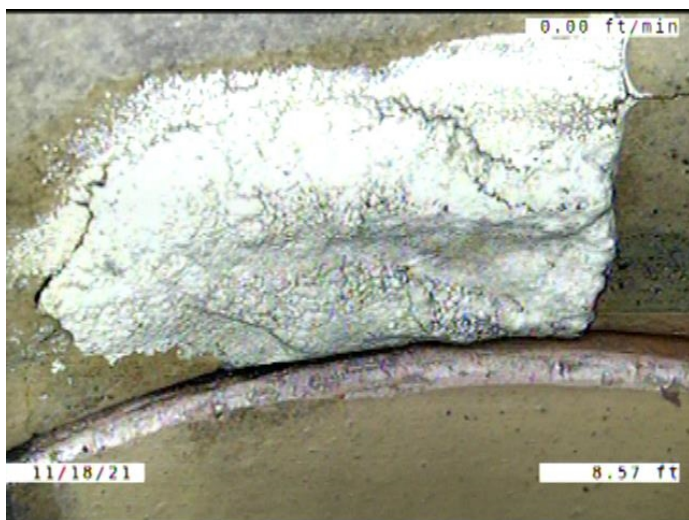
Code: **DAE**  
 Description: **Deposits Attached Encrustation**

Distance (ft): **8.6**  
 Structural Grade: **0**  
 O&M Grade: **2**  
 Clock Start/From: **8**  
 Clock To: **11**  
 1st Value:  
 2nd Value:  
 Value Percent: **5.000**  
 Continuous Index:  
 Within 8" of Joint: **YES**  
 Remarks:

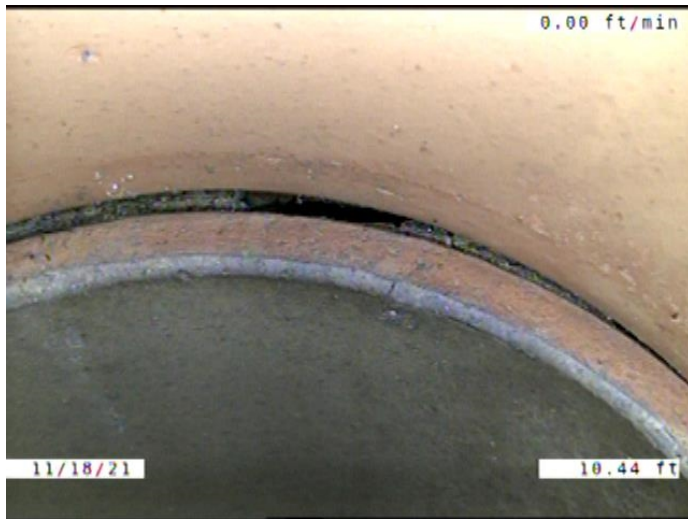
Code: **JOMD**  
 Description: **Joint Offset Medium Defective**

Distance (ft): **10.4**  
 Structural Grade: **3**  
 O&M Grade: **0**  
 Clock Start/From:  
 Clock To:  
 1st Value:  
 2nd Value:  
 Value Percent:  
 Continuous Index:  
 Within 8" of Joint: **NO**  
 Remarks: **SOIL VISIBLE**

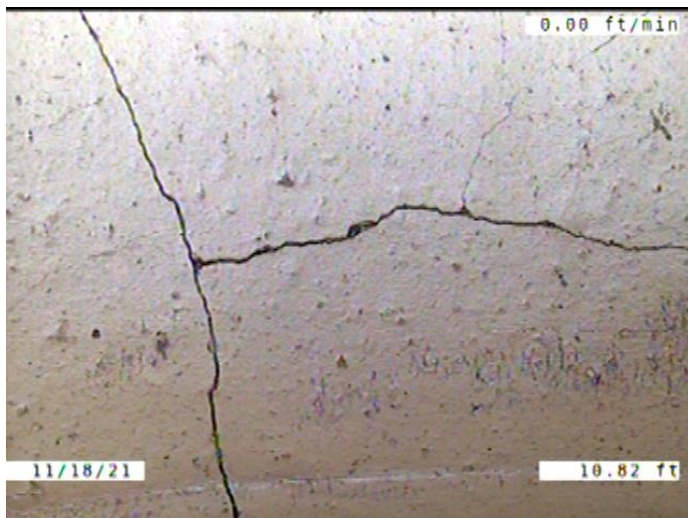
Code: **CM**  
 Description: **Crack Multiple**

Distance (ft): **10.8**  
 Structural Grade: **3**  
 O&M Grade: **0**  
 Clock Start/From: **10**  
 Clock To: **1**  
 1st Value:  
 2nd Value:  
 Value Percent:  
 Continuous Index:  
 Within 8" of Joint: **YES**  
 Remarks:

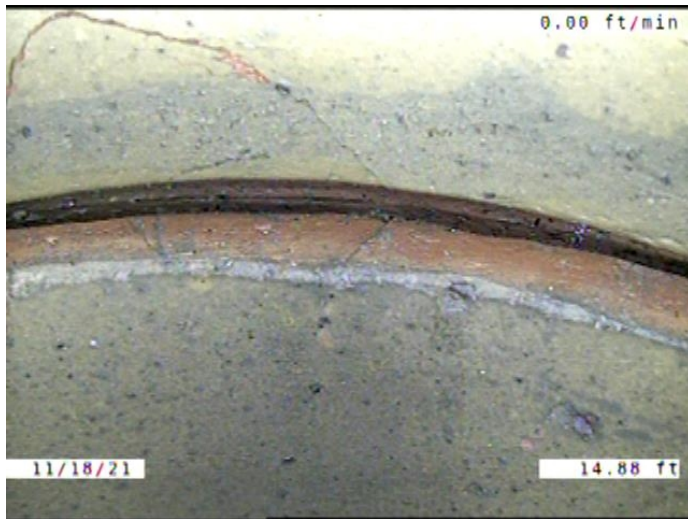
Code: **JOMD**  
 Description: **Joint Offset Medium Defective**

Distance (ft): **14.9**  
 Structural Grade: **3**  
 O&M Grade: **0**  
 Clock Start/From:  
 Clock To:  
 1st Value:  
 2nd Value:  
 Value Percent:  
 Continuous Index:  
 Within 8" of Joint: **NO**  
 Remarks:

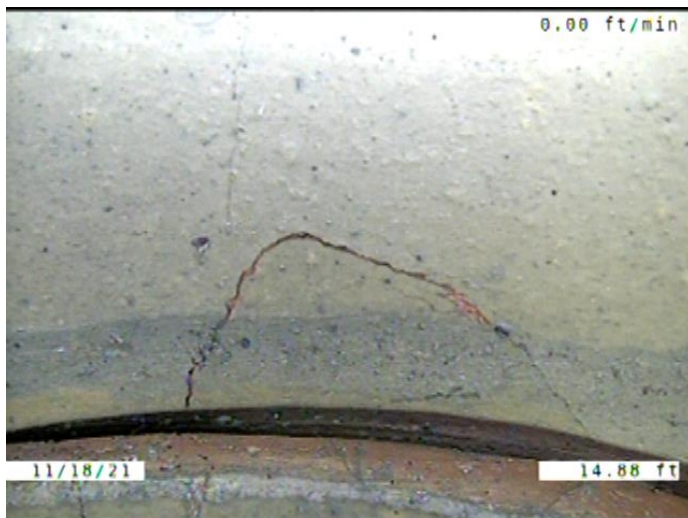
Code: **CM**  
 Description: **Crack Multiple**

Distance (ft): **14.9**  
 Structural Grade: **3**  
 O&M Grade: **0**  
 Clock Start/From: **12**  
 Clock To: **1**  
 1st Value:  
 2nd Value:  
 Value Percent:  
 Continuous Index:  
 Within 8" of Joint: **YES**  
 Remarks:

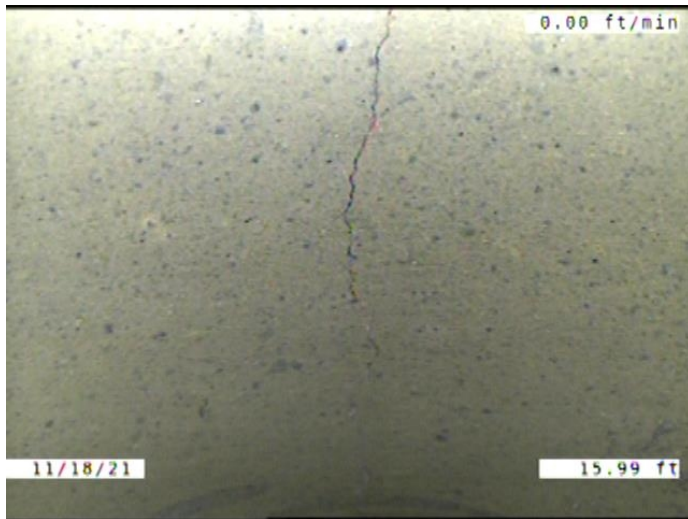
Code: **CM**  
Description: **Crack Multiple**

Distance (ft): **16.0**  
Structural Grade: **3**  
O&M Grade: **0**  
Clock Start/From: **11**  
Clock To: **1**  
1st Value:  
2nd Value:  
Value Percent:  
Continuous Index: **S01**  
Within 8" of Joint: **YES**  
Remarks:

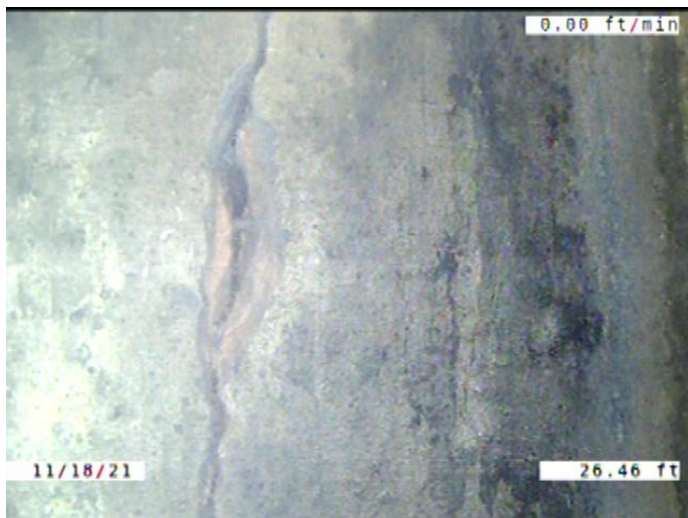
Code: **FM**  
Description: **Fracture Multiple**

Distance (ft): **26.5**  
Structural Grade: **4**  
O&M Grade: **0**  
Clock Start/From: **12**  
Clock To: **12**  
1st Value:  
2nd Value:  
Value Percent:  
Continuous Index: **S02**  
Within 8" of Joint: **YES**  
Remarks:

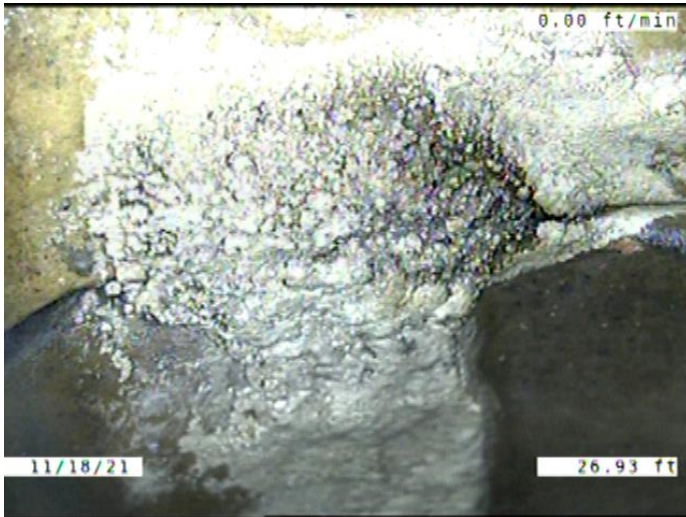
Code: **DAE**  
 Description: **Deposits Attached Encrustation**

Distance (ft): **26.9**  
 Structural Grade: **0**  
 O&M Grade: **2**  
 Clock Start/From: **7**  
 Clock To: **12**  
 1st Value:  
 2nd Value:  
 Value Percent: **5.000**  
 Continuous Index: **S03**  
 Within 8" of Joint: **YES**  
 Remarks:

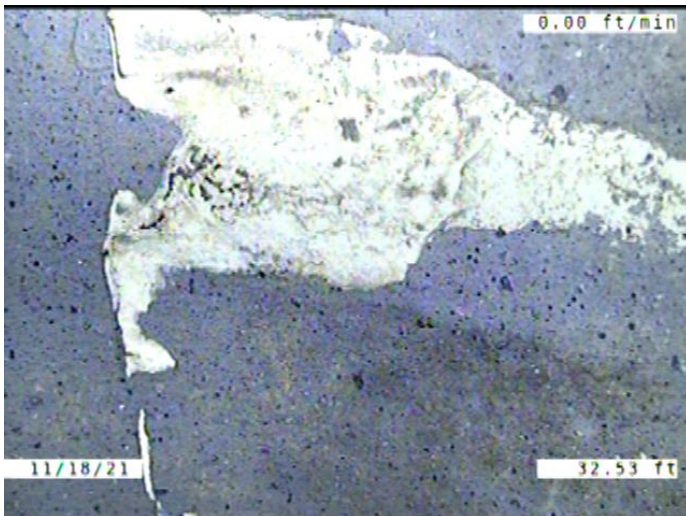
Code: **DAE**  
 Description: **Deposits Attached Encrustation**

Distance (ft): **32.5**  
 Structural Grade: **0**  
 O&M Grade: **2**  
 Clock Start/From: **1**  
 Clock To: **5**  
 1st Value:  
 2nd Value:  
 Value Percent: **5.000**  
 Continuous Index: **S04**  
 Within 8" of Joint: **YES**  
 Remarks:

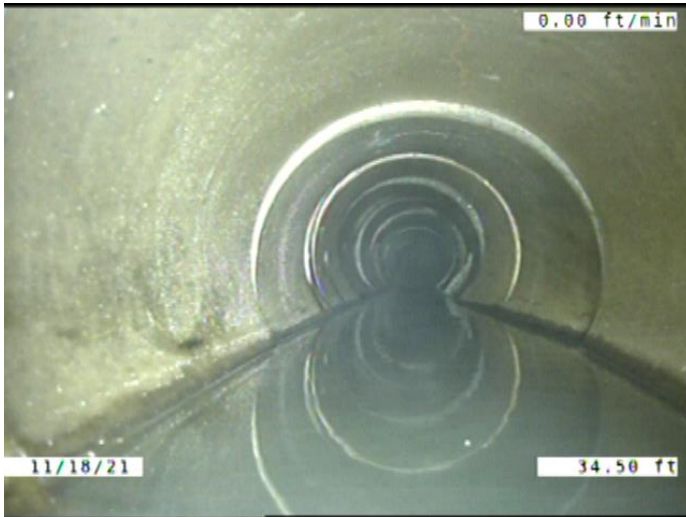
Code: **CM**  
Description: **Crack Multiple**

Distance (ft): **34.5**  
Structural Grade: **3**  
O&M Grade: **0**  
Clock Start/From: **11**  
Clock To: **1**  
1st Value:  
2nd Value:  
Value Percent:  
Continuous Index: **F01**  
Within 8" of Joint: **YES**  
Remarks:

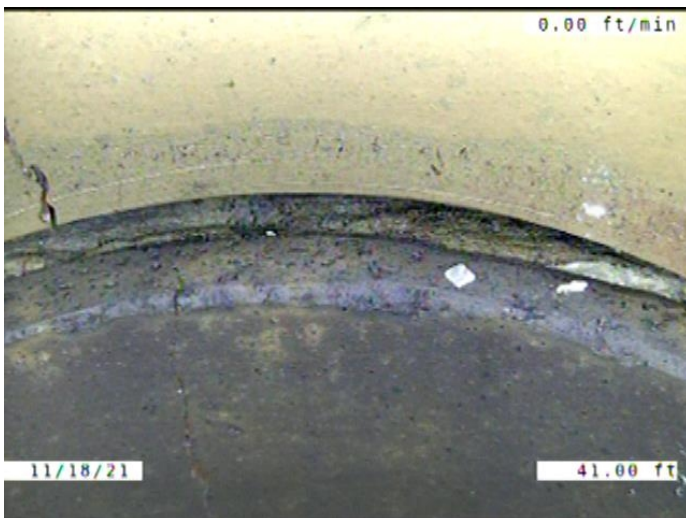
Code: **JOMD**  
Description: **Joint Offset Medium Defective**

Distance (ft): **41.0**  
Structural Grade: **3**  
O&M Grade: **0**  
Clock Start/From:  
Clock To:  
1st Value:  
2nd Value:  
Value Percent:  
Continuous Index:  
Within 8" of Joint: **NO**  
Remarks:

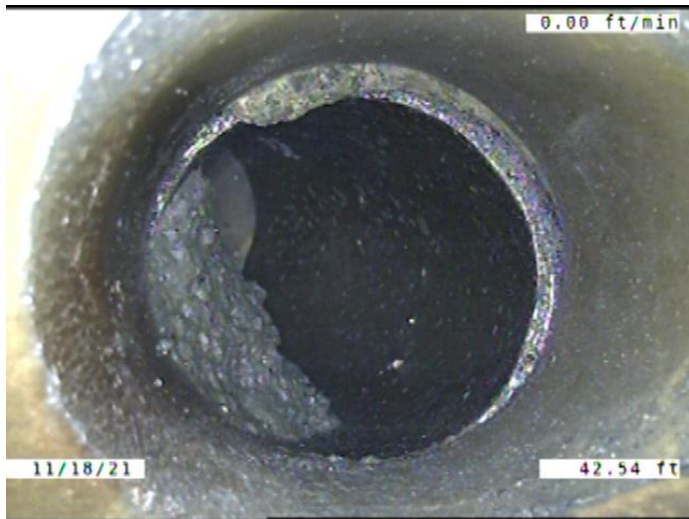
Code:	<b>TF</b>
Description:	<b>Tap Factory</b>
Distance (ft):	<b>42.5</b>
Structural Grade:	<b>0</b>
O&M Grade:	<b>0</b>
Clock Start/From:	<b>11</b>
Clock To:	
1st Value:	<b>4.000</b>
2nd Value:	
Value Percent:	
Continuous Index:	
Within 8" of Joint:	<b>YES</b>
Remarks:	<b>OFFSET. ENCRUSTATION AROUND THE JOINT.</b>

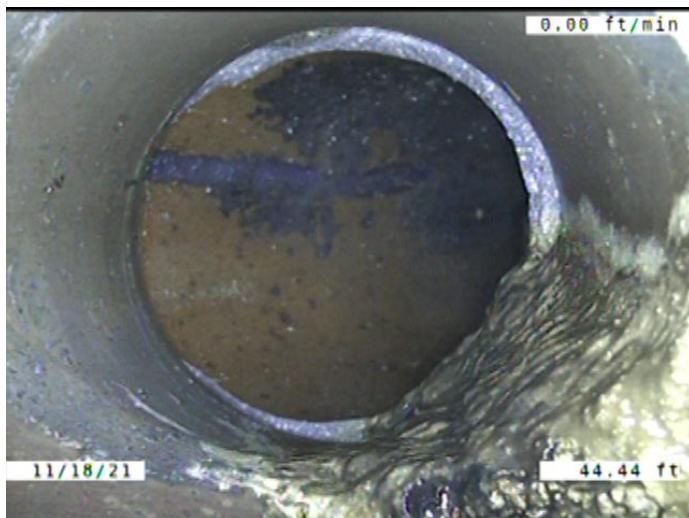
Code:	<b>TF</b>
Description:	<b>Tap Factory</b>
Distance (ft):	<b>44.4</b>
Structural Grade:	<b>0</b>
O&M Grade:	<b>0</b>
Clock Start/From:	<b>1</b>
Clock To:	
1st Value:	<b>4.000</b>
2nd Value:	
Value Percent:	
Continuous Index:	
Within 8" of Joint:	<b>YES</b>
Remarks:	<b>ENCRUSTATION COMING OUT OF THE TAP INTO THE MAIN.</b>

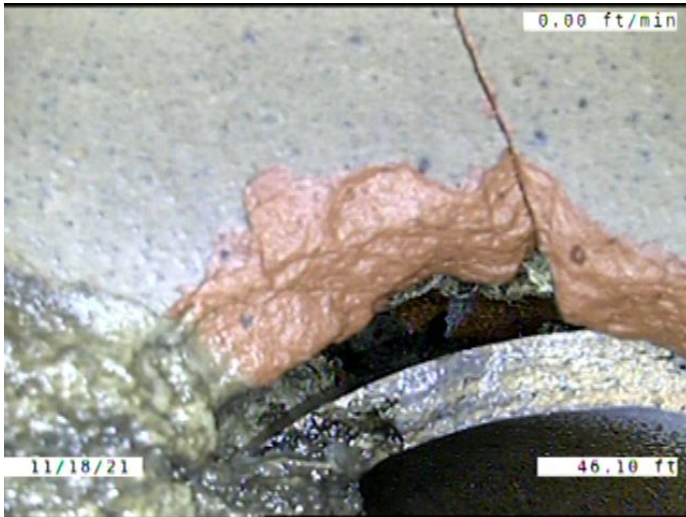
Code: **BSV**  
 Description: **Broken Soil Visible**

Distance (ft): **46.1**  
 Structural Grade: **5**  
 O&M Grade: **0**  
 Clock Start/From: **10**  
 Clock To: **12**  
 1st Value:  
 2nd Value:  
 Value Percent:  
 Continuous Index:  
 Within 8" of Joint: **YES**  
 Remarks:

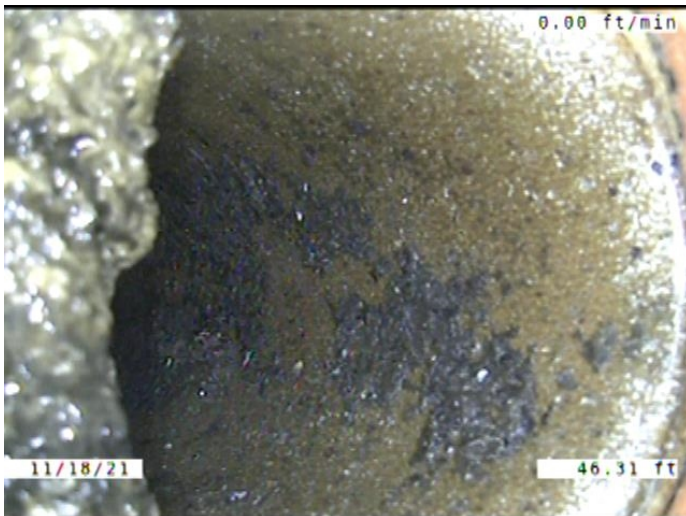
Code: **TBD**  
 Description: **Tap Break-in/Hammer Defective**

Distance (ft): **46.3**  
 Structural Grade: **0**  
 O&M Grade: **3**  
 Clock Start/From: **11**  
 Clock To:  
 1st Value: **4.000**  
 2nd Value:  
 Value Percent:  
 Continuous Index:  
 Within 8" of Joint: **YES**  
 Remarks: **ENCrustATION COMING OUT OF THE TAP INTO THE MAIN.**

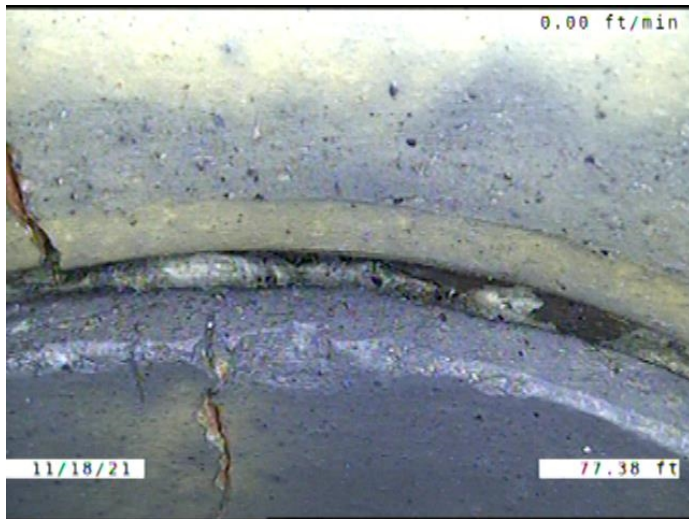
Code: **JOMD**  
 Description: **Joint Offset Medium Defective**

Distance (ft): **77.4**  
 Structural Grade: **3**  
 O&M Grade: **0**  
 Clock Start/From:  
 Clock To:  
 1st Value:  
 2nd Value:  
 Value Percent:  
 Continuous Index:  
 Within 8" of Joint: **NO**  
 Remarks:

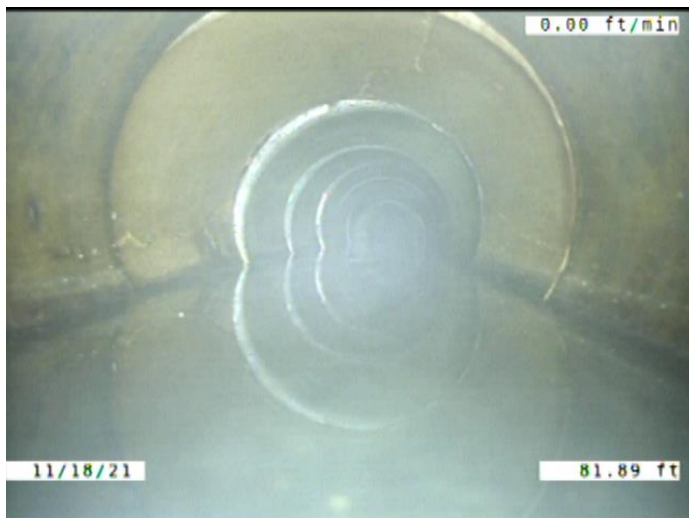
Code: **MWLS**  
 Description: **Miscellaneous Water Level Sag**

Distance (ft): **81.9**  
 Structural Grade: **2**  
 O&M Grade: **0**  
 Clock Start/From:  
 Clock To:  
 1st Value:  
 2nd Value:  
 Value Percent: **15.000**  
 Continuous Index: **S05**  
 Within 8" of Joint: **NO**  
 Remarks:

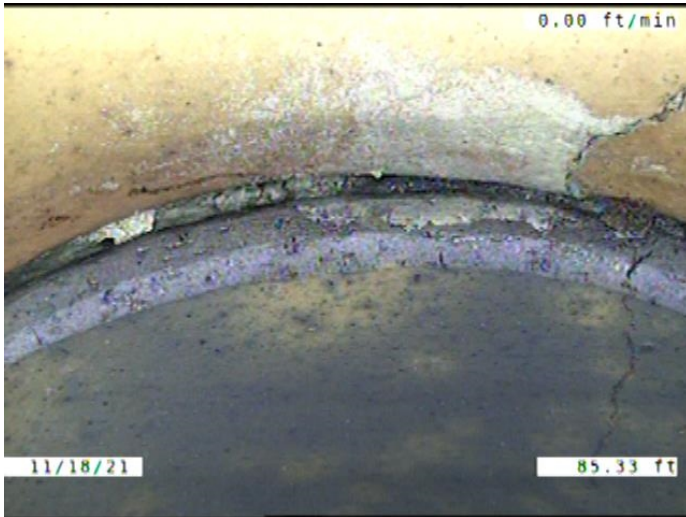
Code: **JOMD**  
 Description: **Joint Offset Medium Defective**

Distance (ft): **85.3**  
 Structural Grade: **3**  
 O&M Grade: **0**  
 Clock Start/From:  
 Clock To:  
 1st Value:  
 2nd Value:  
 Value Percent:  
 Continuous Index:  
 Within 8" of Joint: **NO**  
 Remarks:

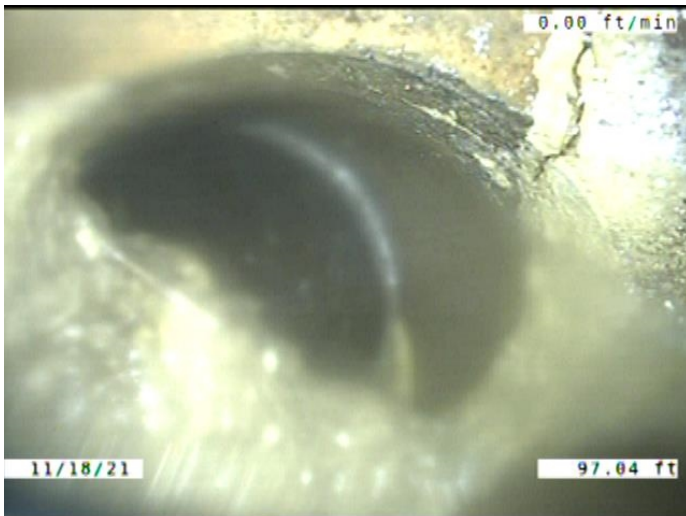
Code: **TFD**  
 Description: **Tap Factory Defective**

Distance (ft): **97.0**  
 Structural Grade: **0**  
 O&M Grade: **3**  
 Clock Start/From: **11**  
 Clock To:  
 1st Value: **4.000**  
 2nd Value:  
 Value Percent:  
 Continuous Index:  
 Within 8" of Joint: **YES**  
 Remarks: **BROKEN. ENCRUSTATION COMING OUT OF THE TAP INTO THE MAIN.**

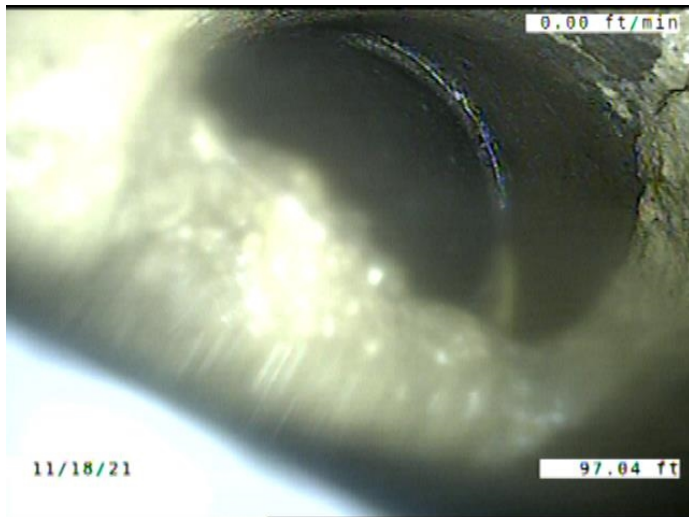
Code: **DAE**  
 Description: **Deposits Attached Encrustation**

Distance (ft): **97.0**  
 Structural Grade: **0**  
 O&M Grade: **2**  
 Clock Start/From: **9**  
 Clock To: **11**  
 1st Value:  
 2nd Value:  
 Value Percent: **10.000**  
 Continuous Index:  
 Within 8" of Joint: **YES**  
 Remarks:

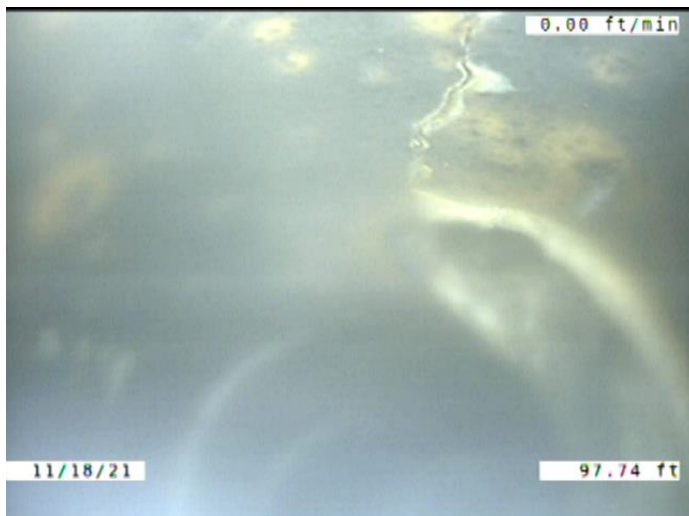
Code: **FM**  
 Description: **Fracture Multiple**

Distance (ft): **97.7**  
 Structural Grade: **4**  
 O&M Grade: **0**  
 Clock Start/From: **12**  
 Clock To: **12**  
 1st Value:  
 2nd Value:  
 Value Percent:  
 Continuous Index: **F02**  
 Within 8" of Joint: **YES**  
 Remarks:

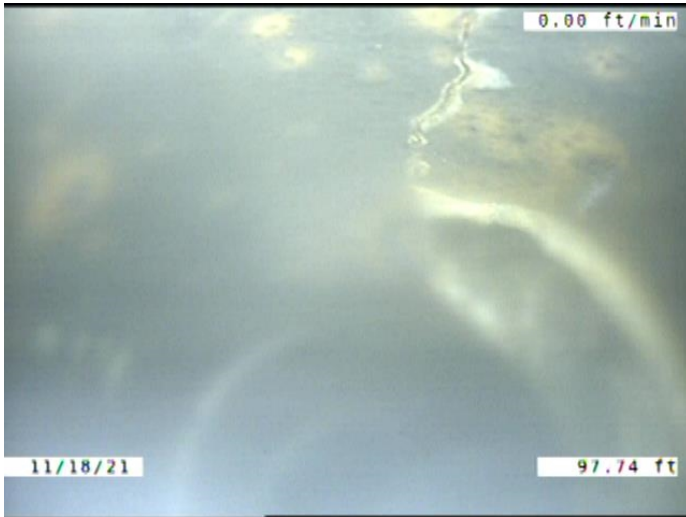
Code: **DAE**  
Description: **Deposits Attached Encrustation**

Distance (ft): **97.7**  
Structural Grade: **0**  
O&M Grade: **2**  
Clock Start/From: **7**  
Clock To: **12**  
1st Value:  
2nd Value:  
Value Percent: **5.000**  
Continuous Index: **F03**  
Within 8" of Joint: **YES**  
Remarks:

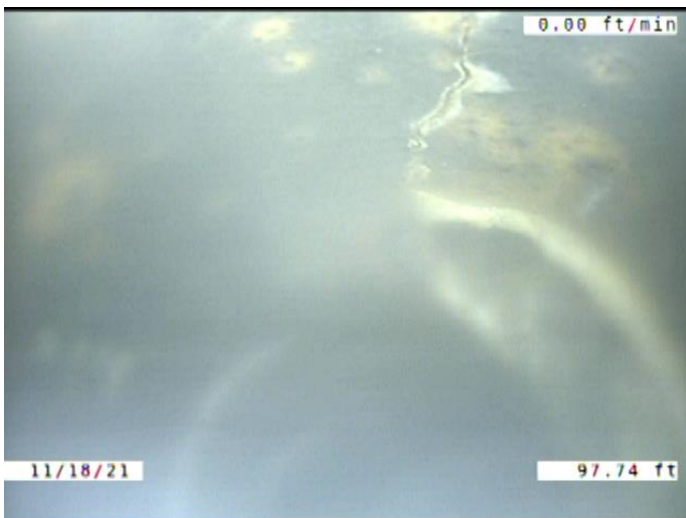
Code: **DAE**  
Description: **Deposits Attached Encrustation**

Distance (ft): **97.7**  
Structural Grade: **0**  
O&M Grade: **2**  
Clock Start/From: **1**  
Clock To: **5**  
1st Value:  
2nd Value:  
Value Percent: **5.000**  
Continuous Index: **F04**  
Within 8" of Joint: **YES**  
Remarks:

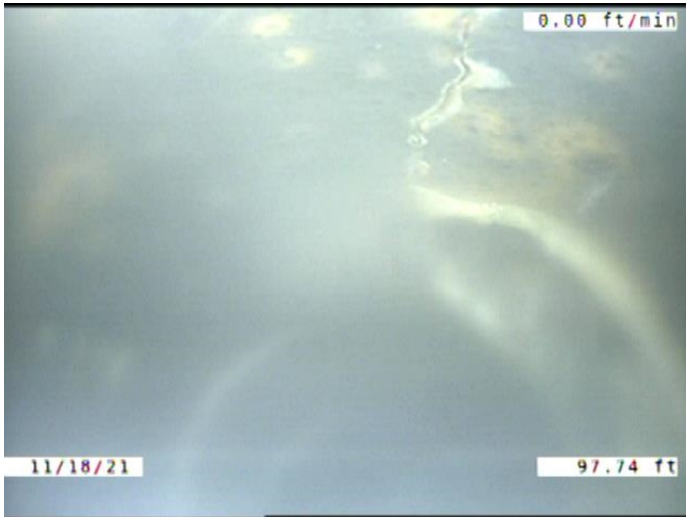
Code: **MWLS**  
 Description: **Miscellaneous Water Level Sag**

Distance (ft): **97.7**  
 Structural Grade: **2**  
 O&M Grade: **0**  
 Clock Start/From:  
 Clock To:  
 1st Value:  
 2nd Value:  
 Value Percent: **15.000**  
 Continuous Index: **F05**  
 Within 8" of Joint: **NO**  
 Remarks:

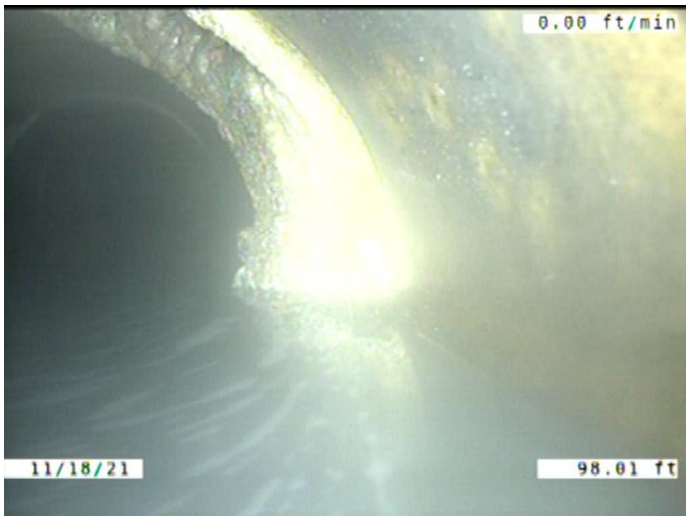
Code: **MSA**  
 Description: **Miscellaneous Survey Abandoned**

Distance (ft): **98.0**  
 Structural Grade: **0**  
 O&M Grade: **0**  
 Clock Start/From:  
 Clock To:  
 1st Value:  
 2nd Value:  
 Value Percent:  
 Continuous Index:  
 Within 8" of Joint: **NO**  
 Remarks: **MADE IT TO THE POINT OF OVERLAP.  
 REVERSAL COMPLETE.**
