## Profile/Photo Observation Report

Street:	<b>Henry</b>	Flow Control:	<b>Not Controlled</b>
City:	<b>Hobart, IN</b>	Year Renewed:	
Location:	<b>Other</b>	Tape/Media #:	
Purpose:	<b>Not Known</b>	Dia/Height:	<b>12"</b>
Use:	<b>Sanitary</b>	Material:	<b>VCP</b>
Drain Area:	<b>NA</b>	Lining:	
Category:	<b>NA</b>		
Comment:	<b>Flow direction wrong.</b>

Location Details:		Direction of Survey:	<b>Downstream</b>
US MH:	<b>M-605-013</b>	DS MH:	<b>M-605-014</b>
		Total Length Surveyed (ft):	<b>85.4</b>

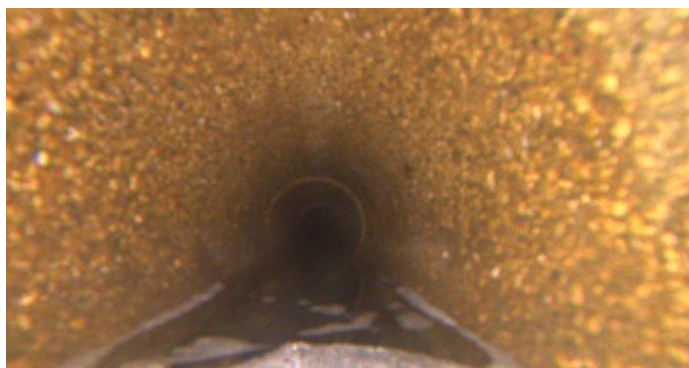
Code: **AMH**  
 Description: **Manhole**

Distance (ft): **.0**  
 Structural Grade: **0**  
 O&M Grade: **0**  
 Clock Start/From:  
 Clock To:  
 1st Value:  
 2nd Value:  
 Value Percent:  
 Continuous Index:  
 Within 8" of Joint: **NO**  
 Remarks: **M-605-013**

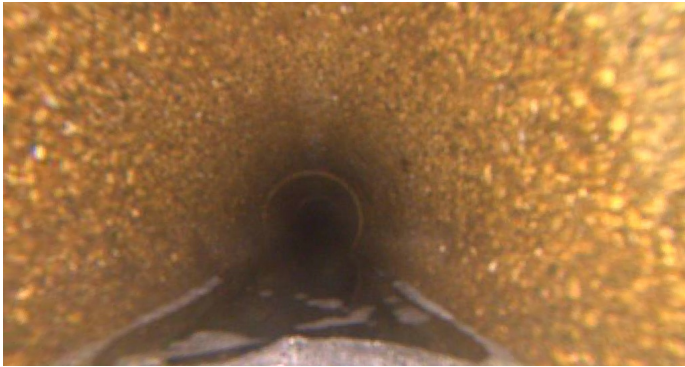
Code:	<b>MWL</b>
Description:	<b>Water Level</b>

Distance (ft):	<b>.0</b>
Structural Grade:	<b>0</b>
O&M Grade:	<b>0</b>
Clock Start/From:	
Clock To:	
1st Value:	
2nd Value:	
Value Percent:	<b>10.000</b>
Continuous Index:	
Within 8" of Joint:	<b>NO</b>
Remarks:

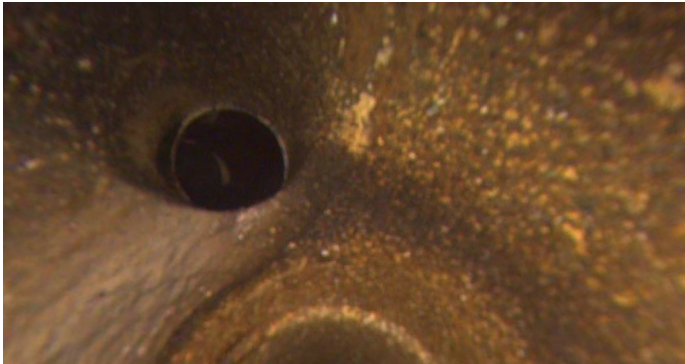
Code:	<b>TF</b>
Description:	<b>Tap Factory</b>

Distance (ft):	<b>21.2</b>
Structural Grade:	<b>0</b>
O&M Grade:	<b>0</b>
Clock Start/From:	<b>11</b>
Clock To:	
1st Value:	<b>4.000</b>
2nd Value:	
Value Percent:	
Continuous Index:	
Within 8" of Joint:	
Remarks:

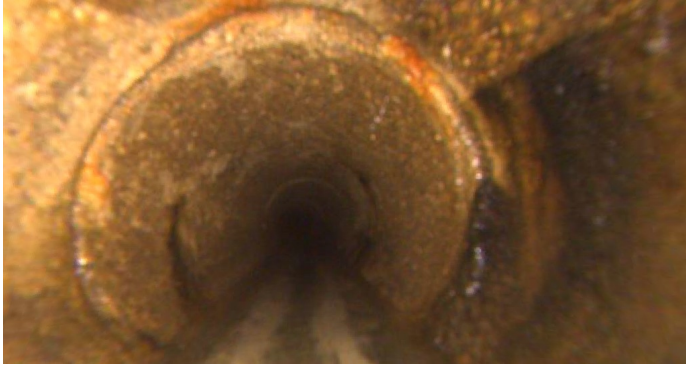
Code: **CL**  
Description: **Crack Longitudinal**

Distance (ft): **27.9**  
Structural Grade: **2**  
O&M Grade: **0**  
Clock Start/From: **3**  
Clock To:  
1st Value:  
2nd Value:  
Value Percent:  
Continuous Index:  
Within 8" of Joint: **YES**  
Remarks:

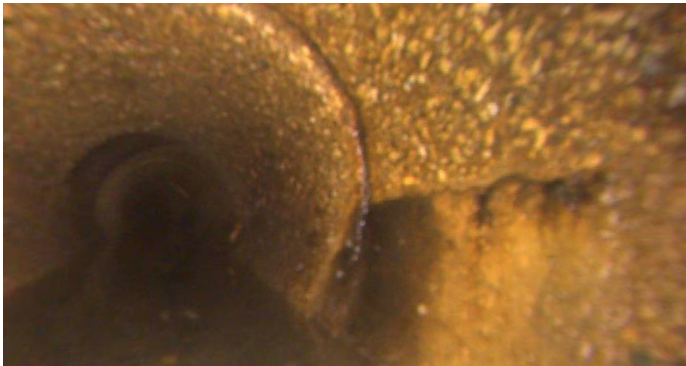
Code: **CL**  
Description: **Crack Longitudinal**

Distance (ft): **69.7**  
Structural Grade: **2**  
O&M Grade: **0**  
Clock Start/From: **4**  
Clock To:  
1st Value:  
2nd Value:  
Value Percent:  
Continuous Index:  
Within 8" of Joint:  
Remarks:

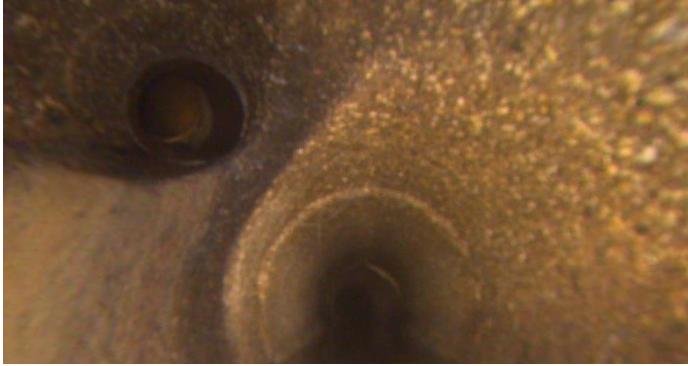
Code: **TF**  
Description: **Tap Factory**

Distance (ft): **71.9**  
Structural Grade: **0**  
O&M Grade: **0**  
Clock Start/From: **2**  
Clock To:  
1st Value: **4.000**  
2nd Value:  
Value Percent:  
Continuous Index:  
Within 8" of Joint:  
Remarks:

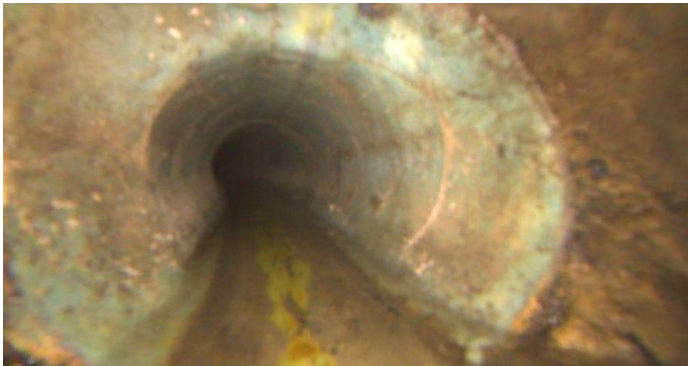
Code: **AMH**  
Description: **Manhole**

Distance (ft): **85.4**  
Structural Grade: **0**  
O&M Grade: **0**  
Clock Start/From:  
Clock To:  
1st Value:  
2nd Value:  
Value Percent:  
Continuous Index:  
Within 8" of Joint: **NO**  
Remarks: **M-605-014**
