Profile/Photo Observation Report

Date:	04/26/2018	Weather:		Coding:	PACP 6.0
Pipe Length (ft):	164.9	Owner:	NA	Pre Clean:	Not Known
P.O.#:		Surveyor:	Mark Ruby	PSR:	P-605-017-013
Customer:		Clean Date:	01/01/1900	Shape:	C

Street:	COURT ST	Flow Control:	Not Controlled
City:	Hobart, IN	Year Renewed:	
Location:	Other	Tape/Media #:	
Purpose:	Not Known	Dia/Height:	12"
Use:	Sanitary	Material:	VCP
Drain Area:	NA	Lining:	
Category:	NA		
Comment:	Flow direction wrong. Debris at 63'.

Location Details:		Direction of Survey:	Downstream
US MH:	M-605-013	DS MH:	M-605-017
		Total Length Surveyed (ft):	64.3

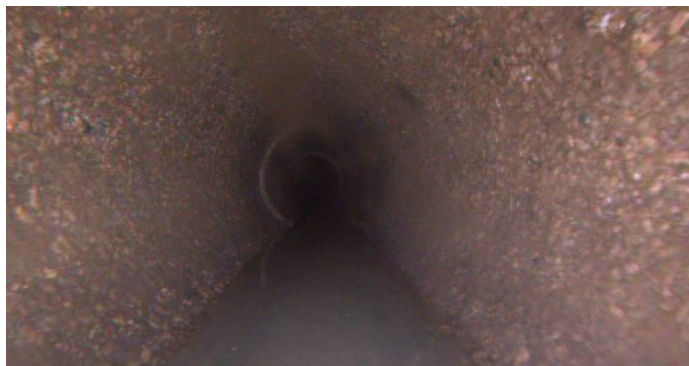
Code: **AMH**
 Description: **Manhole**
 Distance (ft): **.0**
 Structural Grade: **0**
 O&M Grade: **0**
 Clock Start/From:
 Clock To:
 1st Value:
 2nd Value:
 Value Percent:
 Continuous Index:
 Within 8" of Joint: **NO**
 Remarks: **M-605-013**

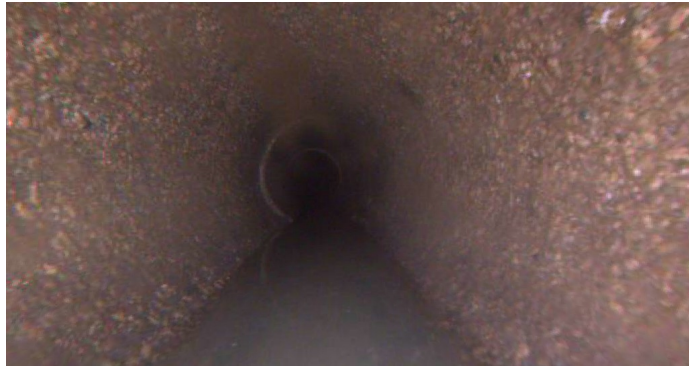
Code: **MWL**
Description: **Water Level**

Distance (ft): **.0**
Structural Grade: **0**
O&M Grade: **0**
Clock Start/From:
Clock To:
1st Value:
2nd Value:
Value Percent: **10.000**
Continuous Index:
Within 8" of Joint: **NO**
Remarks:

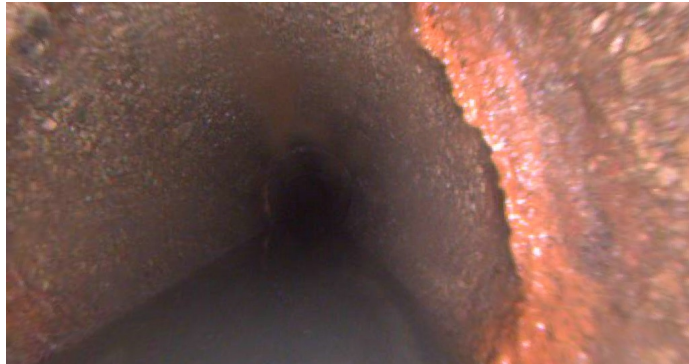
Code: **DAZ**
Description: **Deposits Attached Other**

Distance (ft): **27.7**
Structural Grade: **0**
O&M Grade: **2**
Clock Start/From: **7**
Clock To: **5**
1st Value:
2nd Value:
Value Percent: **5.000**
Continuous Index:
Within 8" of Joint: **YES**
Remarks:

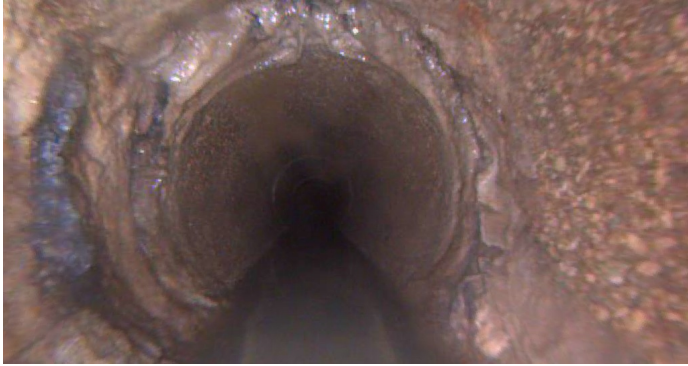
Code:	DAZ
Description:	Deposits Attached Other
Distance (ft):	49.0
Structural Grade:	0
O&M Grade:	2
Clock Start/From:	7
Clock To:	5
1st Value:	
2nd Value:	
Value Percent:	5.000
Continuous Index:	
Within 8" of Joint:	YES
Remarks:

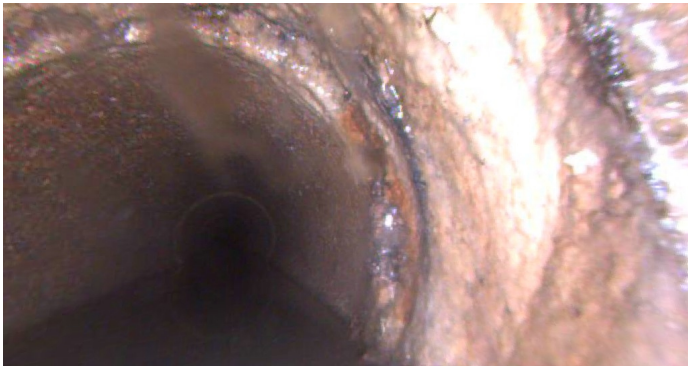
Code:	MSA
Description:	Abandoned Survey
Distance (ft):	64.3
Structural Grade:	0
O&M Grade:	0
Clock Start/From:	
Clock To:	
1st Value:	
2nd Value:	
Value Percent:	
Continuous Index:	
Within 8" of Joint:	NO
Remarks:	DSF
