Profile/Photo Observation Report

Street:	Henry	Flow Control:	Not Controlled
City:	Hobart, IN	Year Renewed:	
Location:	Other	Tape/Media #:	
Purpose:	Not Known	Dia/Height:	12"
Use:	Sanitary	Material:	VCP
Drain Area:	NA	Lining:	
Category:	NA		
Comment:	Flow direction wrong. Debris at 63'.

Location Details:		Direction of Survey:	Downstream
US MH:	M-605-013	DS MH:	M-605-017
		Total Length Surveyed (ft):	64.3

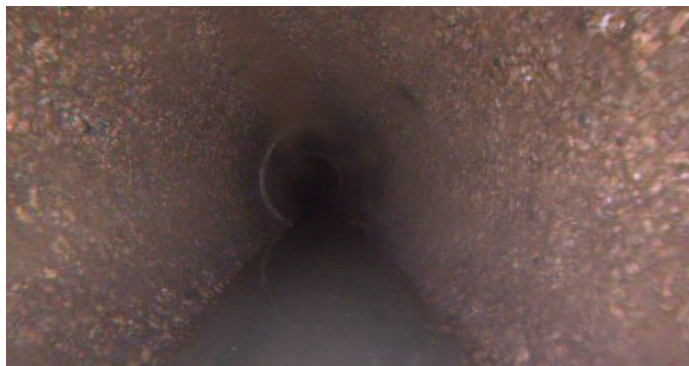
Code: **AMH**
Description: **Manhole**

Distance (ft): **.0**
Structural Grade: **0**
O&M Grade: **0**
Clock Start/From:
Clock To:
1st Value:
2nd Value:
Value Percent:
Continuous Index:
Within 8" of Joint: **NO**
Remarks: **M-605-013**

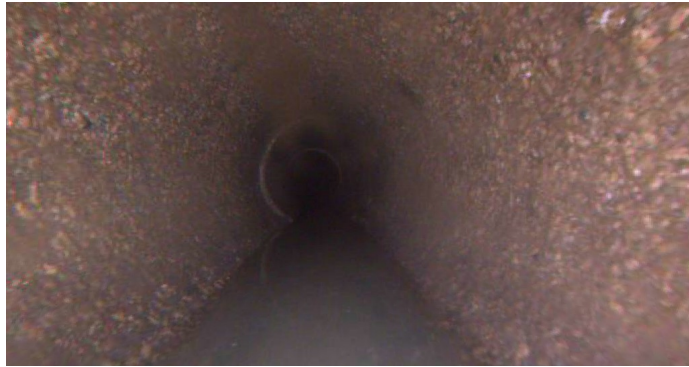
Code: **MWL**
Description: **Water Level**

Distance (ft): **.0**
Structural Grade: **0**
O&M Grade: **0**
Clock Start/From:
Clock To:
1st Value:
2nd Value:
Value Percent: **10.000**
Continuous Index:
Within 8" of Joint: **NO**
Remarks:

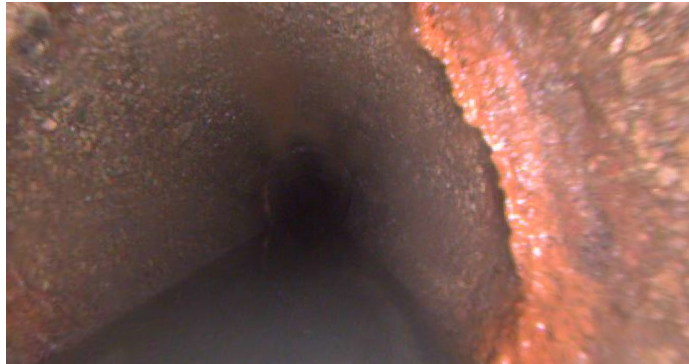
Code: **DAZ**
Description: **Deposits Attached Other**

Distance (ft): **27.7**
Structural Grade: **0**
O&M Grade: **2**
Clock Start/From: **7**
Clock To: **5**
1st Value:
2nd Value:
Value Percent: **5.000**
Continuous Index:
Within 8" of Joint: **YES**
Remarks:

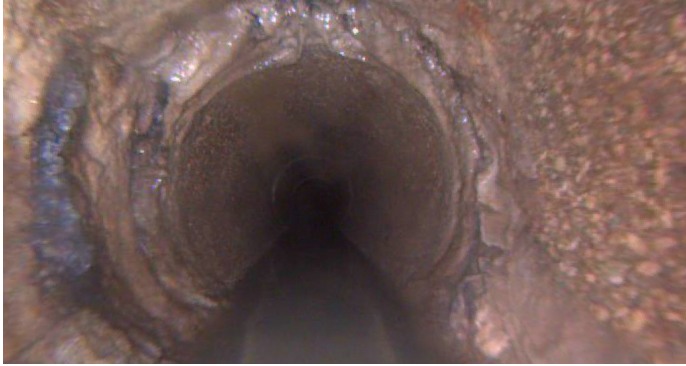
Code:	DAZ
Description:	Deposits Attached Other
Distance (ft):	49.0
Structural Grade:	0
O&M Grade:	2
Clock Start/From:	7
Clock To:	5
1st Value:	
2nd Value:	
Value Percent:	5.000
Continuous Index:	
Within 8" of Joint:	YES
Remarks:

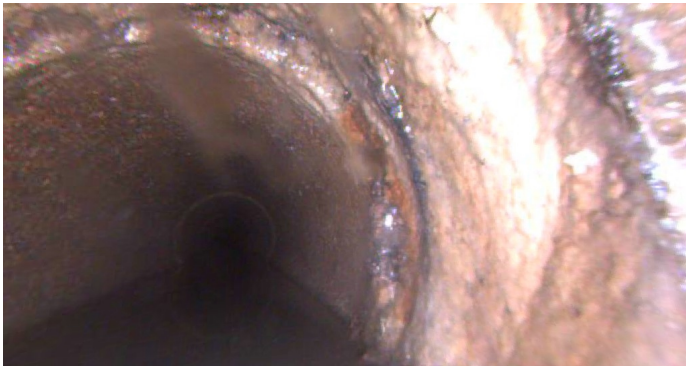
Code:	MSA
Description:	Abandoned Survey
Distance (ft):	64.3
Structural Grade:	0
O&M Grade:	0
Clock Start/From:	
Clock To:	
1st Value:	
2nd Value:	
Value Percent:	
Continuous Index:	
Within 8" of Joint:	NO
Remarks:	DSF
