Profile/Photo Observation Report

Date:	04/26/2018	Weather:		Coding:	PACP 6.0
Pipe Length (ft):	194.9	Owner:	NA	Pre Clean:	Not Known
P.O.#:		Surveyor:	Jay Black U-1013-0619395	PSR:	P-605-015-014
Customer:		Clean Date:	01/01/1900	Shape:	C

Street:	W 2ND ST	Flow Control:	Not Controlled
City:	Hobart, IN	Year Renewed:	
Location:	Other	Tape/Media #:	
Purpose:	Not Known	Dia/Height:	12"
Use:	Sanitary	Material:	VCP
Drain Area:	NA	Lining:	
Category:	NA		
Comment:	Flow direction wrong. Debris at tap at 30'.		
Location Details:		Direction of Survey:	Downstream
US MH:	M-605-014	DS MH:	M-605-015
		Total Length Surveyed (ft):	31.3

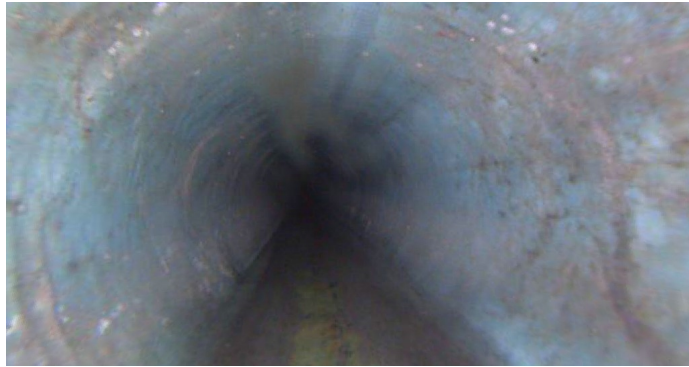
Code:	MWL
Description:	Water Level
Distance (ft):	.0
Structural Grade:	0
O&M Grade:	0
Clock Start/From:	
Clock To:	
1st Value:	
2nd Value:	
Value Percent:	10.000
Continuous Index:	
Within 8" of Joint:	NO
Remarks:

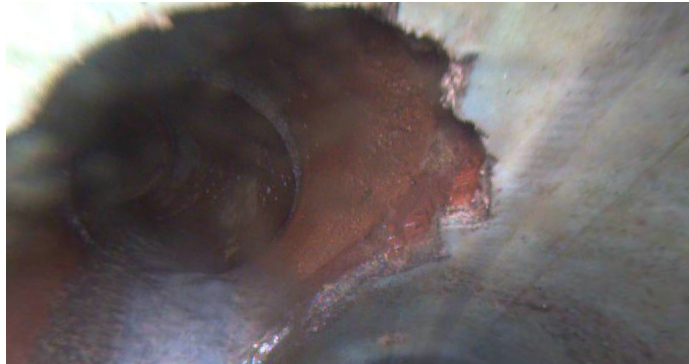
Code:	TF
Description:	Tap Factory
Distance (ft):	21.4
Structural Grade:	0
O&M Grade:	0
Clock Start/From:	10
Clock To:	
1st Value:	4.000
2nd Value:	
Value Percent:	
Continuous Index:	
Within 8" of Joint:	
Remarks:

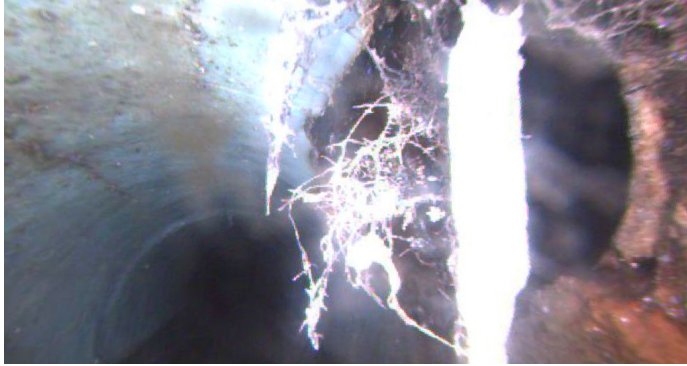
Code:	TBD
Description:	Tap Break-in Defective
Distance (ft):	31.2
Structural Grade:	0
O&M Grade:	3
Clock Start/From:	3
Clock To:	
1st Value:	4.000
2nd Value:	
Value Percent:	
Continuous Index:	
Within 8" of Joint:	
Remarks:	Roots

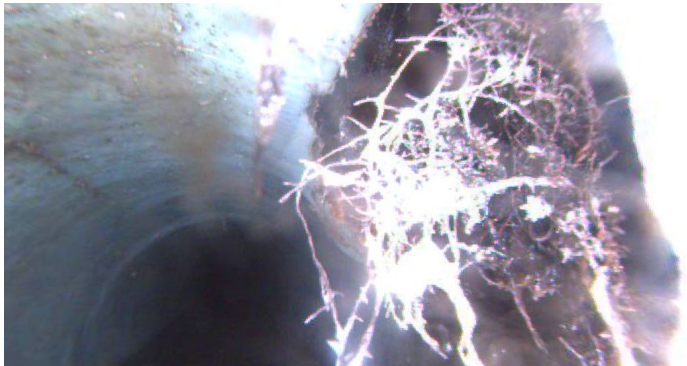
Code:	MSA
Description:	Abandoned Survey
Distance (ft):	31.3
Structural Grade:	0
O&M Grade:	0
Clock Start/From:	
Clock To:	
1st Value:	
2nd Value:	
Value Percent:	
Continuous Index:	
Within 8" of Joint:	NO
Remarks:	tbd
