Profile/Photo Observation Report

Street:	2nd	Flow Control:	Not Controlled
City:	Hobart, IN	Year Renewed:	
Location:	Other	Tape/Media #:	
Purpose:	Not Known	Dia/Height:	12"
Use:	Sanitary	Material:	VCP
Drain Area:	NA	Lining:	
Category:	NA		
Comment:	Flow direction wrong. Debris at tap at 30'.		
Location Details:		Direction of Survey:	Downstream
US MH:	M-605-014	DS MH:	M-605-015
		Total Length Surveyed (ft):	31.3

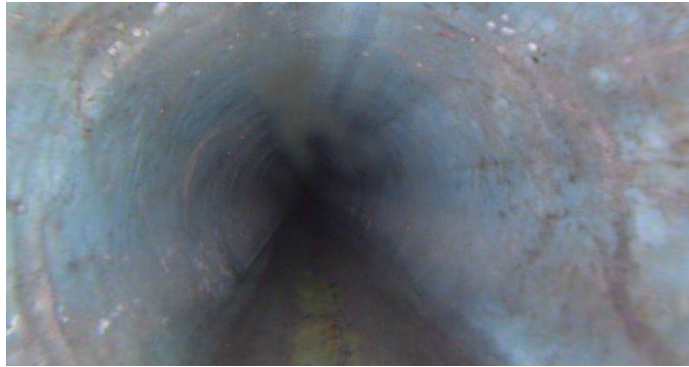
Code: **MWL**
Description: **Water Level**

Distance (ft): **.0**
Structural Grade: **0**
O&M Grade: **0**
Clock Start/From:
Clock To:
1st Value:
2nd Value:
Value Percent: **10.000**
Continuous Index:
Within 8" of Joint: **NO**
Remarks:

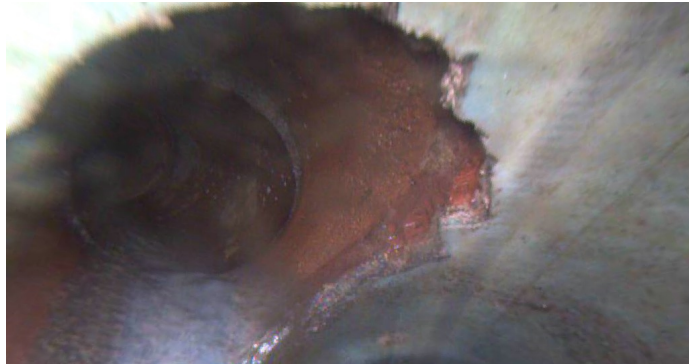
Code: **TF**
Description: **Tap Factory**

Distance (ft): **21.4**
Structural Grade: **0**
O&M Grade: **0**
Clock Start/From: **10**
Clock To:
1st Value: **4.000**
2nd Value:
Value Percent:
Continuous Index:
Within 8" of Joint:
Remarks:

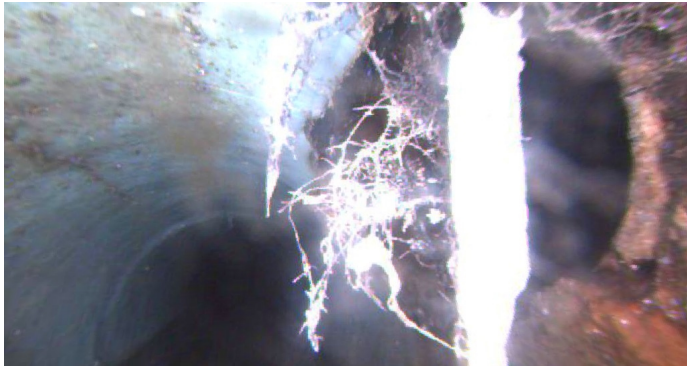
Code:	TBD
Description:	Tap Break-in Defective
Distance (ft):	31.2
Structural Grade:	0
O&M Grade:	3
Clock Start/From:	3
Clock To:	
1st Value:	4.000
2nd Value:	
Value Percent:	
Continuous Index:	
Within 8" of Joint:	
Remarks:	Roots

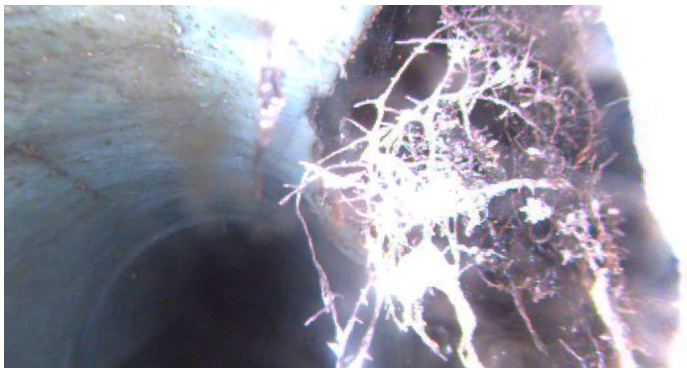
Code:	MSA
Description:	Abandoned Survey
Distance (ft):	31.3
Structural Grade:	0
O&M Grade:	0
Clock Start/From:	
Clock To:	
1st Value:	
2nd Value:	
Value Percent:	
Continuous Index:	
Within 8" of Joint:	NO
Remarks:	tbd
