Profile/Photo Observation Report

Date:	04/26/2018	Weather:		Coding:	PACP 6.0
Pipe Length (ft):	118.1	Owner:	NA	Pre Clean:	Not Known
P.O.#:		Surveyor:	Mark Ruby	PSR:	P-605-016-015
Customer:		Clean Date:	01/01/1900	Shape:	C

Street:	W 2ND ST	Flow Control:	Not Controlled
City:	Hobart, IN	Year Renewed:	
Location:	Other	Tape/Media #:	
Purpose:	Not Known	Dia/Height:	12"
Use:	Sanitary	Material:	PVC
Drain Area:	NA	Lining:	
Category:	NA		
Comment:	Flow direction wrong.

Location Details:		Direction of Survey:	Upstream
US MH:	M-605-015	DS MH:	M-605-016
		Total Length Surveyed (ft):	76.5

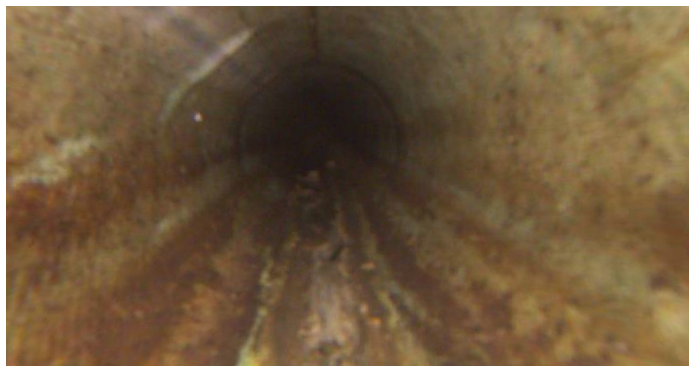
Code: **AMH**
Description: **Manhole**

Distance (ft): **.0**
Structural Grade: **0**
O&M Grade: **0**
Clock Start/From:
Clock To:
1st Value:
2nd Value:
Value Percent:
Continuous Index:
Within 8" of Joint: **NO**
Remarks: **M-605-016**

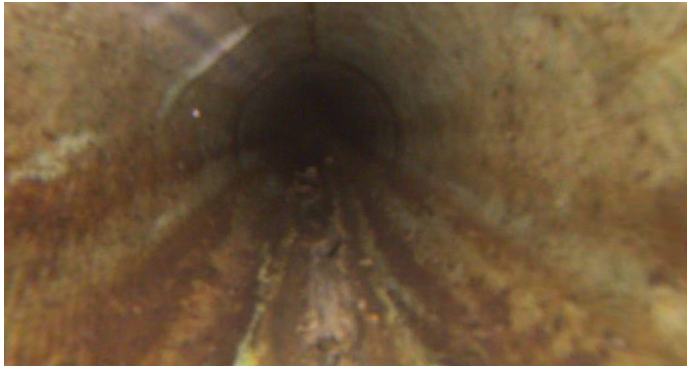
Code: **MWL**
Description: **Water Level**

Distance (ft): **.0**
Structural Grade: **0**
O&M Grade: **0**
Clock Start/From:
Clock To:
1st Value:
2nd Value:
Value Percent: **10.000**
Continuous Index:
Within 8" of Joint: **NO**
Remarks:

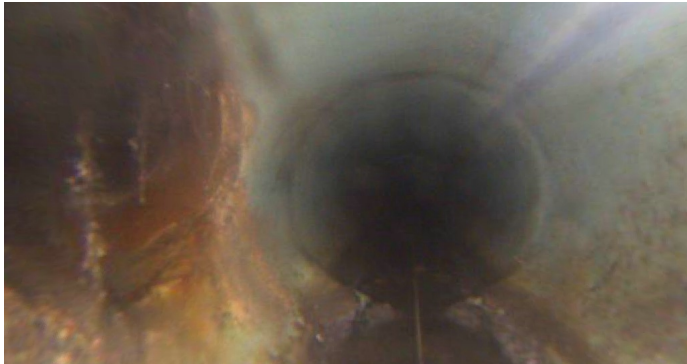
Code: **TB**
Description: **Tap Break-in**

Distance (ft): **35.4**
Structural Grade: **0**
O&M Grade: **0**
Clock Start/From: **4**
Clock To:
1st Value: **4.000**
2nd Value:
Value Percent:
Continuous Index:
Within 8" of Joint:
Remarks:

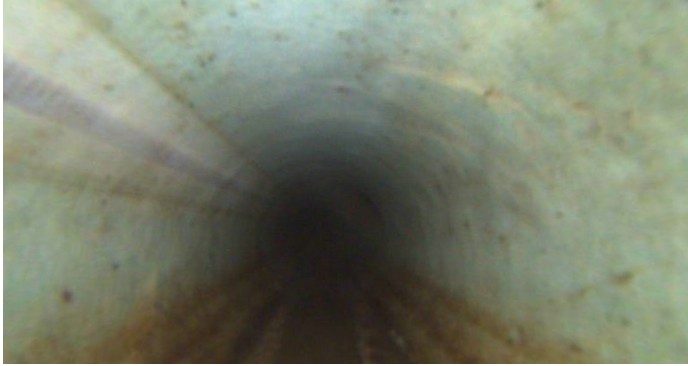
Code:	MSA
Description:	Abandoned Survey
Distance (ft):	76.5
Structural Grade:	0
O&M Grade:	0
Clock Start/From:	
Clock To:	
1st Value:	
2nd Value:	
Value Percent:	
Continuous Index:	
Within 8" of Joint:	NO
Remarks:	No blockage
