Profile/Photo Observation Report

Date:	04/26/2018	Weather:		Coding:	PACP 6.0
Pipe Length (ft):	118.1	Owner:	NA	Pre Clean:	Not Known
P.O.#:		Surveyor:	Mark Ruby	PSR:	P-605-016-015
Customer:		Clean Date:	01/01/1900	Shape:	C

Street:	2nd	Flow Control:	Not Controlled
City:	Hobart, IN	Year Renewed:	
Location:	Other	Tape/Media #:	
Purpose:	Not Known	Dia/Height:	12"
Use:	Sanitary	Material:	PVC
Drain Area:	NA	Lining:	
Category:	NA		
Comment:	Flow direction wrong.

Location Details:		Direction of Survey:	Upstream
US MH:	M-605-015	DS MH:	M-605-016
		Total Length Surveyed (ft):	76.5

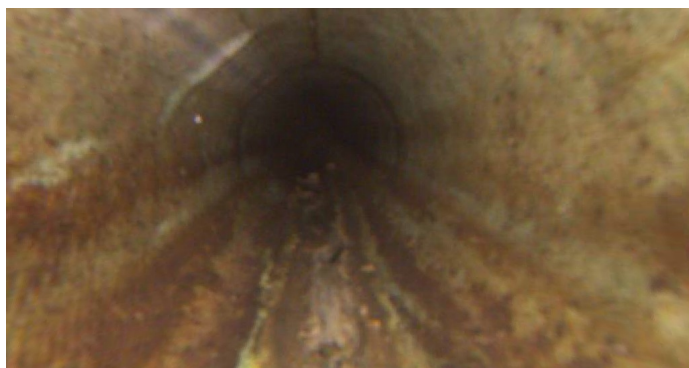
Code: **AMH**
 Description: **Manhole**

Distance (ft): **.0**
 Structural Grade: **0**
 O&M Grade: **0**
 Clock Start/From:
 Clock To:
 1st Value:
 2nd Value:
 Value Percent:
 Continuous Index:
 Within 8" of Joint: **NO**
 Remarks: **M-605-016**

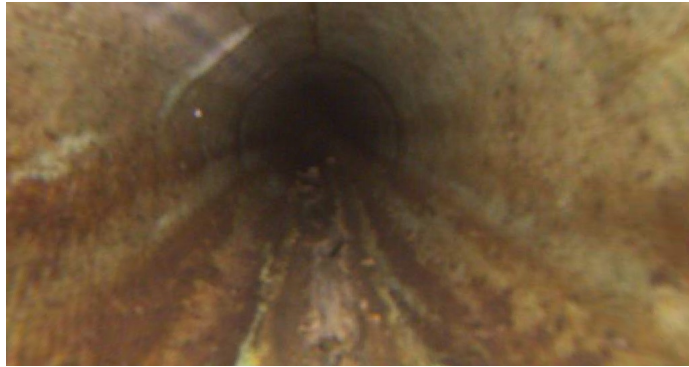
Code: **MWL**
Description: **Water Level**

Distance (ft): **.0**
Structural Grade: **0**
O&M Grade: **0**
Clock Start/From:
Clock To:
1st Value:
2nd Value:
Value Percent: **10.000**
Continuous Index:
Within 8" of Joint: **NO**
Remarks:

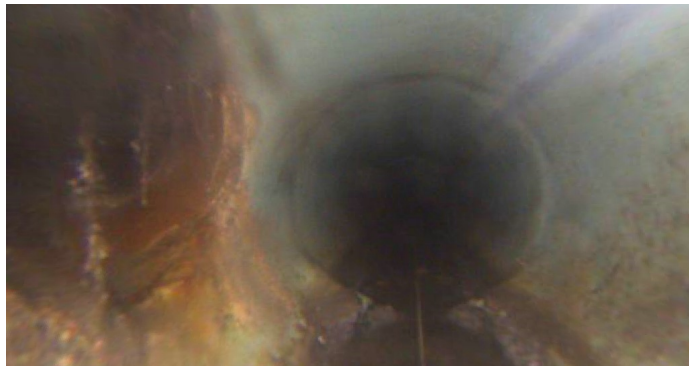
Code: **TB**
Description: **Tap Break-in**

Distance (ft): **35.4**
Structural Grade: **0**
O&M Grade: **0**
Clock Start/From: **4**
Clock To:
1st Value: **4.000**
2nd Value:
Value Percent:
Continuous Index:
Within 8" of Joint:
Remarks:

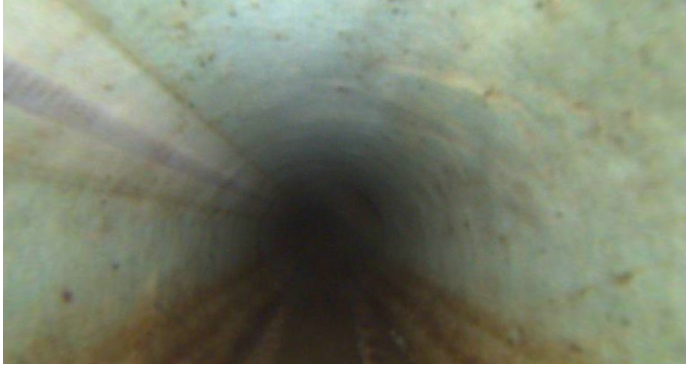
Code:	MSA
Description:	Abandoned Survey
Distance (ft):	76.5
Structural Grade:	0
O&M Grade:	0
Clock Start/From:	
Clock To:	
1st Value:	
2nd Value:	
Value Percent:	
Continuous Index:	
Within 8" of Joint:	NO
Remarks:	No blockage
