Profile/Photo Observation Report

Date:	04/26/2018	Weather:		Coding:	PACP 6.0
Pipe Length (ft):	118.1	Owner:	NA	Pre Clean:	Not Known
P.O.#:		Surveyor:	Jen Costello	PSR:	P-605-016-015
Customer:		Clean Date:	01/01/1900	Shape:	C

Street:	2nd	Flow Control:	Not Controlled
City:	Hobart, IN	Year Renewed:	
Location:	Other	Tape/Media #:	
Purpose:	Not Known	Dia/Height:	12"
Use:	Sanitary	Material:	VCP
Drain Area:	NA	Lining:	Cured in Place
Category:	NA		
Comment:	Flow direction wrong. Redeployment. Debris at 24'.		
Location Details:		Direction of Survey:	Upstream
US MH:	M-605-015	DS MH:	M-605-016
		Total Length Surveyed (ft):	25.6

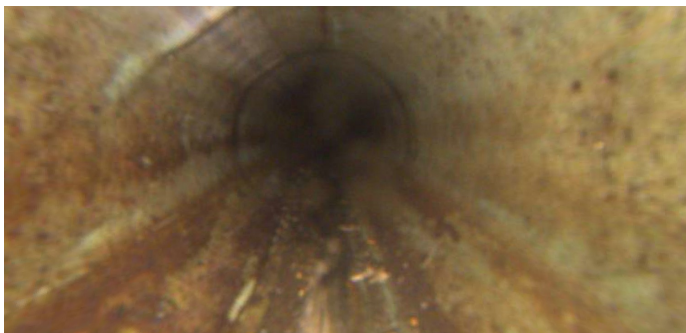
Code: **AMH**
Description: **Manhole**

Distance (ft): **.0**
Structural Grade: **0**
O&M Grade: **0**
Clock Start/From:
Clock To:
1st Value:
2nd Value:
Value Percent:
Continuous Index:
Within 8" of Joint: **NO**
Remarks: **M-605-016**

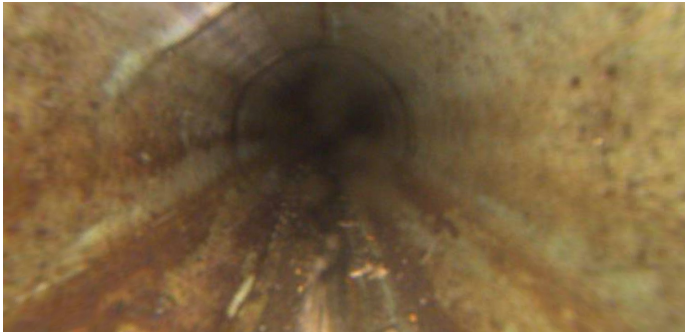
Code:	MWL
Description:	Water Level

Distance (ft):	.0
Structural Grade:	0
O&M Grade:	0
Clock Start/From:	
Clock To:	
1st Value:	
2nd Value:	
Value Percent:	5.000
Continuous Index:	
Within 8" of Joint:	NO
Remarks:

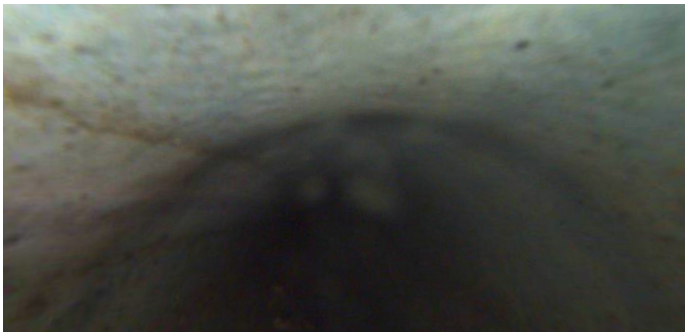
Code:	MSA
Description:	Abandoned Survey

Distance (ft):	25.6
Structural Grade:	0
O&M Grade:	0
Clock Start/From:	
Clock To:	
1st Value:	
2nd Value:	
Value Percent:	
Continuous Index:	
Within 8" of Joint:	NO
Remarks:	unknown
