Profile/Photo Observation Report

| P.O.#: | YES502259 | Surveyor: | S. Bucklin | PSR: | P-605-016-015 |

| Street: | West 2nd Street | Flow Control: | Not Controlled |

| US MH: | M-605-015 | DS MH: | M-605-016 |

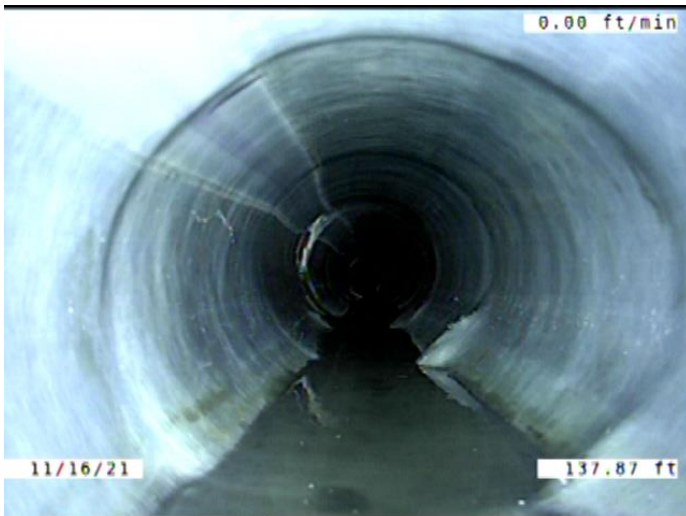
Code: **MWLS**
 Description: **Miscellaneous Water Level Sag**

Distance (ft): **137.9**
 Structural Grade: **2**
 O&M Grade: **0**
 Clock Start/From:
 Clock To:
 1st Value:
 2nd Value:
 Value Percent: **5.000**
 Continuous Index:
 Within 8" of Joint: **NO**
 Remarks:

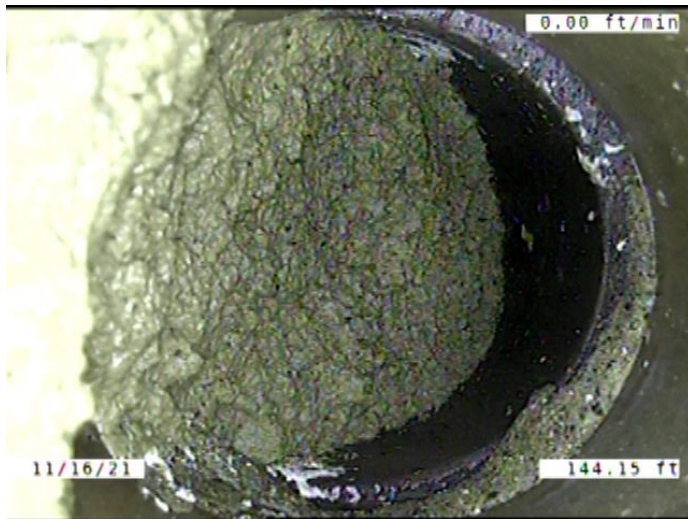
Code: **TBD**
Description: **Tap Break-in/Hammer Defective**

Distance (ft): **144.1**
Structural Grade: **0**
O&M Grade: **3**
Clock Start/From: **10**
Clock To:
1st Value: **4.000**
2nd Value:
Value Percent:
Continuous Index:
Within 8" of Joint: **NO**
Remarks: **LOOKS TO BE 100% PLUGGED**

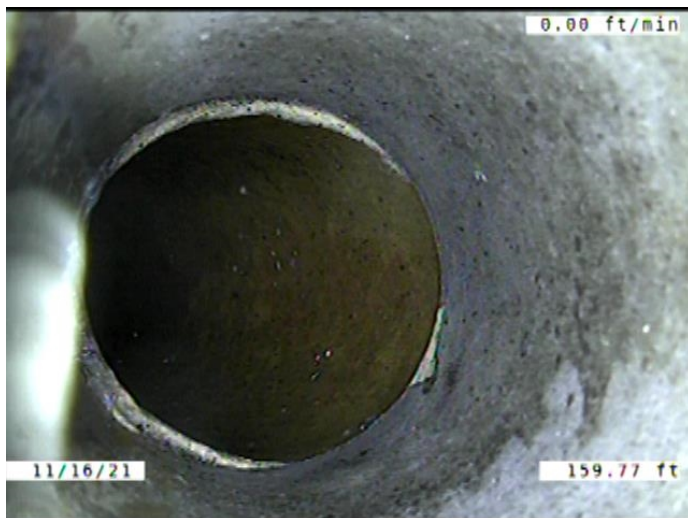
Code: **TBD**
Description: **Tap Break-in/Hammer Defective**

Distance (ft): **159.8**
Structural Grade: **0**
O&M Grade: **3**
Clock Start/From: **11**
Clock To:
1st Value: **4.000**
2nd Value:
Value Percent:
Continuous Index:
Within 8" of Joint: **NO**
Remarks: **CONNECTION LOOKS TO BE BROKEN. ACTIVE TAP**

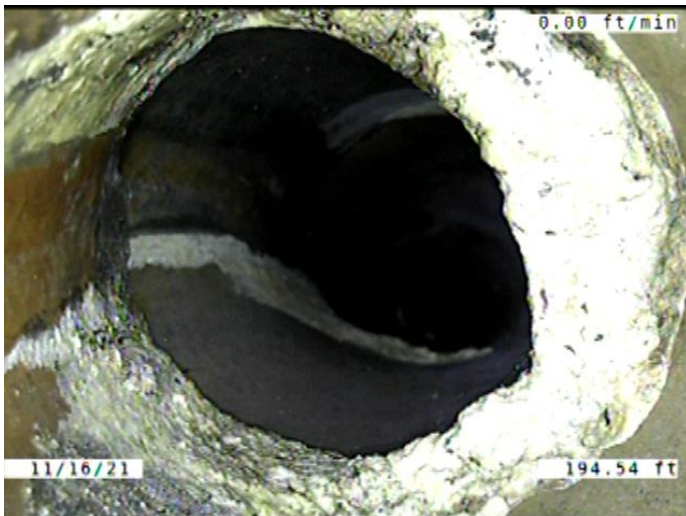
Code: **TB**
Description: **Tap Break-in/Hammer**

Distance (ft): **194.5**
Structural Grade: **0**
O&M Grade: **0**
Clock Start/From: **10**
Clock To:
1st Value: **4.000**
2nd Value:
Value Percent:
Continuous Index:
Within 8" of Joint: **NO**
Remarks: **CONSTANTLY RUNNING WATER.
ENCRUSTATION IN THE TAP**

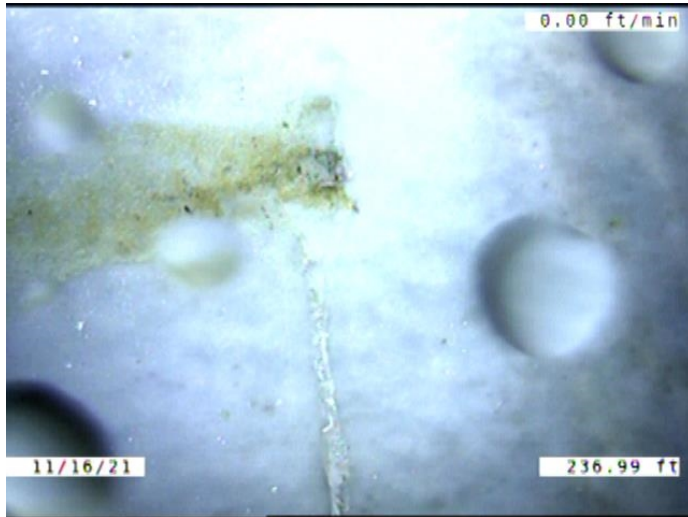
Code: **LFZ**
 Description: **Lining Feature Other**

Distance (ft): **237.0**
 Structural Grade: **0**
 O&M Grade: **0**
 Clock Start/From: **10**
 Clock To:
 1st Value:
 2nd Value:
 Value Percent:
 Continuous Index:
 Within 8" of Joint: **NO**
 Remarks: **LOOKS TO HAVE A CUT IN THE LINER. ENCRUSTATION FORMING UNDER IT.**

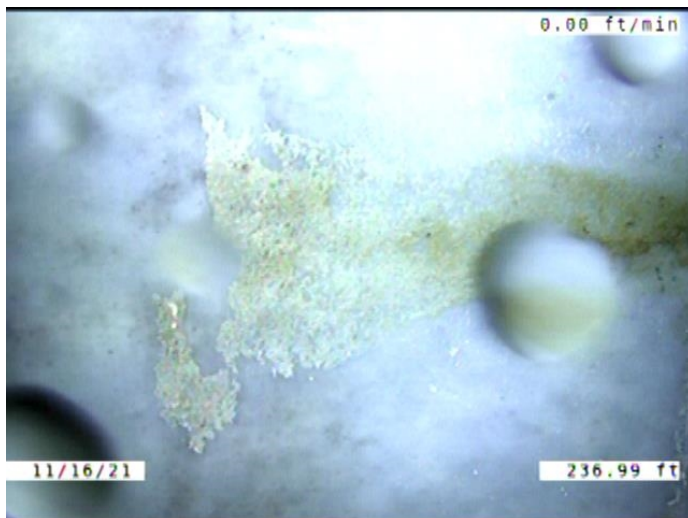
Code: **DAGS**
 Description: **Deposits Attached Grease**

Distance (ft): **237.0**
 Structural Grade: **0**
 O&M Grade: **2**
 Clock Start/From: **8**
 Clock To: **10**
 1st Value:
 2nd Value:
 Value Percent: **5.000**
 Continuous Index:
 Within 8" of Joint: **NO**
 Remarks:

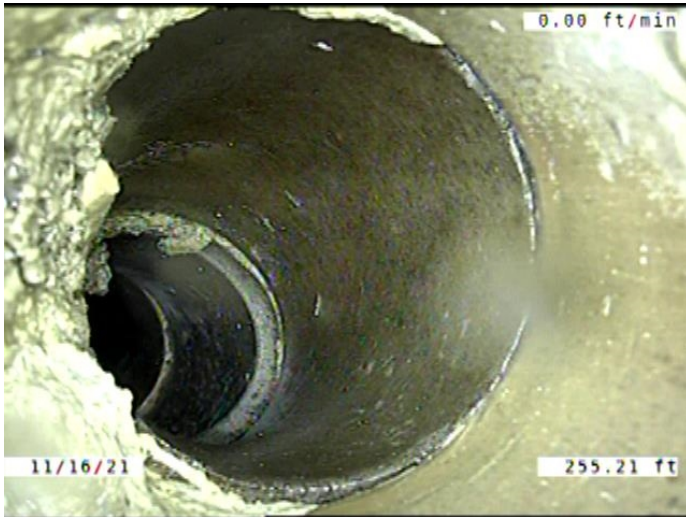
Code: **TB**
Description: **Tap Break-in/Hammer**

Distance (ft): **255.2**
Structural Grade: **0**
O&M Grade: **0**
Clock Start/From: **10**
Clock To:
1st Value: **4.000**
2nd Value:
Value Percent:
Continuous Index:
Within 8" of Joint: **NO**
Remarks: **ENCRUSTATION IN THE TAP**
