Profile/Photo Observation Report

Date:	11/16/2021	Weather:		Coding:	PACP 7.0
Pipe Length (ft):	312.9	Owner:	City of Hobart	Pre Clean:	Light Cleaning
P.O.#:	YES502259	Surveyor:	S. Bucklin	PSR:	P-605-016-015
Customer:	City of Hobart	Clean Date:	11/16/2021	Shape:	C

Street:	West 2nd Street	Flow Control:	Not Controlled
City:	Hobart, IN	Year Renewed:	
Location:	Local rural streets with light traffic, t	Tape/Media #:	
Purpose:	Routine Assessment	Dia/Height:	10"
Use:	Sanitary Sewage Pipe	Material:	VCP
Drain Area:		Lining:	Cured-In-Place Pipe
Category:	NA		
Comment:

Location Details:		Direction of Survey:	Downstream
US MH:	M-605-015	DS MH:	M-605-016
		Total Length Surveyed (ft):	312.9

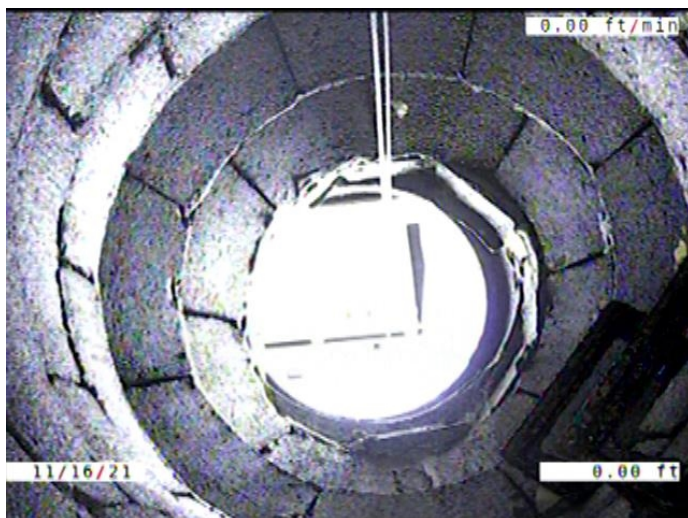
Code: **AMH**
 Description: **Manhole**

Distance (ft): **.0**
 Structural Grade: **0**
 O&M Grade: **0**
 Clock Start/From:
 Clock To:
 1st Value:
 2nd Value:
 Value Percent:
 Continuous Index:
 Within 8" of Joint: **NO**
 Remarks: **M-605-015**

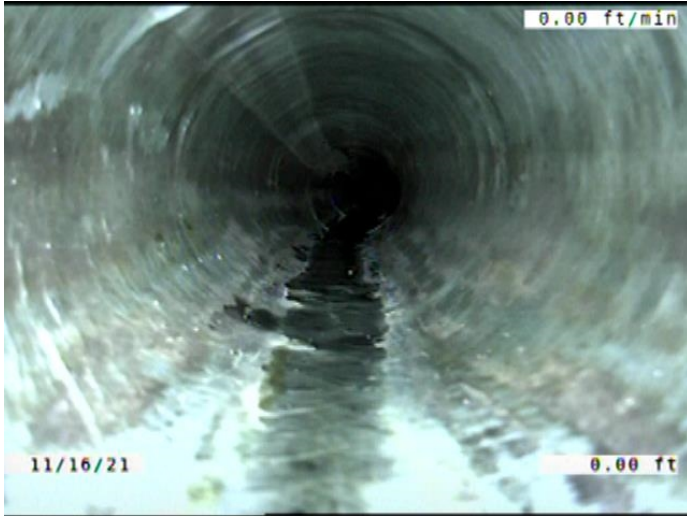
Code: **MWL**
Description: **Miscellaneous Water Level**

Distance (ft): **.0**
Structural Grade: **0**
O&M Grade: **0**
Clock Start/From:
Clock To:
1st Value:
2nd Value:
Value Percent: **5.000**
Continuous Index:
Within 8" of Joint: **NO**
Remarks:

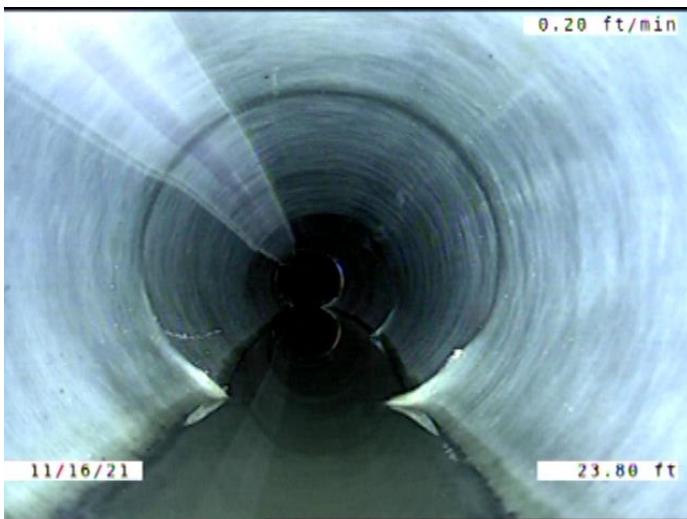
Code: **MWLS**
Description: **Miscellaneous Water Level Sag**

Distance (ft): **23.3**
Structural Grade: **2**
O&M Grade: **0**
Clock Start/From:
Clock To:
1st Value:
2nd Value:
Value Percent: **5.000**
Continuous Index: **S01**
Within 8" of Joint: **NO**
Remarks:

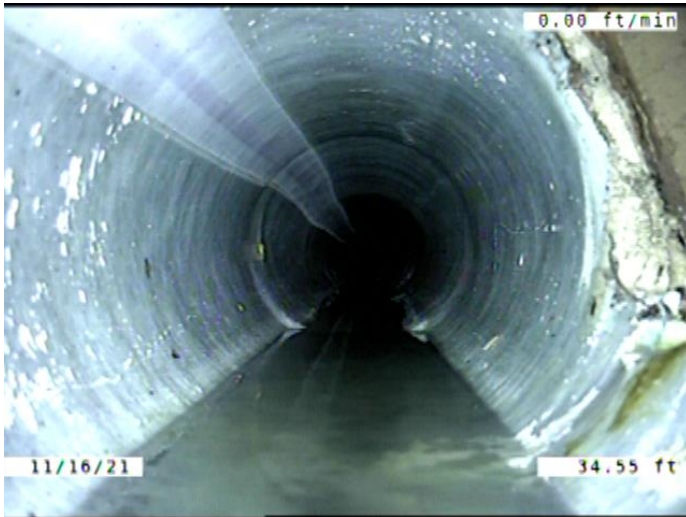
Code: **MWLS**
Description: **Miscellaneous Water Level Sag**

Distance (ft): **34.6**
Structural Grade: **2**
O&M Grade: **0**
Clock Start/From:
Clock To:
1st Value:
2nd Value:
Value Percent: **5.000**
Continuous Index: **F01**
Within 8" of Joint: **NO**
Remarks:

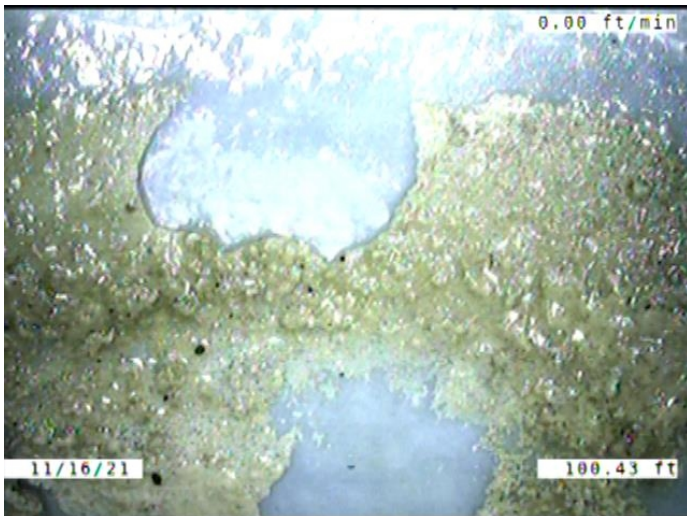
Code: **DAE**
 Description: **Deposits Attached Encrustation**

Distance (ft): **100.4**
 Structural Grade: **0**
 O&M Grade: **2**
 Clock Start/From: **2**
 Clock To: **5**
 1st Value:
 2nd Value:
 Value Percent: **5.000**
 Continuous Index:
 Within 8" of Joint: **NO**
 Remarks:

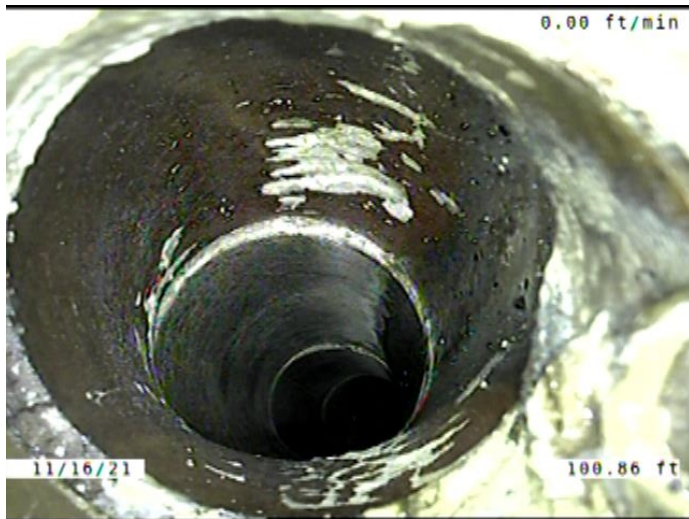
Code: **TB**
Description: **Tap Break-in/Hammer**

Distance (ft): **100.9**
Structural Grade: **0**
O&M Grade: **0**
Clock Start/From: **3**
Clock To:
1st Value: **4.000**
2nd Value:
Value Percent:
Continuous Index:
Within 8" of Joint: **NO**
Remarks: **ENCRUSTATION AROUND THE CONNECTION**

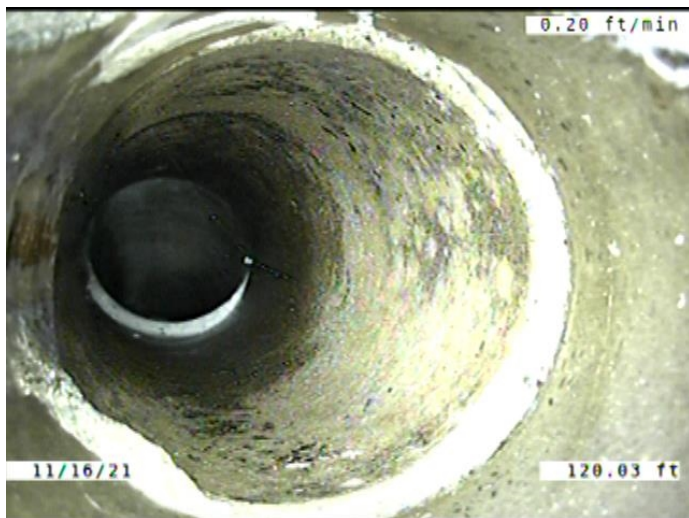
Code: **TB**
Description: **Tap Break-in/Hammer**

Distance (ft): **120.0**
Structural Grade: **0**
O&M Grade: **0**
Clock Start/From: **10**
Clock To:
1st Value: **4.000**
2nd Value:
Value Percent:
Continuous Index:
Within 8" of Joint: **NO**
Remarks:

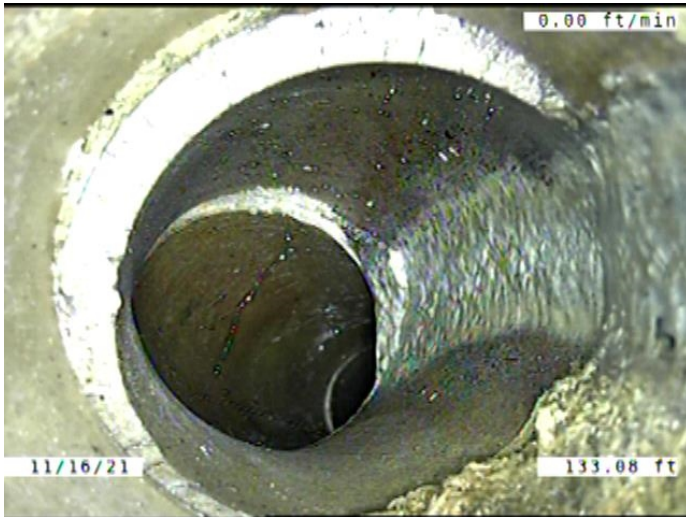
Code: **TBA**
 Description: **Tap Break-in Activity**

Distance (ft): **133.1**
 Structural Grade: **0**
 O&M Grade: **0**
 Clock Start/From: **3**
 Clock To:
 1st Value: **4.000**
 2nd Value:
 Value Percent:
 Continuous Index:
 Within 8" of Joint: **NO**
 Remarks: **ENCRUSTATION IN THE TAP**

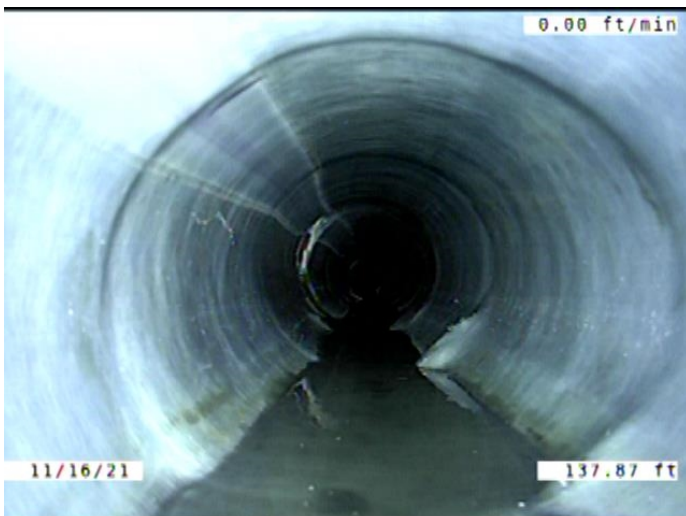
Code: **MWLS**
 Description: **Miscellaneous Water Level Sag**

Distance (ft): **137.9**
 Structural Grade: **2**
 O&M Grade: **0**
 Clock Start/From:
 Clock To:
 1st Value:
 2nd Value:
 Value Percent: **5.000**
 Continuous Index:
 Within 8" of Joint: **NO**
 Remarks:

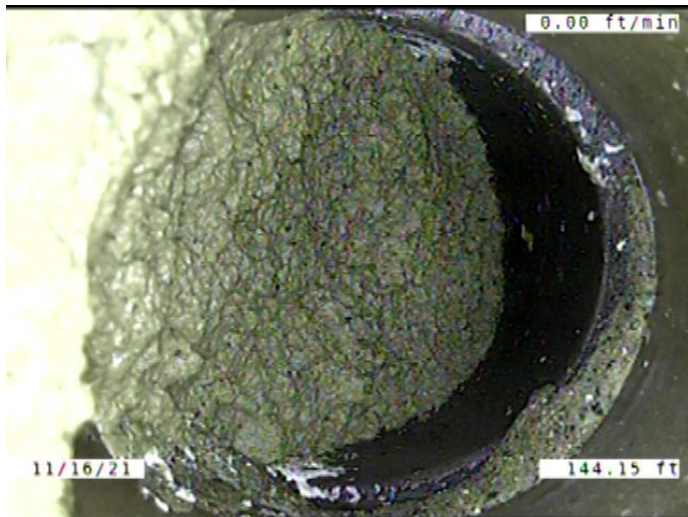
Code: **TBD**
 Description: **Tap Break-in/Hammer Defective**

Distance (ft): **144.1**
 Structural Grade: **0**
 O&M Grade: **3**
 Clock Start/From: **10**
 Clock To:
 1st Value: **4.000**
 2nd Value:
 Value Percent:
 Continuous Index:
 Within 8" of Joint: **NO**
 Remarks: **LOOKS TO BE 100% PLUGGED**

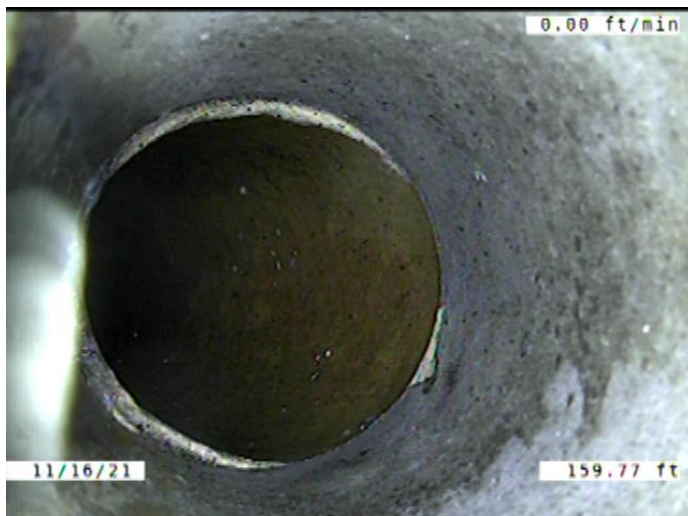
Code: **TBD**
 Description: **Tap Break-in/Hammer Defective**

Distance (ft): **159.8**
 Structural Grade: **0**
 O&M Grade: **3**
 Clock Start/From: **11**
 Clock To:
 1st Value: **4.000**
 2nd Value:
 Value Percent:
 Continuous Index:
 Within 8" of Joint: **NO**
 Remarks: **CONNECTION LOOKS TO BE BROKEN. ACTIVE TAP**

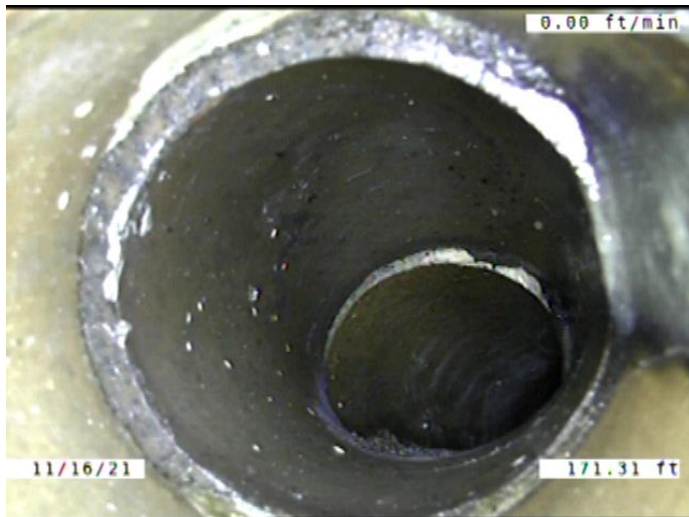
Code: **TB**
Description: **Tap Break-in/Hammer**

Distance (ft): **171.3**
Structural Grade: **0**
O&M Grade: **0**
Clock Start/From: **2**
Clock To:
1st Value: **4.000**
2nd Value:
Value Percent:
Continuous Index:
Within 8" of Joint: **NO**
Remarks:

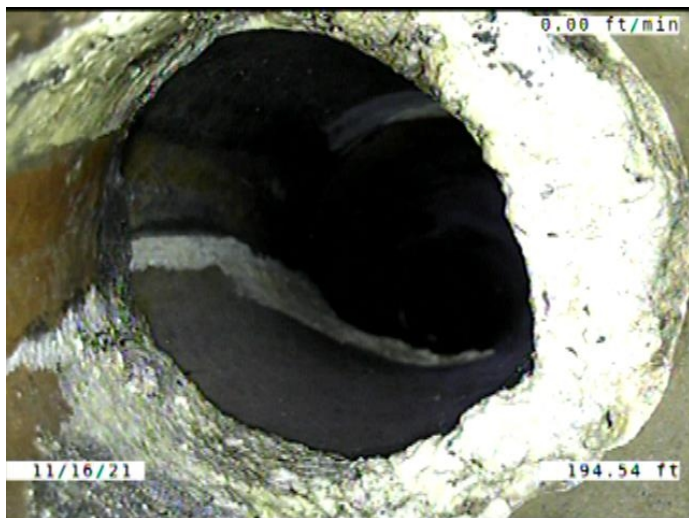
Code: **TB**
Description: **Tap Break-in/Hammer**

Distance (ft): **194.5**
Structural Grade: **0**
O&M Grade: **0**
Clock Start/From: **10**
Clock To:
1st Value: **4.000**
2nd Value:
Value Percent:
Continuous Index:
Within 8" of Joint: **NO**
Remarks: **CONSTANTLY RUNNING WATER.
ENCRUSTATION IN THE TAP**

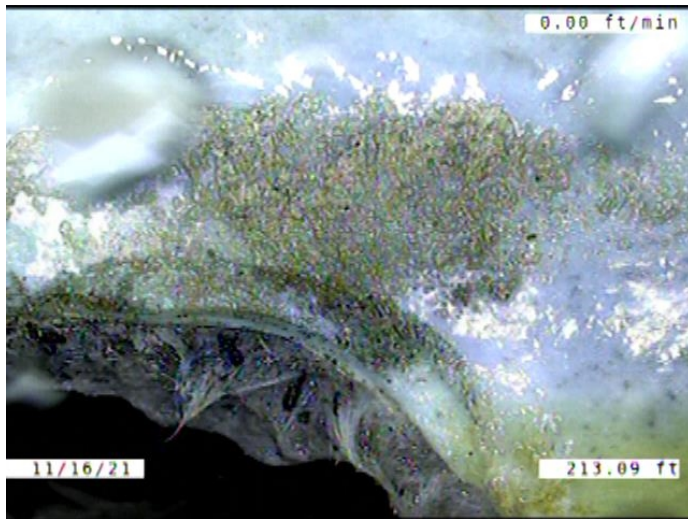
Code:	DAE
Description:	Deposits Attached Encrustation
Distance (ft):	213.1
Structural Grade:	0
O&M Grade:	2
Clock Start/From:	1
Clock To:	5
1st Value:	
2nd Value:	
Value Percent:	5.000
Continuous Index:	
Within 8" of Joint:	NO
Remarks:

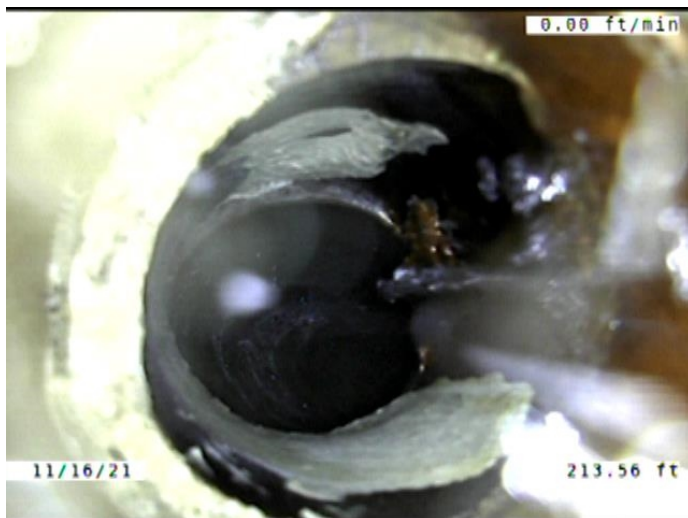
Code:	TBD
Description:	Tap Break-in/Hammer Defective
Distance (ft):	213.6
Structural Grade:	0
O&M Grade:	3
Clock Start/From:	2
Clock To:	
1st Value:	4.000
2nd Value:	
Value Percent:	
Continuous Index:	
Within 8" of Joint:	YES
Remarks:	CONSTANTLY RUNNING A LOT OF WATER. ENCRUSTATION IN AND AR

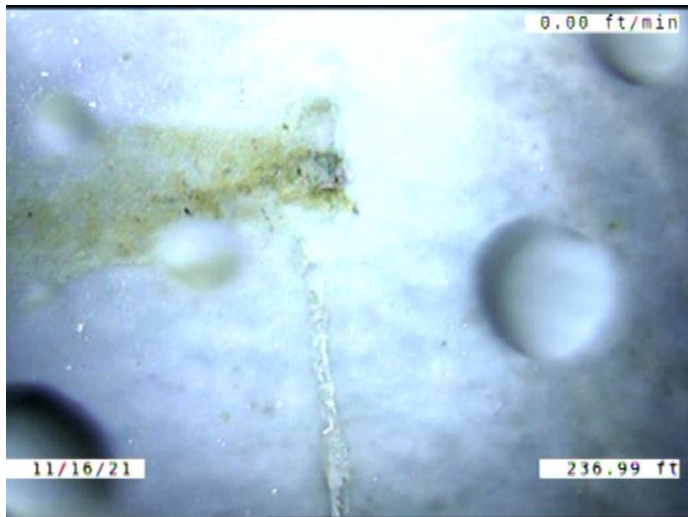
Code: **LFZ**
 Description: **Lining Feature Other**

Distance (ft): **237.0**
 Structural Grade: **0**
 O&M Grade: **0**
 Clock Start/From: **10**
 Clock To:
 1st Value:
 2nd Value:
 Value Percent:
 Continuous Index:
 Within 8" of Joint: **NO**
 Remarks: **LOOKS TO HAVE A CUT IN THE LINER. ENCRUSTATION FORMING UNDER IT.**

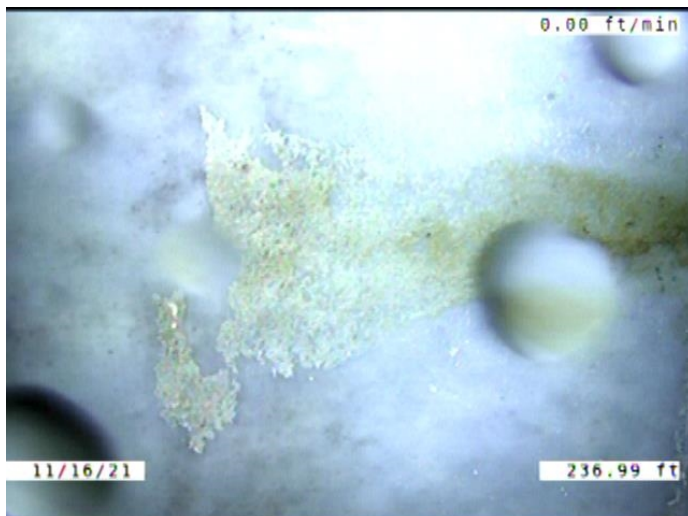
Code: **DAGS**
 Description: **Deposits Attached Grease**

Distance (ft): **237.0**
 Structural Grade: **0**
 O&M Grade: **2**
 Clock Start/From: **8**
 Clock To: **10**
 1st Value:
 2nd Value:
 Value Percent: **5.000**
 Continuous Index:
 Within 8" of Joint: **NO**
 Remarks:

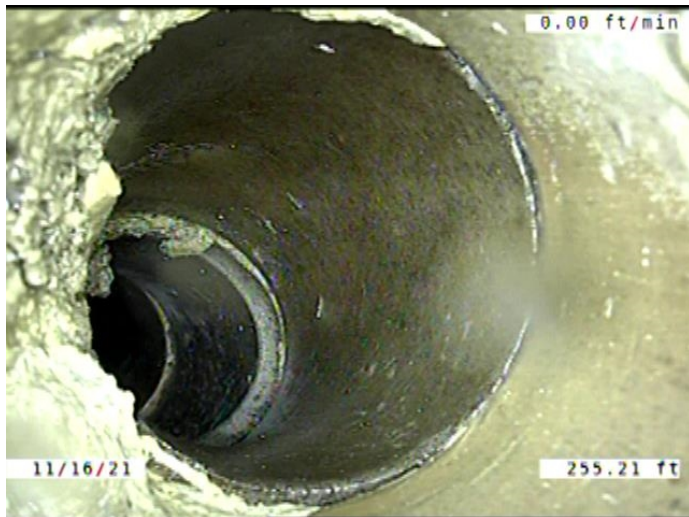
Code: **TB**
Description: **Tap Break-in/Hammer**

Distance (ft): **255.2**
Structural Grade: **0**
O&M Grade: **0**
Clock Start/From: **10**
Clock To:
1st Value: **4.000**
2nd Value:
Value Percent:
Continuous Index:
Within 8" of Joint: **NO**
Remarks: **ENCRUSTATION IN THE TAP**

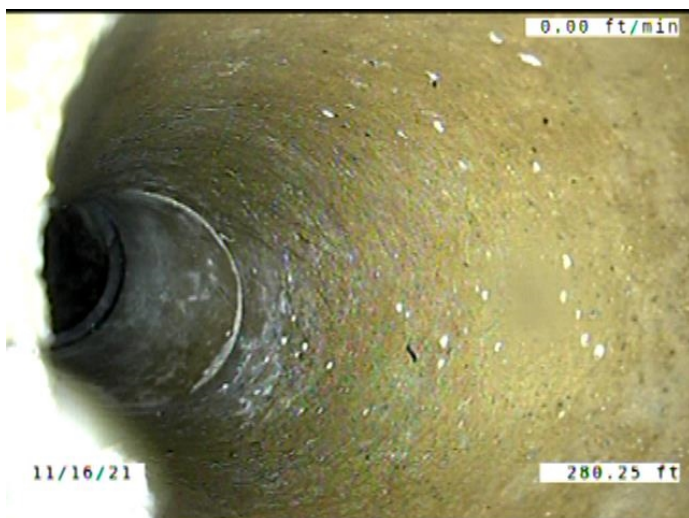
Code: **TB**
Description: **Tap Break-in/Hammer**

Distance (ft): **280.2**
Structural Grade: **0**
O&M Grade: **0**
Clock Start/From: **10**
Clock To:
1st Value: **4.000**
2nd Value:
Value Percent:
Continuous Index:
Within 8" of Joint: **NO**
Remarks:

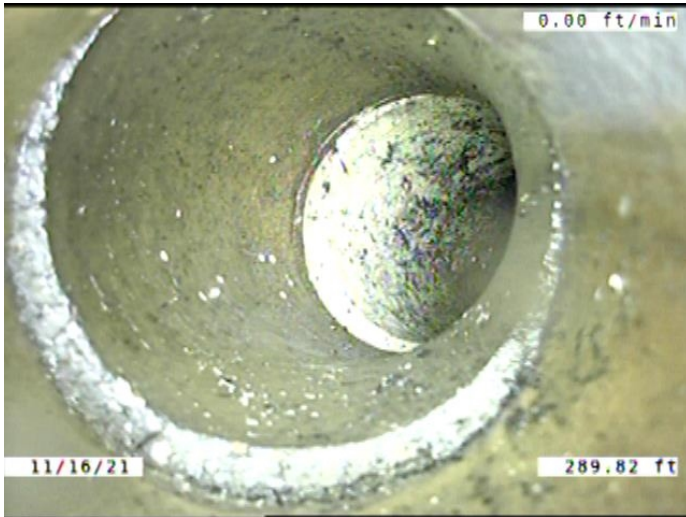
Code: **TB**
 Description: **Tap Break-in/Hammer**

Distance (ft): **289.8**
 Structural Grade: **0**
 O&M Grade: **0**
 Clock Start/From: **1**
 Clock To:
 1st Value: **4.000**
 2nd Value:
 Value Percent:
 Continuous Index:
 Within 8" of Joint: **NO**
 Remarks:

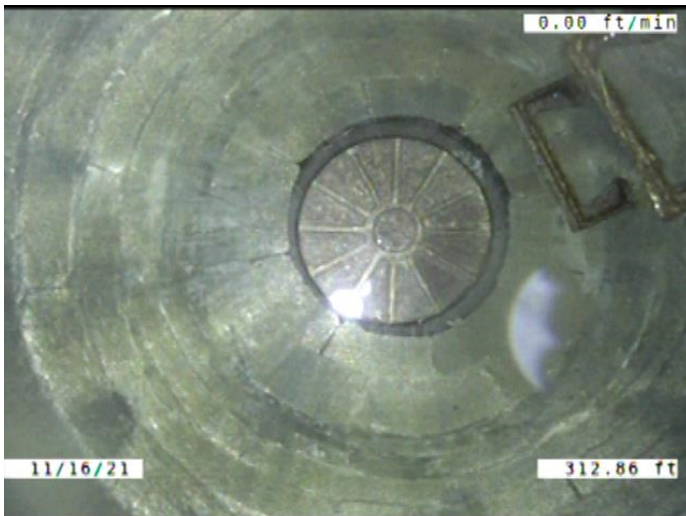
Code: **AMH**
 Description: **Manhole**

Distance (ft): **312.9**
 Structural Grade: **0**
 O&M Grade: **0**
 Clock Start/From:
 Clock To:
 1st Value:
 2nd Value:
 Value Percent:
 Continuous Index:
 Within 8" of Joint: **NO**
 Remarks: **M-605-016**
