Profile/Photo Observation Report

Date:	11/16/2021	Weather:		Coding:	PACP 7.0
Pipe Length (ft):	333.0	Owner:	City of Hobart	Pre Clean:	Heavy Cleaning
P.O.#:	YES502259	Surveyor:	S. Bucklin	PSR:	P-605-018-017
Customer:	City of Hobart	Clean Date:	11/16/2021	Shape:	C

Street:	Court Street	Flow Control:	Not Controlled
City:	Hobart, IN	Year Renewed:	
Location:	Local rural streets with light traffic, t	Tape/Media #:	
Purpose:	Routine Assessment	Dia/Height:	12"
Use:	Sanitary Sewage Pipe	Material:	VCP
Drain Area:		Lining:	None
Category:	NA		
Comment:			
Location Details:		Direction of Survey:	Downstream
US MH:	M-605-017	DS MH:	M-605-018
		Total Length Surveyed (ft):	333.0

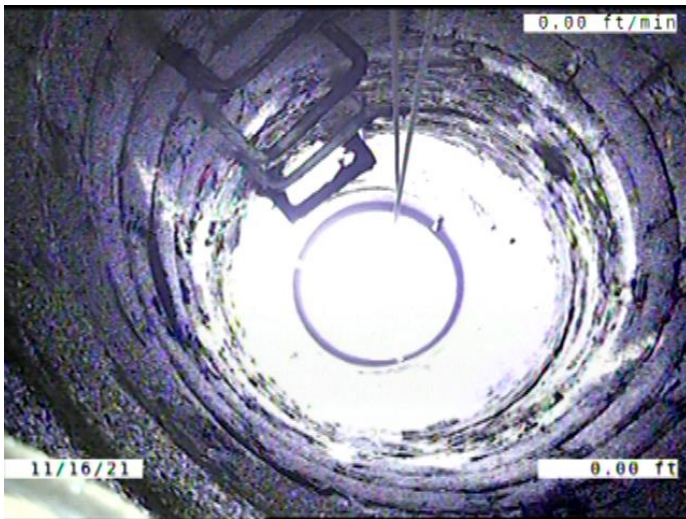
Code: **AMH**
Description: **Manhole**

Distance (ft): **.0**
Structural Grade: **0**
O&M Grade: **0**
Clock Start/From:
Clock To:
1st Value:
2nd Value:
Value Percent:
Continuous Index:
Within 8" of Joint: **NO**
Remarks: **M-605-017**

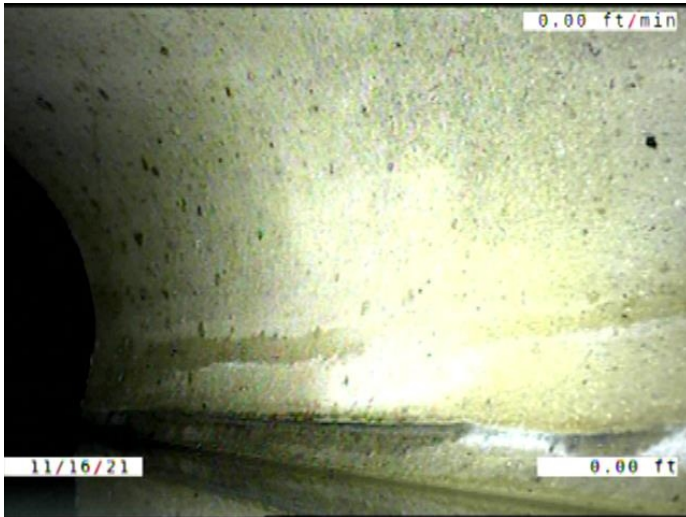
Code:	MWL
Description:	Miscellaneous Water Level
Distance (ft):	.0
Structural Grade:	0
O&M Grade:	0
Clock Start/From:	
Clock To:	
1st Value:	
2nd Value:	
Value Percent:	10.000
Continuous Index:	
Within 8" of Joint:	NO
Remarks:

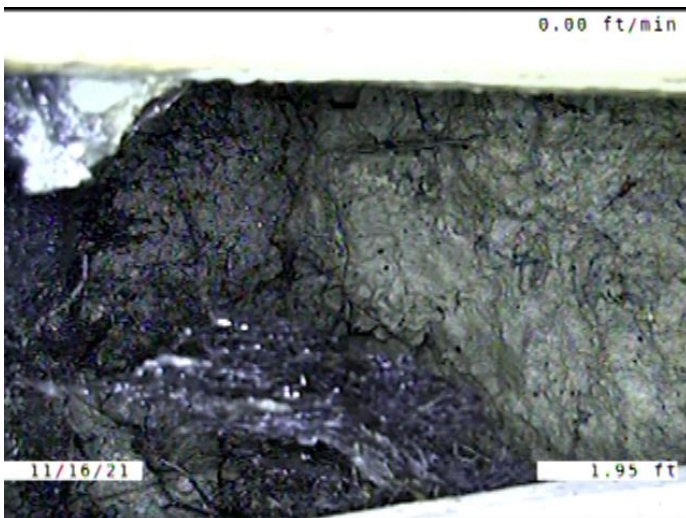
Code:	JSL
Description:	Joint Separated Large
Distance (ft):	2.0
Structural Grade:	4
O&M Grade:	0
Clock Start/From:	
Clock To:	
1st Value:	
2nd Value:	
Value Percent:	
Continuous Index:	
Within 8" of Joint:	NO
Remarks:	SOIL VISIBLE.

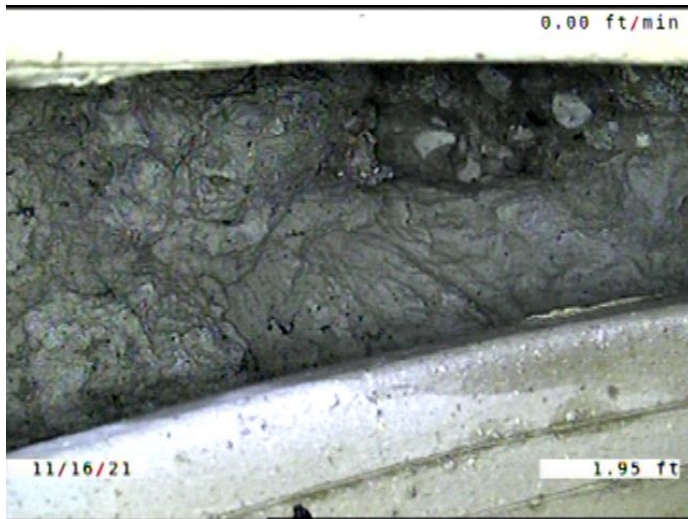
Code: **JAL**
Description: **Joint Angular Large**

Distance (ft): **2.0**
Structural Grade: **4**
O&M Grade: **0**
Clock Start/From:
Clock To:
1st Value:
2nd Value:
Value Percent:
Continuous Index:
Within 8" of Joint: **NO**
Remarks: **SOIL VISIBLE**

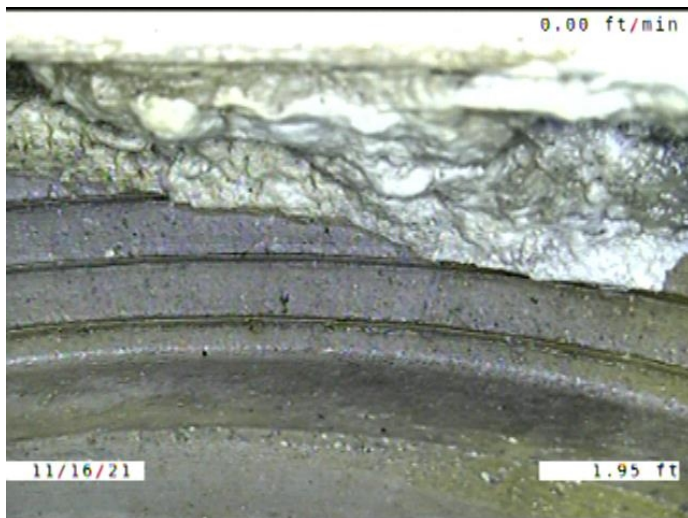
Code: **DAE**
Description: **Deposits Attached Encrustation**

Distance (ft): **2.0**
Structural Grade: **0**
O&M Grade: **2**
Clock Start/From: **12**
Clock To: **3**
1st Value:
2nd Value:
Value Percent: **5.000**
Continuous Index:
Within 8" of Joint: **YES**
Remarks:

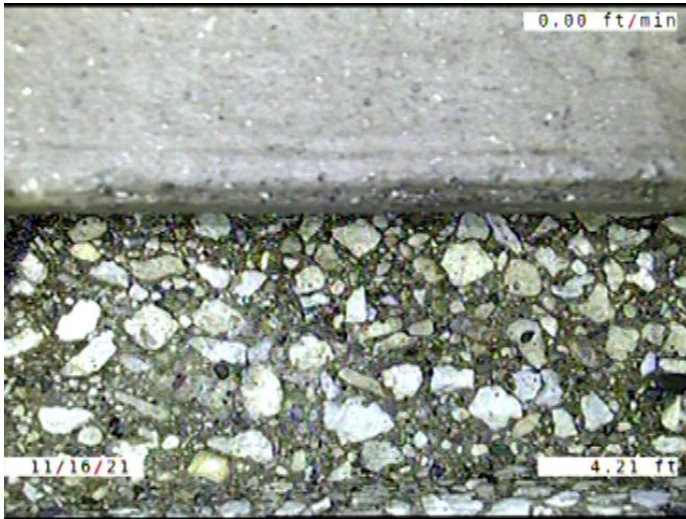
Code: **JSM**
Description: **Joint Separated Medium**

Distance (ft): **4.2**
Structural Grade: **3**
O&M Grade: **0**
Clock Start/From:
Clock To:
1st Value:
2nd Value:
Value Percent:
Continuous Index:
Within 8" of Joint: **NO**
Remarks:

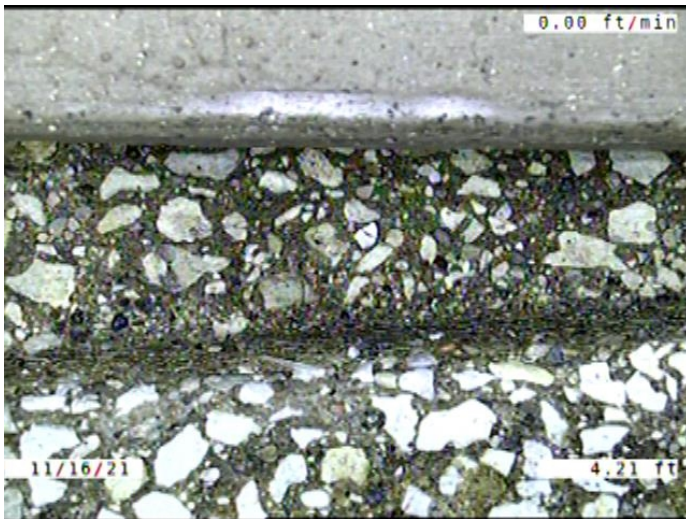
Code: **MMC**
Description: **Miscellaneous Material Change**

Distance (ft): **4.2**
Structural Grade: **0**
O&M Grade: **0**
Clock Start/From:
Clock To:
1st Value:
2nd Value:
Value Percent:
Continuous Index:
Within 8" of Joint: **NO**
Remarks: **VCP TO CONCRETE**

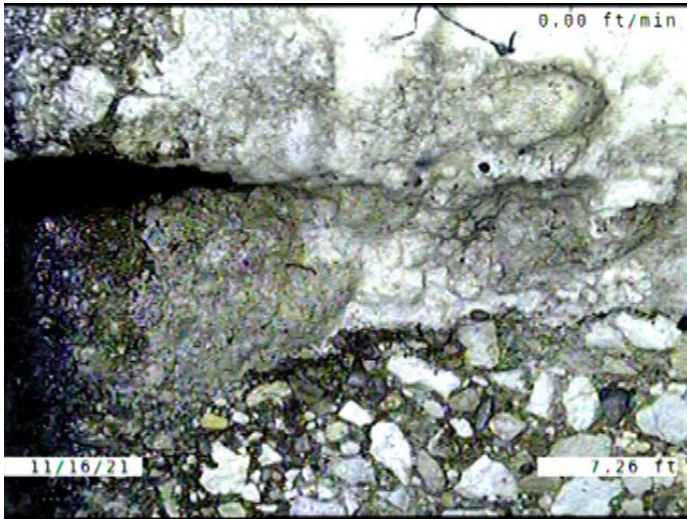
Code: **DAE**
 Description: **Deposits Attached Encrustation**

Distance (ft): **7.3**
 Structural Grade: **0**
 O&M Grade: **2**
 Clock Start/From: **8**
 Clock To: **4**
 1st Value:
 2nd Value:
 Value Percent: **5.000**
 Continuous Index: **S01**
 Within 8" of Joint: **YES**
 Remarks:

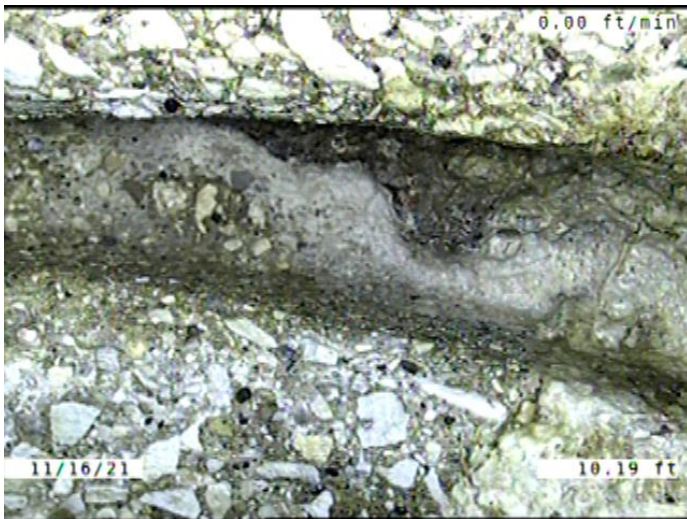
Code: **JAL**
 Description: **Joint Angular Large**

Distance (ft): **10.2**
 Structural Grade: **4**
 O&M Grade: **0**
 Clock Start/From:
 Clock To:
 1st Value:
 2nd Value:
 Value Percent:
 Continuous Index:
 Within 8" of Joint: **NO**
 Remarks:

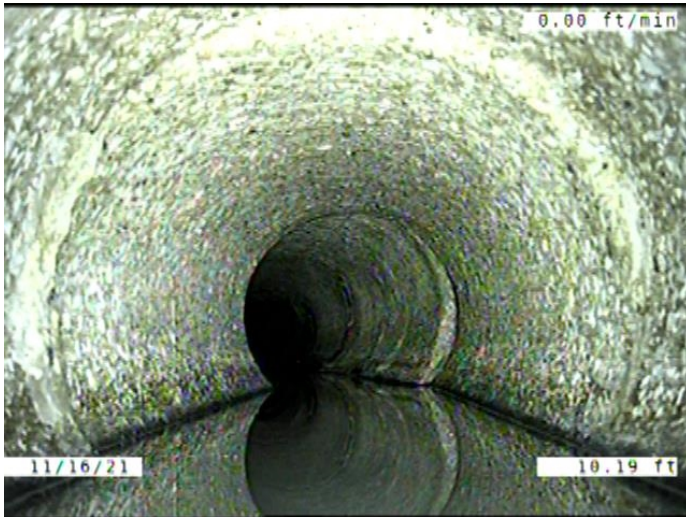
Code: **LL**
 Description: **Line Left**

Distance (ft): **10.2**
 Structural Grade: **0**
 O&M Grade: **2**
 Clock Start/From:
 Clock To:
 1st Value:
 2nd Value:
 Value Percent: **20.000**
 Continuous Index:
 Within 8" of Joint: **NO**
 Remarks:

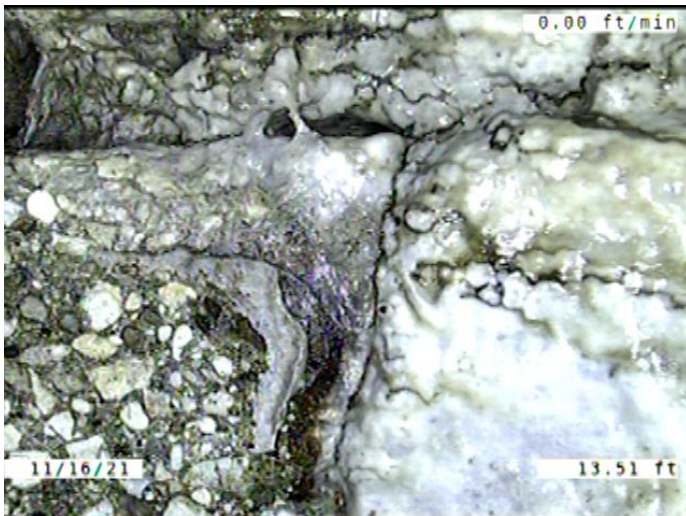
Code: **CL**
 Description: **Crack Longitudinal**

Distance (ft): **13.5**
 Structural Grade: **2**
 O&M Grade: **0**
 Clock Start/From: **2**
 Clock To:
 1st Value:
 2nd Value:
 Value Percent:
 Continuous Index:
 Within 8" of Joint: **YES**
 Remarks:

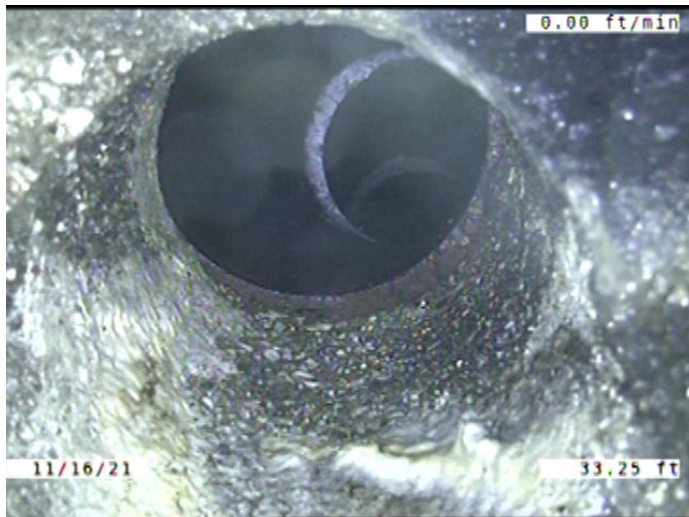
Code: **TF**
Description: **Tap Factory**

Distance (ft): **33.2**
Structural Grade: **0**
O&M Grade: **0**
Clock Start/From: **1**
Clock To:
1st Value: **4.000**

2nd Value:
Value Percent:
Continuous Index:
Within 8" of Joint: **YES**
Remarks: **ENCrustATION AROUND THE INSIDE OF THE TAP**

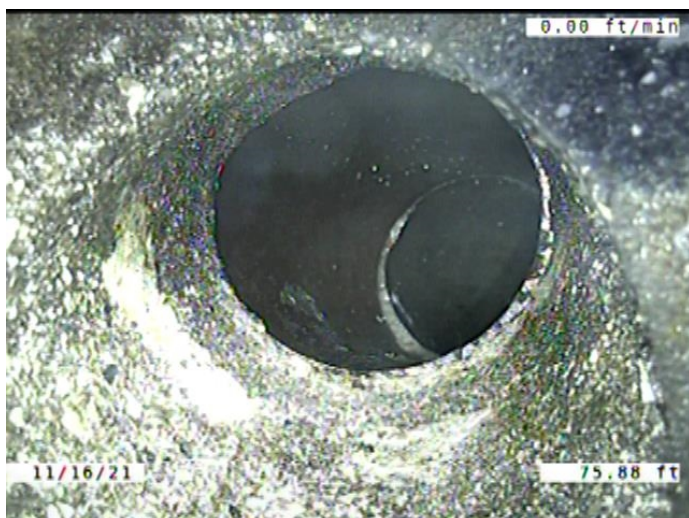
Code: **TF**
Description: **Tap Factory**

Distance (ft): **75.9**
Structural Grade: **0**
O&M Grade: **0**
Clock Start/From: **1**
Clock To:
1st Value: **4.000**

2nd Value:
Value Percent:
Continuous Index:
Within 8" of Joint: **YES**
Remarks:

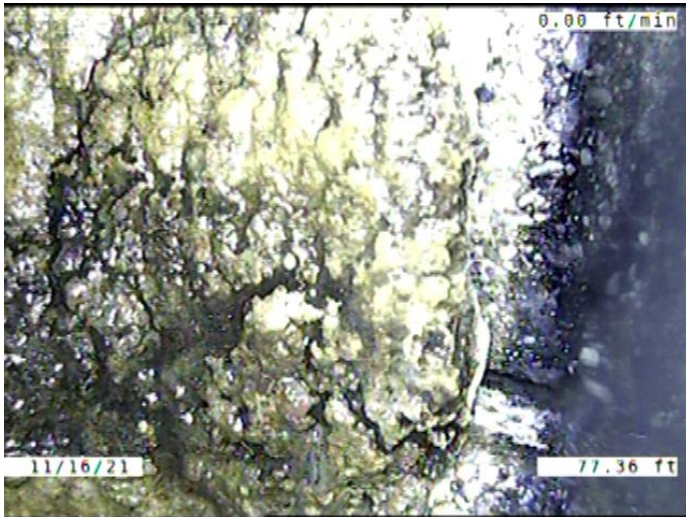
Code: **IDJ**
 Description: **Infiltration Dripper Joint**

Distance (ft): **77.4**
 Structural Grade: **0**
 O&M Grade: **3**
 Clock Start/From: **3**
 Clock To: **4**
 1st Value:
 2nd Value:
 Value Percent:
 Continuous Index:
 Within 8" of Joint: **YES**
 Remarks:

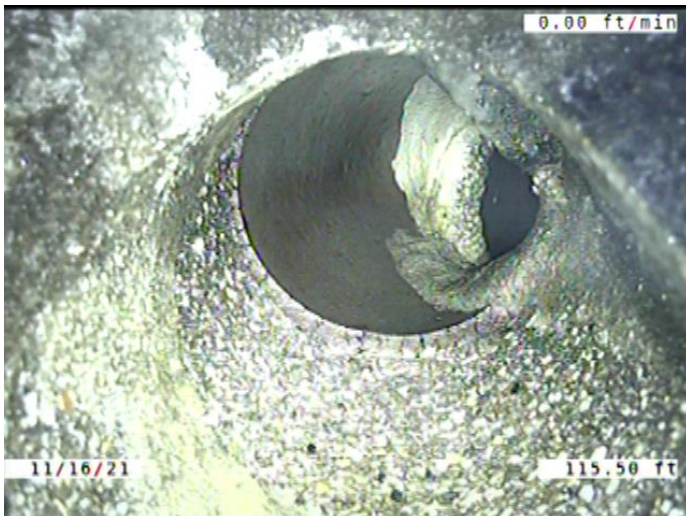
Code: **TF**
 Description: **Tap Factory**

Distance (ft): **115.5**
 Structural Grade: **0**
 O&M Grade: **0**
 Clock Start/From: **1**
 Clock To:
 1st Value: **4.000**
 2nd Value:
 Value Percent:
 Continuous Index:
 Within 8" of Joint: **YES**
 Remarks: **ENCRUSTATION IN THE TAP**

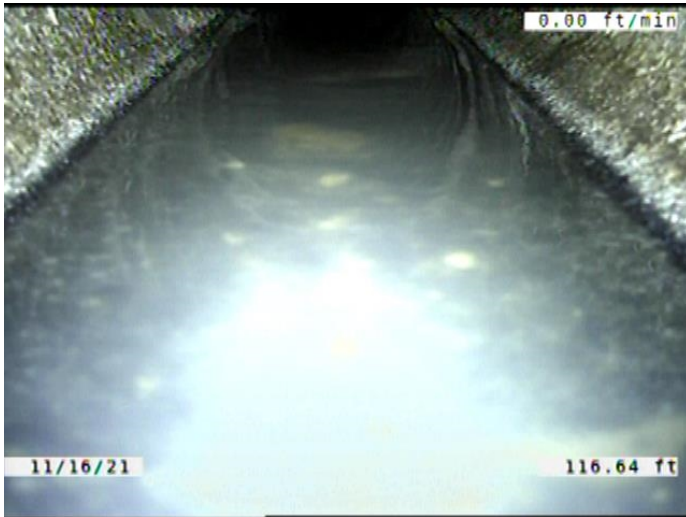
Code: **DSF**
 Description: **Deposits Settled Fine**

Distance (ft): **116.6**
 Structural Grade: **0**
 O&M Grade: **2**
 Clock Start/From: **5**
 Clock To: **7**
 1st Value:
 2nd Value:
 Value Percent: **5.000**
 Continuous Index: **S02**
 Within 8" of Joint: **YES**
 Remarks:

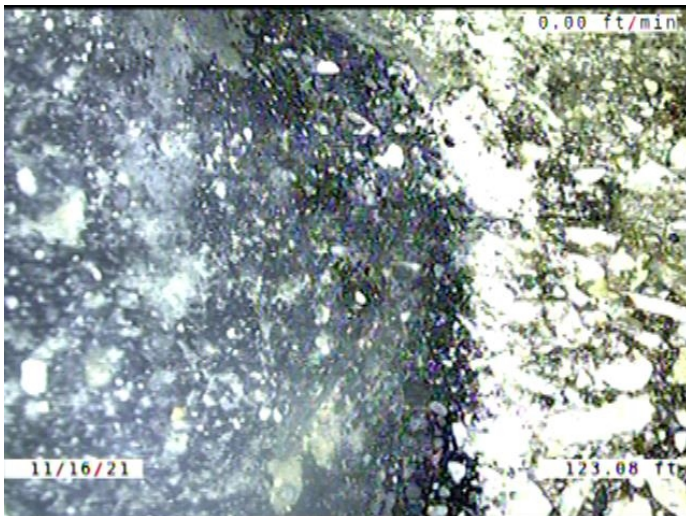
Code: **DAE**
 Description: **Deposits Attached Encrustation**

Distance (ft): **123.1**
 Structural Grade: **0**
 O&M Grade: **2**
 Clock Start/From: **4**
 Clock To: **8**
 1st Value:
 2nd Value:
 Value Percent: **5.000**
 Continuous Index:
 Within 8" of Joint: **YES**
 Remarks:

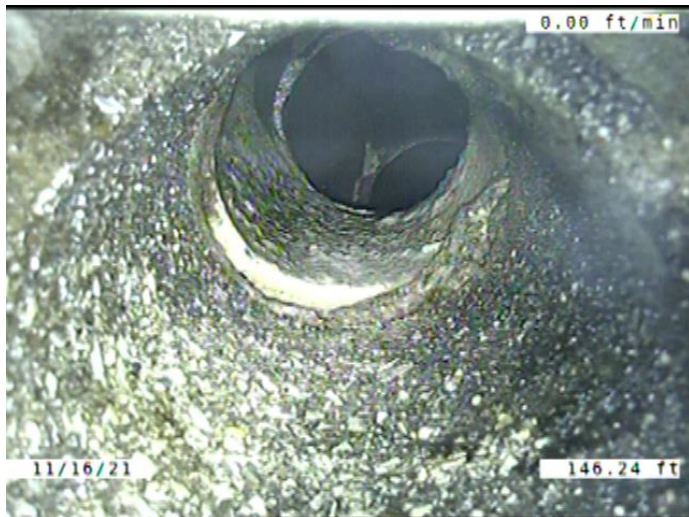
Code: **TFA**
 Description: **Tap Factory Activity**

Distance (ft): **146.2**
 Structural Grade: **0**
 O&M Grade: **0**
 Clock Start/From: **1**
 Clock To:
 1st Value: **4.000**
 2nd Value:
 Value Percent:
 Continuous Index:
 Within 8" of Joint: **YES**
 Remarks:

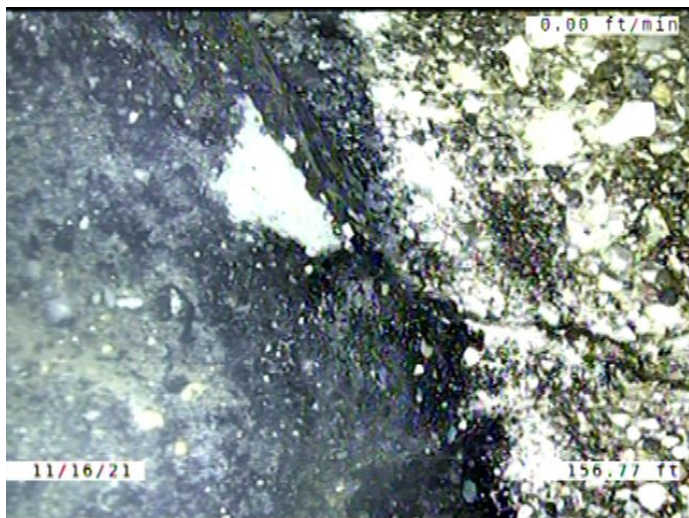
Code: **DAE**
 Description: **Deposits Attached Encrustation**

Distance (ft): **156.8**
 Structural Grade: **0**
 O&M Grade: **2**
 Clock Start/From: **4**
 Clock To: **8**
 1st Value:
 2nd Value:
 Value Percent: **5.000**
 Continuous Index:
 Within 8" of Joint: **YES**
 Remarks:

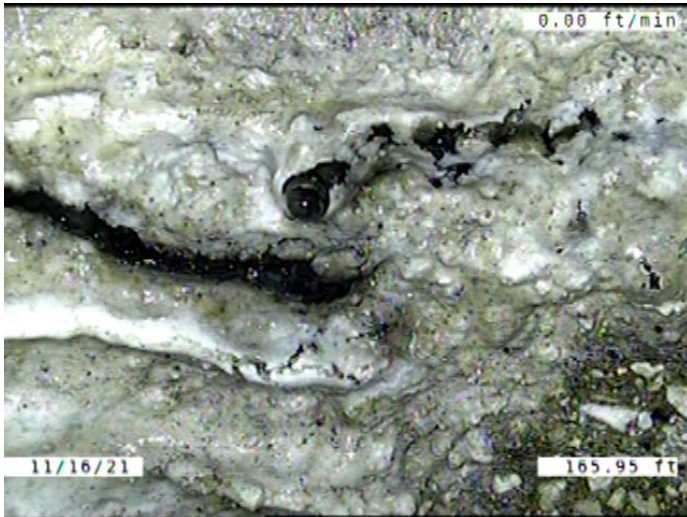
Code: **IWJ**
 Description: **Infiltration Weeper Joint**

Distance (ft): **165.9**
 Structural Grade: **0**
 O&M Grade: **2**
 Clock Start/From: **11**
 Clock To: **12**
 1st Value:
 2nd Value:
 Value Percent:
 Continuous Index:
 Within 8" of Joint: **YES**
 Remarks:

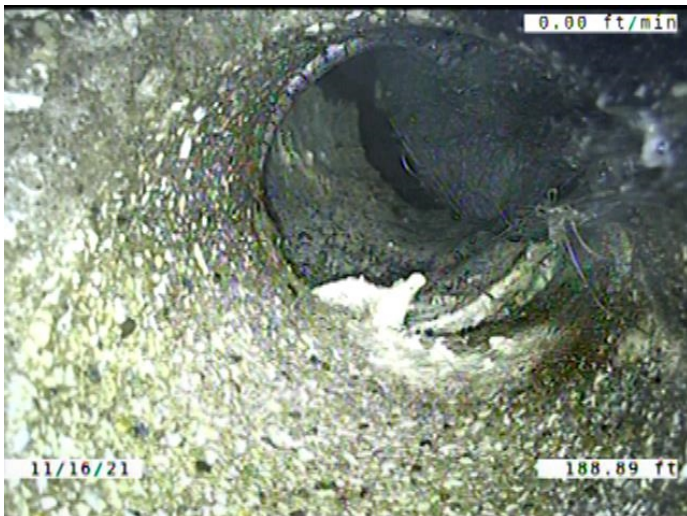
Code: **TF**
 Description: **Tap Factory**

Distance (ft): **188.9**
 Structural Grade: **0**
 O&M Grade: **0**
 Clock Start/From: **1**
 Clock To:
 1st Value: **4.000**
 2nd Value:
 Value Percent:
 Continuous Index:
 Within 8" of Joint: **YES**
 Remarks: **ENCrustation IN THE TAP. ROOTS GROWING IN THE TAP. CONSTANTLY**

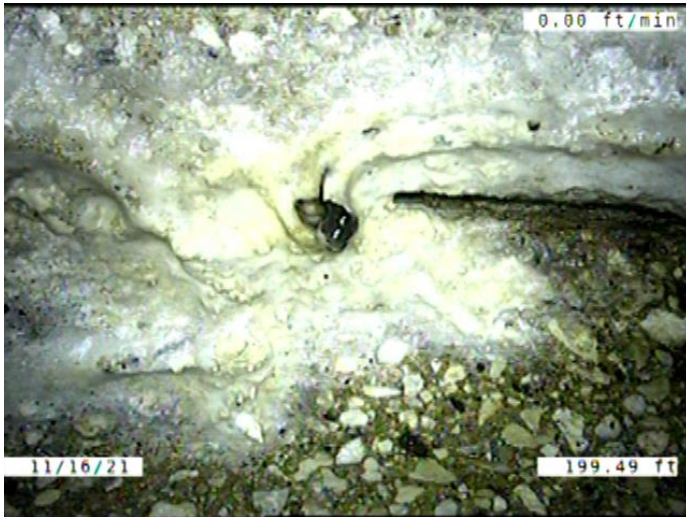
Code: **IWJ**
 Description: **Infiltration Weeper Joint**

Distance (ft): **199.5**
 Structural Grade: **0**
 O&M Grade: **2**
 Clock Start/From: **12**
 Clock To:
 1st Value:
 2nd Value:
 Value Percent:
 Continuous Index:
 Within 8" of Joint: **YES**
 Remarks:

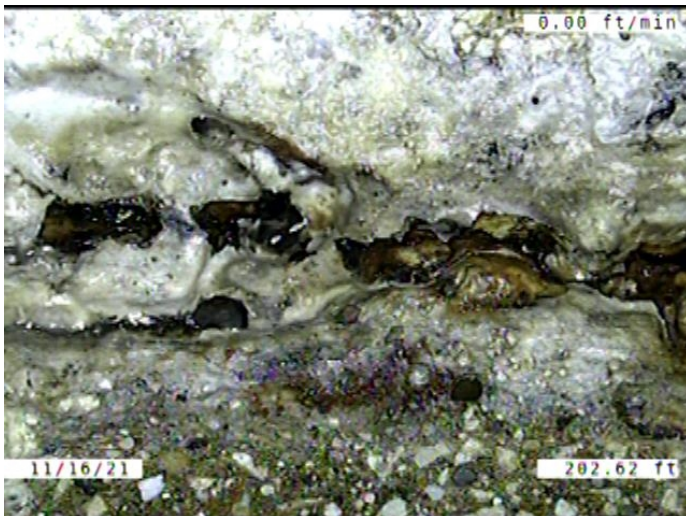
Code: **IWJ**
 Description: **Infiltration Weeper Joint**

Distance (ft): **202.6**
 Structural Grade: **0**
 O&M Grade: **2**
 Clock Start/From: **11**
 Clock To: **1**
 1st Value:
 2nd Value:
 Value Percent:
 Continuous Index:
 Within 8" of Joint: **YES**
 Remarks:

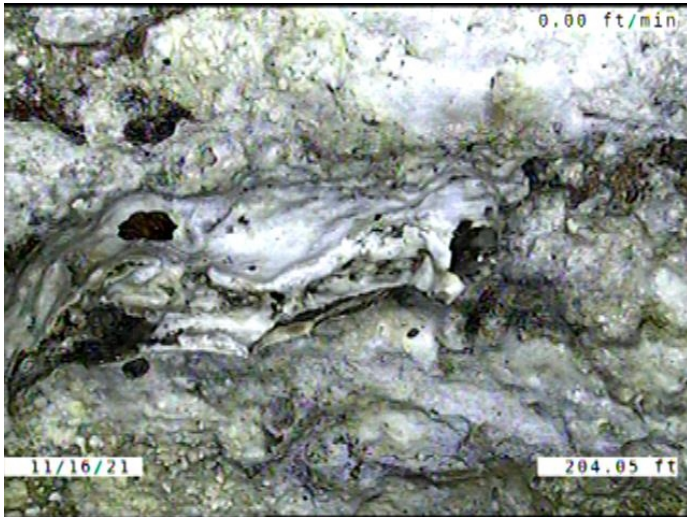
Code: **IWB**
 Description: **Infiltration Weeper Barrel**

Distance (ft): **204.1**
 Structural Grade: **0**
 O&M Grade: **2**
 Clock Start/From: **1**
 Clock To:
 1st Value:
 2nd Value:
 Value Percent:
 Continuous Index:
 Within 8" of Joint: **NO**
 Remarks:

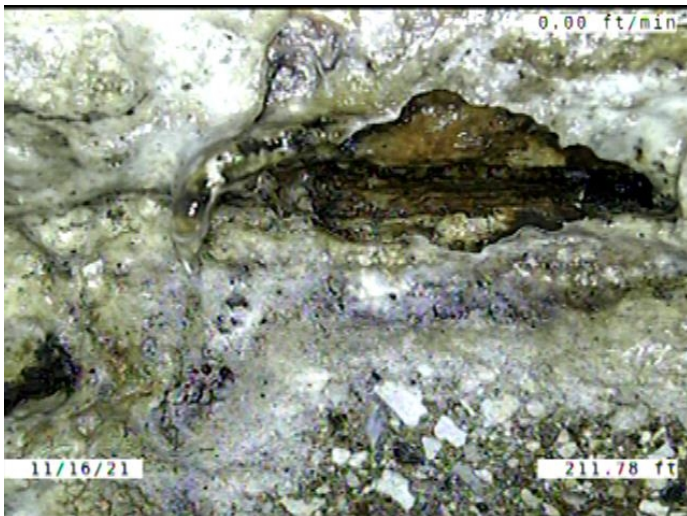
Code: **IWJ**
 Description: **Infiltration Weeper Joint**

Distance (ft): **211.8**
 Structural Grade: **0**
 O&M Grade: **2**
 Clock Start/From: **12**
 Clock To: **1**
 1st Value:
 2nd Value:
 Value Percent:
 Continuous Index:
 Within 8" of Joint: **YES**
 Remarks:

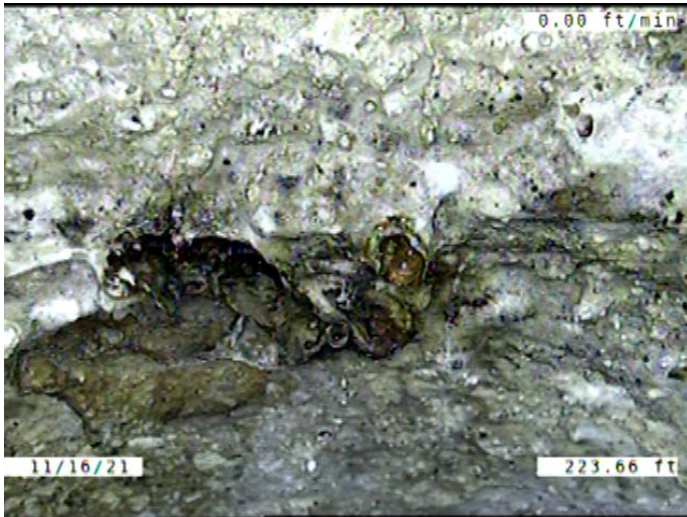
Code: **IDJ**
Description: **Infiltration Dripper Joint**

Distance (ft): **223.7**
Structural Grade: **0**
O&M Grade: **3**
Clock Start/From: **12**
Clock To:
1st Value:
2nd Value:
Value Percent:
Continuous Index:
Within 8" of Joint: **YES**
Remarks:

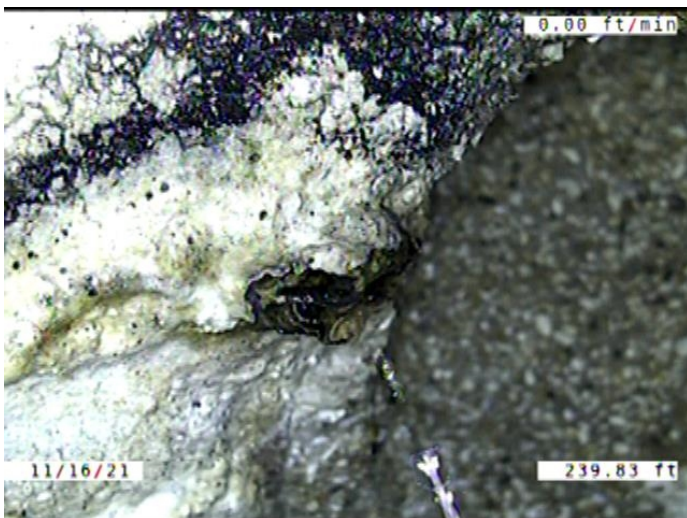
Code: **IDL**
Description: **Infiltration Dripper Lateral**

Distance (ft): **239.8**
Structural Grade: **0**
O&M Grade: **3**
Clock Start/From: **12**
Clock To:
1st Value:
2nd Value:
Value Percent:
Continuous Index:
Within 8" of Joint: **YES**
Remarks:

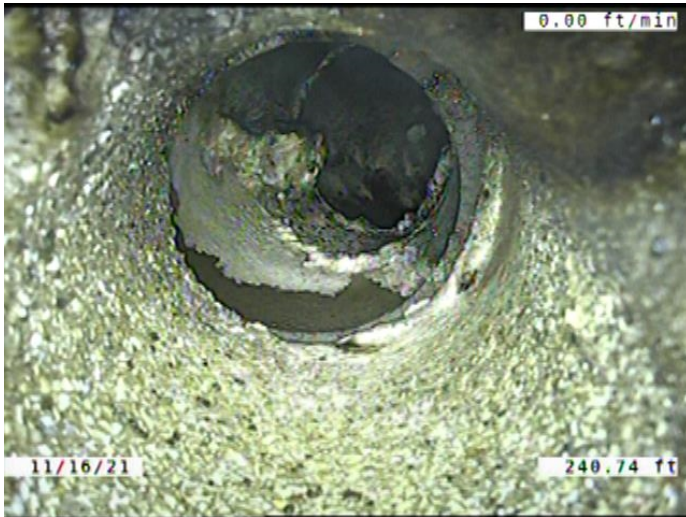
Code: **TF**
Description: **Tap Factory**

Distance (ft): **240.7**
Structural Grade: **0**
O&M Grade: **0**
Clock Start/From: **1**
Clock To:
1st Value: **4.000**
2nd Value:
Value Percent:
Continuous Index:
Within 8" of Joint: **YES**
Remarks: **ENCrustATION IN THE TAP.
CONSTANTLY DRIPPING WATER.**

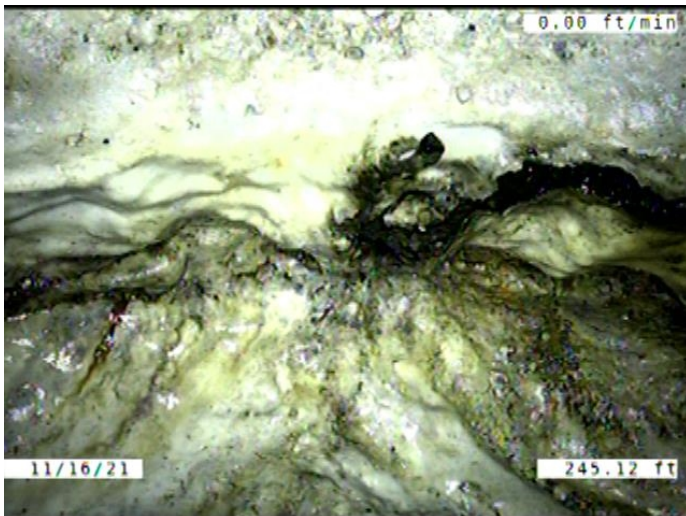
Code: **IWJ**
Description: **Infiltration Weeper Joint**

Distance (ft): **245.1**
Structural Grade: **0**
O&M Grade: **2**
Clock Start/From: **12**
Clock To:
1st Value:
2nd Value:
Value Percent:
Continuous Index:
Within 8" of Joint: **YES**
Remarks:

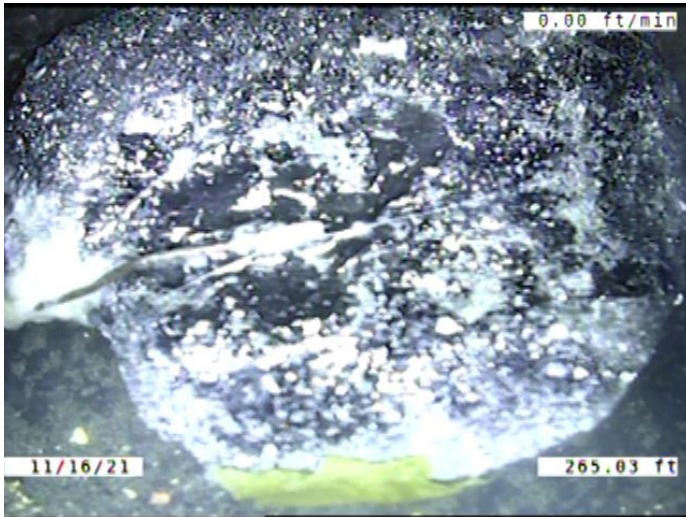
Code: **OBN**
 Description: **Obstruction Construction Debris**

Distance (ft): **265.0**
 Structural Grade: **0**
 O&M Grade: **2**
 Clock Start/From: **6**
 Clock To:
 1st Value:
 2nd Value:
 Value Percent: **5.000**
 Continuous Index:
 Within 8" of Joint: **NO**
 Remarks:

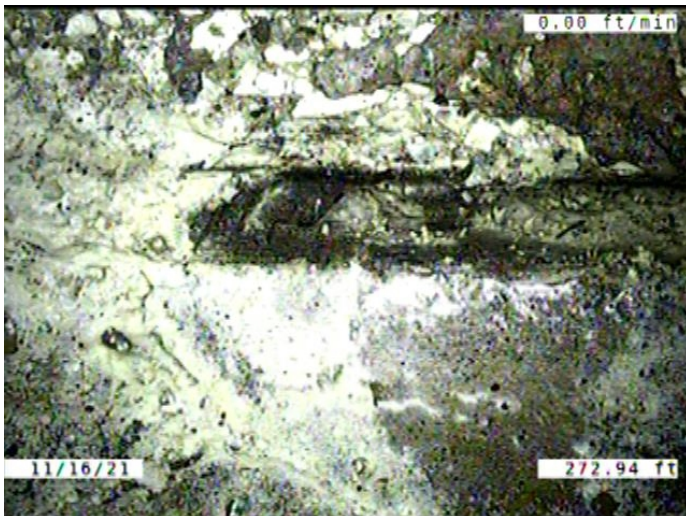
Code: **MMC**
 Description: **Miscellaneous Material Change**

Distance (ft): **272.9**
 Structural Grade: **0**
 O&M Grade: **0**
 Clock Start/From:
 Clock To:
 1st Value:
 2nd Value:
 Value Percent:
 Continuous Index:
 Within 8" of Joint: **NO**
 Remarks: **CONCRETE TO VCP**

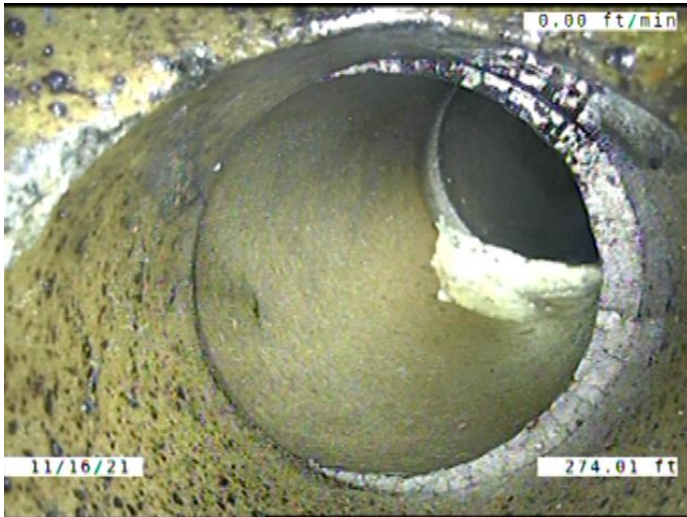
Code: **TF**
Description: **Tap Factory**

Distance (ft): **274.0**
Structural Grade: **0**
O&M Grade: **0**
Clock Start/From: **1**
Clock To:
1st Value: **4.000**
2nd Value:
Value Percent:
Continuous Index:
Within 8" of Joint: **YES**
Remarks:

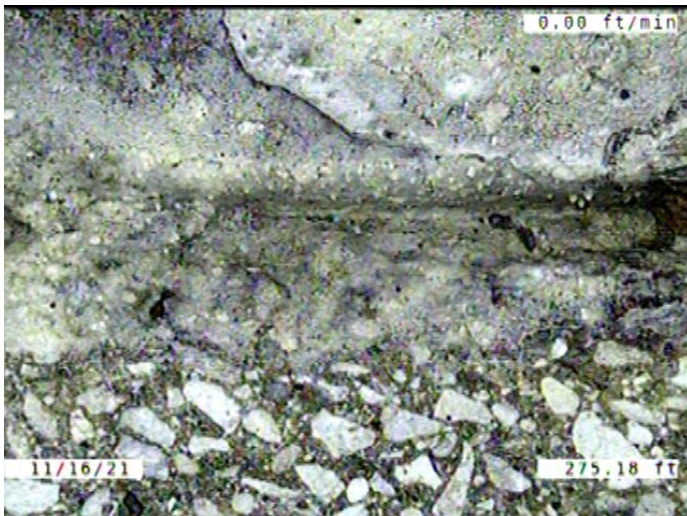
Code: **MMC**
Description: **Miscellaneous Material Change**

Distance (ft): **275.2**
Structural Grade: **0**
O&M Grade: **0**
Clock Start/From:
Clock To:
1st Value:
2nd Value:
Value Percent:
Continuous Index:
Within 8" of Joint: **NO**
Remarks: **VCP TO CONCRETE**

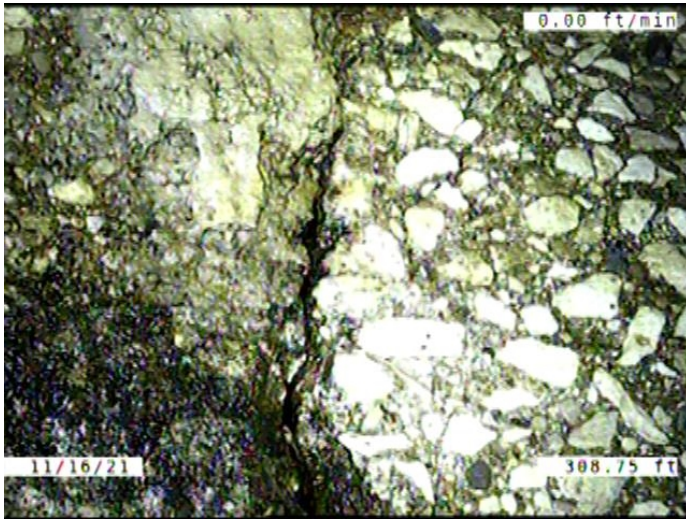
Code: **FM**
Description: **Fracture Multiple**

Distance (ft): **308.7**
Structural Grade: **4**
O&M Grade: **0**
Clock Start/From: **8**
Clock To: **4**
1st Value:
2nd Value:
Value Percent:
Continuous Index: **S03**
Within 8" of Joint: **YES**
Remarks:

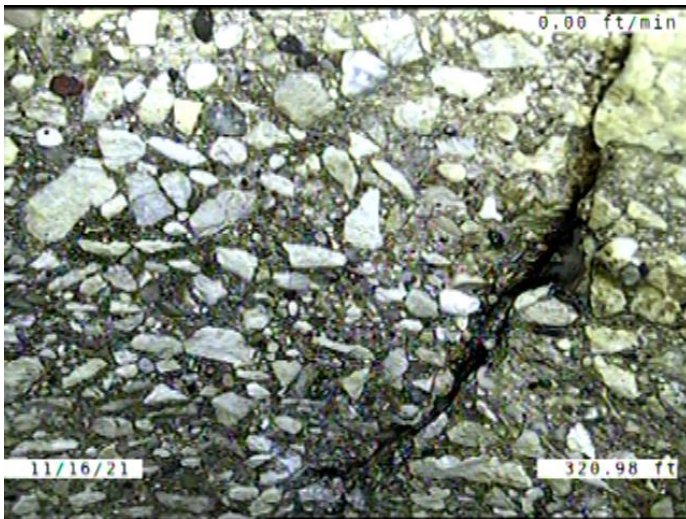
Code: **FM**
Description: **Fracture Multiple**

Distance (ft): **321.0**
Structural Grade: **4**
O&M Grade: **0**
Clock Start/From: **8**
Clock To: **4**
1st Value:
2nd Value:
Value Percent:
Continuous Index: **F03**
Within 8" of Joint: **YES**
Remarks:

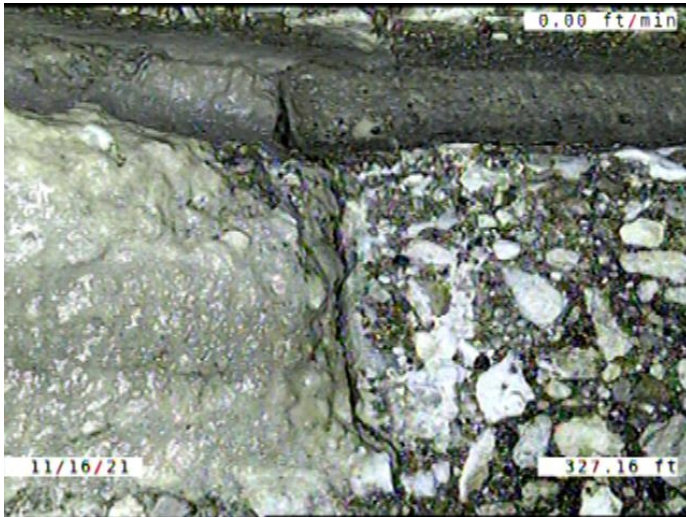
Code: **FL**
 Description: **Fracture Longitudinal**

Distance (ft): **327.2**
 Structural Grade: **3**
 O&M Grade: **0**
 Clock Start/From: **10**
 Clock To:
 1st Value:
 2nd Value:
 Value Percent:
 Continuous Index:
 Within 8" of Joint: **YES**
 Remarks:

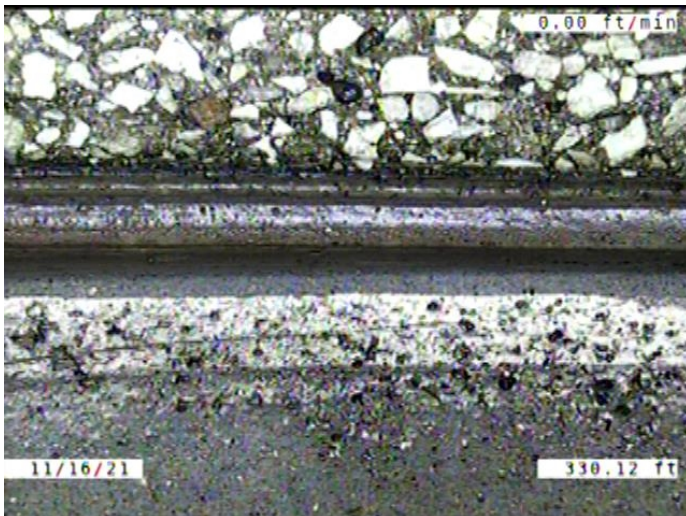
Code: **MMC**
 Description: **Miscellaneous Material Change**

Distance (ft): **330.1**
 Structural Grade: **0**
 O&M Grade: **0**
 Clock Start/From:
 Clock To:
 1st Value:
 2nd Value:
 Value Percent:
 Continuous Index:
 Within 8" of Joint: **NO**
 Remarks: **CONCRETE TO VCP**

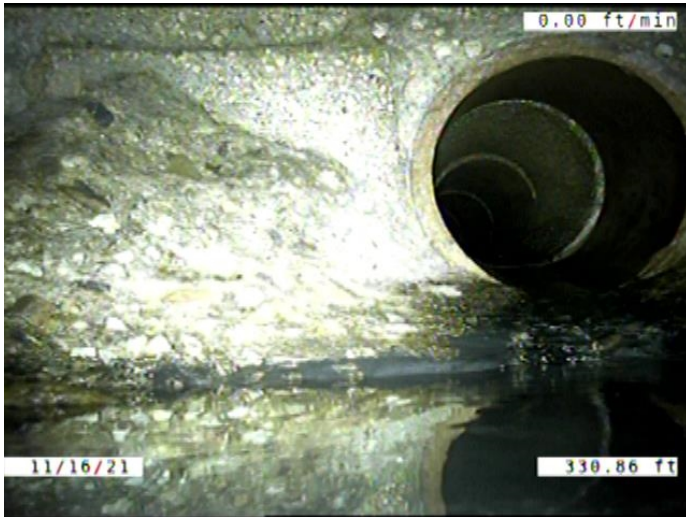
Code: **DAE**
Description: **Deposits Attached Encrustation**

Distance (ft): **330.9**
Structural Grade: **0**
O&M Grade: **2**
Clock Start/From: **8**
Clock To: **4**
1st Value:
2nd Value:
Value Percent: **5.000**
Continuous Index: **F01**
Within 8" of Joint: **YES**
Remarks:

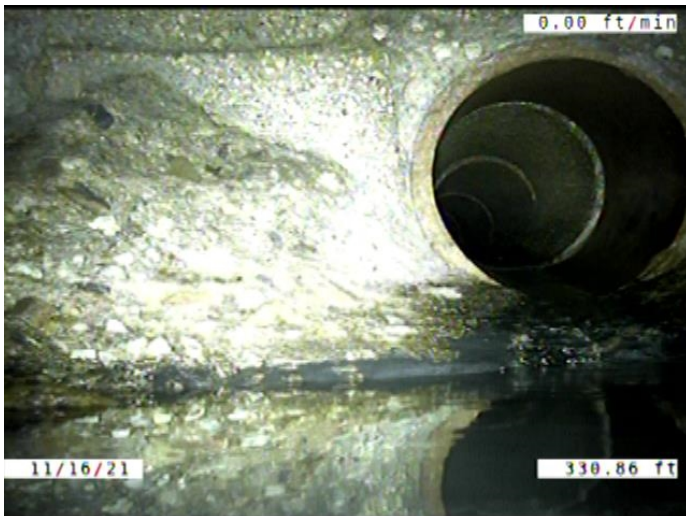
Code: **DSF**
Description: **Deposits Settled Fine**

Distance (ft): **330.9**
Structural Grade: **0**
O&M Grade: **2**
Clock Start/From: **5**
Clock To: **7**
1st Value:
2nd Value:
Value Percent: **5.000**
Continuous Index: **F02**
Within 8" of Joint: **YES**
Remarks:

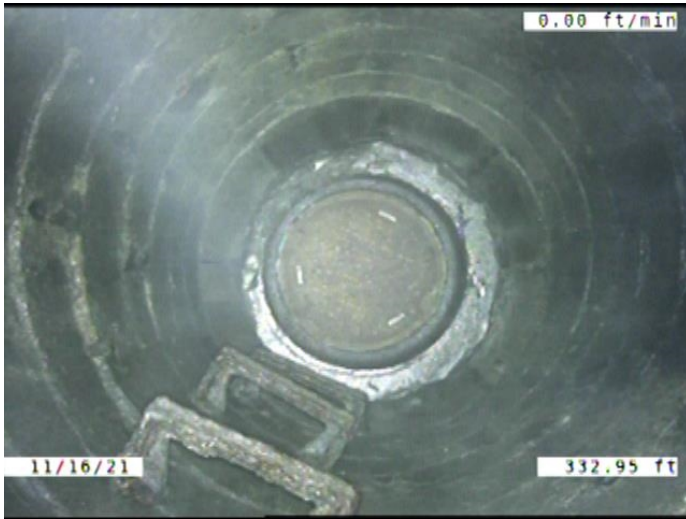
Code:	AMH
Description:	Manhole
Distance (ft):	333.0
Structural Grade:	0
O&M Grade:	0
Clock Start/From:	
Clock To:	
1st Value:	
2nd Value:	
Value Percent:	
Continuous Index:	
Within 8" of Joint:	NO
Remarks:	M-605-018
