Profile/Photo Observation Report

Date:	10/19/2021	Weather:		Coding:	PACP 6.0
Pipe Length (ft):		Owner:	Hobart, IN	Pre Clean:	Not Known
P.O.#:	897_1	Surveyor:	M. Pielacha	PSR:	P-605-018-019
Customer:	Hobart, IN	Clean Date:		Shape:	C

Street:	Court Street	Flow Control:	
City:	Hobart, IN	Year Renewed:	
Location:	Light Highway	Tape/Media #:	897
Purpose:	Routine Assessment	Dia/Height:	10"
Use:	Sanitary	Material:	VCP
Drain Area:		Lining:	
Category:	NA		
Comment:

Location Details:		Direction of Survey:	Upstream
US MH:	M-605-18	DS MH:	M-605-19
		Total Length Surveyed (ft):	160.3

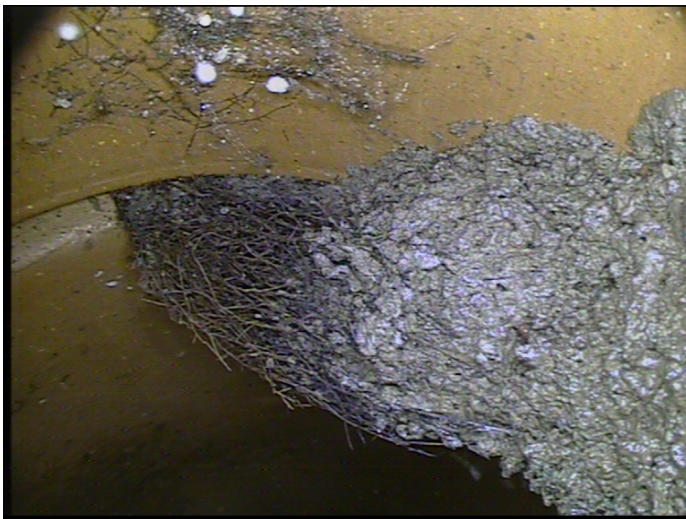
Code: **RMJ**
Description: **Roots Medium Joint**

Distance (ft): **7.3**
Structural Grade: **0**
O&M Grade: **3**
Clock Start/From: **1**
Clock To: **5**
1st Value:
2nd Value:
Value Percent: **10.000**
Continuous Index: **S01**
Within 8" of Joint: **YES**
Remarks:

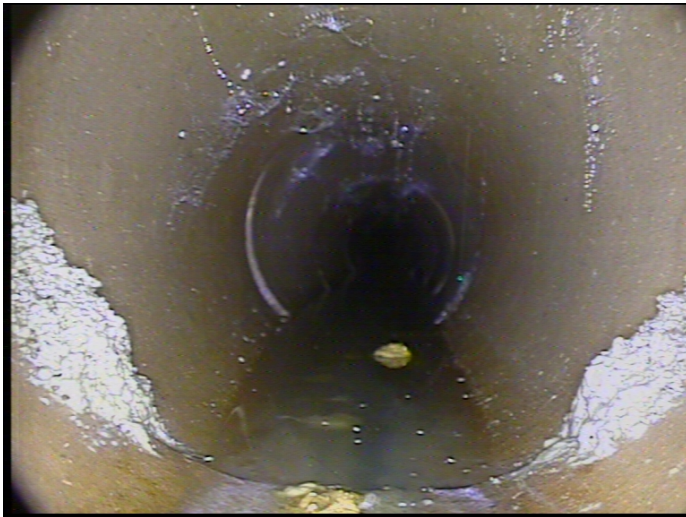
Code: **RMJ**
Description: **Roots Medium Joint**

Distance (ft): **24.5**
Structural Grade: **0**
O&M Grade: **3**
Clock Start/From: **1**
Clock To: **5**
1st Value:
2nd Value:
Value Percent: **10.000**
Continuous Index: **F01**
Within 8" of Joint: **YES**
Remarks:

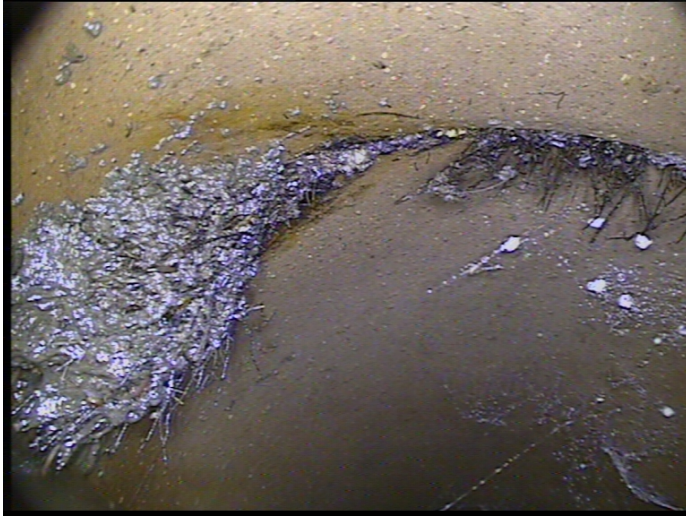
Code:	RMJ
Description:	Roots Medium Joint
Distance (ft):	34.4
Structural Grade:	0
O&M Grade:	3
Clock Start/From:	8
Clock To:	11
1st Value:	
2nd Value:	
Value Percent:	5.000
Continuous Index:	
Within 8" of Joint:	YES
Remarks:

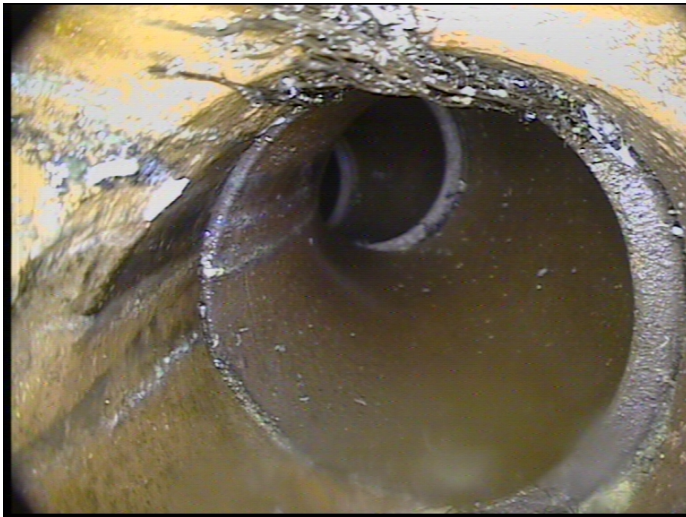
Code:	TFD
Description:	Tap Factory Defective
Distance (ft):	49.3
Structural Grade:	0
O&M Grade:	2
Clock Start/From:	9
Clock To:	
1st Value:	4.000
2nd Value:	
Value Percent:	
Continuous Index:	
Within 8" of Joint:	NO
Remarks:	roots

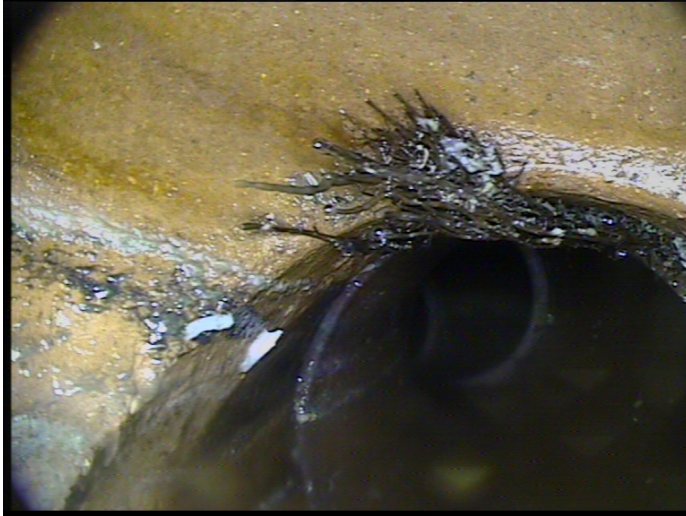
Code:	RFL
Description:	Roots Fine Lateral
Distance (ft):	49.3
Structural Grade:	0
O&M Grade:	1
Clock Start/From:	9
Clock To:	
1st Value:	
2nd Value:	
Value Percent:	
Continuous Index:	
Within 8" of Joint:	NO
Remarks:

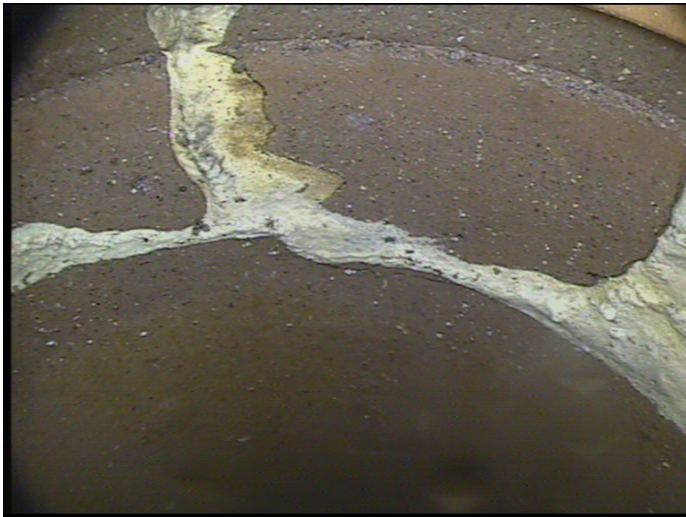
Code:	CM
Description:	Crack Multiple
Distance (ft):	51.3
Structural Grade:	3
O&M Grade:	0
Clock Start/From:	11
Clock To:	3
1st Value:	
2nd Value:	
Value Percent:	
Continuous Index:	
Within 8" of Joint:	YES
Remarks:

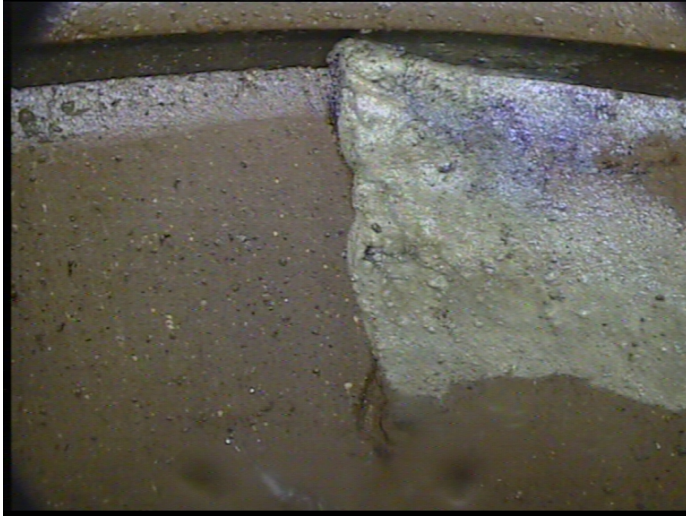
Code:	CL
Description:	Crack Longitudinal
Distance (ft):	57.6
Structural Grade:	2
O&M Grade:	0
Clock Start/From:	1
Clock To:	
1st Value:	
2nd Value:	
Value Percent:	
Continuous Index:	
Within 8" of Joint:	YES
Remarks:

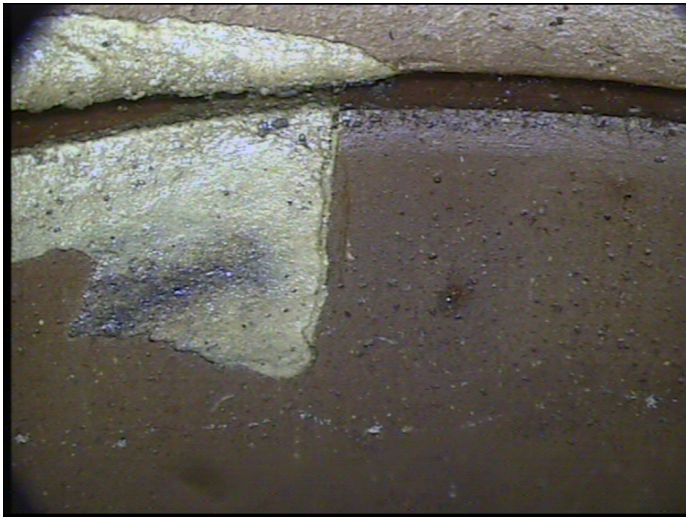
Code:	CL
Description:	Crack Longitudinal
Distance (ft):	59.3
Structural Grade:	2
O&M Grade:	0
Clock Start/From:	10
Clock To:	
1st Value:	
2nd Value:	
Value Percent:	
Continuous Index:	
Within 8" of Joint:	YES
Remarks:

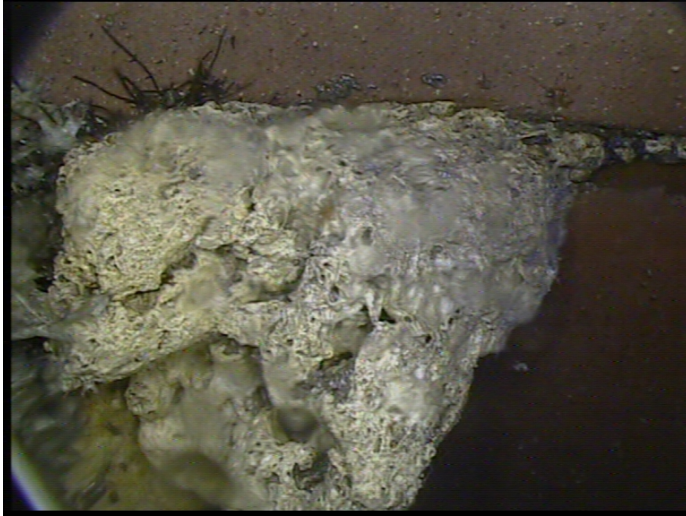
Code: **DAE**
Description: **Deposits Attached Encrustation**

Distance (ft): **63.1**
Structural Grade: **0**
O&M Grade: **2**
Clock Start/From: **9**
Clock To: **10**
1st Value:
2nd Value:
Value Percent: **5.000**
Continuous Index:
Within 8" of Joint: **YES**
Remarks:

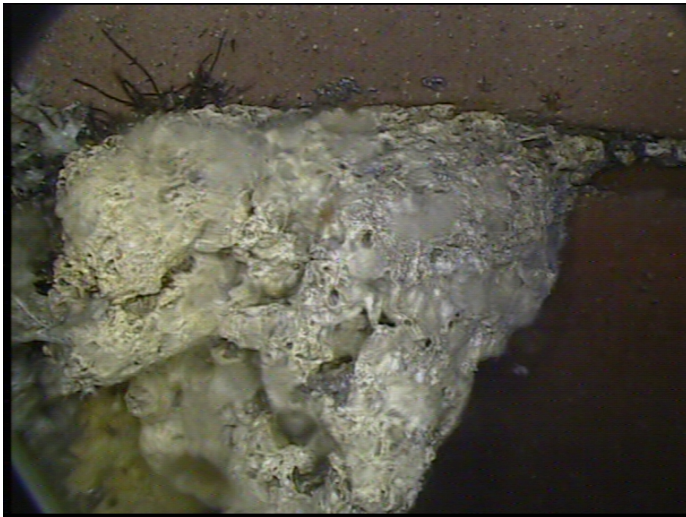
Code: **RFJ**
Description: **Roots Fine Joint**

Distance (ft): **63.1**
Structural Grade: **0**
O&M Grade: **1**
Clock Start/From: **9**
Clock To:
1st Value:
2nd Value:
Value Percent:
Continuous Index:
Within 8" of Joint: **YES**
Remarks:

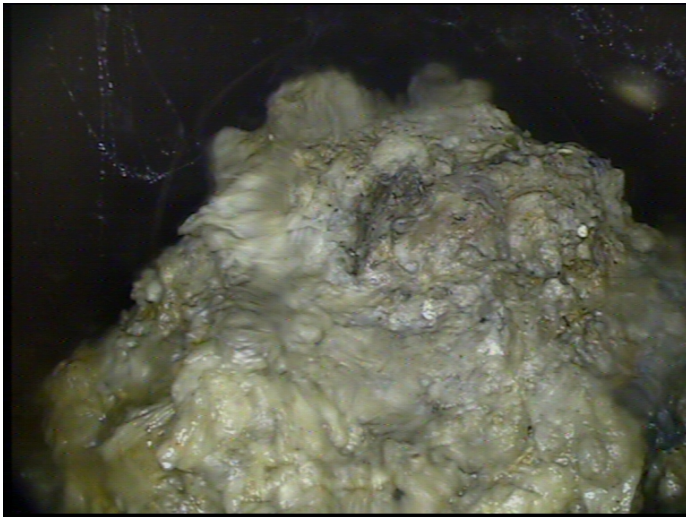
Code: **OBZ**
Description: **Obstacle Other**

Distance (ft): **83.8**
Structural Grade: **0**
O&M Grade: **4**
Clock Start/From: **7**
Clock To: **5**
1st Value:
2nd Value:
Value Percent: **30.000**
Continuous Index:
Within 8" of Joint: **NO**
Remarks: **Debris**

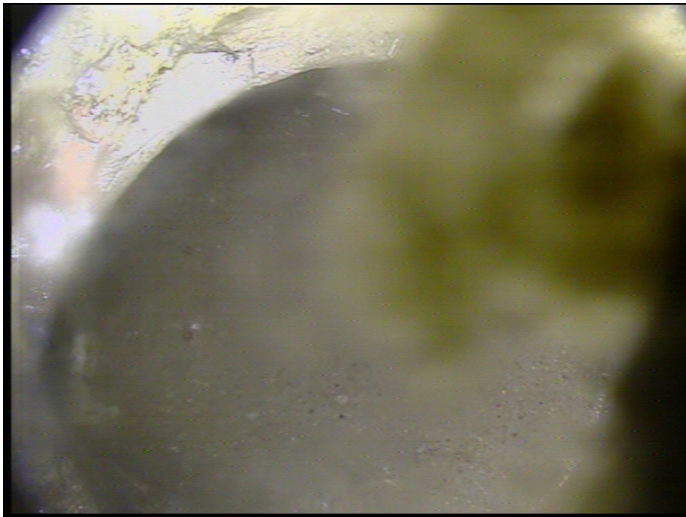
Code: **TB**
Description: **Tap Break-in**

Distance (ft): **125.3**
Structural Grade: **0**
O&M Grade: **0**
Clock Start/From: **10**
Clock To:
1st Value: **4.000**
2nd Value:
Value Percent:
Continuous Index:
Within 8" of Joint: **NO**
Remarks:
