Profile/Photo Observation Report

Street:	COURT ST & HENRY ST	Flow Control:	Not Controlled
City:	Hobart, IN	Year Renewed:	
Location:	Other	Tape/Media #:	
Purpose:	Not Known	Dia/Height:	12"
Use:	Sanitary	Material:	VCP
Drain Area:	NA	Lining:	
Category:	NA		
Comment:	Flow direction wrong.

Location Details:		Direction of Survey:	Upstream
US MH:	M-605-018	DS MH:	M-605-020
		Total Length Surveyed (ft):	84.9

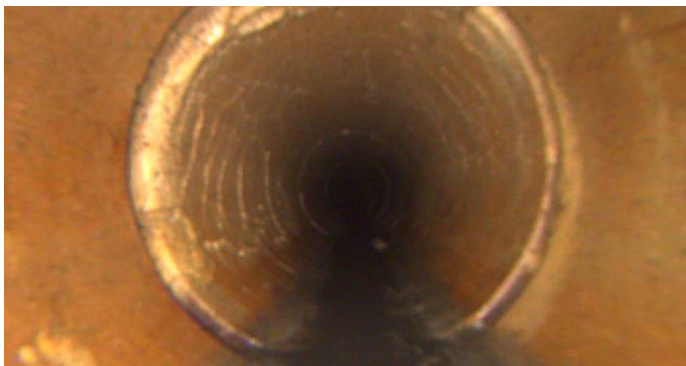
Code: **AMH**
Description: **Manhole**

Distance (ft): **.0**
Structural Grade: **0**
O&M Grade: **0**
Clock Start/From:
Clock To:
1st Value:
2nd Value:
Value Percent:
Continuous Index:
Within 8" of Joint: **NO**
Remarks: **M-605-020**

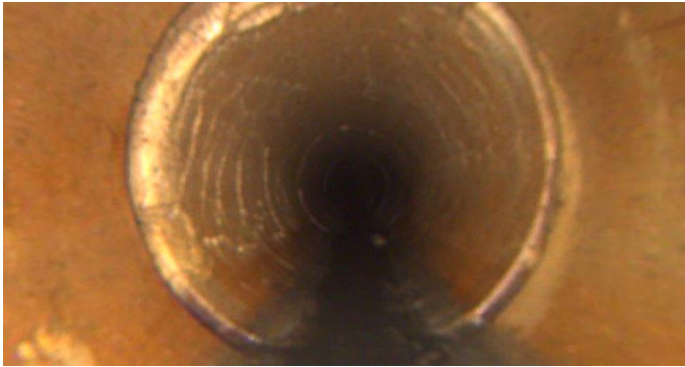
Code:	MWL
Description:	Water Level

Distance (ft):	.0
Structural Grade:	0
O&M Grade:	0
Clock Start/From:	
Clock To:	
1st Value:	
2nd Value:	
Value Percent:	10.000
Continuous Index:	
Within 8" of Joint:	NO
Remarks:

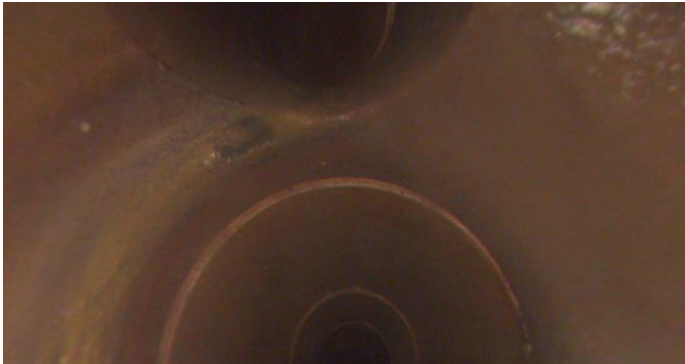
Code:	TF
Description:	Tap Factory

Distance (ft):	6.5
Structural Grade:	0
O&M Grade:	0
Clock Start/From:	12
Clock To:	
1st Value:	4.000
2nd Value:	
Value Percent:	
Continuous Index:	
Within 8" of Joint:	
Remarks:

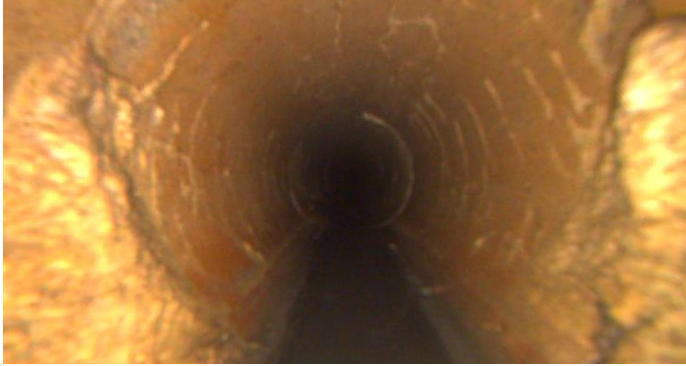
Code: **DAGS**
Description: **Deposits Attached Grease**

Distance (ft): **15.1**
Structural Grade: **0**
O&M Grade: **2**
Clock Start/From: **7**
Clock To: **5**
1st Value:
2nd Value:
Value Percent: **5.000**
Continuous Index:
Within 8" of Joint: **YES**
Remarks:

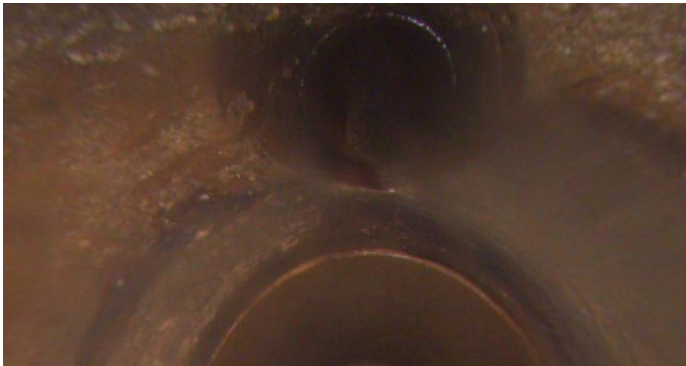
Code: **TF**
Description: **Tap Factory**

Distance (ft): **26.7**
Structural Grade: **0**
O&M Grade: **0**
Clock Start/From: **12**
Clock To:
1st Value: **4.000**
2nd Value:
Value Percent:
Continuous Index:
Within 8" of Joint:
Remarks:

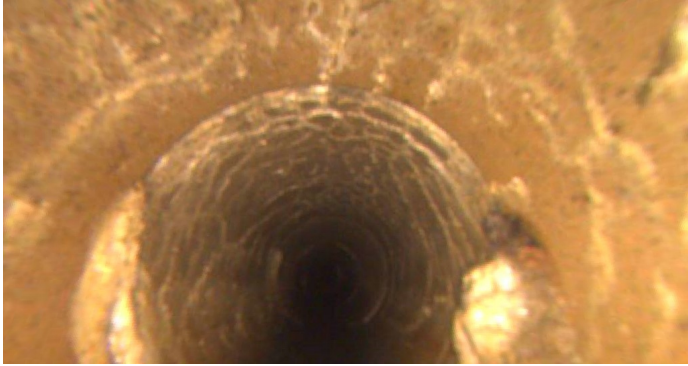
Code: **CM**
Description: **Crack Multiple**

Distance (ft): **28.9**
Structural Grade: **3**
O&M Grade: **0**
Clock Start/From: **7**
Clock To: **5**
1st Value:
2nd Value:
Value Percent:
Continuous Index: **S01**
Within 8" of Joint:
Remarks:

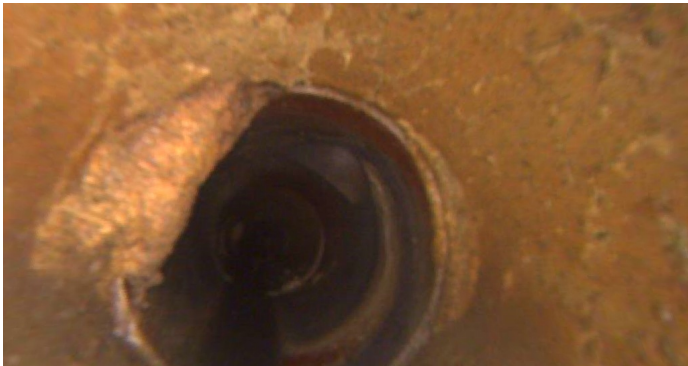
Code: **DAGS**
Description: **Deposits Attached Grease**

Distance (ft): **42.9**
Structural Grade: **0**
O&M Grade: **2**
Clock Start/From: **7**
Clock To: **5**
1st Value:
2nd Value:
Value Percent: **5.000**
Continuous Index:
Within 8" of Joint: **YES**
Remarks:

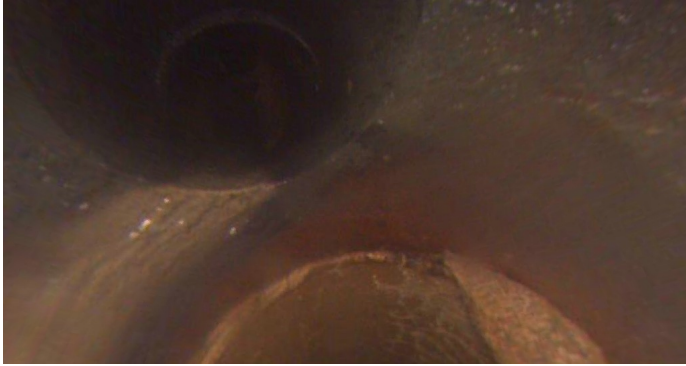
Code: **TF**
Description: **Tap Factory**

Distance (ft): **44.7**
Structural Grade: **0**
O&M Grade: **0**
Clock Start/From: **2**
Clock To:
1st Value: **4.000**
2nd Value:
Value Percent:
Continuous Index:
Within 8" of Joint:
Remarks:

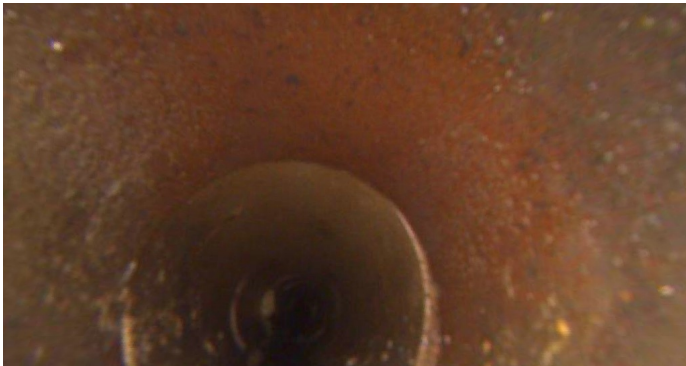
Code: **CM**
Description: **Crack Multiple**

Distance (ft): **44.7**
Structural Grade: **3**
O&M Grade: **0**
Clock Start/From: **7**
Clock To: **5**
1st Value:
2nd Value:
Value Percent:
Continuous Index: **F01**
Within 8" of Joint:
Remarks:

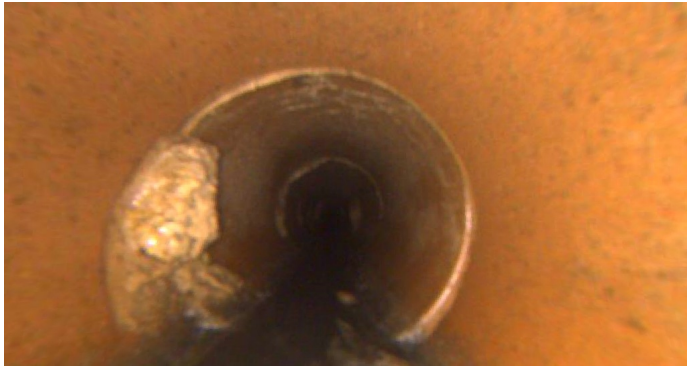
Code:	DAGS
Description:	Deposits Attached Grease
Distance (ft):	49.0
Structural Grade:	0
O&M Grade:	2
Clock Start/From:	7
Clock To:	9
1st Value:	
2nd Value:	
Value Percent:	5.000
Continuous Index:	S02
Within 8" of Joint:	YES
Remarks:

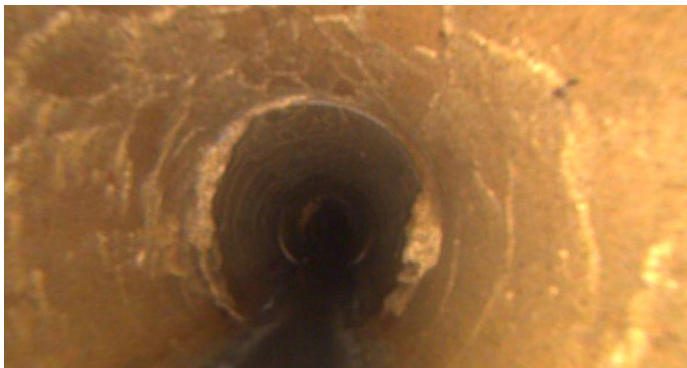
Code:	CM
Description:	Crack Multiple
Distance (ft):	60.8
Structural Grade:	3
O&M Grade:	0
Clock Start/From:	7
Clock To:	5
1st Value:	
2nd Value:	
Value Percent:	
Continuous Index:	
Within 8" of Joint:	
Remarks:

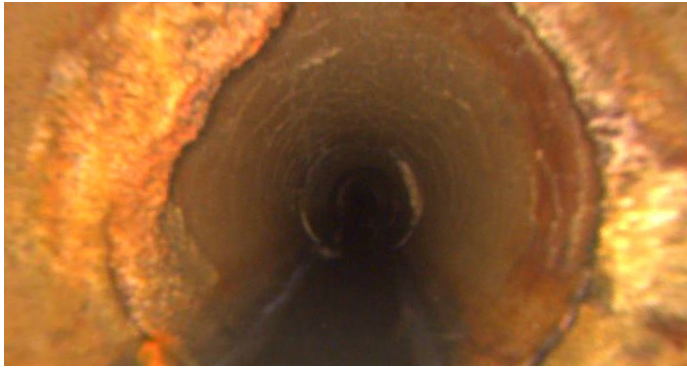
Code:	DAGS
Description:	Deposits Attached Grease
Distance (ft):	65.6
Structural Grade:	0
O&M Grade:	2
Clock Start/From:	7
Clock To:	5
1st Value:	
2nd Value:	
Value Percent:	5.000
Continuous Index:	
Within 8" of Joint:	YES
Remarks:

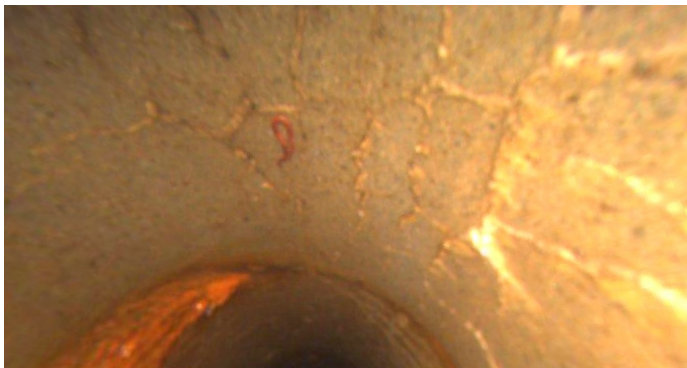
Code:	CM
Description:	Crack Multiple
Distance (ft):	77.4
Structural Grade:	3
O&M Grade:	0
Clock Start/From:	7
Clock To:	5
1st Value:	
2nd Value:	
Value Percent:	
Continuous Index:	
Within 8" of Joint:	
Remarks:

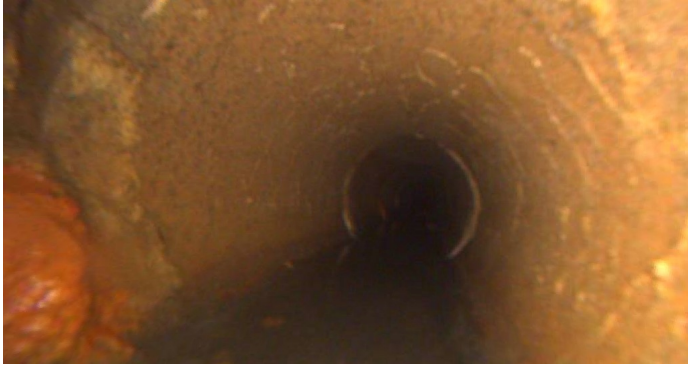
Code:	DAGS
Description:	Deposits Attached Grease
Distance (ft):	82.2
Structural Grade:	0
O&M Grade:	2
Clock Start/From:	7
Clock To:	9
1st Value:	
2nd Value:	
Value Percent:	5.000
Continuous Index:	F02
Within 8" of Joint:	YES
Remarks:

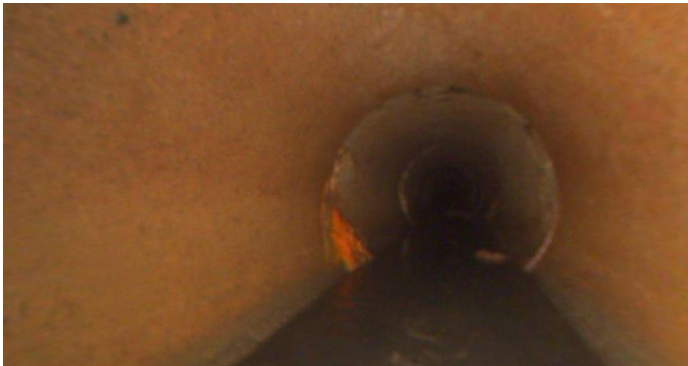
Code:	MSA
Description:	Abandoned Survey
Distance (ft):	84.9
Structural Grade:	0
O&M Grade:	0
Clock Start/From:	
Clock To:	
1st Value:	
2nd Value:	
Value Percent:	
Continuous Index:	
Within 8" of Joint:	NO
Remarks:	No debris
