Profile/Photo Observation Report

Date:	04/26/2018	Weather:		Coding:	PACP 6.0
Pipe Length (ft):	166.5	Owner:	NA	Pre Clean:	Not Known
P.O.#:		Surveyor:	Mark Ruby	PSR:	P-605-020-018
Customer:		Clean Date:	01/01/1900	Shape:	C

Street:	Henry	Flow Control:	Not Controlled
City:	Hobart, IN	Year Renewed:	
Location:	Other	Tape/Media #:	
Purpose:	Not Known	Dia/Height:	12"
Use:	Sanitary	Material:	VCP
Drain Area:	NA	Lining:	
Category:	NA		
Comment:	Flow direction wrong.

Location Details:		Direction of Survey:	Upstream
US MH:	M-605-018	DS MH:	M-605-020
		Total Length Surveyed (ft):	84.9

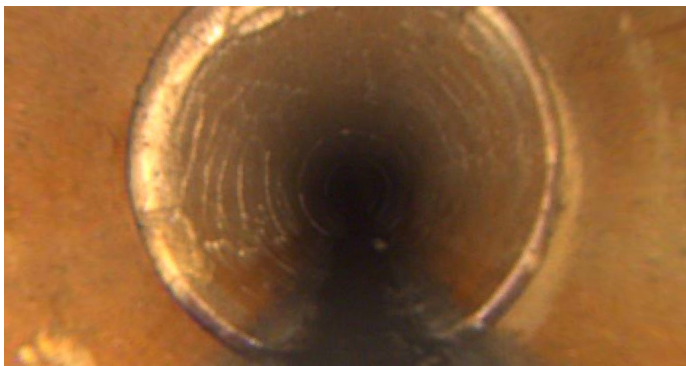
Code: **AMH**
Description: **Manhole**

Distance (ft): **.0**
Structural Grade: **0**
O&M Grade: **0**
Clock Start/From:
Clock To:
1st Value:
2nd Value:
Value Percent:
Continuous Index:
Within 8" of Joint: **NO**
Remarks: **M-605-020**

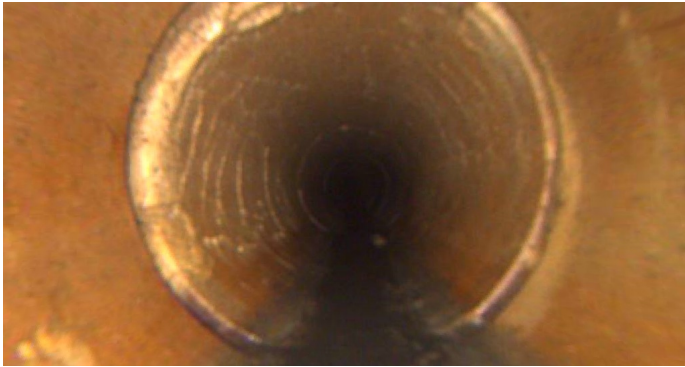
Code:	MWL
Description:	Water Level

Distance (ft):	.0
Structural Grade:	0
O&M Grade:	0
Clock Start/From:	
Clock To:	
1st Value:	
2nd Value:	
Value Percent:	10.000
Continuous Index:	
Within 8" of Joint:	NO
Remarks:

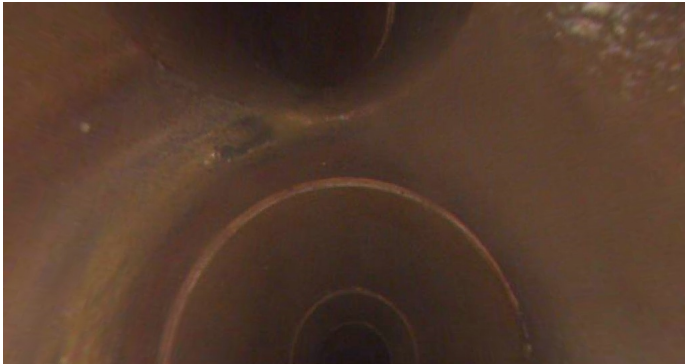
Code:	TF
Description:	Tap Factory

Distance (ft):	6.5
Structural Grade:	0
O&M Grade:	0
Clock Start/From:	12
Clock To:	
1st Value:	4.000
2nd Value:	
Value Percent:	
Continuous Index:	
Within 8" of Joint:	
Remarks:

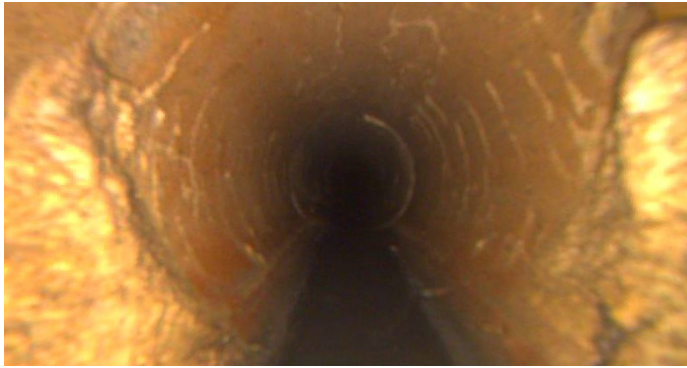
Code: **DAGS**
Description: **Deposits Attached Grease**

Distance (ft): **15.1**
Structural Grade: **0**
O&M Grade: **2**
Clock Start/From: **7**
Clock To: **5**
1st Value:
2nd Value:
Value Percent: **5.000**
Continuous Index:
Within 8" of Joint: **YES**
Remarks:

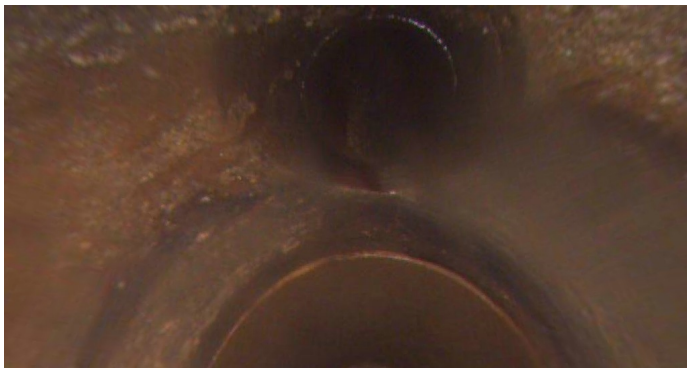
Code: **TF**
Description: **Tap Factory**

Distance (ft): **26.7**
Structural Grade: **0**
O&M Grade: **0**
Clock Start/From: **12**
Clock To:
1st Value: **4.000**
2nd Value:
Value Percent:
Continuous Index:
Within 8" of Joint:
Remarks:

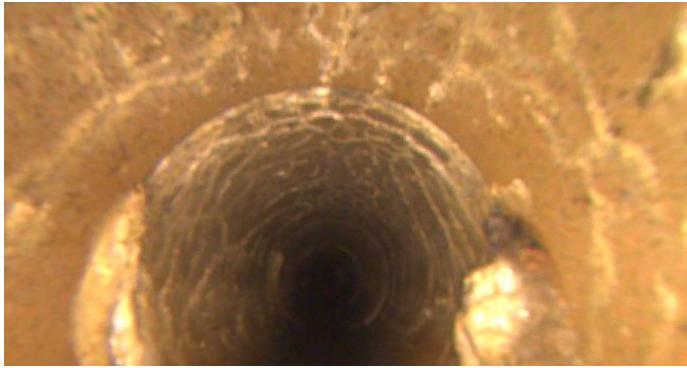
Code: **CM**
Description: **Crack Multiple**

Distance (ft): **28.9**
Structural Grade: **3**
O&M Grade: **0**
Clock Start/From: **7**
Clock To: **5**
1st Value:
2nd Value:
Value Percent:
Continuous Index: **S01**
Within 8" of Joint:
Remarks:

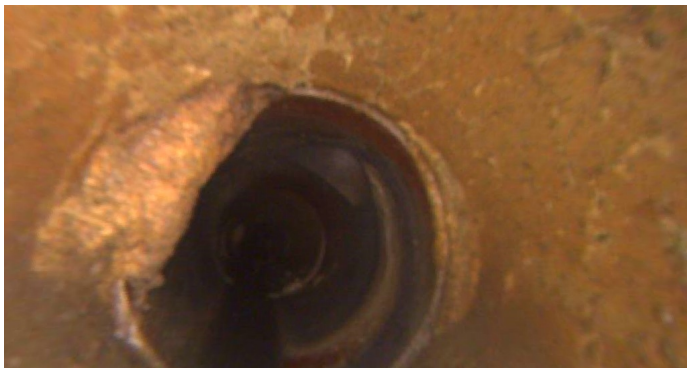
Code: **DAGS**
Description: **Deposits Attached Grease**

Distance (ft): **42.9**
Structural Grade: **0**
O&M Grade: **2**
Clock Start/From: **7**
Clock To: **5**
1st Value:
2nd Value:
Value Percent: **5.000**
Continuous Index:
Within 8" of Joint: **YES**
Remarks:

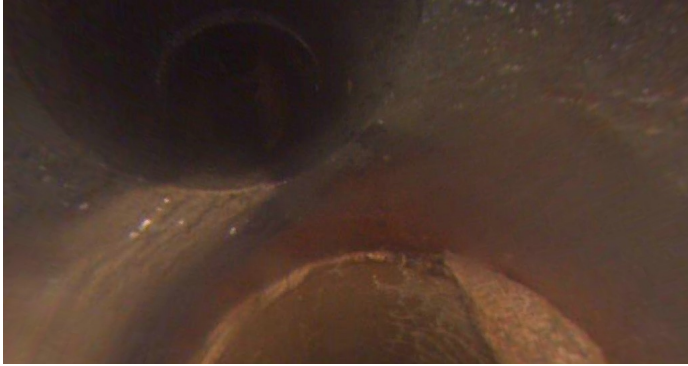
Code: **TF**
Description: **Tap Factory**

Distance (ft): **44.7**
Structural Grade: **0**
O&M Grade: **0**
Clock Start/From: **2**
Clock To:
1st Value: **4.000**
2nd Value:
Value Percent:
Continuous Index:
Within 8" of Joint:
Remarks:

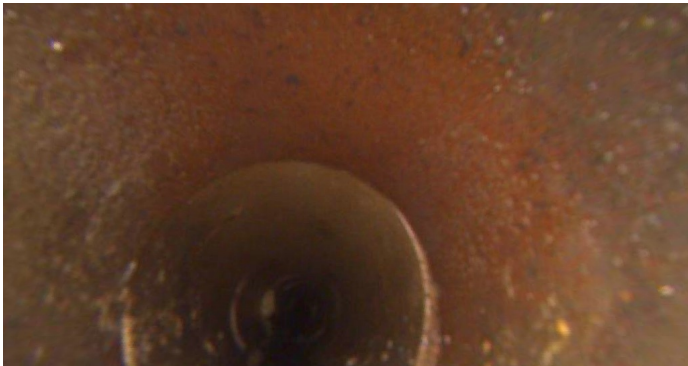
Code: **CM**
Description: **Crack Multiple**

Distance (ft): **44.7**
Structural Grade: **3**
O&M Grade: **0**
Clock Start/From: **7**
Clock To: **5**
1st Value:
2nd Value:
Value Percent:
Continuous Index: **F01**
Within 8" of Joint:
Remarks:

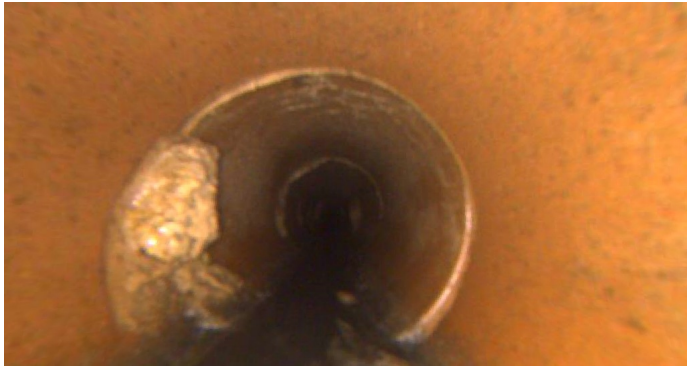
Code:	DAGS
Description:	Deposits Attached Grease
Distance (ft):	49.0
Structural Grade:	0
O&M Grade:	2
Clock Start/From:	7
Clock To:	9
1st Value:	
2nd Value:	
Value Percent:	5.000
Continuous Index:	S02
Within 8" of Joint:	YES
Remarks:

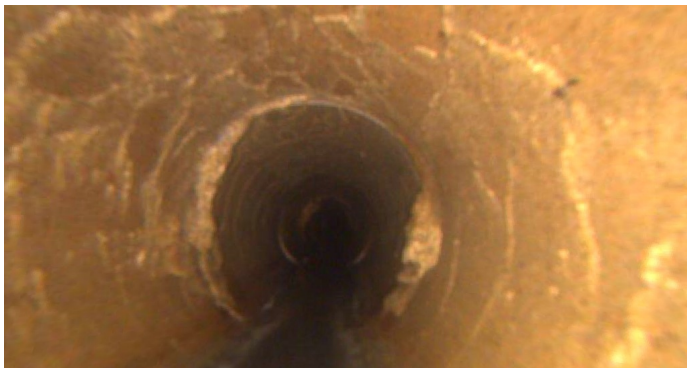
Code:	CM
Description:	Crack Multiple
Distance (ft):	60.8
Structural Grade:	3
O&M Grade:	0
Clock Start/From:	7
Clock To:	5
1st Value:	
2nd Value:	
Value Percent:	
Continuous Index:	
Within 8" of Joint:	
Remarks:

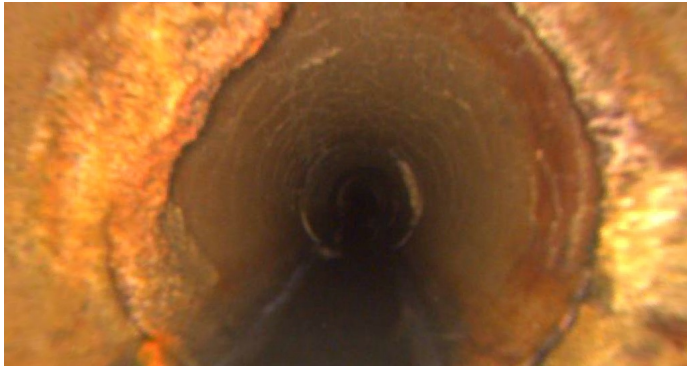
Code:	DAGS
Description:	Deposits Attached Grease
Distance (ft):	65.6
Structural Grade:	0
O&M Grade:	2
Clock Start/From:	7
Clock To:	5
1st Value:	
2nd Value:	
Value Percent:	5.000
Continuous Index:	
Within 8" of Joint:	YES
Remarks:

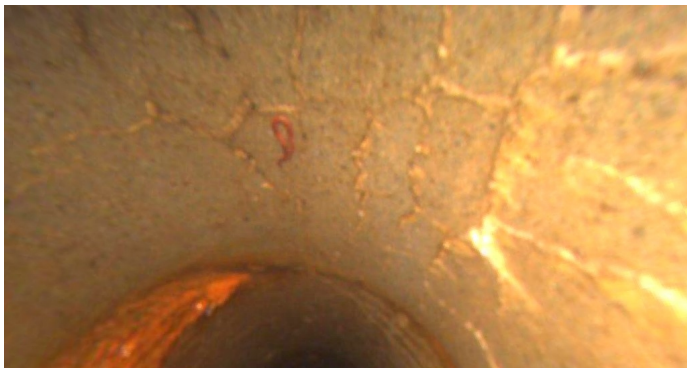
Code:	CM
Description:	Crack Multiple
Distance (ft):	77.4
Structural Grade:	3
O&M Grade:	0
Clock Start/From:	7
Clock To:	5
1st Value:	
2nd Value:	
Value Percent:	
Continuous Index:	
Within 8" of Joint:	
Remarks:

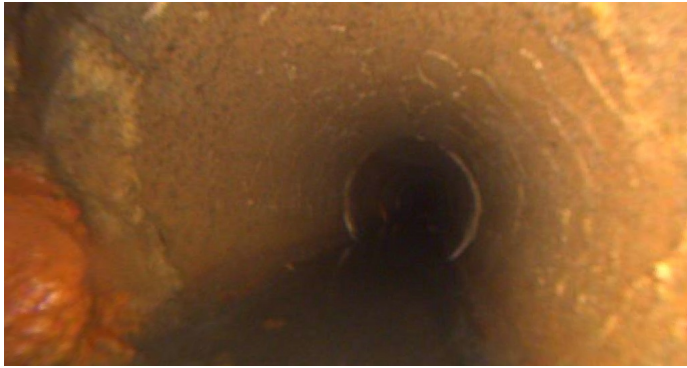
Code:	DAGS
Description:	Deposits Attached Grease
Distance (ft):	82.2
Structural Grade:	0
O&M Grade:	2
Clock Start/From:	7
Clock To:	9
1st Value:	
2nd Value:	
Value Percent:	5.000
Continuous Index:	F02
Within 8" of Joint:	YES
Remarks:

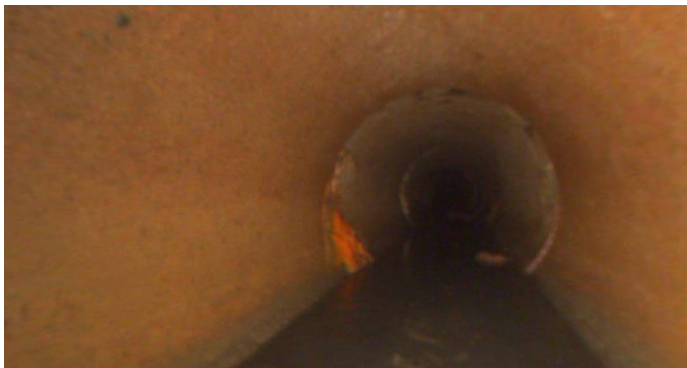
Code:	MSA
Description:	Abandoned Survey
Distance (ft):	84.9
Structural Grade:	0
O&M Grade:	0
Clock Start/From:	
Clock To:	
1st Value:	
2nd Value:	
Value Percent:	
Continuous Index:	
Within 8" of Joint:	NO
Remarks:	No debris
