Profile/Photo Observation Report

Date:	11/16/2021	Weather:		Coding:	PACP 7.0
Pipe Length (ft):	173.0	Owner:	City of Hobart	Pre Clean:	Heavy Cleaning
P.O.#:	YES502259	Surveyor:	S. Bucklin	PSR:	P-605-020-018
Customer:	City of Hobart	Clean Date:	11/16/2021	Shape:	C

Street:	Henry Street	Flow Control:	Not Controlled
City:	Hobart, IN	Year Renewed:	
Location:	Local rural streets with light traffic, t	Tape/Media #:	
Purpose:	Routine Assessment	Dia/Height:	12"
Use:	Sanitary Sewage Pipe	Material:	VCP
Drain Area:		Lining:	None
Category:	NA		
Comment:			
Location Details:		Direction of Survey:	Downstream
US MH:	M-605-018	DS MH:	M-605-020
		Total Length Surveyed (ft):	173.0

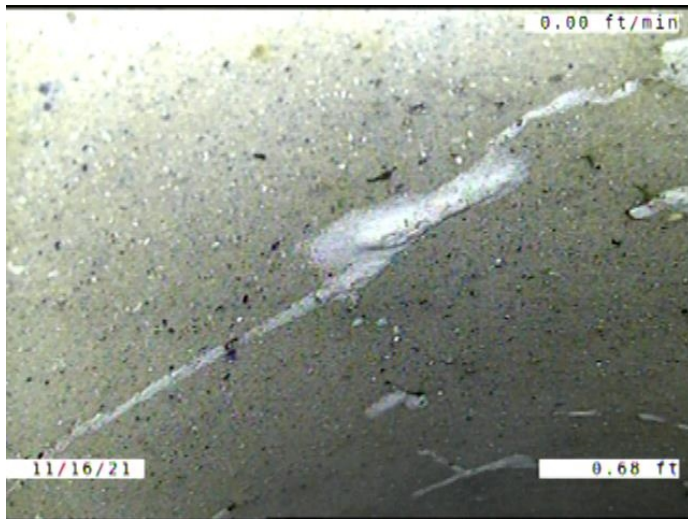
Code: **DAE**
Description: **Deposits Attached Encrustation**

Distance (ft): **.7**
Structural Grade: **0**
O&M Grade: **2**
Clock Start/From: **7**
Clock To: **5**
1st Value:
2nd Value:
Value Percent: **5.000**
Continuous Index: **S01**
Within 8" of Joint: **YES**
Remarks:

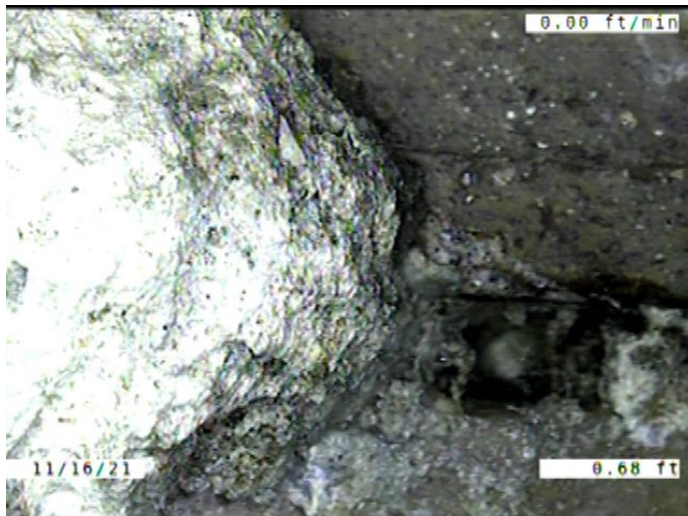
Code: **DAE**
Description: **Deposits Attached Encrustation**

Distance (ft): **.7**
Structural Grade: **0**
O&M Grade: **2**
Clock Start/From: **4**
Clock To: **7**
1st Value:
2nd Value:
Value Percent: **10.000**
Continuous Index:
Within 8" of Joint: **YES**
Remarks:

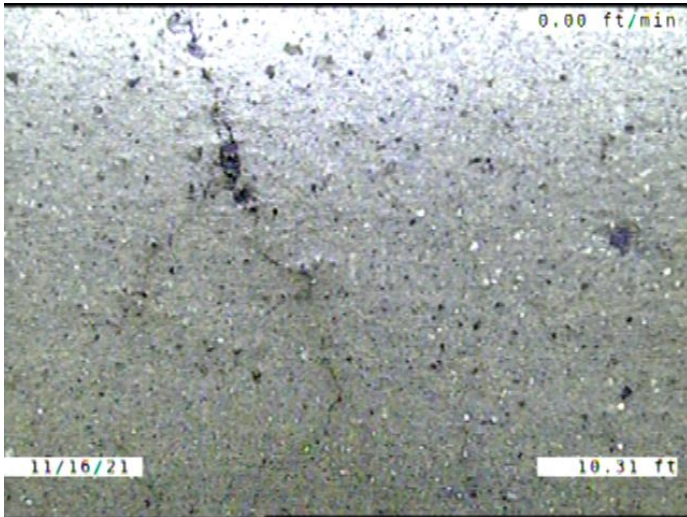
Code: **CM**
Description: **Crack Multiple**

Distance (ft): **10.3**
Structural Grade: **3**
O&M Grade: **0**
Clock Start/From: **11**
Clock To: **1**
1st Value:
2nd Value:
Value Percent:
Continuous Index:
Within 8" of Joint: **YES**
Remarks:

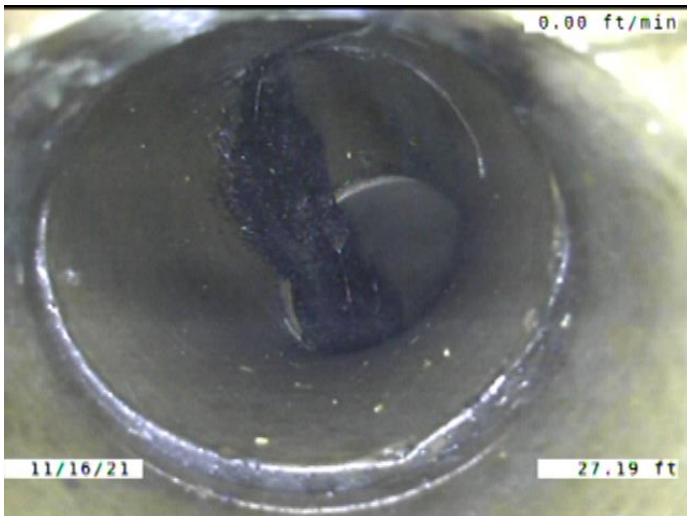
Code: **TF**
Description: **Tap Factory**

Distance (ft): **27.2**
Structural Grade: **0**
O&M Grade: **0**
Clock Start/From: **12**
Clock To:
1st Value: **4.000**
2nd Value:
Value Percent:
Continuous Index:
Within 8" of Joint: **YES**
Remarks: **ROOTS GROWING IN THE TAP**

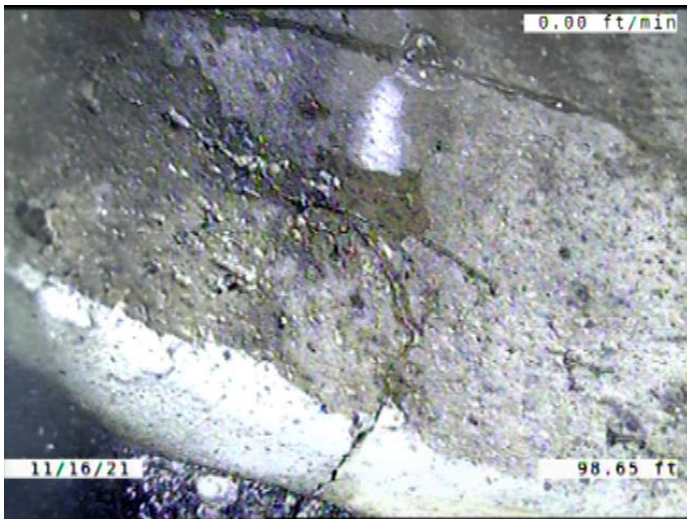
Code: **CM**
Description: **Crack Multiple**

Distance (ft): **98.6**
Structural Grade: **3**
O&M Grade: **0**
Clock Start/From: **3**
Clock To: **6**
1st Value:
2nd Value:
Value Percent:
Continuous Index:
Within 8" of Joint: **YES**
Remarks:

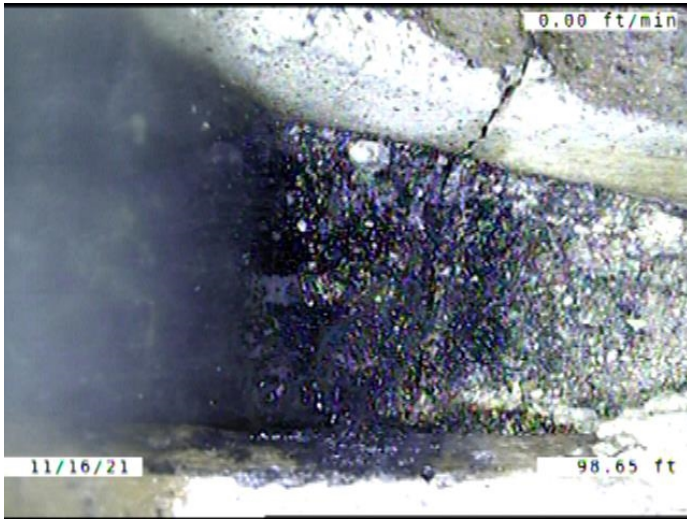
Code: **JOMD**
Description: **Joint Offset Medium Defective**

Distance (ft): **98.6**
Structural Grade: **3**
O&M Grade: **0**
Clock Start/From:
Clock To:
1st Value:
2nd Value:
Value Percent:
Continuous Index:
Within 8" of Joint: **NO**
Remarks:

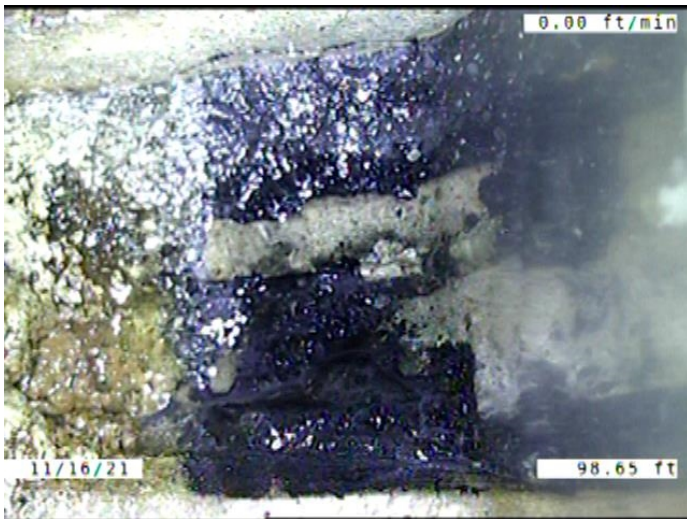
Code: **JAL**
Description: **Joint Angular Large**

Distance (ft): **98.6**
Structural Grade: **4**
O&M Grade: **0**
Clock Start/From:
Clock To:
1st Value:
2nd Value:
Value Percent:
Continuous Index:
Within 8" of Joint: **NO**
Remarks:

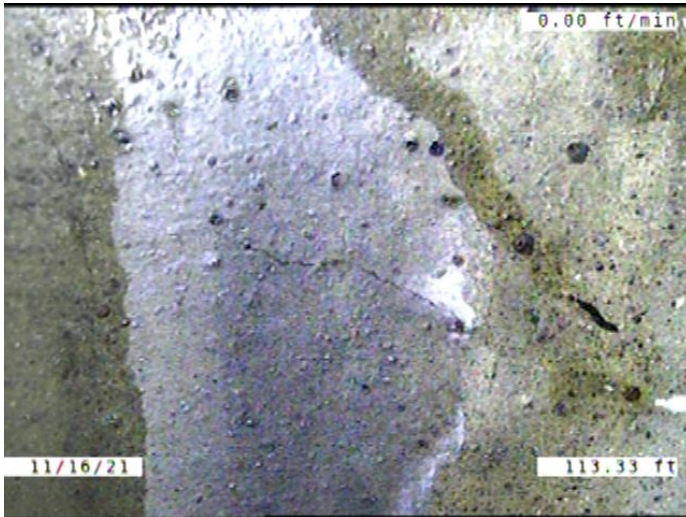
Code: **CM**
Description: **Crack Multiple**

Distance (ft): **113.3**
Structural Grade: **3**
O&M Grade: **0**
Clock Start/From: **8**
Clock To: **9**
1st Value:
2nd Value:
Value Percent:
Continuous Index:
Within 8" of Joint: **YES**
Remarks:

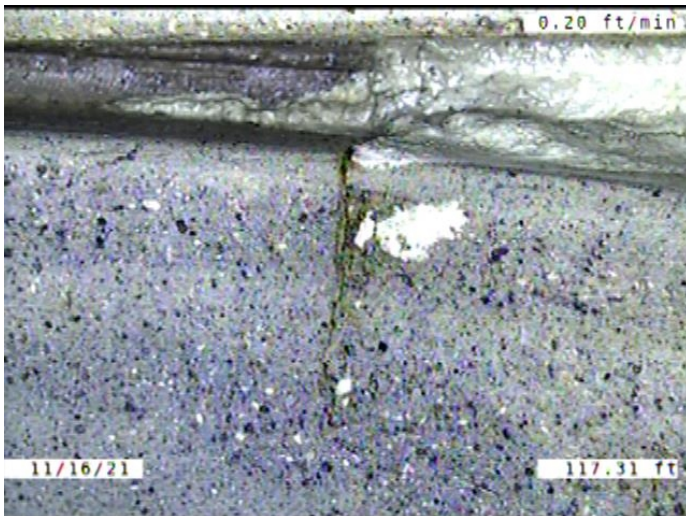
Code: **CL**
Description: **Crack Longitudinal**

Distance (ft): **117.3**
Structural Grade: **2**
O&M Grade: **0**
Clock Start/From: **2**
Clock To:
1st Value:
2nd Value:
Value Percent:
Continuous Index:
Within 8" of Joint: **YES**
Remarks:

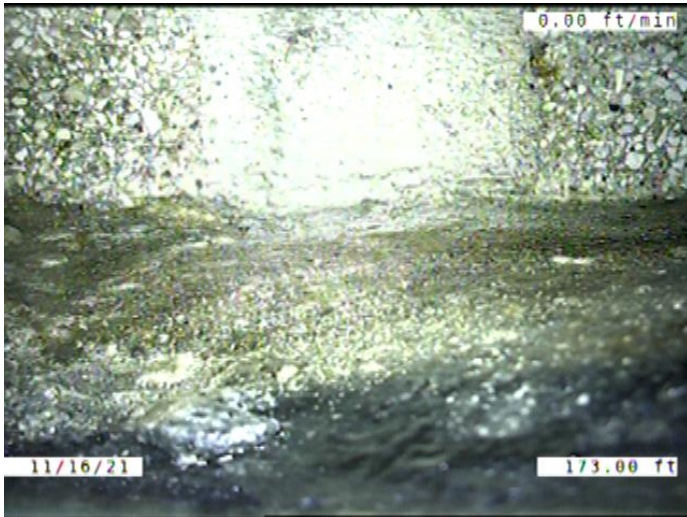
Code: **DAE**
 Description: **Deposits Attached Encrustation**

Distance (ft): **173.0**
 Structural Grade: **0**
 O&M Grade: **2**
 Clock Start/From: **7**
 Clock To: **5**
 1st Value:
 2nd Value:
 Value Percent: **5.000**
 Continuous Index: **F01**
 Within 8" of Joint: **YES**
 Remarks:
