## Profile/Photo Observation Report

Date:	<b>11/16/2021</b>	Weather:		Coding:	<b>PACP 7.0</b>
Pipe Length (ft):	<b>173.0</b>	Owner:	<b>City of Hobart</b>	Pre Clean:	<b>Heavy Cleaning</b>
P.O.#:	<b>YES502259</b>	Surveyor:	<b>S. Bucklin</b>	PSR:	<b>P-605-020-018</b>
Customer:	<b>City of Hobart</b>	Clean Date:	<b>11/16/2021</b>	Shape:	<b>C</b>

Street:	<b>Henry Street</b>	Flow Control:	<b>Not Controlled</b>
City:	<b>Hobart, IN</b>	Year Renewed:	
Location:	<b>Local rural streets with light traffic, t</b>	Tape/Media #:	
Purpose:	<b>Routine Assessment</b>	Dia/Height:	<b>12"</b>
Use:	<b>Sanitary Sewage Pipe</b>	Material:	<b>VCP</b>
Drain Area:		Lining:	<b>None</b>
Category:	<b>NA</b>		
Comment:			
Location Details:		Direction of Survey:	<b>Downstream</b>
US MH:	<b>M-605-018</b>	DS MH:	<b>M-605-020</b>
		Total Length Surveyed (ft):	<b>173.0</b>

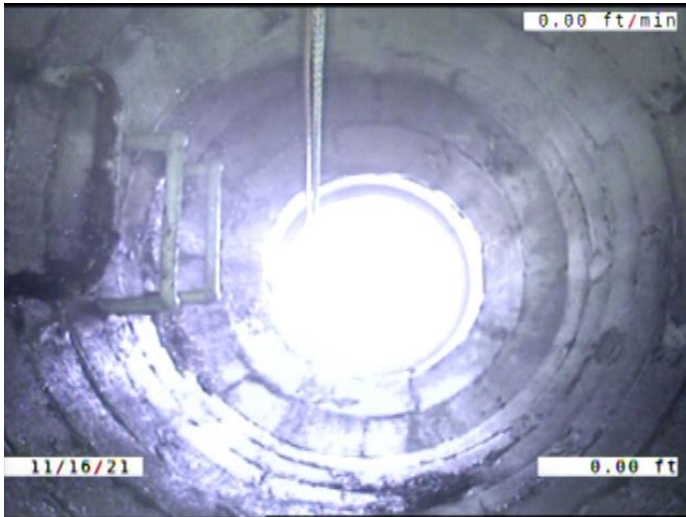
Code: **AMH**  
 Description: **Manhole**

Distance (ft): **.0**  
 Structural Grade: **0**  
 O&M Grade: **0**  
 Clock Start/From:  
 Clock To:  
 1st Value:  
 2nd Value:  
 Value Percent:  
 Continuous Index:  
 Within 8" of Joint: **NO**  
 Remarks: **M-605-018**

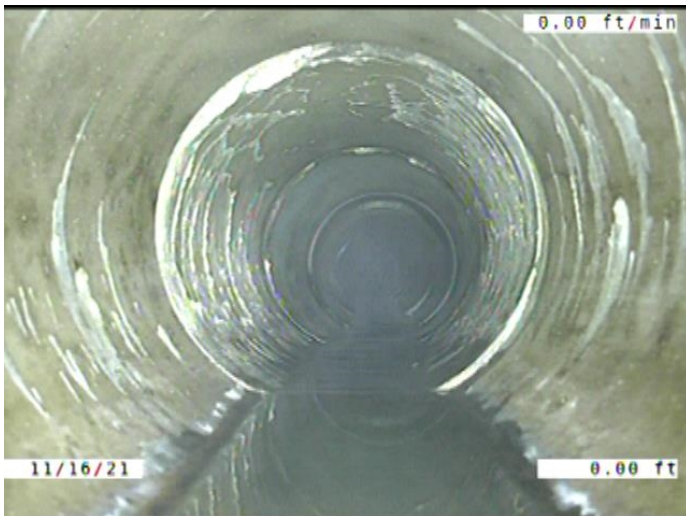
Code: **MWL**  
 Description: **Miscellaneous Water Level**

Distance (ft): **.0**  
 Structural Grade: **0**  
 O&M Grade: **0**  
 Clock Start/From:  
 Clock To:  
 1st Value:  
 2nd Value:  
 Value Percent: **5.000**  
 Continuous Index:  
 Within 8" of Joint: **NO**  
 Remarks:

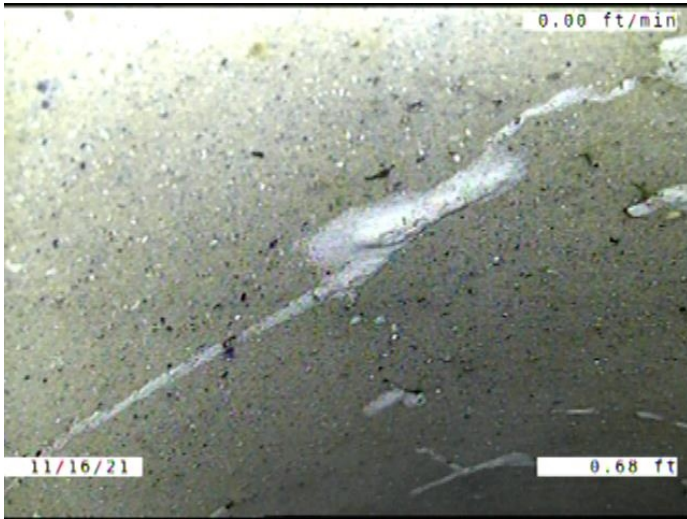
Code: **DAE**  
Description: **Deposits Attached Encrustation**

Distance (ft): **.7**  
Structural Grade: **0**  
O&M Grade: **2**  
Clock Start/From: **7**  
Clock To: **5**  
1st Value:  
2nd Value:  
Value Percent: **5.000**  
Continuous Index: **S01**  
Within 8" of Joint: **YES**  
Remarks:

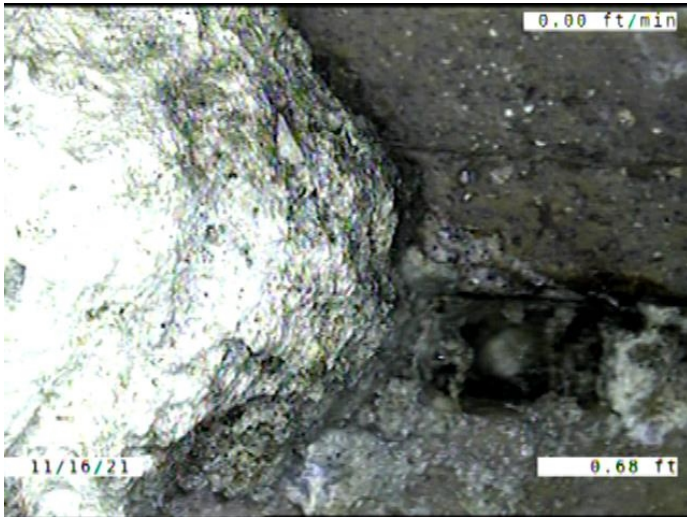
Code: **DAE**  
Description: **Deposits Attached Encrustation**

Distance (ft): **.7**  
Structural Grade: **0**  
O&M Grade: **2**  
Clock Start/From: **4**  
Clock To: **7**  
1st Value:  
2nd Value:  
Value Percent: **10.000**  
Continuous Index:  
Within 8" of Joint: **YES**  
Remarks:

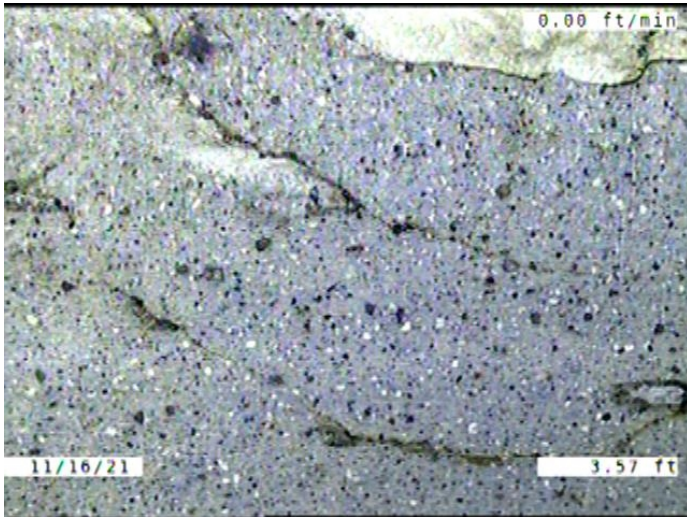
Code: **CM**  
 Description: **Crack Multiple**

Distance (ft): **3.6**  
 Structural Grade: **3**  
 O&M Grade: **0**  
 Clock Start/From: **9**  
 Clock To: **11**  
 1st Value:  
 2nd Value:  
 Value Percent:  
 Continuous Index:  
 Within 8" of Joint: **YES**  
 Remarks:

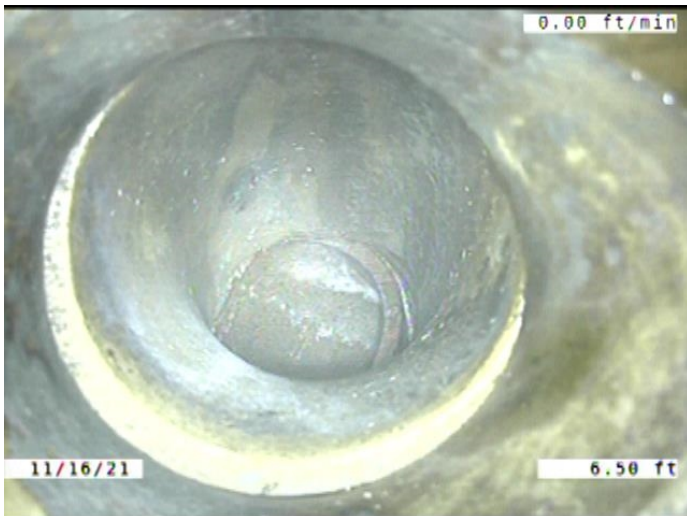
Code: **TF**  
 Description: **Tap Factory**

Distance (ft): **6.5**  
 Structural Grade: **0**  
 O&M Grade: **0**  
 Clock Start/From: **1**  
 Clock To:  
 1st Value: **4.000**  
 2nd Value:  
 Value Percent:  
 Continuous Index:  
 Within 8" of Joint: **YES**  
 Remarks:

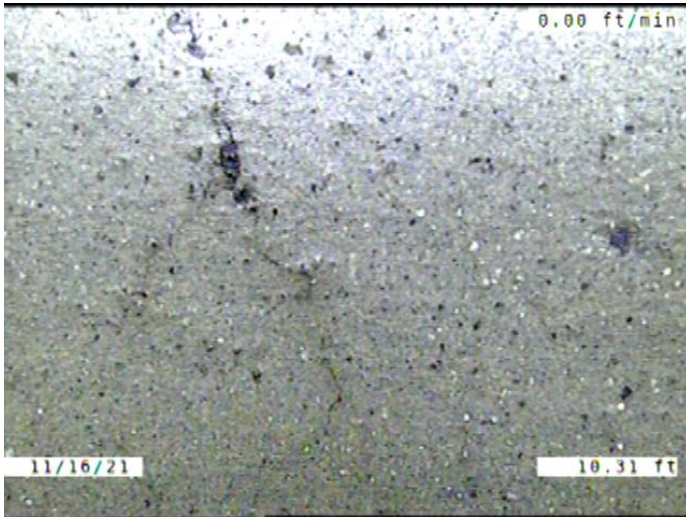
Code: **CM**  
Description: **Crack Multiple**

Distance (ft): **10.3**  
Structural Grade: **3**  
O&M Grade: **0**  
Clock Start/From: **11**  
Clock To: **1**  
1st Value:  
2nd Value:  
Value Percent:  
Continuous Index:  
Within 8" of Joint: **YES**  
Remarks:

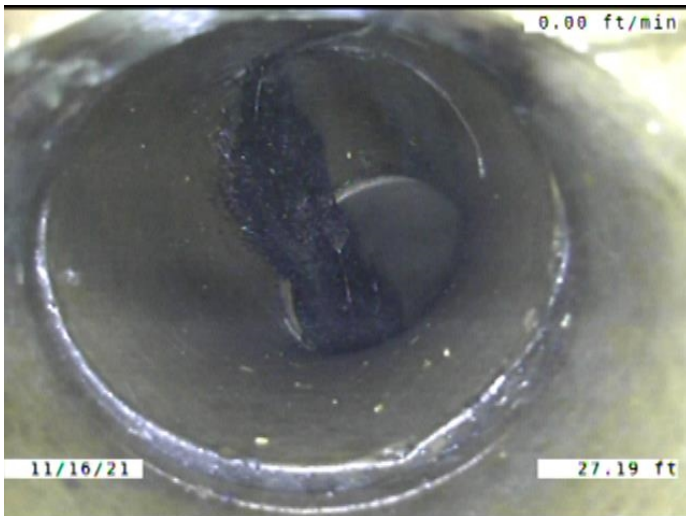
Code: **TF**  
Description: **Tap Factory**

Distance (ft): **27.2**  
Structural Grade: **0**  
O&M Grade: **0**  
Clock Start/From: **12**  
Clock To:  
1st Value: **4.000**  
2nd Value:  
Value Percent:  
Continuous Index:  
Within 8" of Joint: **YES**  
Remarks: **ROOTS GROWING IN THE TAP**

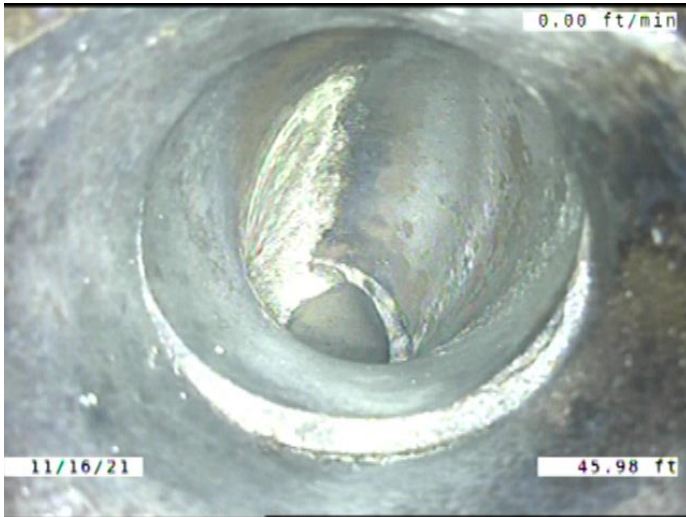
Code: **TF**  
 Description: **Tap Factory**

Distance (ft): **46.0**  
 Structural Grade: **0**  
 O&M Grade: **0**  
 Clock Start/From: **12**  
 Clock To:  
 1st Value: **4.000**  
 2nd Value:  
 Value Percent:  
 Continuous Index:  
 Within 8" of Joint: **YES**  
 Remarks:

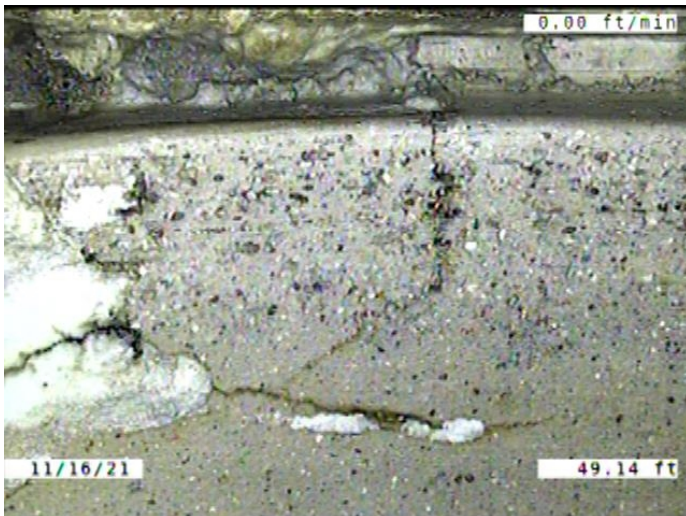
Code: **CM**  
 Description: **Crack Multiple**

Distance (ft): **49.1**  
 Structural Grade: **3**  
 O&M Grade: **0**  
 Clock Start/From: **10**  
 Clock To: **12**  
 1st Value:  
 2nd Value:  
 Value Percent:  
 Continuous Index:  
 Within 8" of Joint: **YES**  
 Remarks:

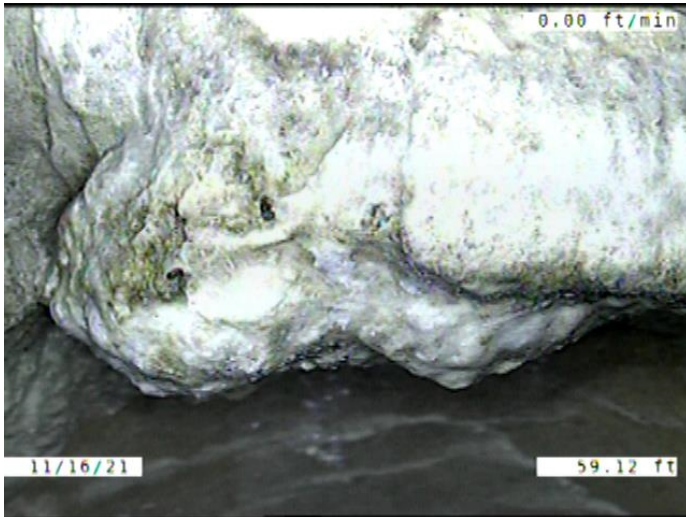
Code: **DAE**  
 Description: **Deposits Attached Encrustation**

Distance (ft): **59.1**  
 Structural Grade: **0**  
 O&M Grade: **2**  
 Clock Start/From: **7**  
 Clock To: **5**  
 1st Value:  
 2nd Value:  
 Value Percent: **10.000**  
 Continuous Index:  
 Within 8" of Joint: **YES**  
 Remarks:

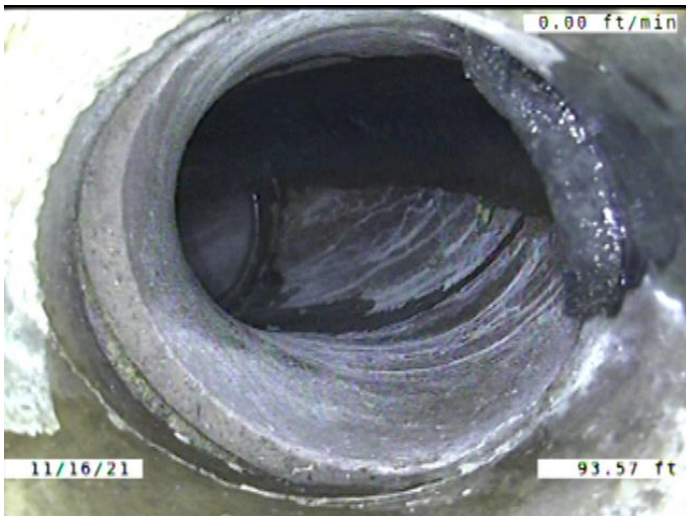
Code: **TFD**  
 Description: **Tap Factory Defective**

Distance (ft): **93.6**  
 Structural Grade: **0**  
 O&M Grade: **3**  
 Clock Start/From: **2**  
 Clock To:  
 1st Value: **4.000**  
 2nd Value:  
 Value Percent:  
 Continuous Index:  
 Within 8" of Joint: **YES**  
 Remarks: **OFFSET**

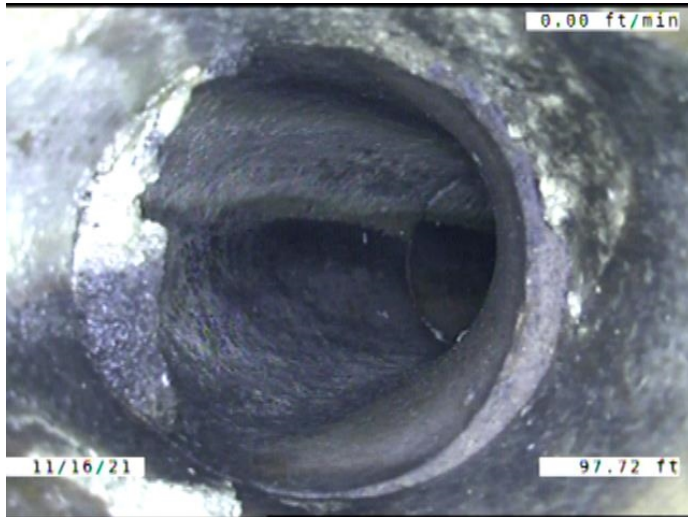
Code: **TF**  
 Description: **Tap Factory**

Distance (ft): **97.7**  
 Structural Grade: **0**  
 O&M Grade: **0**  
 Clock Start/From: **11**  
 Clock To:  
 1st Value: **4.000**  
 2nd Value:  
 Value Percent:  
 Continuous Index:  
 Within 8" of Joint: **YES**  
 Remarks:

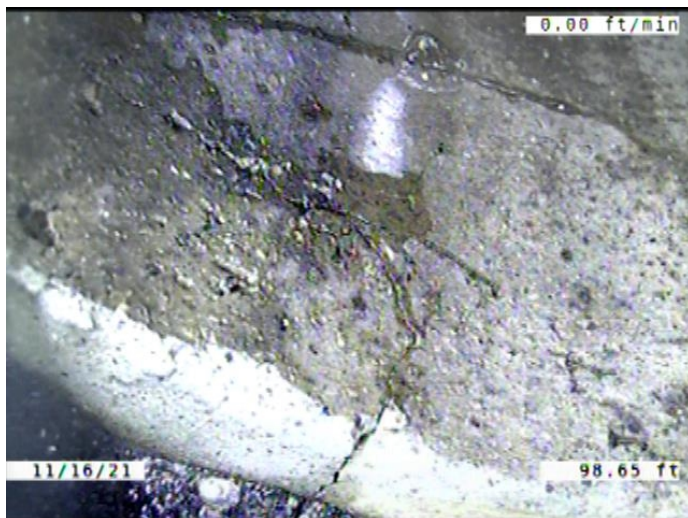
Code: **CM**  
 Description: **Crack Multiple**

Distance (ft): **98.6**  
 Structural Grade: **3**  
 O&M Grade: **0**  
 Clock Start/From: **3**  
 Clock To: **6**  
 1st Value:  
 2nd Value:  
 Value Percent:  
 Continuous Index:  
 Within 8" of Joint: **YES**  
 Remarks:

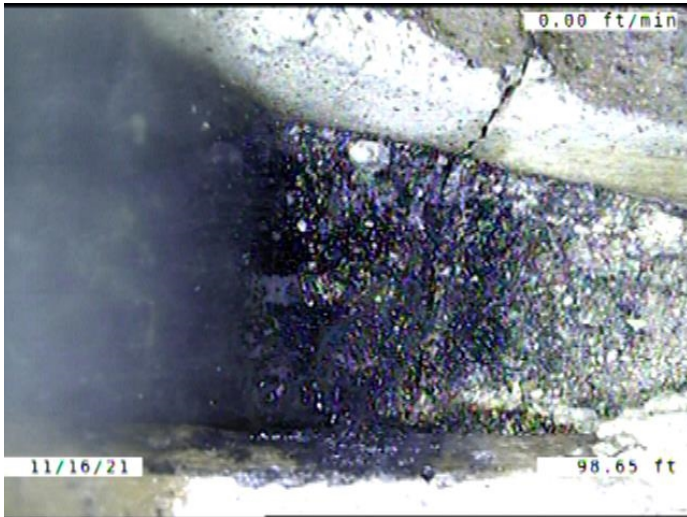
Code: **JOMD**  
Description: **Joint Offset Medium Defective**

Distance (ft): **98.6**  
Structural Grade: **3**  
O&M Grade: **0**  
Clock Start/From:  
Clock To:  
1st Value:  
2nd Value:  
Value Percent:  
Continuous Index:  
Within 8" of Joint: **NO**  
Remarks:

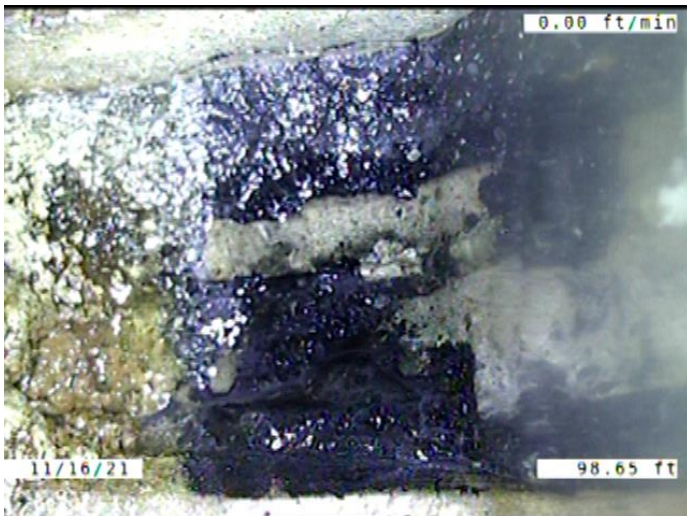
Code: **JAL**  
Description: **Joint Angular Large**

Distance (ft): **98.6**  
Structural Grade: **4**  
O&M Grade: **0**  
Clock Start/From:  
Clock To:  
1st Value:  
2nd Value:  
Value Percent:  
Continuous Index:  
Within 8" of Joint: **NO**  
Remarks:

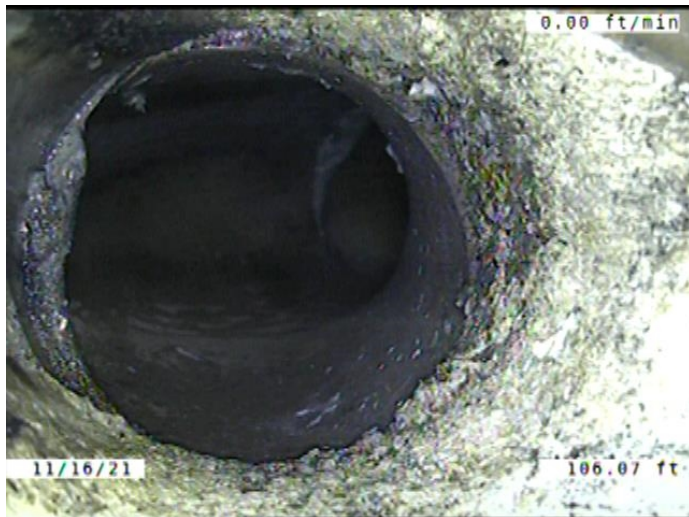
Code: **TFD**  
 Description: **Tap Factory Defective**

Distance (ft): **106.1**  
 Structural Grade: **0**  
 O&M Grade: **3**  
 Clock Start/From: **11**  
 Clock To:  
 1st Value: **4.000**  
 2nd Value:  
 Value Percent:  
 Continuous Index:  
 Within 8" of Joint: **YES**  
 Remarks: **ENCrustATION AROUND THE TAP. CONSTANTLY RUNNING WATER**

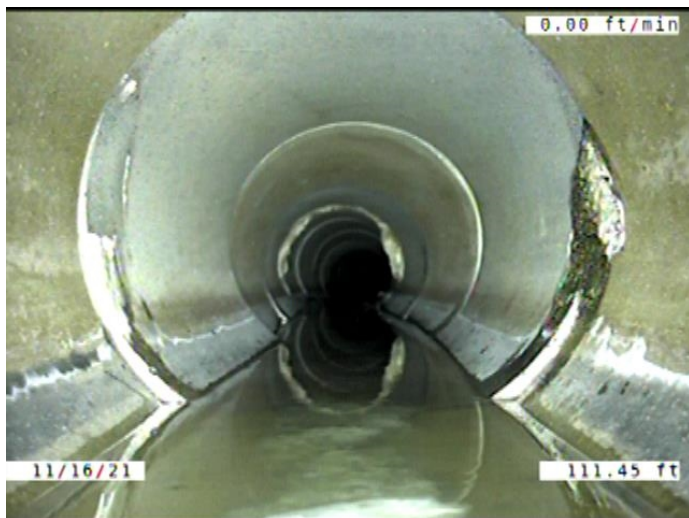
Code: **MWLS**  
 Description: **Miscellaneous Water Level Sag**

Distance (ft): **111.5**  
 Structural Grade: **2**  
 O&M Grade: **0**  
 Clock Start/From:  
 Clock To:  
 1st Value:  
 2nd Value:  
 Value Percent: **5.000**  
 Continuous Index: **S02**  
 Within 8" of Joint: **NO**  
 Remarks:

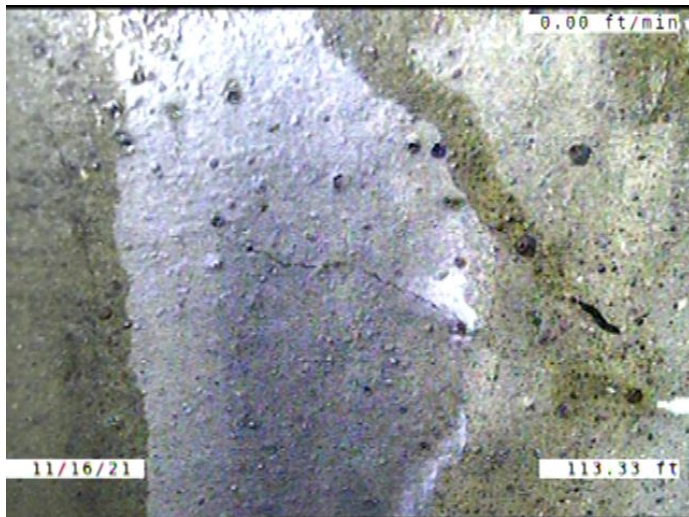
Code: **CM**  
 Description: **Crack Multiple**

Distance (ft): **113.3**  
 Structural Grade: **3**  
 O&M Grade: **0**  
 Clock Start/From: **8**  
 Clock To: **9**  
 1st Value:  
 2nd Value:  
 Value Percent:  
 Continuous Index:  
 Within 8" of Joint: **YES**  
 Remarks:

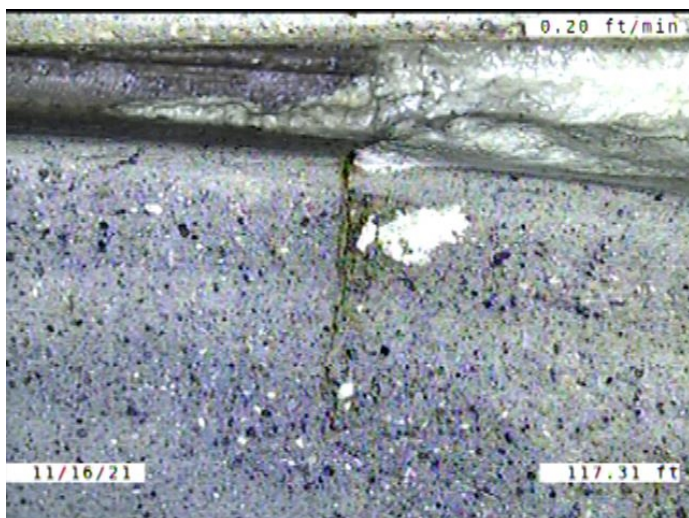
Code: **CL**  
 Description: **Crack Longitudinal**

Distance (ft): **117.3**  
 Structural Grade: **2**  
 O&M Grade: **0**  
 Clock Start/From: **2**  
 Clock To:  
 1st Value:  
 2nd Value:  
 Value Percent:  
 Continuous Index:  
 Within 8" of Joint: **YES**  
 Remarks:

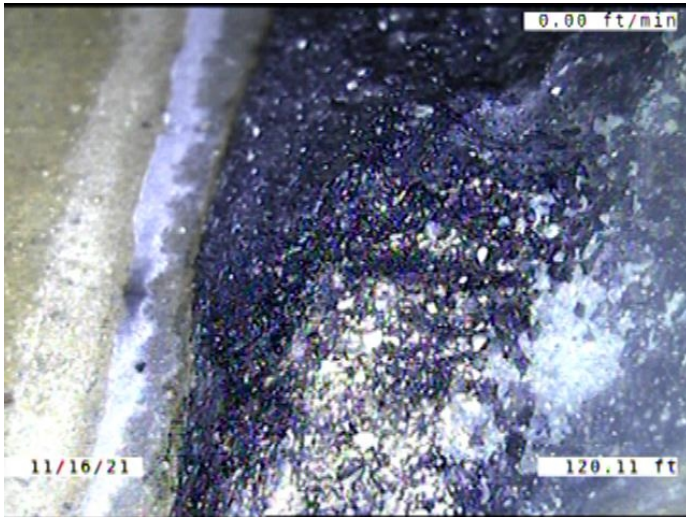
Code: **DAE**  
 Description: **Deposits Attached Encrustation**

Distance (ft): **120.1**  
 Structural Grade: **0**  
 O&M Grade: **2**  
 Clock Start/From: **4**  
 Clock To: **8**  
 1st Value:  
 2nd Value:  
 Value Percent: **5.000**  
 Continuous Index:  
 Within 8" of Joint: **YES**  
 Remarks:

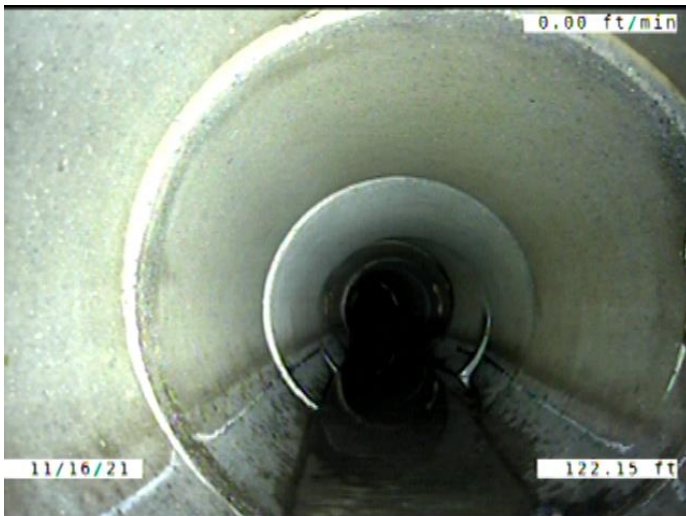
Code: **MWLS**  
 Description: **Miscellaneous Water Level Sag**

Distance (ft): **122.2**  
 Structural Grade: **2**  
 O&M Grade: **0**  
 Clock Start/From:  
 Clock To:  
 1st Value:  
 2nd Value:  
 Value Percent: **5.000**  
 Continuous Index: **F02**  
 Within 8" of Joint: **NO**  
 Remarks:

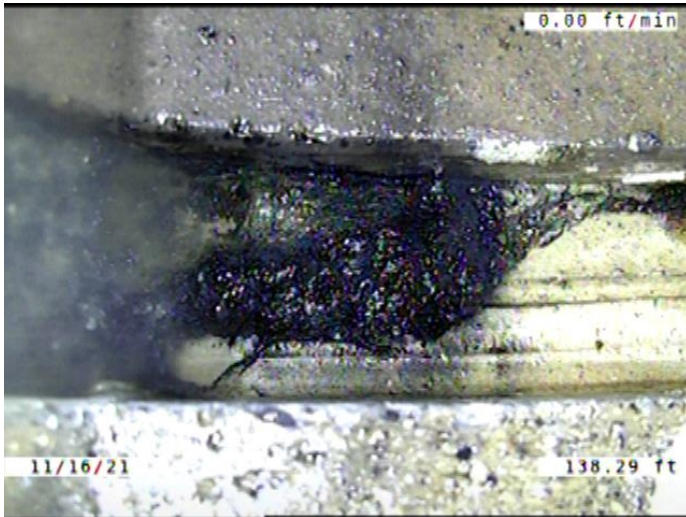
Code: **JAM**  
 Description: **Joint Angular Medium**

Distance (ft): **138.3**  
 Structural Grade: **3**  
 O&M Grade: **0**  
 Clock Start/From:  
 Clock To:  
 1st Value:  
 2nd Value:  
 Value Percent:  
 Continuous Index:  
 Within 8" of Joint: **NO**  
 Remarks:

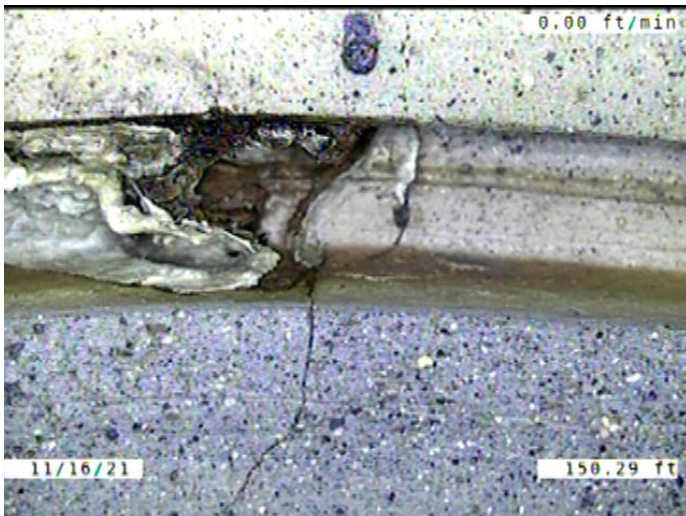
Code: **CM**  
 Description: **Crack Multiple**

Distance (ft): **150.3**  
 Structural Grade: **3**  
 O&M Grade: **0**  
 Clock Start/From: **11**  
 Clock To: **12**  
 1st Value:  
 2nd Value:  
 Value Percent:  
 Continuous Index:  
 Within 8" of Joint: **YES**  
 Remarks:

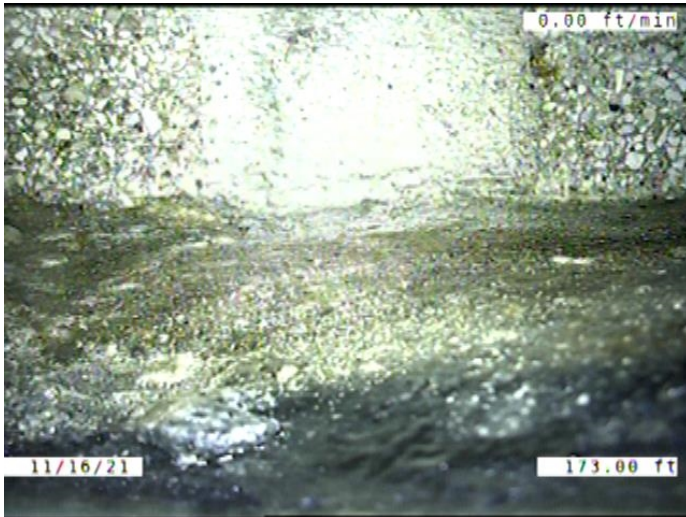
Code: **DAE**  
 Description: **Deposits Attached Encrustation**

Distance (ft): **173.0**  
 Structural Grade: **0**  
 O&M Grade: **2**  
 Clock Start/From: **7**  
 Clock To: **5**  
 1st Value:  
 2nd Value:  
 Value Percent: **5.000**  
 Continuous Index: **F01**  
 Within 8" of Joint: **YES**  
 Remarks:

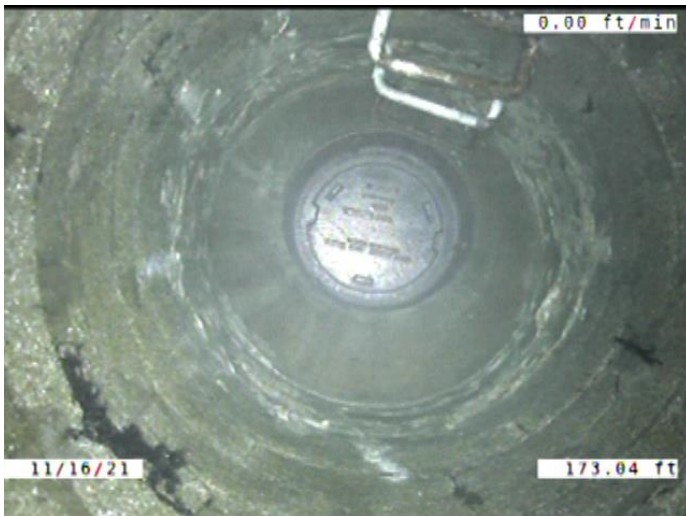
Code: **AMH**  
 Description: **Manhole**

Distance (ft): **173.0**  
 Structural Grade: **0**  
 O&M Grade: **0**  
 Clock Start/From:  
 Clock To:  
 1st Value:  
 2nd Value:  
 Value Percent:  
 Continuous Index:  
 Within 8" of Joint: **NO**  
 Remarks: **M-605-020**
