Profile/Photo Observation Report

Street:	HENRY ST	Flow Control:	Not Controlled
City:	Hobart, IN	Year Renewed:	
Location:	Other	Tape/Media #:	
Purpose:	Not Known	Dia/Height:	12"
Use:	Sanitary	Material:	VCP
Drain Area:	NA	Lining:	
Category:	NA		
Comment:	Flow direction wrong. Reverse setup.

Location Details:		Direction of Survey:	Upstream
US MH:	M-605-020	DS MH:	M-605-021
		Total Length Surveyed (ft):	45.6

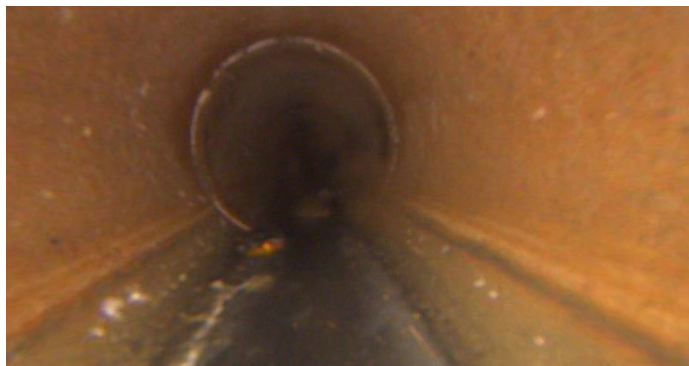
Code: **AMH**
Description: **Manhole**

Distance (ft): **.0**
Structural Grade: **0**
O&M Grade: **0**
Clock Start/From:
Clock To:
1st Value:
2nd Value:
Value Percent:
Continuous Index:
Within 8" of Joint: **NO**
Remarks: **M-605-021**

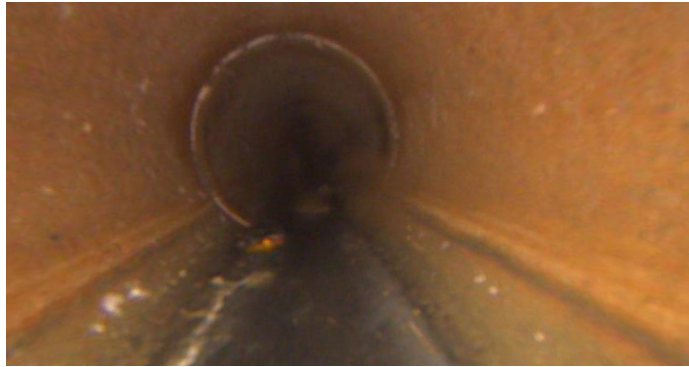
Code: **MWL**
Description: **Water Level**

Distance (ft): **.0**
Structural Grade: **0**
O&M Grade: **0**
Clock Start/From:
Clock To:
1st Value:
2nd Value:
Value Percent: **10.000**
Continuous Index:
Within 8" of Joint: **NO**
Remarks:

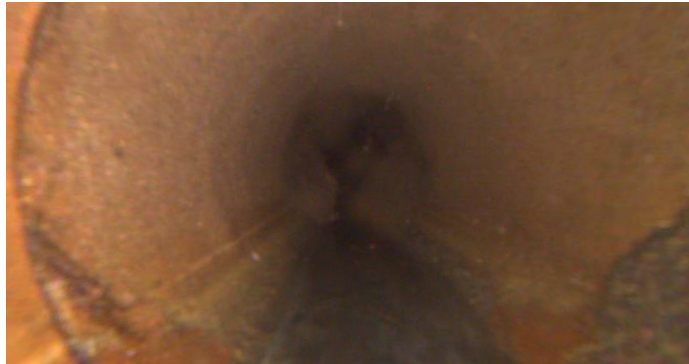
Code: **RFJ**
Description: **Roots Fine Joint**

Distance (ft): **4.0**
Structural Grade: **0**
O&M Grade: **1**
Clock Start/From: **7**
Clock To: **5**
1st Value:
2nd Value:
Value Percent:
Continuous Index: **S01**
Within 8" of Joint: **YES**
Remarks:

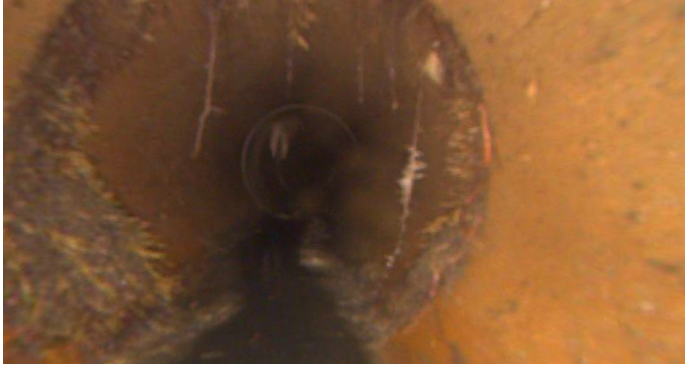
Code: **RFJ**
Description: **Roots Fine Joint**

Distance (ft): **13.5**
Structural Grade: **0**
O&M Grade: **1**
Clock Start/From: **7**
Clock To: **5**
1st Value:
2nd Value:
Value Percent:
Continuous Index: **F01**
Within 8" of Joint: **YES**
Remarks:

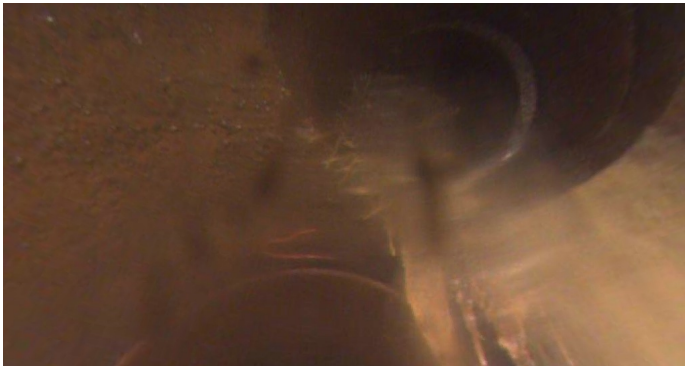
Code: **TFD**
Description: **Tap Factory Defective**

Distance (ft): **17.2**
Structural Grade: **0**
O&M Grade: **2**
Clock Start/From: **10**
Clock To:
1st Value: **4.000**
2nd Value:
Value Percent:
Continuous Index:
Within 8" of Joint:
Remarks: **RFL**

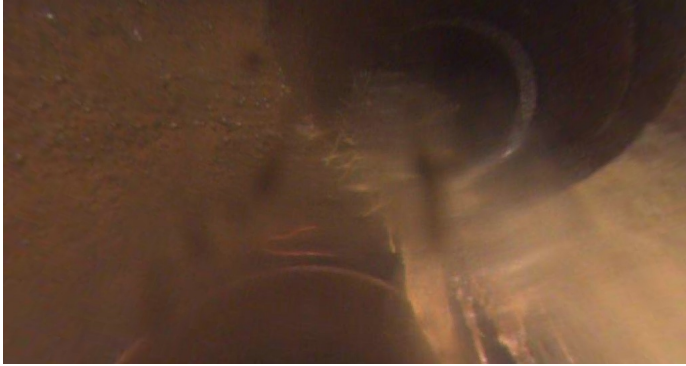
Code: **RFL**
Description: **Roots Fine Lateral**

Distance (ft): **17.2**
Structural Grade: **0**
O&M Grade: **1**
Clock Start/From: **10**
Clock To:
1st Value:
2nd Value:
Value Percent:
Continuous Index:
Within 8" of Joint: **NO**
Remarks:

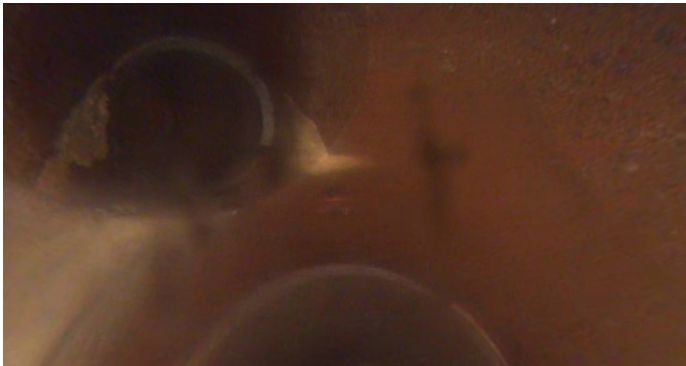
Code: **TF**
Description: **Tap Factory**

Distance (ft): **19.4**
Structural Grade: **0**
O&M Grade: **0**
Clock Start/From: **2**
Clock To:
1st Value: **4.000**
2nd Value:
Value Percent:
Continuous Index:
Within 8" of Joint:
Remarks:

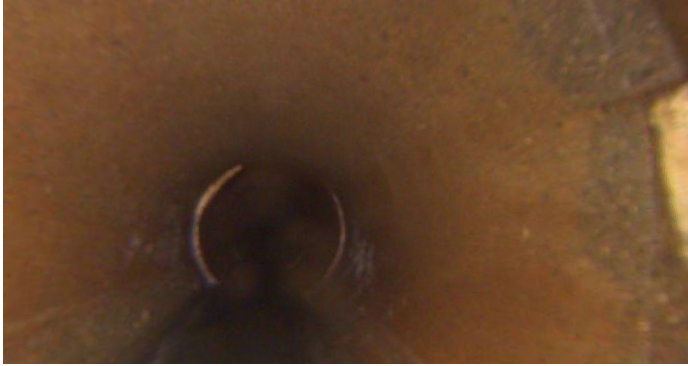
Code: **CL**
Description: **Crack Longitudinal**

Distance (ft): **32.2**
Structural Grade: **2**
O&M Grade: **0**
Clock Start/From: **3**
Clock To:
1st Value:
2nd Value:
Value Percent:
Continuous Index:
Within 8" of Joint: **YES**
Remarks:

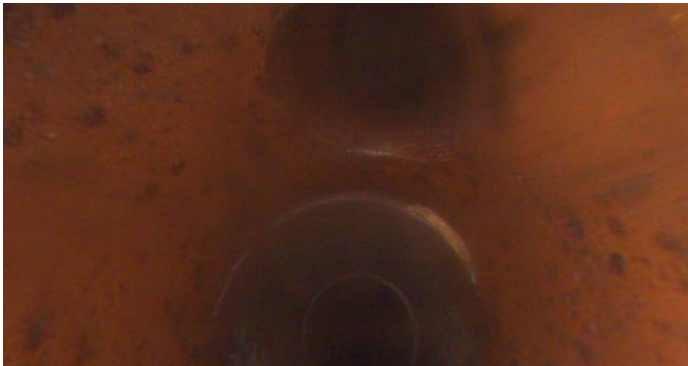
Code: **TF**
Description: **Tap Factory**

Distance (ft): **35.8**
Structural Grade: **0**
O&M Grade: **0**
Clock Start/From: **11**
Clock To:
1st Value: **4.000**
2nd Value:
Value Percent:
Continuous Index:
Within 8" of Joint:
Remarks:

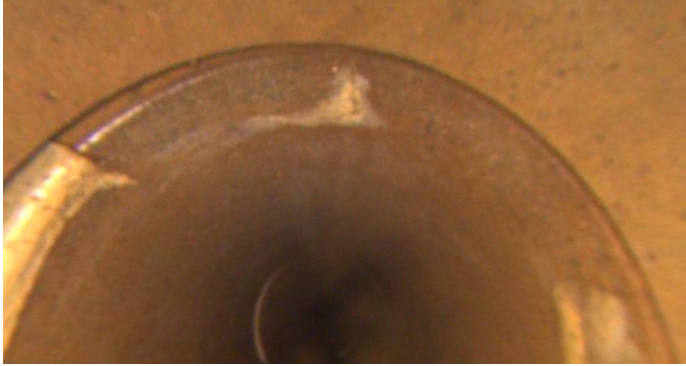
Code: **CM**
Description: **Crack Multiple**

Distance (ft): **44.1**
Structural Grade: **3**
O&M Grade: **0**
Clock Start/From: **8**
Clock To: **4**
1st Value:
2nd Value:
Value Percent:
Continuous Index:
Within 8" of Joint: **YES**
Remarks:

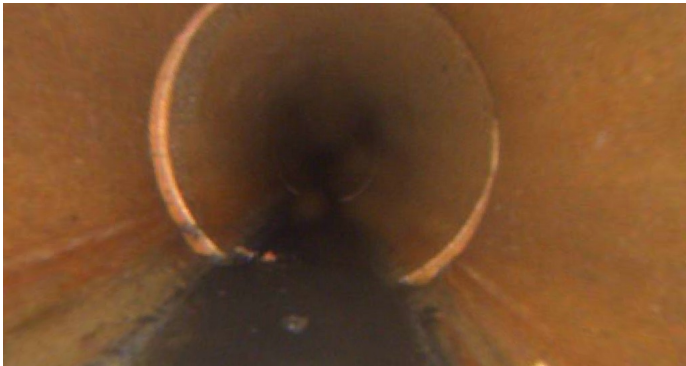
Code: **MSA**
Description: **Abandoned Survey**

Distance (ft): **45.6**
Structural Grade: **0**
O&M Grade: **0**
Clock Start/From:
Clock To:
1st Value:
2nd Value:
Value Percent:
Continuous Index:
Within 8" of Joint: **NO**
Remarks: **No blockage**
