Profile/Photo Observation Report

Street:	Henry	Flow Control:	Not Controlled
City:	Hobart, IN	Year Renewed:	
Location:	Other	Tape/Media #:	
Purpose:	Not Known	Dia/Height:	12"
Use:	Sanitary	Material:	VCP
Drain Area:	NA	Lining:	
Category:	NA		
Comment:	Flow direction wrong. Reverse setup.

Location Details:		Direction of Survey:	Upstream
US MH:	M-605-020	DS MH:	M-605-021
		Total Length Surveyed (ft):	45.6

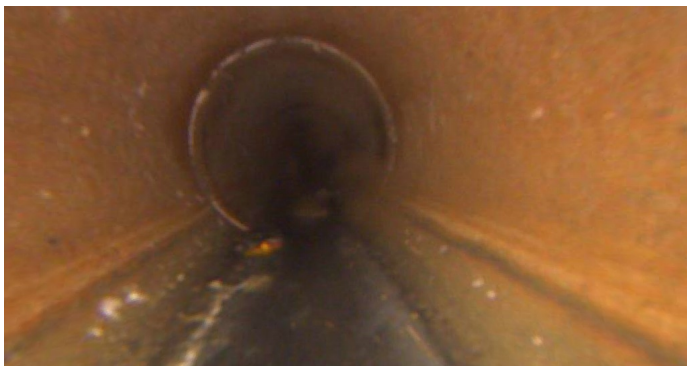
Code: **AMH**
Description: **Manhole**

Distance (ft): **.0**
Structural Grade: **0**
O&M Grade: **0**
Clock Start/From:
Clock To:
1st Value:
2nd Value:
Value Percent:
Continuous Index:
Within 8" of Joint: **NO**
Remarks: **M-605-021**

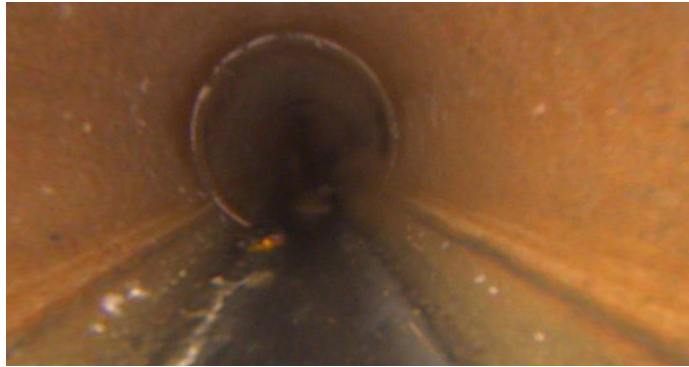
Code: **MWL**
Description: **Water Level**

Distance (ft): **.0**
Structural Grade: **0**
O&M Grade: **0**
Clock Start/From:
Clock To:
1st Value:
2nd Value:
Value Percent: **10.000**
Continuous Index:
Within 8" of Joint: **NO**
Remarks:

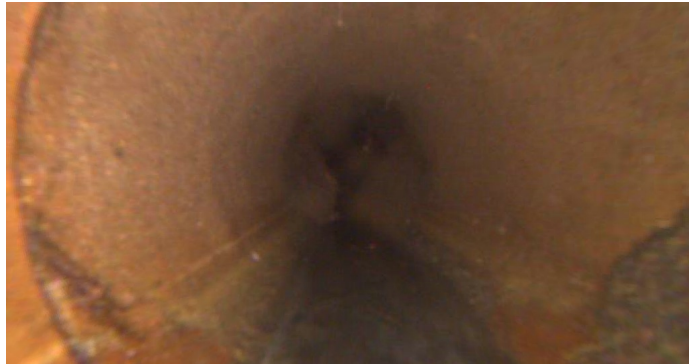
Code: **RFJ**
Description: **Roots Fine Joint**

Distance (ft): **4.0**
Structural Grade: **0**
O&M Grade: **1**
Clock Start/From: **7**
Clock To: **5**
1st Value:
2nd Value:
Value Percent:
Continuous Index: **S01**
Within 8" of Joint: **YES**
Remarks:

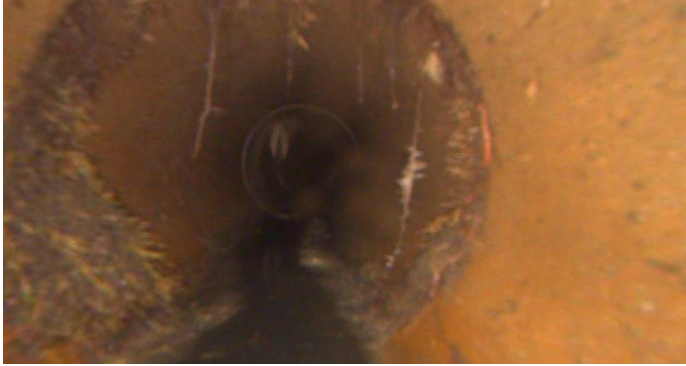
Code: **RFJ**
Description: **Roots Fine Joint**

Distance (ft): **13.5**
Structural Grade: **0**
O&M Grade: **1**
Clock Start/From: **7**
Clock To: **5**
1st Value:
2nd Value:
Value Percent:
Continuous Index: **F01**
Within 8" of Joint: **YES**
Remarks:

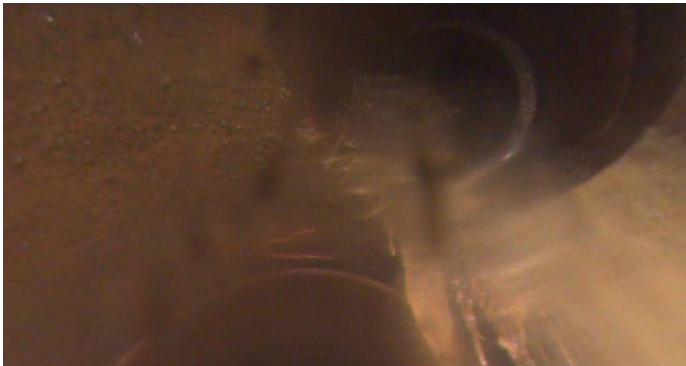
Code: **TFD**
Description: **Tap Factory Defective**

Distance (ft): **17.2**
Structural Grade: **0**
O&M Grade: **2**
Clock Start/From: **10**
Clock To:
1st Value: **4.000**
2nd Value:
Value Percent:
Continuous Index:
Within 8" of Joint:
Remarks: **RFL**

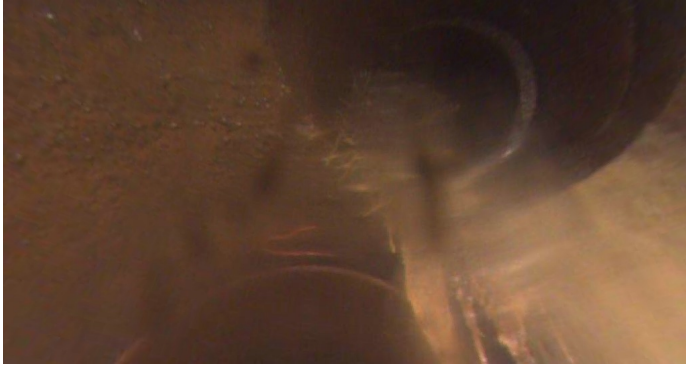
Code: **RFL**
Description: **Roots Fine Lateral**

Distance (ft): **17.2**
Structural Grade: **0**
O&M Grade: **1**
Clock Start/From: **10**
Clock To:
1st Value:
2nd Value:
Value Percent:
Continuous Index:
Within 8" of Joint: **NO**
Remarks:

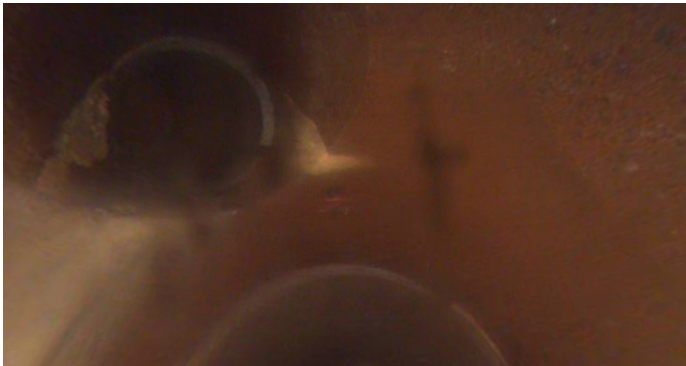
Code: **TF**
Description: **Tap Factory**

Distance (ft): **19.4**
Structural Grade: **0**
O&M Grade: **0**
Clock Start/From: **2**
Clock To:
1st Value: **4.000**
2nd Value:
Value Percent:
Continuous Index:
Within 8" of Joint:
Remarks:

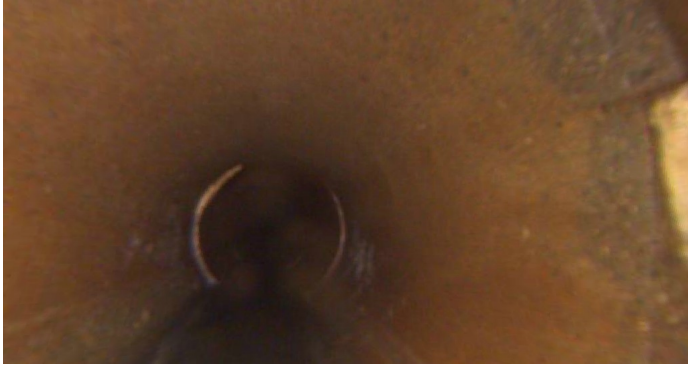
Code: **CL**
Description: **Crack Longitudinal**

Distance (ft): **32.2**
Structural Grade: **2**
O&M Grade: **0**
Clock Start/From: **3**
Clock To:
1st Value:
2nd Value:
Value Percent:
Continuous Index:
Within 8" of Joint: **YES**
Remarks:

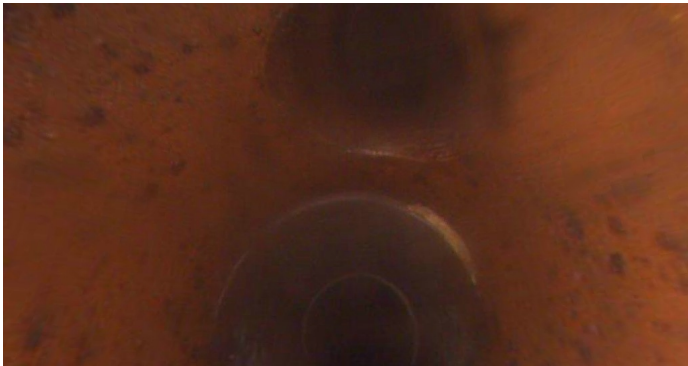
Code: **TF**
Description: **Tap Factory**

Distance (ft): **35.8**
Structural Grade: **0**
O&M Grade: **0**
Clock Start/From: **11**
Clock To:
1st Value: **4.000**
2nd Value:
Value Percent:
Continuous Index:
Within 8" of Joint:
Remarks:

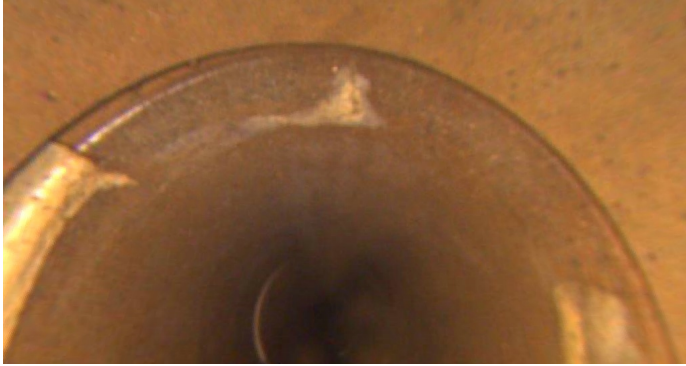
Code: **CM**
Description: **Crack Multiple**

Distance (ft): **44.1**
Structural Grade: **3**
O&M Grade: **0**
Clock Start/From: **8**
Clock To: **4**
1st Value:
2nd Value:
Value Percent:
Continuous Index:
Within 8" of Joint: **YES**
Remarks:

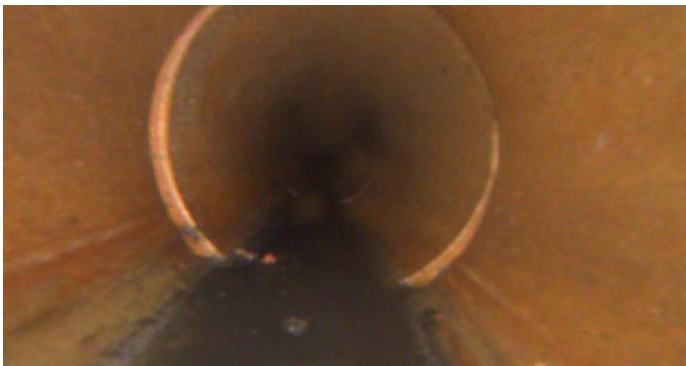
Code: **MSA**
Description: **Abandoned Survey**

Distance (ft): **45.6**
Structural Grade: **0**
O&M Grade: **0**
Clock Start/From:
Clock To:
1st Value:
2nd Value:
Value Percent:
Continuous Index:
Within 8" of Joint: **NO**
Remarks: **No blockage**
