Profile/Photo Observation Report

Date:	04/26/2018	Weather:		Coding:	PACP 6.0
Pipe Length (ft):	190.2	Owner:	NA	Pre Clean:	Not Known
P.O.#:		Surveyor:	Mark Ruby	PSR:	P-605-021-020
Customer:		Clean Date:	01/01/1900	Shape:	C

Street:	HENRY ST	Flow Control:	Not Controlled
City:	Hobart, IN	Year Renewed:	
Location:	Other	Tape/Media #:	
Purpose:	Not Known	Dia/Height:	12"
Use:	Sanitary	Material:	VCP
Drain Area:	NA	Lining:	
Category:	NA		
Comment:	Flow direction wrong. Debris at 127'.

Location Details:		Direction of Survey:	Downstream
US MH:	M-605-020	DS MH:	M-605-021
		Total Length Surveyed (ft):	128.8

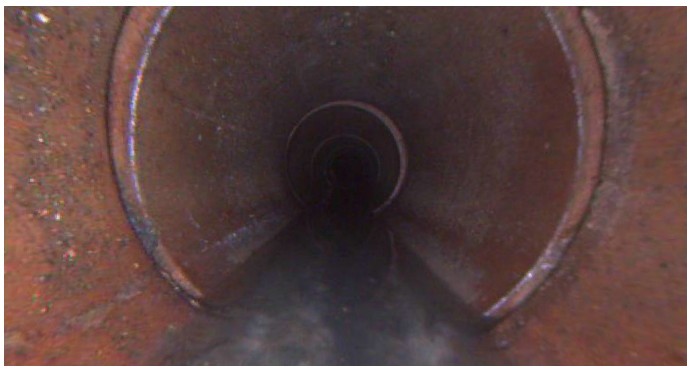
Code: **AMH**
 Description: **Manhole**

Distance (ft): **.0**
 Structural Grade: **0**
 O&M Grade: **0**
 Clock Start/From:
 Clock To:
 1st Value:
 2nd Value:
 Value Percent:
 Continuous Index:
 Within 8" of Joint: **NO**
 Remarks: **M-605-020**

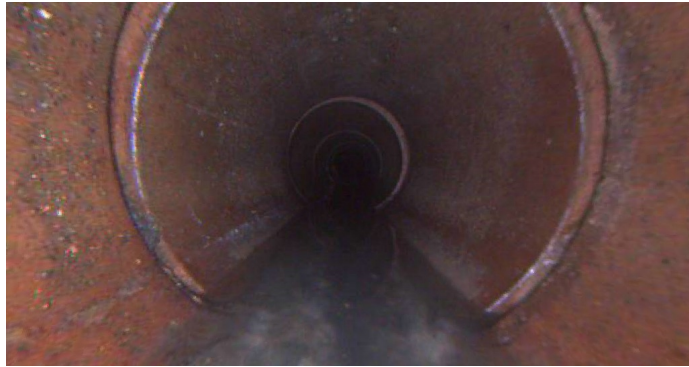
Code: **MWL**
Description: **Water Level**

Distance (ft): **.0**
Structural Grade: **0**
O&M Grade: **0**
Clock Start/From:
Clock To:
1st Value:
2nd Value:
Value Percent: **10.000**
Continuous Index:
Within 8" of Joint: **NO**
Remarks:

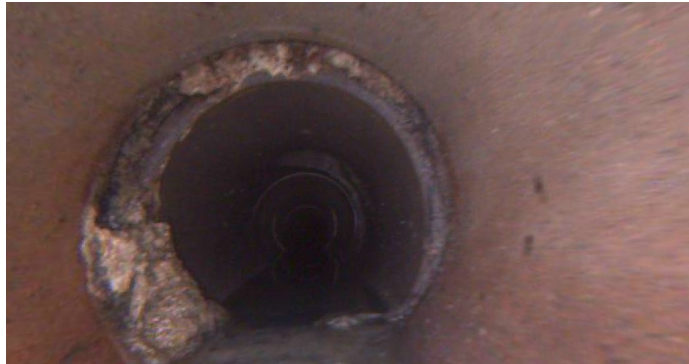
Code: **DAZ**
Description: **Deposits Attached Other**

Distance (ft): **9.0**
Structural Grade: **0**
O&M Grade: **2**
Clock Start/From: **7**
Clock To: **3**
1st Value:
2nd Value:
Value Percent: **5.000**
Continuous Index:
Within 8" of Joint: **YES**
Remarks:

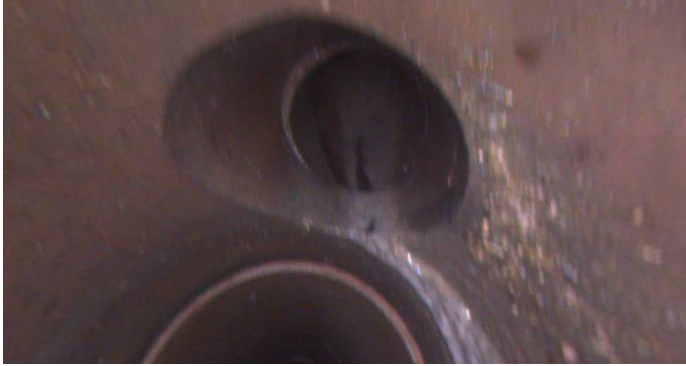
Code: **TF**
Description: **Tap Factory**

Distance (ft): **10.9**
Structural Grade: **0**
O&M Grade: **0**
Clock Start/From: **1**
Clock To:
1st Value: **4.000**
2nd Value:
Value Percent:
Continuous Index:
Within 8" of Joint:
Remarks:

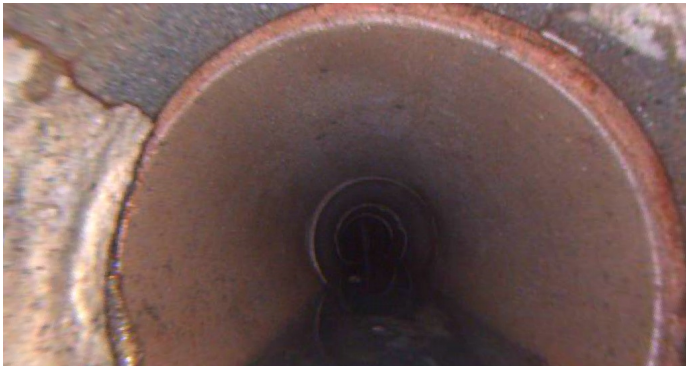
Code: **CL**
Description: **Crack Longitudinal**

Distance (ft): **24.3**
Structural Grade: **2**
O&M Grade: **0**
Clock Start/From: **2**
Clock To:
1st Value:
2nd Value:
Value Percent:
Continuous Index:
Within 8" of Joint: **YES**
Remarks:

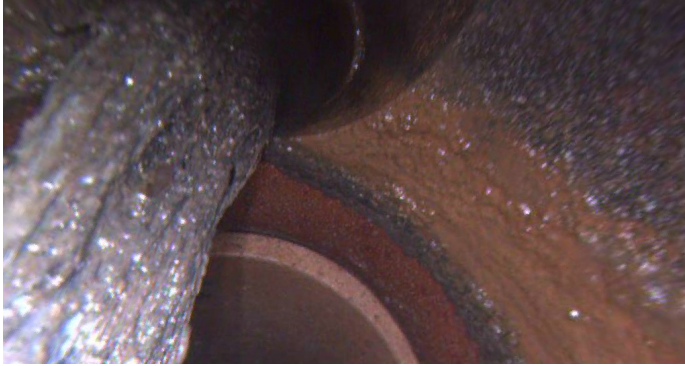
Code: **TFD**
Description: **Tap Factory Defective**

Distance (ft): **32.4**
Structural Grade: **0**
O&M Grade: **2**
Clock Start/From: **1**
Clock To:
1st Value: **4.000**
2nd Value:
Value Percent:
Continuous Index:
Within 8" of Joint:
Remarks: **RML**

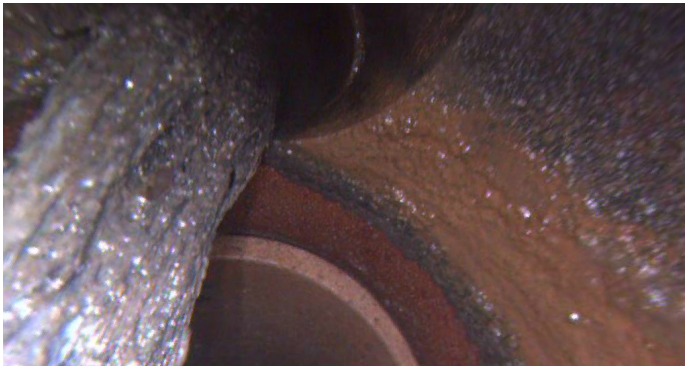
Code: **RML**
Description: **Roots Medium Lateral**

Distance (ft): **32.4**
Structural Grade: **0**
O&M Grade: **3**
Clock Start/From: **1**
Clock To:
1st Value:
2nd Value:
Value Percent: **10.000**
Continuous Index:
Within 8" of Joint: **NO**
Remarks:

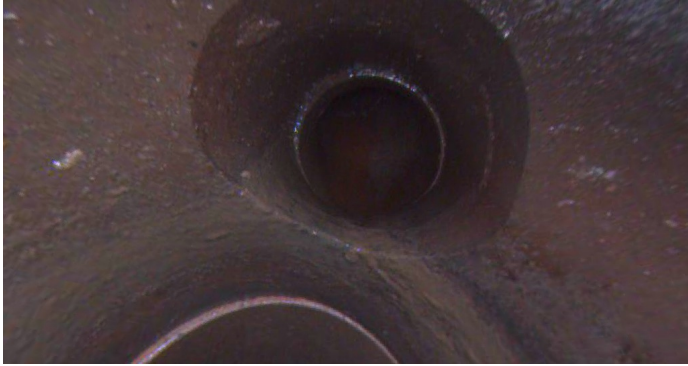
Code: **TF**
Description: **Tap Factory**

Distance (ft): **51.2**
Structural Grade: **0**
O&M Grade: **0**
Clock Start/From: **1**
Clock To:
1st Value: **4.000**
2nd Value:
Value Percent:
Continuous Index:
Within 8" of Joint:
Remarks:

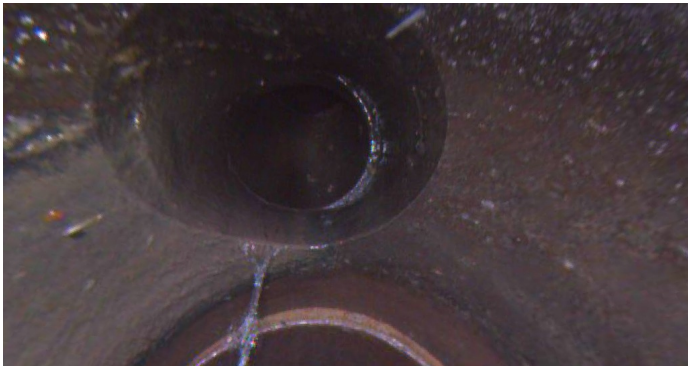
Code: **TFA**
Description: **Tap Factory Active**

Distance (ft): **72.3**
Structural Grade: **0**
O&M Grade: **0**
Clock Start/From: **12**
Clock To:
1st Value: **4.000**
2nd Value:
Value Percent:
Continuous Index:
Within 8" of Joint:
Remarks:

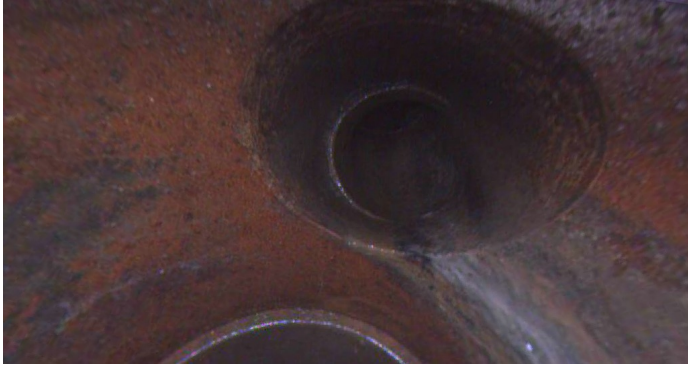
Code: **TF**
Description: **Tap Factory**

Distance (ft): **74.4**
Structural Grade: **0**
O&M Grade: **0**
Clock Start/From: **1**
Clock To:
1st Value: **4.000**
2nd Value:
Value Percent:
Continuous Index:
Within 8" of Joint:
Remarks:

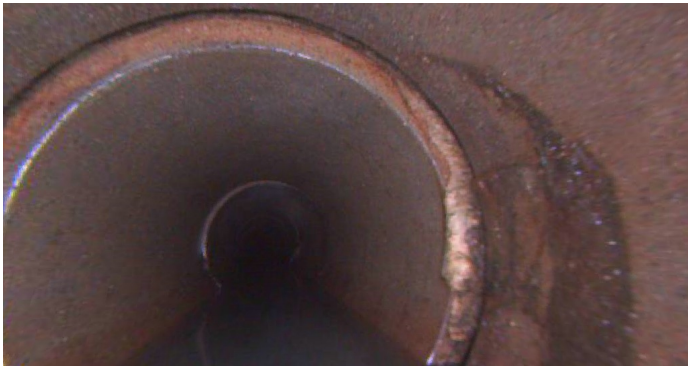
Code: **CM**
Description: **Crack Multiple**

Distance (ft): **91.2**
Structural Grade: **3**
O&M Grade: **0**
Clock Start/From: **1**
Clock To: **4**
1st Value:
2nd Value:
Value Percent:
Continuous Index:
Within 8" of Joint: **YES**
Remarks:

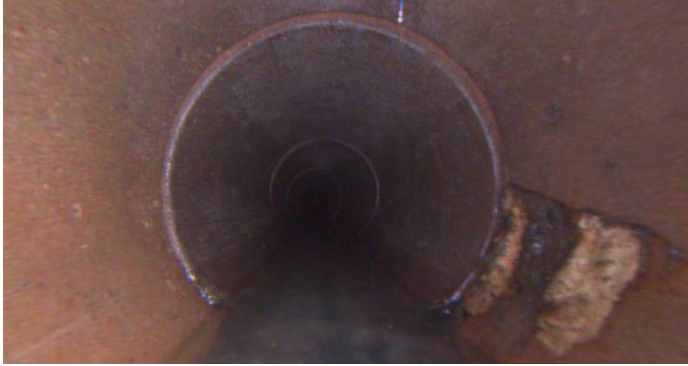
Code: **CL**
Description: **Crack Longitudinal**

Distance (ft): **95.3**
Structural Grade: **2**
O&M Grade: **0**
Clock Start/From: **4**
Clock To:
1st Value:
2nd Value:
Value Percent:
Continuous Index:
Within 8" of Joint: **YES**
Remarks:

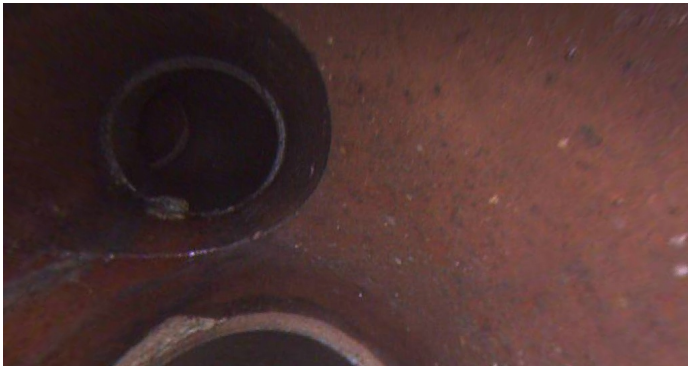
Code: **TF**
Description: **Tap Factory**

Distance (ft): **111.9**
Structural Grade: **0**
O&M Grade: **0**
Clock Start/From: **11**
Clock To:
1st Value: **4.000**
2nd Value:
Value Percent:
Continuous Index:
Within 8" of Joint:
Remarks:

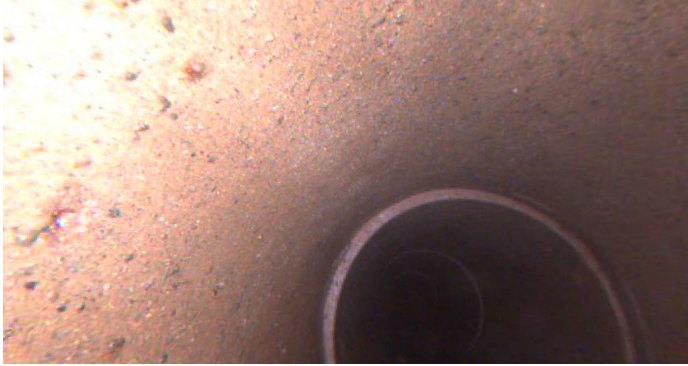
Code:	MSA
Description:	Abandoned Survey
Distance (ft):	128.8
Structural Grade:	0
O&M Grade:	0
Clock Start/From:	
Clock To:	
1st Value:	
2nd Value:	
Value Percent:	
Continuous Index:	
Within 8" of Joint:	NO
Remarks:	Debris
