Profile/Photo Observation Report

Street:	Henry	Flow Control:	Not Controlled
City:	Hobart, IN	Year Renewed:	
Location:	Other	Tape/Media #:	
Purpose:	Not Known	Dia/Height:	12"
Use:	Sanitary	Material:	VCP
Drain Area:	NA	Lining:	
Category:	NA		
Comment:	Flow direction wrong. Debris at 127'.

Location Details:		Direction of Survey:	Downstream
US MH:	M-605-020	DS MH:	M-605-021
		Total Length Surveyed (ft):	128.8

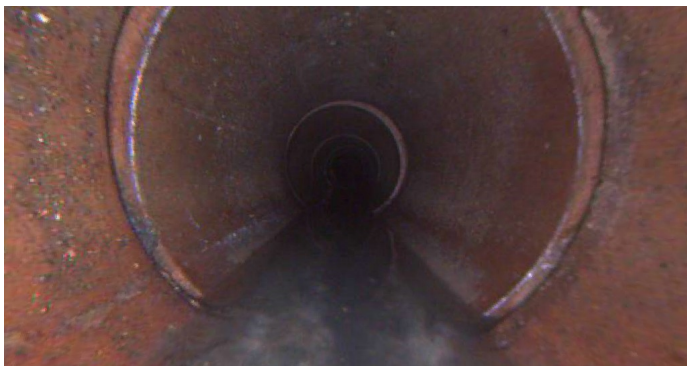
Code: **AMH**
 Description: **Manhole**

Distance (ft): **.0**
 Structural Grade: **0**
 O&M Grade: **0**
 Clock Start/From:
 Clock To:
 1st Value:
 2nd Value:
 Value Percent:
 Continuous Index:
 Within 8" of Joint: **NO**
 Remarks: **M-605-020**

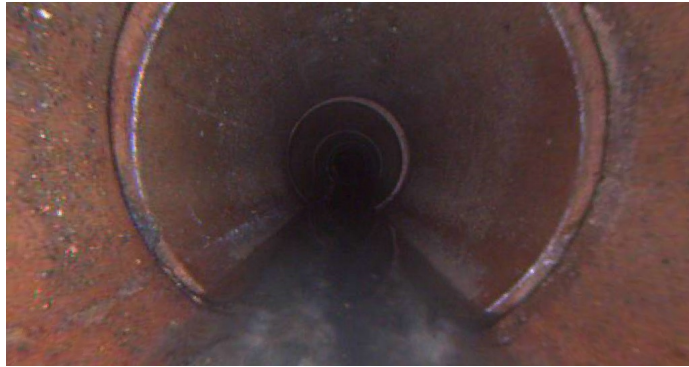
Code: **MWL**
Description: **Water Level**

Distance (ft): **.0**
Structural Grade: **0**
O&M Grade: **0**
Clock Start/From:
Clock To:
1st Value:
2nd Value:
Value Percent: **10.000**
Continuous Index:
Within 8" of Joint: **NO**
Remarks:

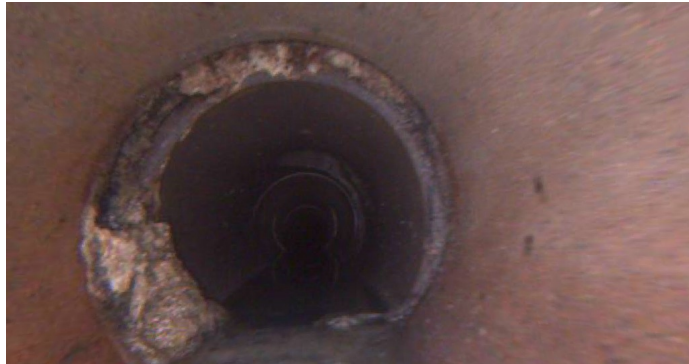
Code: **DAZ**
Description: **Deposits Attached Other**

Distance (ft): **9.0**
Structural Grade: **0**
O&M Grade: **2**
Clock Start/From: **7**
Clock To: **3**
1st Value:
2nd Value:
Value Percent: **5.000**
Continuous Index:
Within 8" of Joint: **YES**
Remarks:

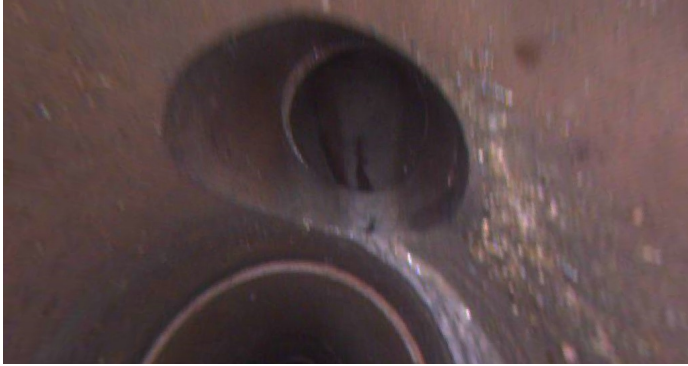
Code: **TF**
Description: **Tap Factory**

Distance (ft): **10.9**
Structural Grade: **0**
O&M Grade: **0**
Clock Start/From: **1**
Clock To:
1st Value: **4.000**
2nd Value:
Value Percent:
Continuous Index:
Within 8" of Joint:
Remarks:

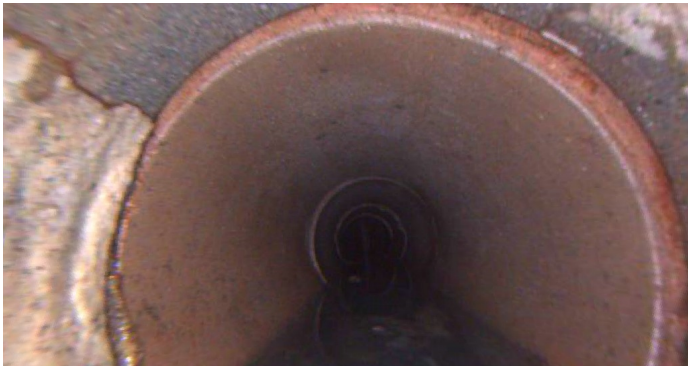
Code: **CL**
Description: **Crack Longitudinal**

Distance (ft): **24.3**
Structural Grade: **2**
O&M Grade: **0**
Clock Start/From: **2**
Clock To:
1st Value:
2nd Value:
Value Percent:
Continuous Index:
Within 8" of Joint: **YES**
Remarks:

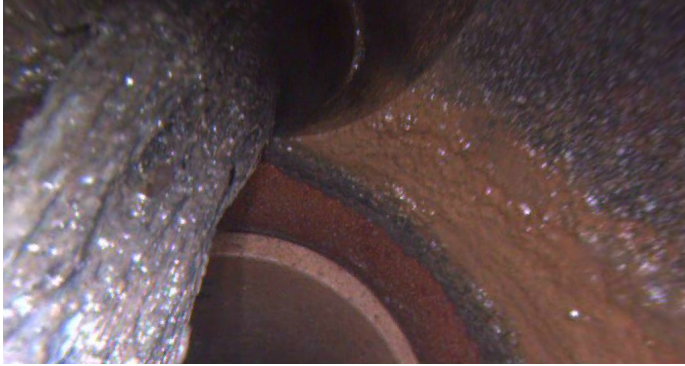
Code: **TFD**
Description: **Tap Factory Defective**

Distance (ft): **32.4**
Structural Grade: **0**
O&M Grade: **2**
Clock Start/From: **1**
Clock To:
1st Value: **4.000**
2nd Value:
Value Percent:
Continuous Index:
Within 8" of Joint:
Remarks: **RML**

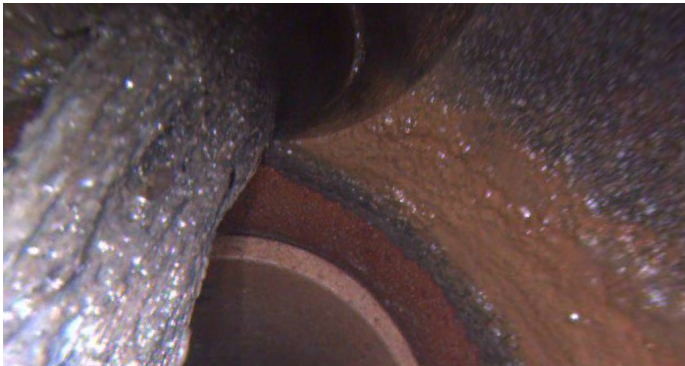
Code: **RML**
Description: **Roots Medium Lateral**

Distance (ft): **32.4**
Structural Grade: **0**
O&M Grade: **3**
Clock Start/From: **1**
Clock To:
1st Value:
2nd Value:
Value Percent: **10.000**
Continuous Index:
Within 8" of Joint: **NO**
Remarks:

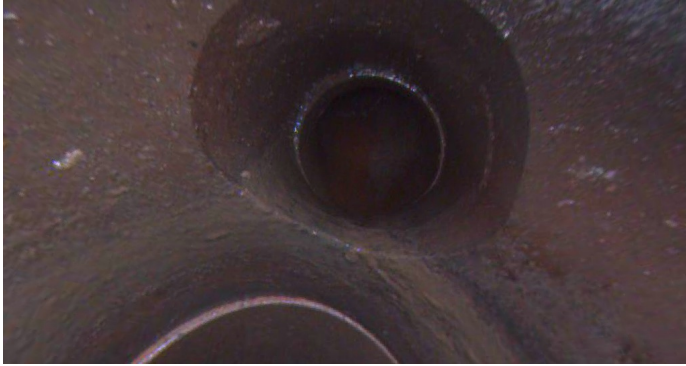
Code: **TF**
Description: **Tap Factory**

Distance (ft): **51.2**
Structural Grade: **0**
O&M Grade: **0**
Clock Start/From: **1**
Clock To:
1st Value: **4.000**
2nd Value:
Value Percent:
Continuous Index:
Within 8" of Joint:
Remarks:

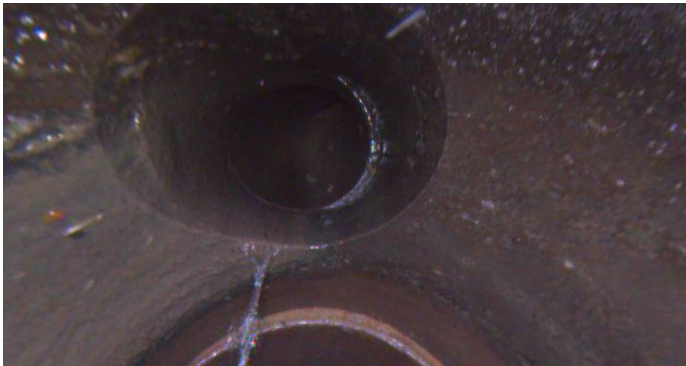
Code: **TFA**
Description: **Tap Factory Active**

Distance (ft): **72.3**
Structural Grade: **0**
O&M Grade: **0**
Clock Start/From: **12**
Clock To:
1st Value: **4.000**
2nd Value:
Value Percent:
Continuous Index:
Within 8" of Joint:
Remarks:

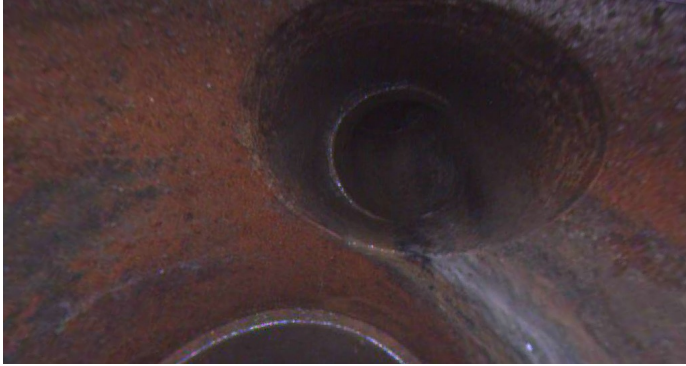
Code: **TF**
Description: **Tap Factory**

Distance (ft): **74.4**
Structural Grade: **0**
O&M Grade: **0**
Clock Start/From: **1**
Clock To:
1st Value: **4.000**
2nd Value:
Value Percent:
Continuous Index:
Within 8" of Joint:
Remarks:

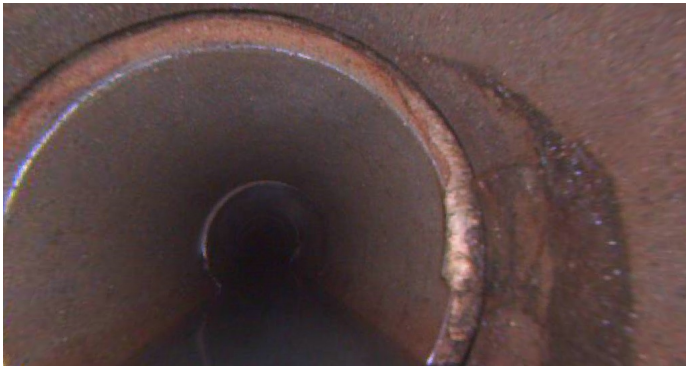
Code: **CM**
Description: **Crack Multiple**

Distance (ft): **91.2**
Structural Grade: **3**
O&M Grade: **0**
Clock Start/From: **1**
Clock To: **4**
1st Value:
2nd Value:
Value Percent:
Continuous Index:
Within 8" of Joint: **YES**
Remarks:

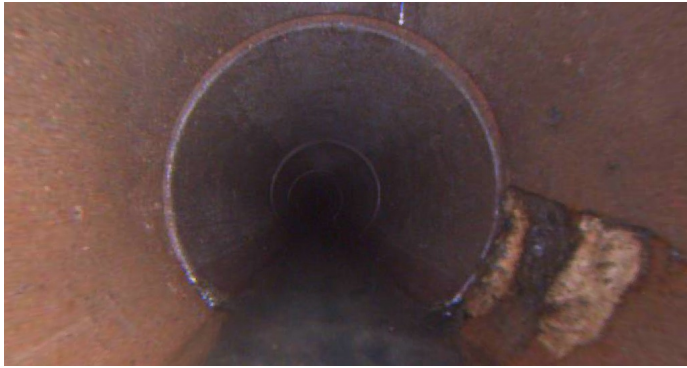
Code: **CL**
Description: **Crack Longitudinal**

Distance (ft): **95.3**
Structural Grade: **2**
O&M Grade: **0**
Clock Start/From: **4**
Clock To:
1st Value:
2nd Value:
Value Percent:
Continuous Index:
Within 8" of Joint: **YES**
Remarks:

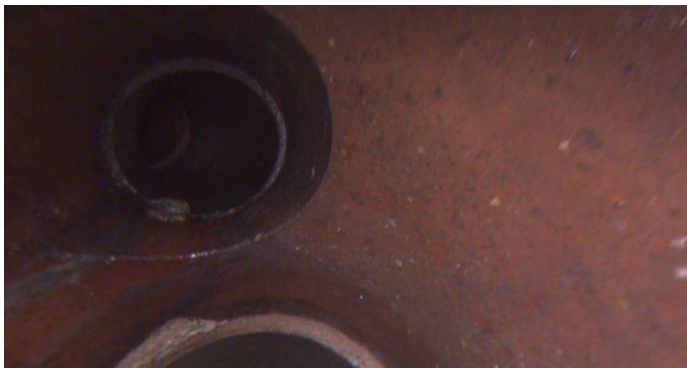
Code: **TF**
Description: **Tap Factory**

Distance (ft): **111.9**
Structural Grade: **0**
O&M Grade: **0**
Clock Start/From: **11**
Clock To:
1st Value: **4.000**
2nd Value:
Value Percent:
Continuous Index:
Within 8" of Joint:
Remarks:

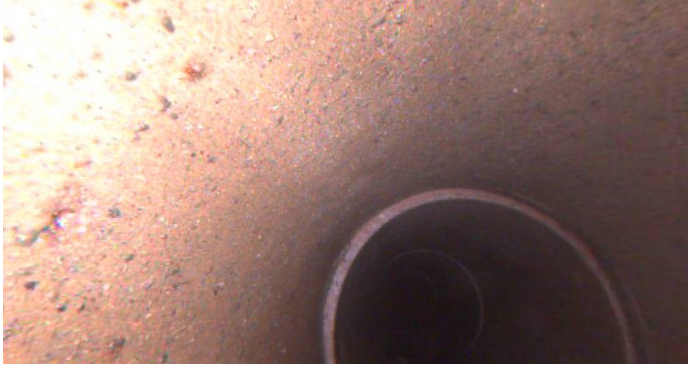
Code:	MSA
Description:	Abandoned Survey
Distance (ft):	128.8
Structural Grade:	0
O&M Grade:	0
Clock Start/From:	
Clock To:	
1st Value:	
2nd Value:	
Value Percent:	
Continuous Index:	
Within 8" of Joint:	NO
Remarks:	Debris
