Street:	Henry Street		Flow Control:	Not Controlled	
City:	City of Hobart		Year Renewed:		
Location:	Local rural streets with light traffic, t		Tape/Media #:		
Purpose:	Routine Assessment		Dia/Height:	12"	
Use:	Sanitary Sewage Pipe		Material:	VCP	
Drain Area:			Lining:	None	
Category:	NA				
Comment:					
Location Details:			Direction of Survey:	Downstream	
US MH:	M-605-021	DS MH:	M-605-023	Total Length Surveyed (ft):	175.7

Tuesday, April 25, 2023

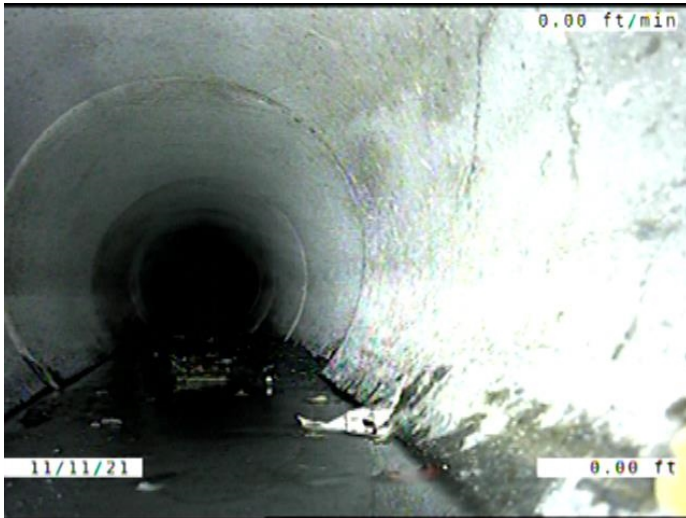
Code: **DSF**
Description: **Deposits Settled Fine**

Distance (ft): **.0**
Structural Grade: **0**
O&M Grade: **2**
Clock Start/From: **5**
Clock To: **7**
1st Value:
2nd Value:
Value Percent: **5.000**
Continuous Index: **S01**
Within 8" of Joint: **YES**
Remarks:

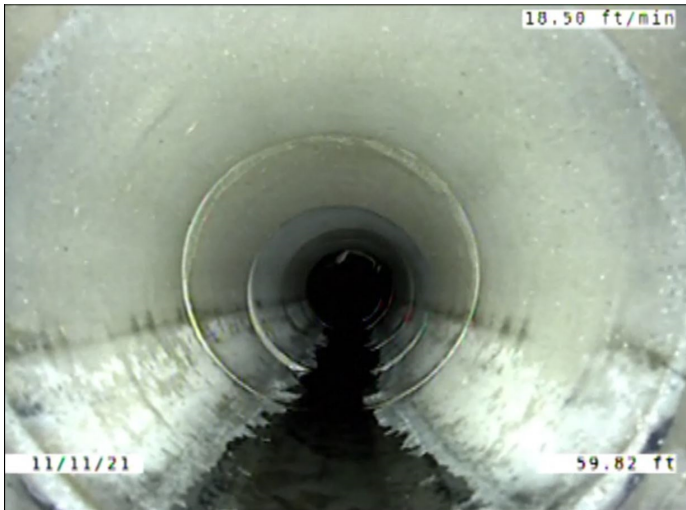
Code: **CL**
Description: **Crack Longitudinal**

Distance (ft): **59.8**
Structural Grade: **2**
O&M Grade: **0**
Clock Start/From: **3**
Clock To:
1st Value:
2nd Value:
Value Percent:
Continuous Index:
Within 8" of Joint: **YES**
Remarks:

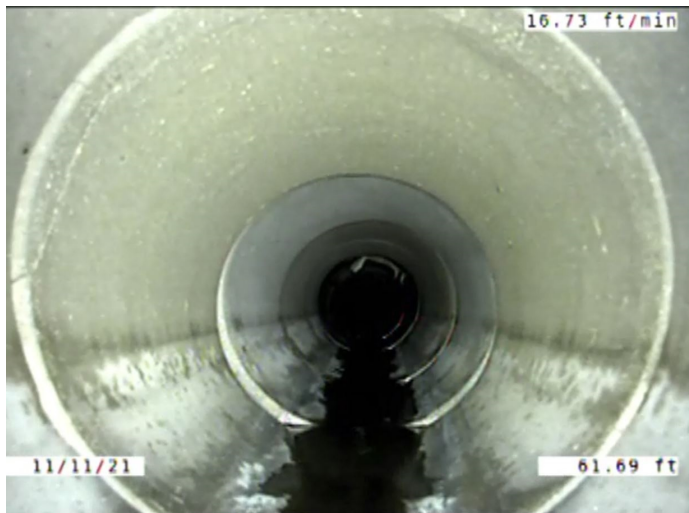
Code: **CC**
Description: **Crack Circumferential**

Distance (ft): **61.7**
Structural Grade: **1**
O&M Grade: **0**
Clock Start/From: **9**
Clock To: **12**
1st Value:
2nd Value:
Value Percent:
Continuous Index:
Within 8" of Joint: **YES**
Remarks:

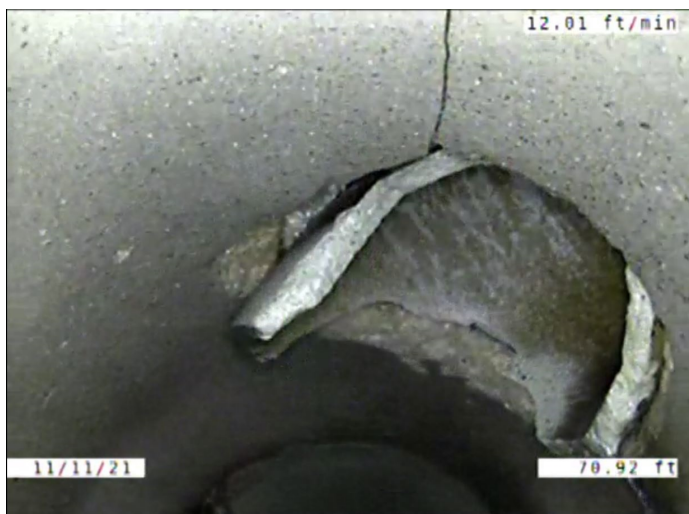
Code: **FM**
Description: **Fracture Multiple**

Distance (ft): **70.9**
Structural Grade: **4**
O&M Grade: **0**
Clock Start/From: **12**
Clock To: **2**
1st Value:
2nd Value:
Value Percent:
Continuous Index:
Within 8" of Joint: **YES**
Remarks:

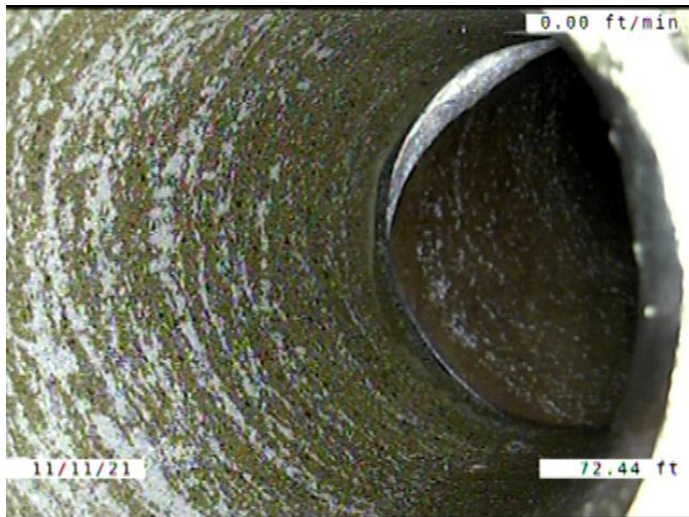
Code: **TBI**
 Description: **Tap Break-in Intruding**

Distance (ft): **72.4**
 Structural Grade: **0**
 O&M Grade: **2**
 Clock Start/From: **1**
 Clock To:
 1st Value: **4.000**
 2nd Value: **2.000**
 Value Percent:
 Continuous Index:
 Within 8" of Joint: **YES**
 Remarks:

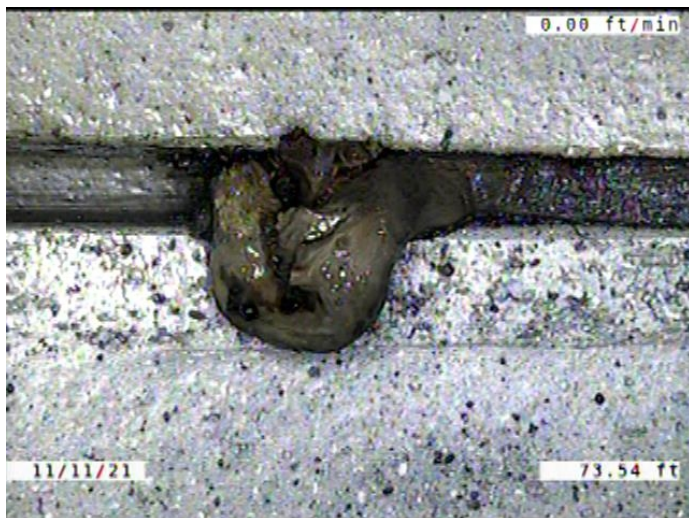
Code: **RTJ**
 Description: **Roots Tap Joint**

Distance (ft): **73.5**
 Structural Grade: **0**
 O&M Grade: **2**
 Clock Start/From: **10**
 Clock To: **1**
 1st Value:
 2nd Value:
 Value Percent: **5.000**
 Continuous Index:
 Within 8" of Joint: **YES**
 Remarks:

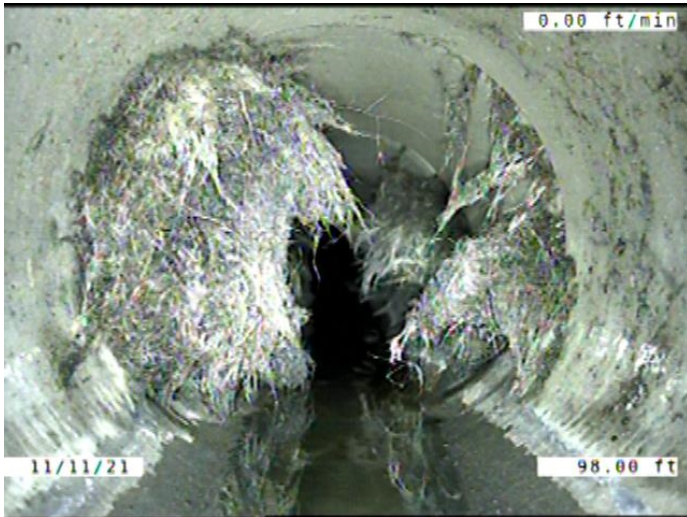
Code: **RMJ**
 Description: **Roots Medium Joint**

Distance (ft): **98.0**
 Structural Grade: **0**
 O&M Grade: **3**
 Clock Start/From: **7**
 Clock To: **4**
 1st Value:
 2nd Value:
 Value Percent: **50.000**
 Continuous Index:
 Within 8" of Joint: **YES**
 Remarks:

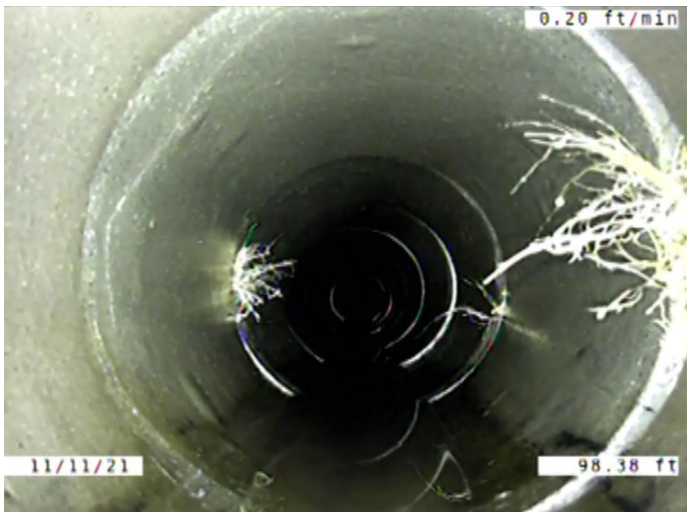
Code: **CC**
 Description: **Crack Circumferential**

Distance (ft): **98.4**
 Structural Grade: **1**
 O&M Grade: **0**
 Clock Start/From: **9**
 Clock To: **12**
 1st Value:
 2nd Value:
 Value Percent:
 Continuous Index:
 Within 8" of Joint: **YES**
 Remarks:

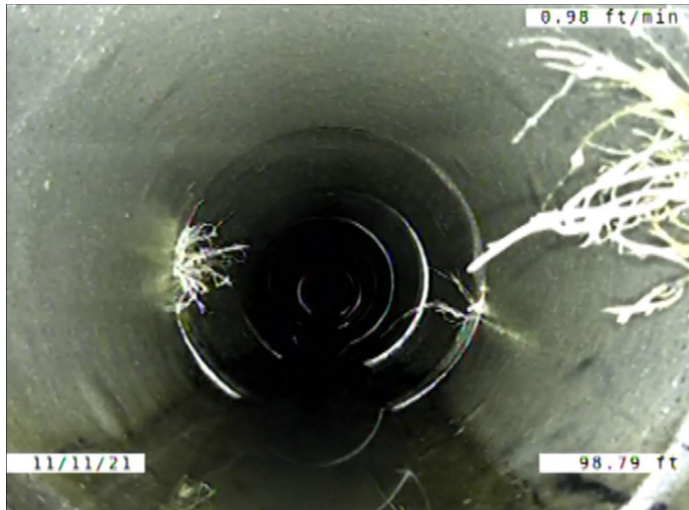
Code: **CL**
 Description: **Crack Longitudinal**

Distance (ft): **98.8**
 Structural Grade: **2**
 O&M Grade: **0**
 Clock Start/From: **4**
 Clock To:
 1st Value:
 2nd Value:
 Value Percent:
 Continuous Index:
 Within 8" of Joint: **YES**
 Remarks:

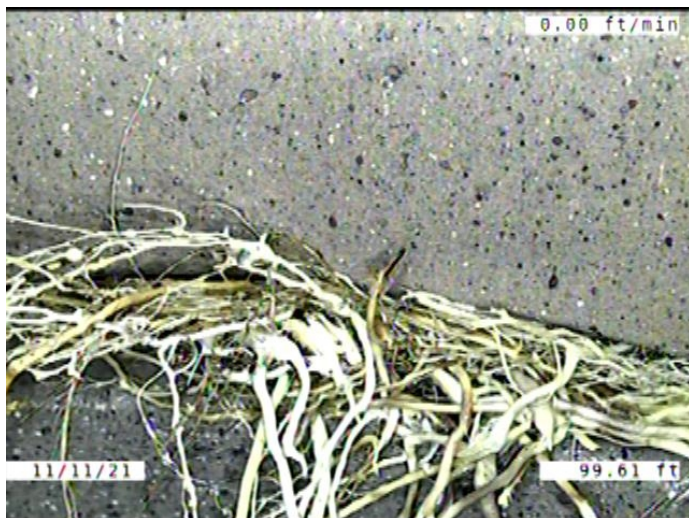
Code: **RMJ**
 Description: **Roots Medium Joint**

Distance (ft): **99.6**
 Structural Grade: **0**
 O&M Grade: **3**
 Clock Start/From: **1**
 Clock To: **4**
 1st Value:
 2nd Value:
 Value Percent: **5.000**
 Continuous Index:
 Within 8" of Joint: **YES**
 Remarks:

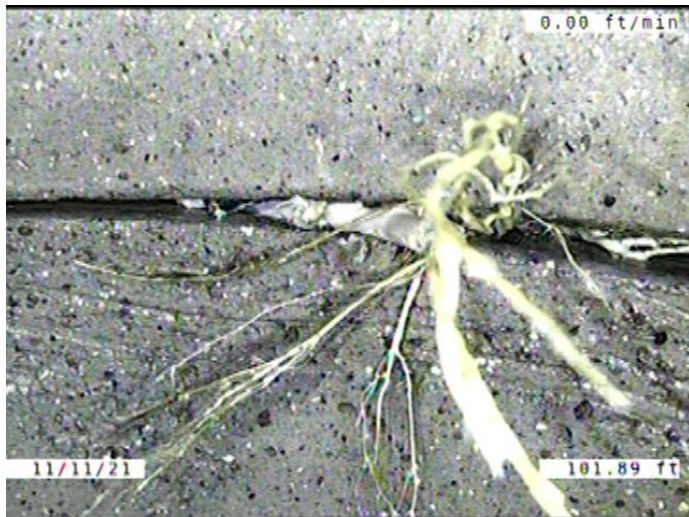
Code: **RFJ**
Description: **Roots Fine Joint**

Distance (ft): **101.9**
Structural Grade: **0**
O&M Grade: **1**
Clock Start/From: **2**
Clock To: **3**
1st Value:
2nd Value:
Value Percent:
Continuous Index:
Within 8" of Joint: **YES**
Remarks:

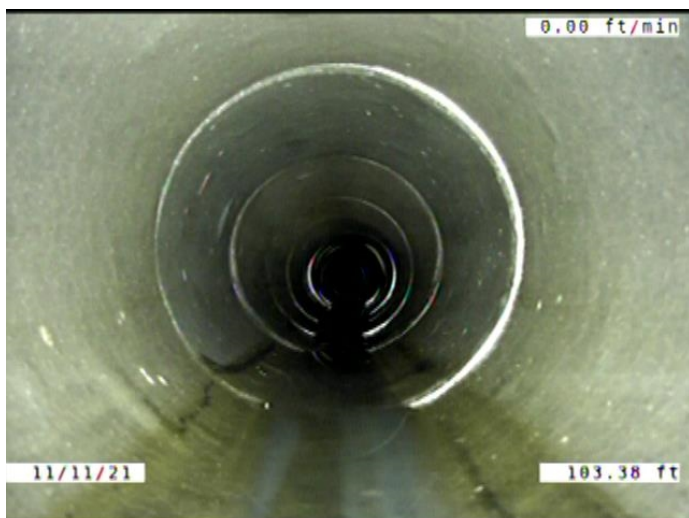
Code: **DSF**
Description: **Deposits Settled Fine**

Distance (ft): **103.4**
Structural Grade: **0**
O&M Grade: **2**
Clock Start/From: **5**
Clock To: **7**
1st Value:
2nd Value:
Value Percent: **5.000**
Continuous Index: **F01**
Within 8" of Joint: **YES**
Remarks:

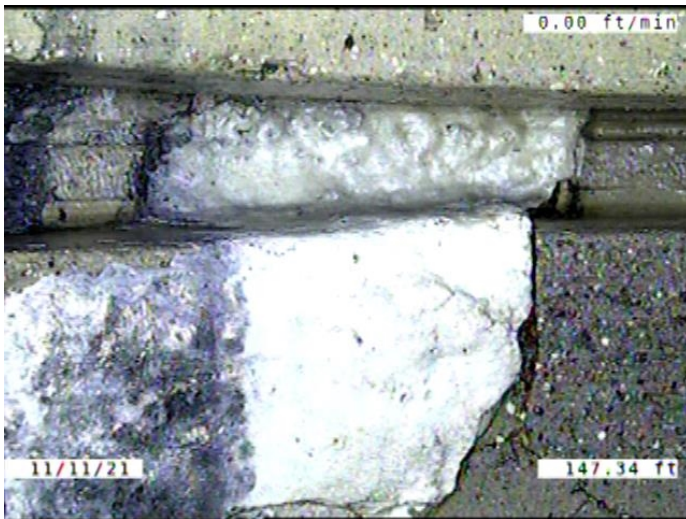
Code: **DAE**
Description: **Deposits Attached Encrustation**

Distance (ft): **147.3**
Structural Grade: **0**
O&M Grade: **2**
Clock Start/From: **9**
Clock To: **10**
1st Value:
2nd Value:
Value Percent: **5.000**
Continuous Index:
Within 8" of Joint: **YES**
Remarks:

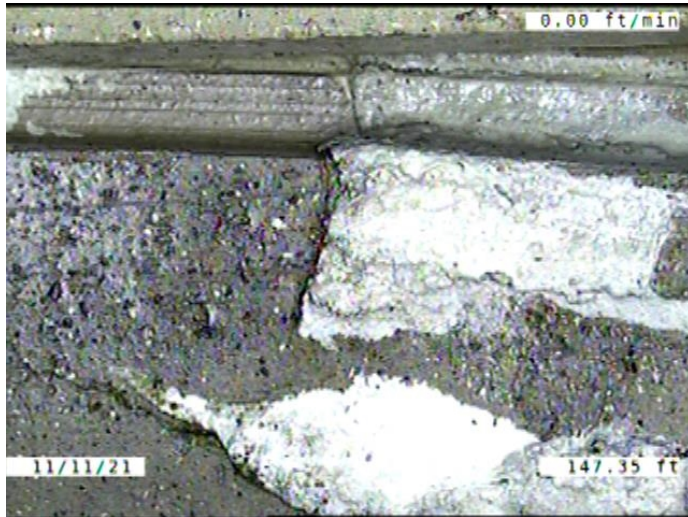
Code: **DAE**
 Description: **Deposits Attached Encrustation**

Distance (ft): **147.3**
 Structural Grade: **0**
 O&M Grade: **2**
 Clock Start/From: **1**
 Clock To: **3**
 1st Value:
 2nd Value:
 Value Percent: **5.000**
 Continuous Index:
 Within 8" of Joint: **YES**
 Remarks:

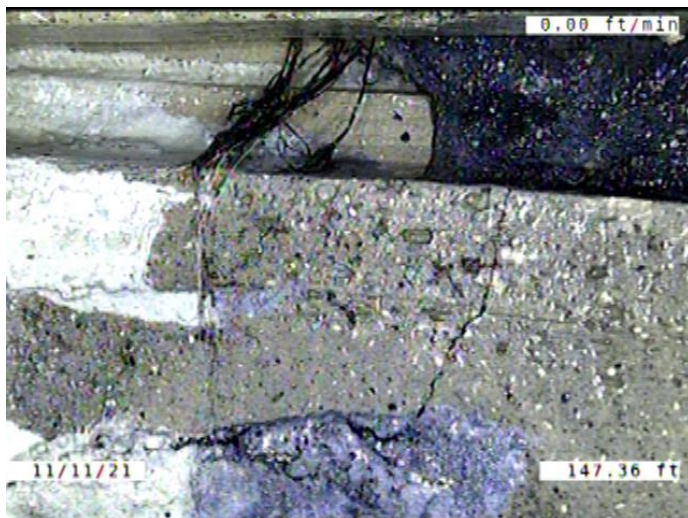
Code: **RFJ**
 Description: **Roots Fine Joint**

Distance (ft): **147.4**
 Structural Grade: **0**
 O&M Grade: **1**
 Clock Start/From: **3**
 Clock To:
 1st Value:
 2nd Value:
 Value Percent:
 Continuous Index:
 Within 8" of Joint: **YES**
 Remarks:

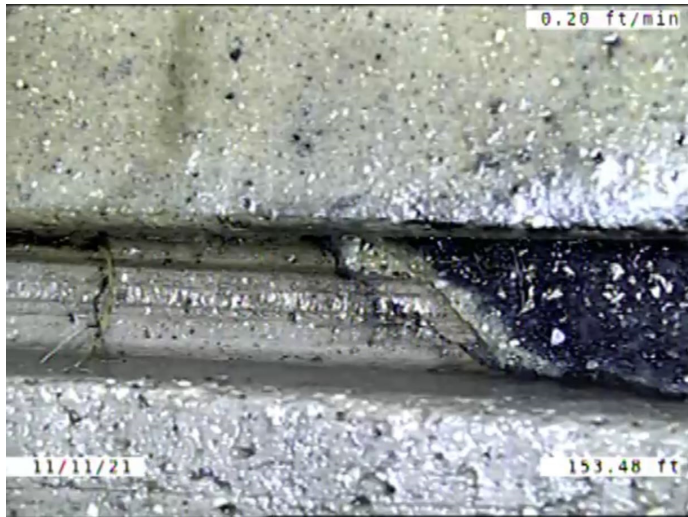
Code: **CM**
 Description: **Crack Multiple**

Distance (ft): **153.5**
 Structural Grade: **3**
 O&M Grade: **0**
 Clock Start/From: **7**
 Clock To: **5**
 1st Value:
 2nd Value:
 Value Percent:
 Continuous Index:
 Within 8" of Joint: **YES**
 Remarks:

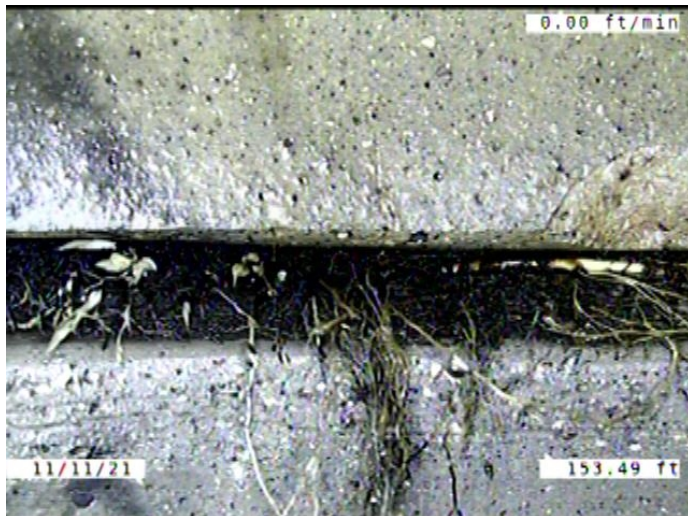
Code: **RFJ**
 Description: **Roots Fine Joint**

Distance (ft): **153.5**
 Structural Grade: **0**
 O&M Grade: **1**
 Clock Start/From: **9**
 Clock To: **2**
 1st Value:
 2nd Value:
 Value Percent:
 Continuous Index:
 Within 8" of Joint: **YES**
 Remarks:
